Results on assessing the effectiveness of wall-window interface details to manage rainwater

Lacasse, M. A.; Manning, M. M.; Rousseau, M. Z.; Cornick, S. M.; Plescia, S.; Nicholls, M.; Nunes, S. C.

11th Canadian Building Science and Technology Conference [Proceedings], pp. 1-14, 2007-03-22

NRCC-49201

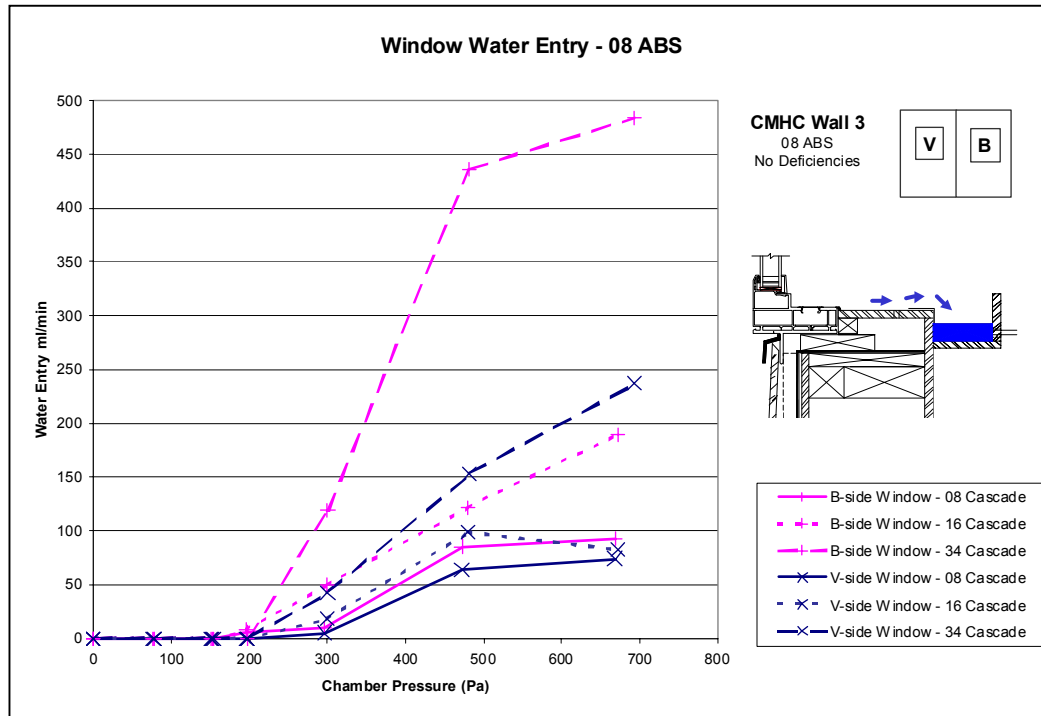
Figure 5 – Water collection rates to trough located at window of specimen W3 (Figure 3 (c) – trough (1)); collection rates (ml/min) are shown in relation to pressure differential (“chamber pressure”) across test specimen (Pa) for both B- and V-side of specimen at different water cascade rates for which, for example, “08 Cascade” refers to nominal cascade rate of 0.8 L/min.-m². The test was conducted for a specimen having an ABS leakage of 0.8 L/s-m² at 75 Pa.

Results from tests in which no deficiencies were introduced on the specimen indicated very little or no water entry to the sub-sill area or behind the cladding for either the B- or V-side of the specimen. However, above a differential test pressure of 200 Pa, water entry at the windows increased substantially. This might have been expected given the sliding window used in the upper part of the combination window; the sliding window is rated as CSA B3 (i.e. 300 Pa). As shown in Figure 5, at the highest differential pressure and water cascade rate (i.e. 700 Pa and 3.4 L/min-m², respectively) water entry at the window of the B-side was roughly double that of the V-side up to a maximum of 484 ml/min on the B-side, and 237 ml/min on the V-side. As well, above these pressure levels, the rate of water entry for either side was dependent on both, increases in water cascade rate and increases in pressure differential. The difference in entry rates across windows that nominally have the same expected performance rating is perhaps due to the

difference in respective water loads at the face of the window proper. These loads are typically affected by any protrusions from the cladding plane be they the window profile or drip cap flashing placed at the head of the window. Both windows had head flashing however, the window on the B-side projected out from the cladding plane to a greater extent (~ 16-mm) than the window on the V-side; hence, the B-side window may have been exposed to more a more substantial water load accounting for the increased entry rates on the B-side as compared to the V-side at the window.

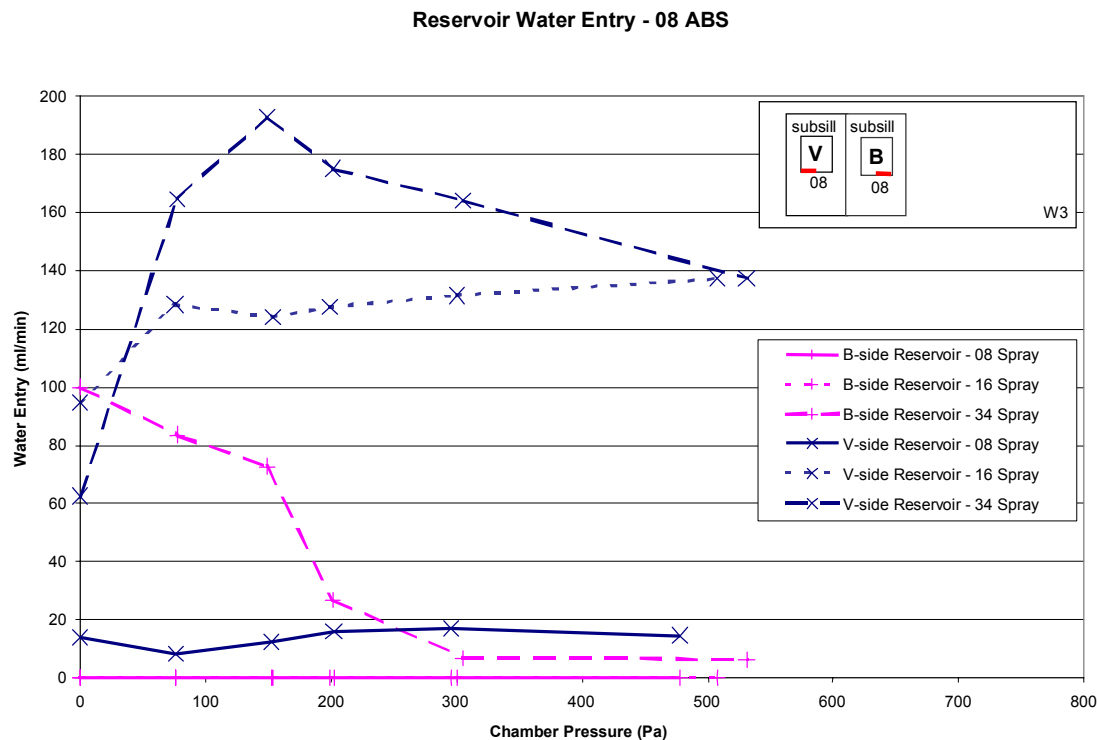
Figure 6 - Water collection rates to trough located beneath subsill (Figure 4 – trough 3) for both B- and V-side of

specimen W3. Collection rates (ml/min) are shown in relation to pressure differential (“chamber pressure”) across test specimen (Pa) at different water cascade rates for which, for example, “08 Cascade” refers to nominal cascade rate of 0.8 L/min.-m². The test was conducted for a specimen having a nominal ABS leakage of 0.8 L/s-m² at 75 Pa.

Water collection in the trough beneath the subsill (see Figure 4, trough (3)) indicated substantial amounts of water entry for the V-as compared to the B-side of the specimen. As shown in Figure 6, at the lowest rate at which water was deposited on the cladding (i.e. 0.8 L/min.-m²) there was no water collected on the B- as compared to the V-side, the rate of collection in trough (3) over the applied differential pressure across the specimen not exceeding ca. 20 ml/min. At a water deposition rate of 1.6 L/min.-m² only the V-side registered water entry, comparatively substantial amounts ranging from ca. 100 to 140 ml/min being collected. At 3.4 L/min.-m², the highest cascade rate tested, water entry was recorded for both sides of the test specimen and ranged from ca. 60 to 190 ml/min, the peak occurring on the V-side, at 150 Pa pressure difference. Notably, water was collected when no pressure was applied across the assembly at substantial rates, upwards of 100 ml/min for the B-side. The entry rates were not dependent on changes in pressure; however, changes in water cascade rate did bring about increases in rates of entry to the collection troughs.
