Field performance of water mains buried in expansive soil

Hu, Y.; Vu, H. Q.

1st International Structural Specialty Conference (CSCE 2006) [Proceedings], pp. 1-13, 2006-05-01

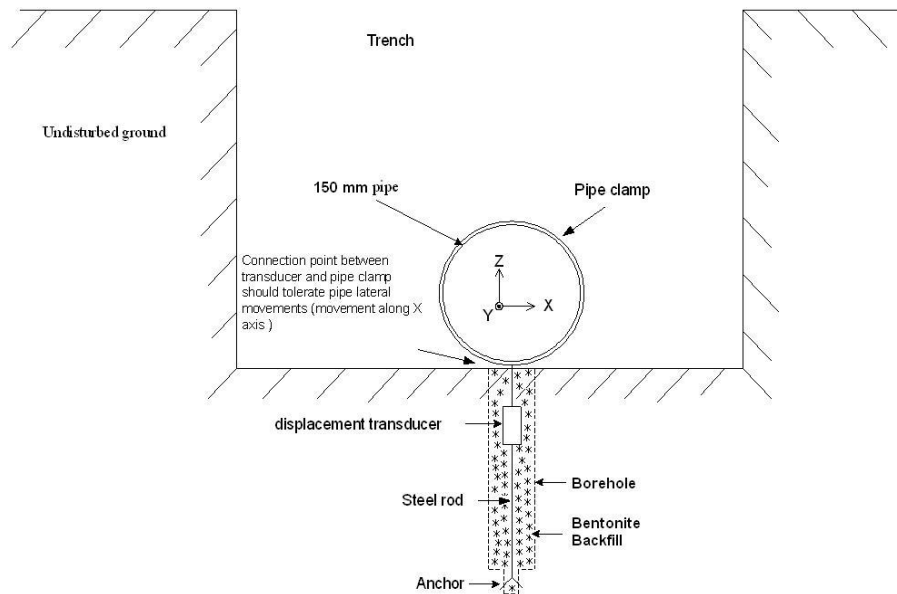
Three custom-built Geokon Model 4450 vibrating wire displacement transducers were installed. One end of each extensometer was attached to the instrumented pipe section with a custom-built clamp to make sure that the extensometers have the same displacement as the pipe at the clamped position. The other end of each extensometer was installed in a borehole and anchored to the ground about 3.6 m below the bottom of the trench (i.e., about 6.6 m below the ground surface). It is believed that the soil at this level will have little movement due to changes in conditions of interest to this work. Thus, the displacements measured by the extensometers should reflect those of the pipe. The boreholes were sealed with Bentonite to prevent water flow into the boreholes and, thus, unintended changes in soil moisture conditions (Figure 2).

Figure 2. Schematic of Rod Extensometer Connection and Installation

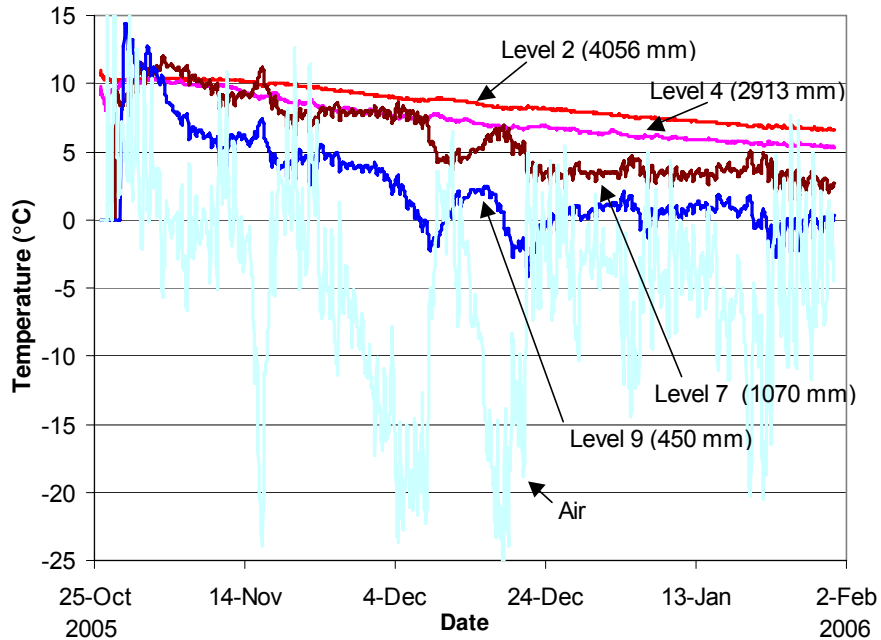
Figure 3 shows the average temperatures from representative levels. It can be seen from this figure that, above the pipe level (Level 4), the closer to the ground surface, the more variable the temperatures; at and below the pipe level, temperature dropped at a fairly stable rate and has not gone below freezing. The deepest 0° isotherm has reached about 700 mm below the pavement surface to the end of January.

Figure 3. Temperature versus time at different levels in the trench

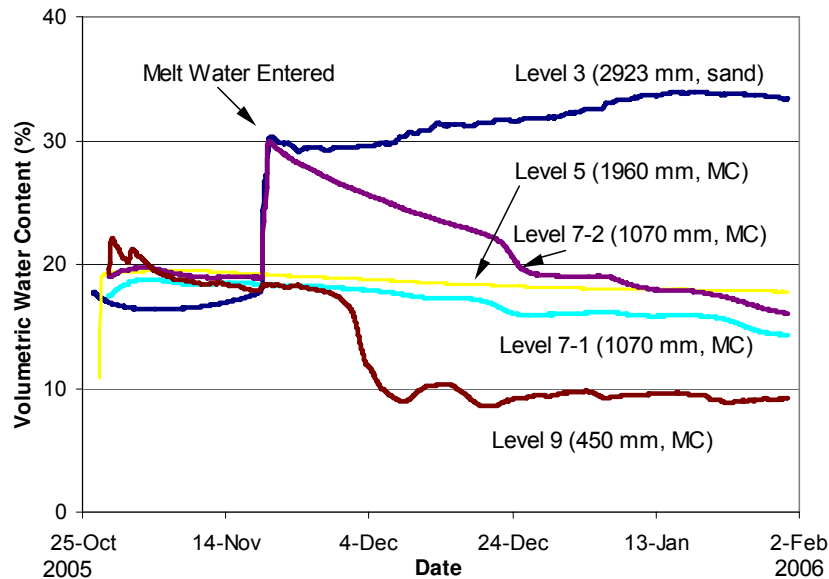
The volumetric water contents at different levels are shown in Fig. 4. This figure shows the water content measurements in the backfill only. The manufacturer-provided calibration curve for the clay soil needs to be re-calibrated and this work is currently being performed. A sudden increase in water content was observed for all sensors at Level 3 and some of the sensors at Level 7 because water from snow melt entered into the trench from the cracks between the new pavement and the curb on November 19, 2005. Although the cracks were later sealed, some TDRs close to the cracks were still affected. Except for Level 3, the water content values in all other levels tended to decrease. It may indicate that water was draining from the top of the trench to the bottom of the trench. Because the clay soil below the trench bottom has a very low permeability, water will accumulate at the bottom of the trench, which may explain the increase in water content at Level 3. The TDRs at Level 9 experienced a big drop in water content that then leveled out. This drop is associated with the freezing of the water at that level. In mid-December the soil temperature at this level was below zero and from that time on the readings from the probes were not valid.

Figure 4. Volumetric water content versus time at different levels in the trench

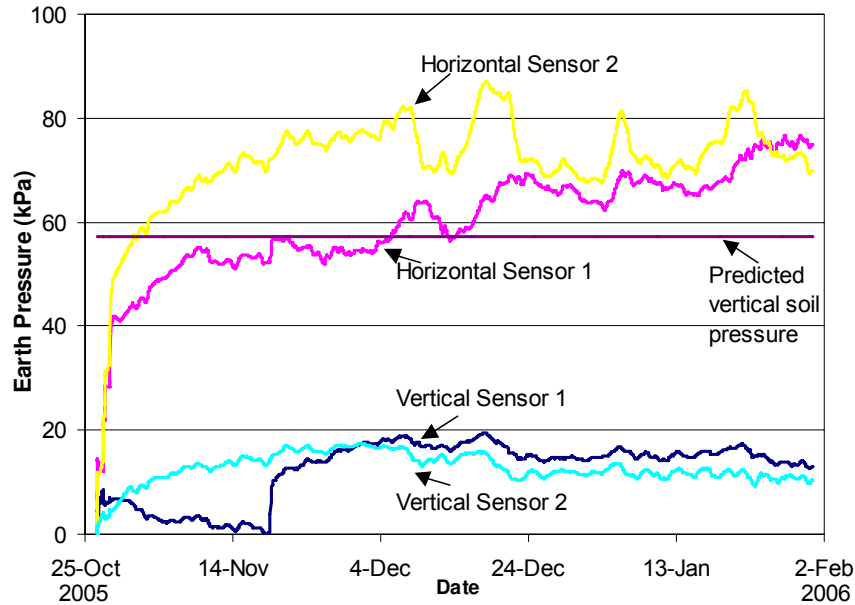
Figure 5 shows the earth pressures experienced by the four pressure cells. The vertical and the horizontal soil pressure increased during the first month, indicating the stabilization of the backfill. After the initial stabilization, it appears that the backfill entered a relatively stable stage with the two vertical measurements approaching each other and the two horizontal ones close to each other as well.

Figure 5. Earth pressures in the trench

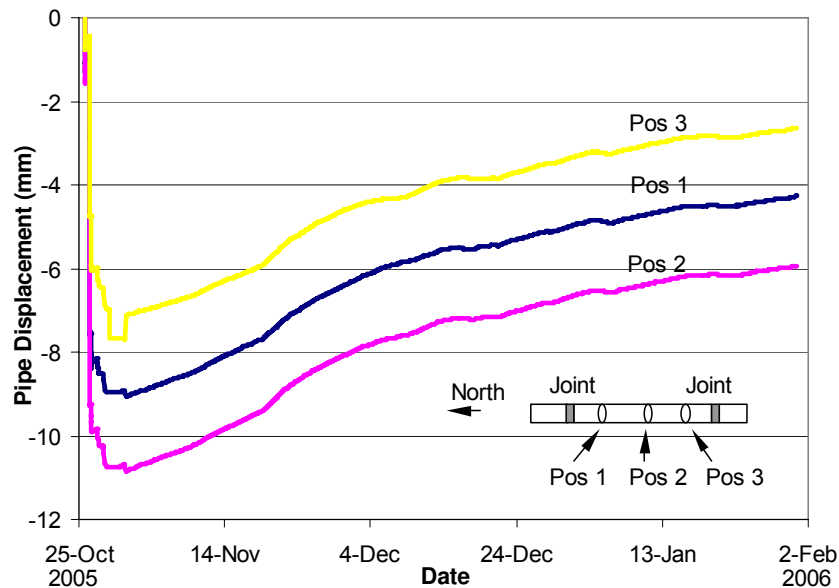
The pipe displacements measured by three displacement transducers are shown in Fig. 6. An initial downward movement was observed for all the three locations. The downward movement was induced by increased pressure from the backfill during construction. After the construction, the pipe tried to establish its new equilibrium position and the displacements were recovering gradually. It can also be observed that the pipe had bigger displacements in its mid-span location (Pos 2) than those of the two other measured locations (Pos 1 and Pos 3). It is understandable because the two ends of the pipe were restrained by joints and could only move slightly in the vertical plane. If the sand bedding was more or less evenly distributed, the pressure from backfill and soil stabilization would produce a bigger displacement around the mid point of the pipe section.

Figure 6. Pipe displacements

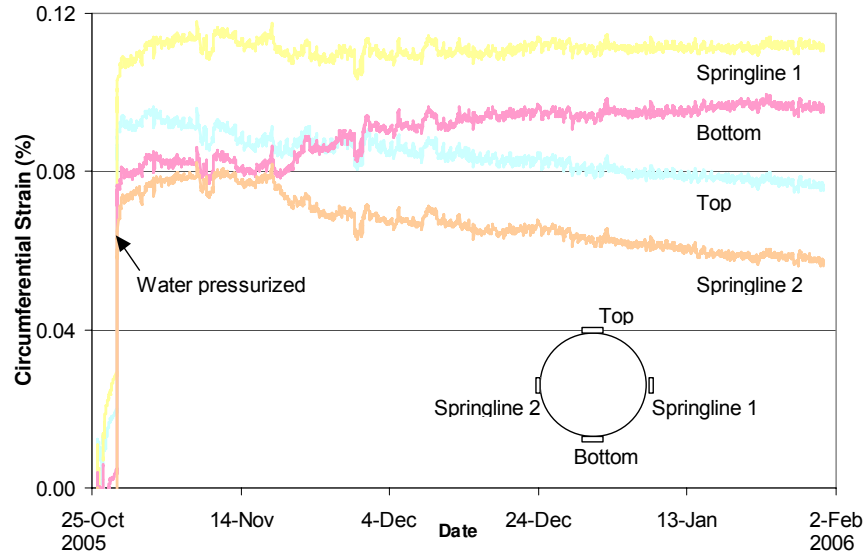
Figure 7 shows the measured circumferential strains at the mid-point of the pipe section (Pos 2). The strains at the other two locations (Pos 1 and Pos 3) have the same magnitude and similar change pattern and are therefore not included here. All the sensors experienced a sudden increase in tensile strain because the pipe was water pressurized at the 4th day of the construction. This figure shows that after pressurization the circumferential strains were in the range between 0.06% and 0.12%.

Figure 7. Circumferential strains at the mid-point of the pipe section

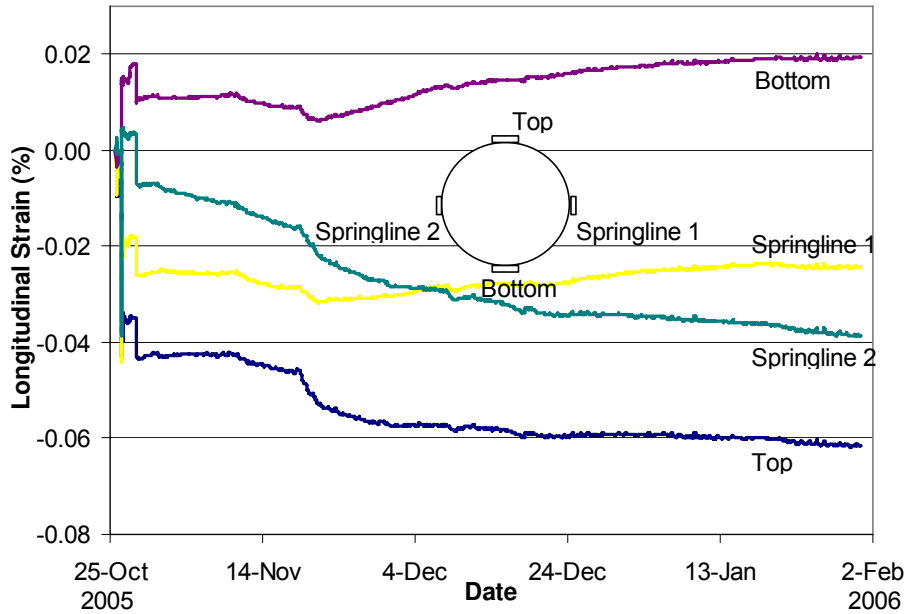
The longitudinal strains at the mid-span section (Pos 2) of the pipe are shown in Fig. 8. The longitudinal strains at the other two locations have a pattern similar to that shown in this figure and are not included here. It is noted that the strain at the top of the pipe has a negative sign whereas that on the bottom of the pipe a positive sign, indicating the pipe was bending downwards, which is consistent with the measurements from the displacement transducers. The strains from the two springlines fall between the top and the bottom, suggesting that the horizontal deformation of the pipe is not as great as the vertical.

Figure 8. Longitudinal strains at the mid-point of the pipe section

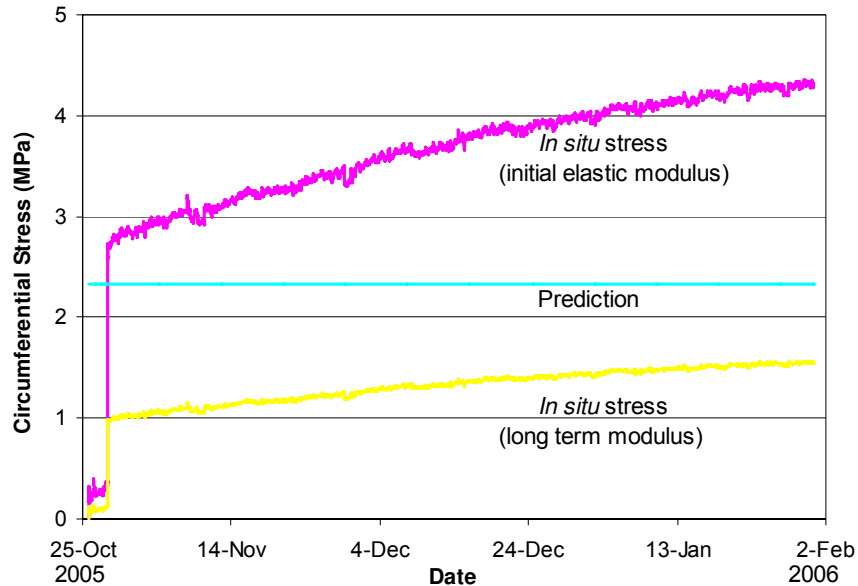
Figure 9 shows the average *in situ* circumferential stresses at the mid-point of the pipe section. Because PVC pipe undergoes creep deformation under loading, two moduli were used to calculate the average stresses: one being initial elastic modulus of 3030 MPa, the other the long-term modulus of 1090 MPa (AASHTO 1998). The third curve is the predicted circumferential stresses on the outside pipe surface calculated from the following equation:

where r_i is the inside pipe radius, r_e the outside pipe radius, p_i the water pressure and p_e the backfill soil pressure. The local operating water pressure is 390 kPa and the backfill soil pressure can be predicted from Eq. (1). As can be seen from the figure, the predicted circumferential stresses based on the operating water pressure and the predicted backfill soil pressure fall within the *in situ* stress ranges calculated using the initial elastic and long term moduli of the pipe material. It should be noted that Eq. (3) is a simplified evaluation of the circumferential stress. The circumferential stress under external load also depends on the bedding conditions. The detailed analysis can be performed either analytically or numerically (Eatkins and Anderson, 2000).

Figure 9. Comparison of the predicted circumferential stresses with *in situ* stresses at the mid-span section of the pipe

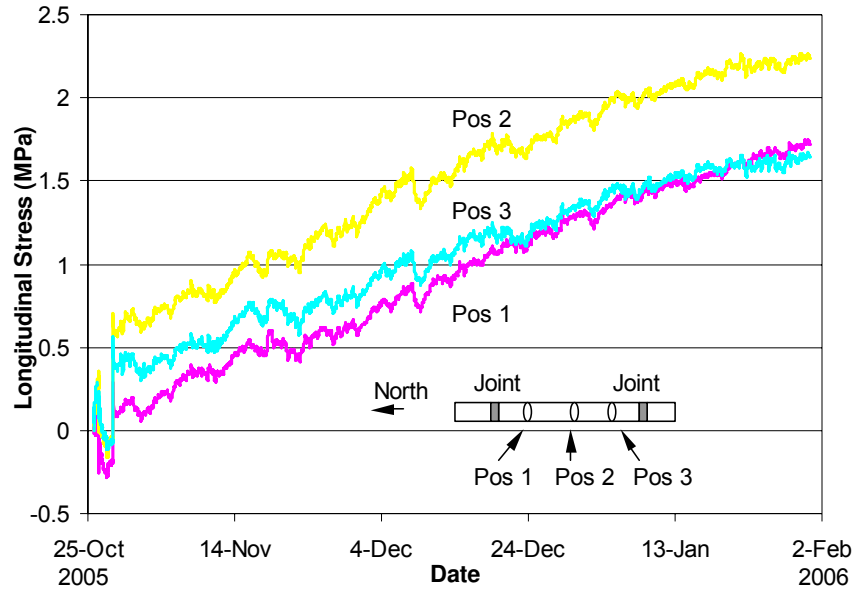
The average *in situ* longitudinal stresses at the three locations (Pos 1, 2 and 3) were calculated using the initial elastic modulus and are shown in Fig. 10. The stresses at the mid span (Pos 2) are higher than those of the other two locations (Pos 1 and 3). It is expected because the average longitudinal stresses were partly induced by temperature variation in the pipe while the pipe deformation is restrained by the surrounding soil (at each joint of the instrumented PVC section and the adjacent original AC pipe, longitudinal movement is allowed, thus, joint restraint along the longitudinal direction could be neglected). A drop in temperature, as observed in Fig. 3, will induce tensile stresses in the pipe due to the friction. The distribution of the longitudinal tensile stresses due to the thermal effect should be higher toward the center of the pipe and close to zero at the end of the pipe.

Figure 10 Average *in situ* longitudinal stresses along pipe
