Photoluminescent Stairway Installation for Evacuation in Office Buildings

Guylène Proulx and Nouredine Bénichou
National Research Council of Canada, Ottawa, Canada

ABSTRACT: Two experiments were conducted to assess the effectiveness of photoluminescent material (PLM) in support of occupant evacuation in office buildings. The first study completed in 1999 was designed to assess the potential use of PLM as a safety communication system to support office occupant evacuation. The study, conducted with PLM made of zinc sulphide pigments, measured the occupants' pre-movement time, movement time and evacuation speed in four stairways with different lighting and PLM installations. The positive outcome of the first study regarding a comparable speed of movement in the different stairways used and the conclusive feedback from the evacuees regarding the PLM wayguidance system led to a second study. The second study, completed in 2008, compared 3 stairway installations of PLM markings and a stairway with emergency lighting, which acted as a reference stairway. This second study used the new generation of alkali earth aluminates PLM pigments providing a brighter output than the first study. R

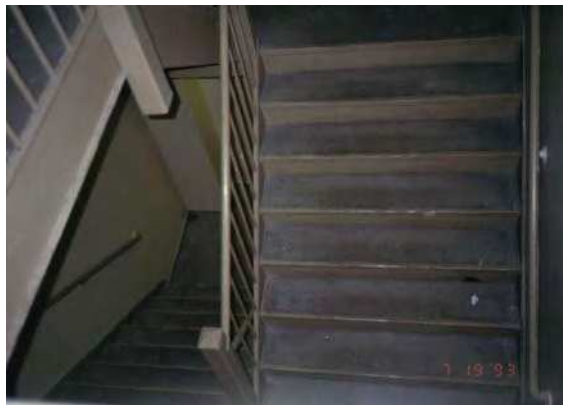
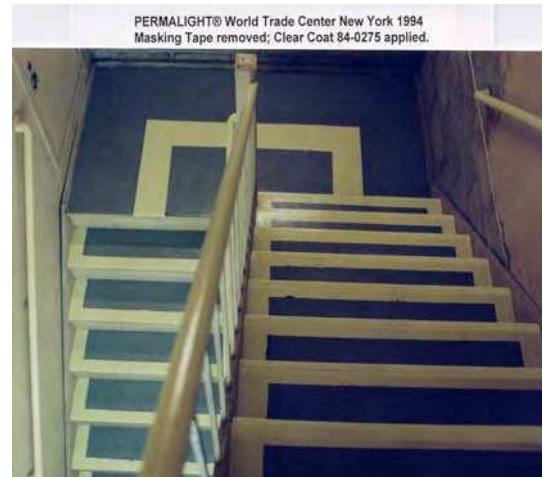
Figure 1. Pictures of a WTC stairway before and after PLM installation after the 1993 event

Soon after this event, the Port Authority of New York and New Jersey, on the recommendation of evacuation experts, decided to install PLM markings in all the stairways of the WTC complex. The installation was made with a PLM paint product from Permalight. The paint installation was a labour intensive job. It required to mask with tape the outline to be painted, apply a base white coat, 3 coats of PLM paint, and a clear sealant on top. The PLM paint was made of zinc sulphide pigments. As can be seen in Figure 1, PLM paint was applied on the handrails, on the nose and side of each step and as a continuous strip on every landing and mid-landings. PLM signs were added on every door in the stairway enclosure identifying the floor level, stairway name and closest re-entry floors.

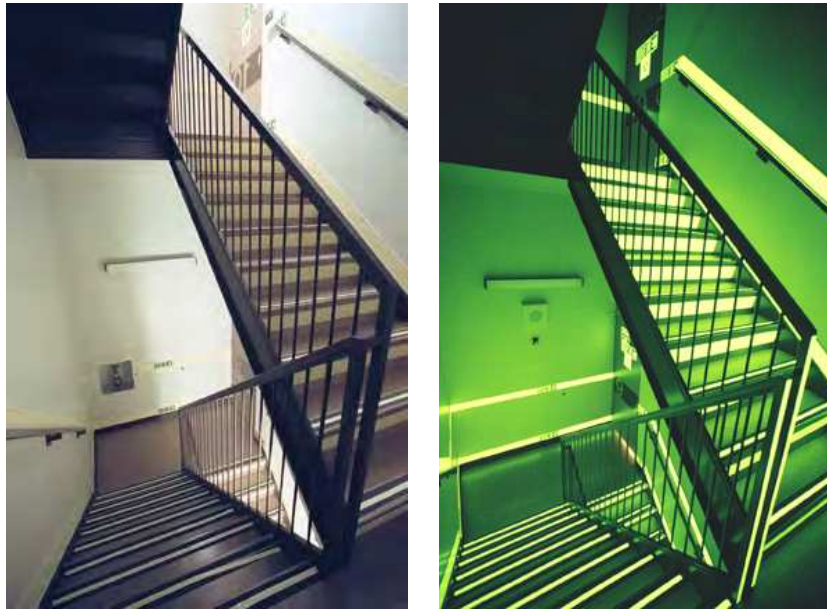
Figure 4: Stairway C with PLM marking, lights on and off, First Study

The typical illumination in the four stairways prior to the fire alarm activation was on average 245 lux. When the alarm was activated, lights were switched off in Stairway C as shown in Figure 4. The PLM output in Stairway C was 89.1 mcd/m² after 2 min of switch off, 7.0 mcd/m² after 30 min and 3.2 mcd/m² after 60 min. This luminance would not meet the brightness rating required today by NYC RS 6-1, although at the time it exceeded the PSPA standard of 4 mcd/m² after 30 min.

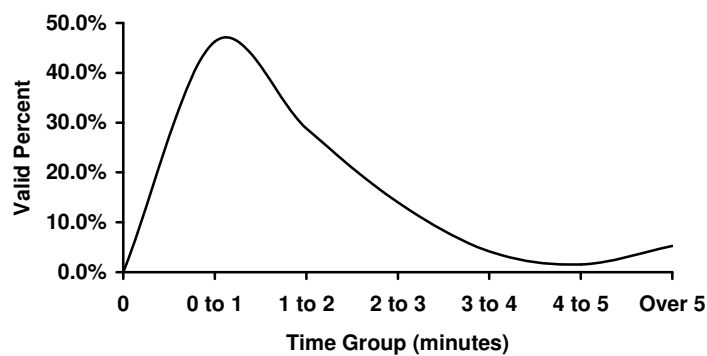
Figure 8. Distribution of premovement time, Second Study

Due to the building’s large surface area and the configuration of the offices and cubicles, it was not possible to record the exact starting time of each occupant upon hearing the fire alarm. It was, however, possible to observe the time of arrival of each person at the at the stairway exit door. The premovement time reported by 46% of the respondents was that they started to leave in less than 1 minute, which is in line with the observation made from the video recordings. Some 29% estimated they took between 1 to 2 minutes to start leaving, 14% took 2 to 3 minutes, and 4% took 3 to 4 minutes. Over 6% or 31 respondents said it took more than 4 minutes to start leaving. Figure 8 shows a distribution of the premovement time. Once occupants decided to evacuate their floor, they moved toward their assigned stairway.

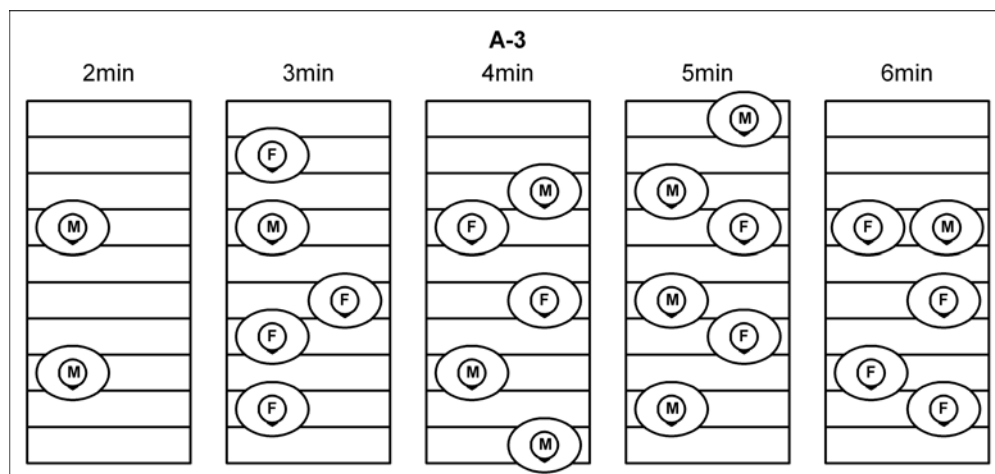
Figure 9. Representation of densities on 3rd floor of Stairway A at different times

Density can be represented by showing positions of evacuees in the stairs, as in Figure 9, which shows density in Stairway A (L marker) on floor 3, at 2, 3, 4, 5 and 6 minutes from the alarm. Such drawings are helpful when analyzing the behaviour of the evacuees as they descend. The representation at 5 min shows the most crowded time of the evacuation, with 6-7 evacuees on one flight of stairs, representing 1.98 p/m². In this kind of crowd it is important to understand that each evacuee has a limited view of the PLM marking as other evacuees are hiding some of the marking. This explains why many mentioned the difficulty identifying the last step of each flight. In a dense crowd evacuees could not see the demarcation line marking the landings and mid-landings so the last step was difficult to identify.
