### Fire resistance of floor assemblies in multi-family dwellings Sultan, M. A.

*Construction Technology Update; no. 20, 1998-09-01*

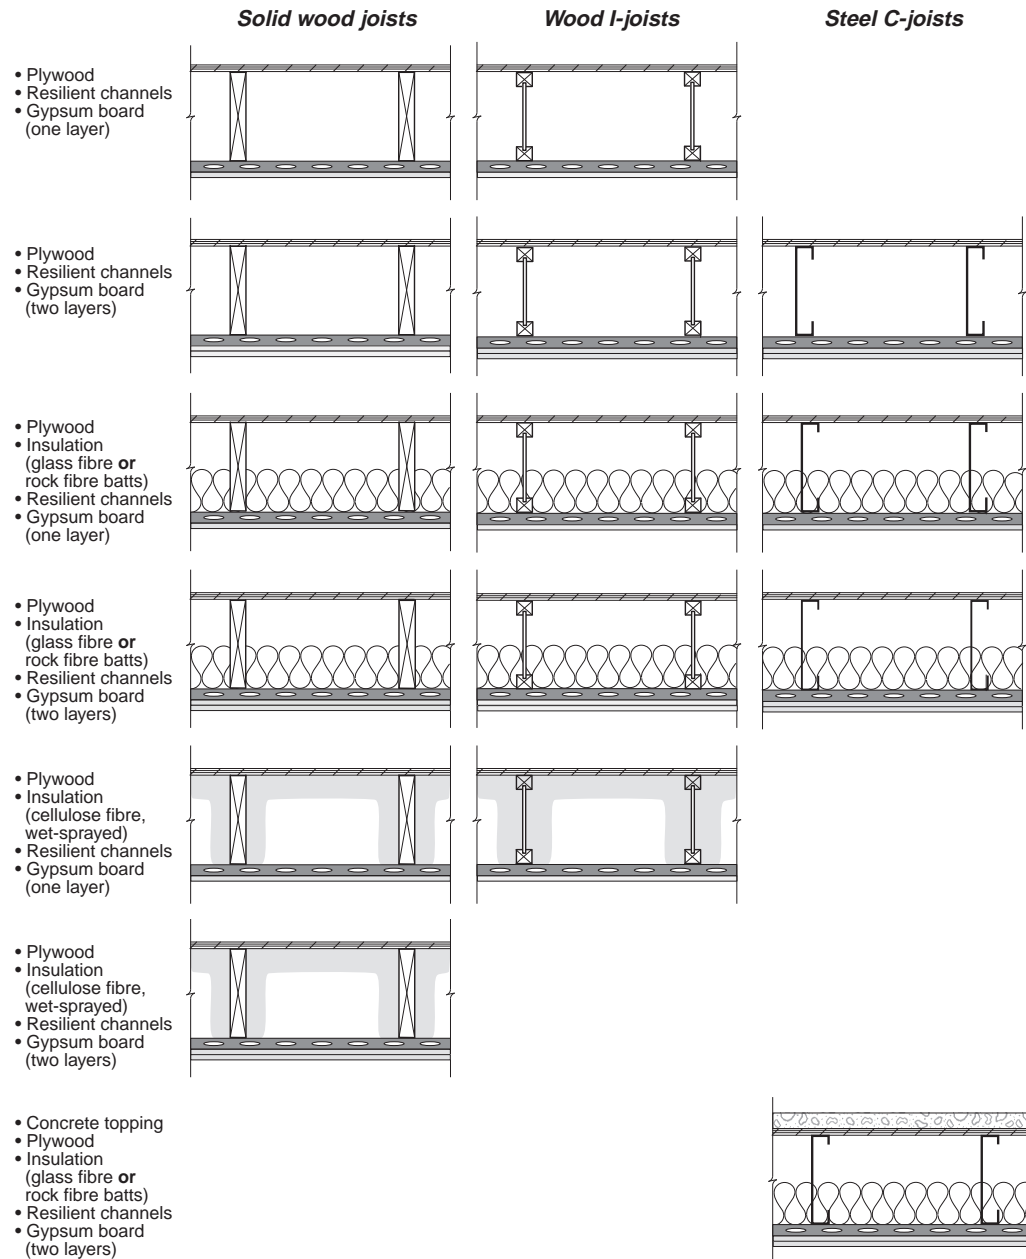
Insulation reduced the fire resistance by 7% in the assembly with glass fibre and increased the fire resistance by 7% in the assembly with rock fibre compared to an assembly with no insulation. The glass fibre

had a negative effect on fire resistance (as was the case with the solid wood joist assembly mentioned above). The rock fibre, however, had a positive effect on fire resistance, contrary to its effect in the assembly with solid wood joists, where it had a negative effect. This difference is due to the difference in failure mechanisms: the solid wood joist assembly failed as a result of flame penetration through the subfloor while the wood I-joist assembly failed structurally as the joists, attacked by fire, were unable to carry the load. Nevertheless, assemblies with wood I-joists, a double layer of gypsum board ceiling finish and glass, rock or cellulose fibre insulation were able to provide a one-hour FRR.
