FIRE DETECTION AND SUPPRESSION STUDIES AT KEMANO VILLAGE

*The Sixth Fire Suppression & Detection Research Application Symposium
Tampa, FL, 23-25 January 2002*

Joseph Z. Su*, George P. Crampton, Don W. Carpenter, Cameron McCartney, Patrice Leroux

Fire Risk Management Program
Institute for Research in Construction
National Research Council of Canada
Ottawa, Canada K1A 0R6

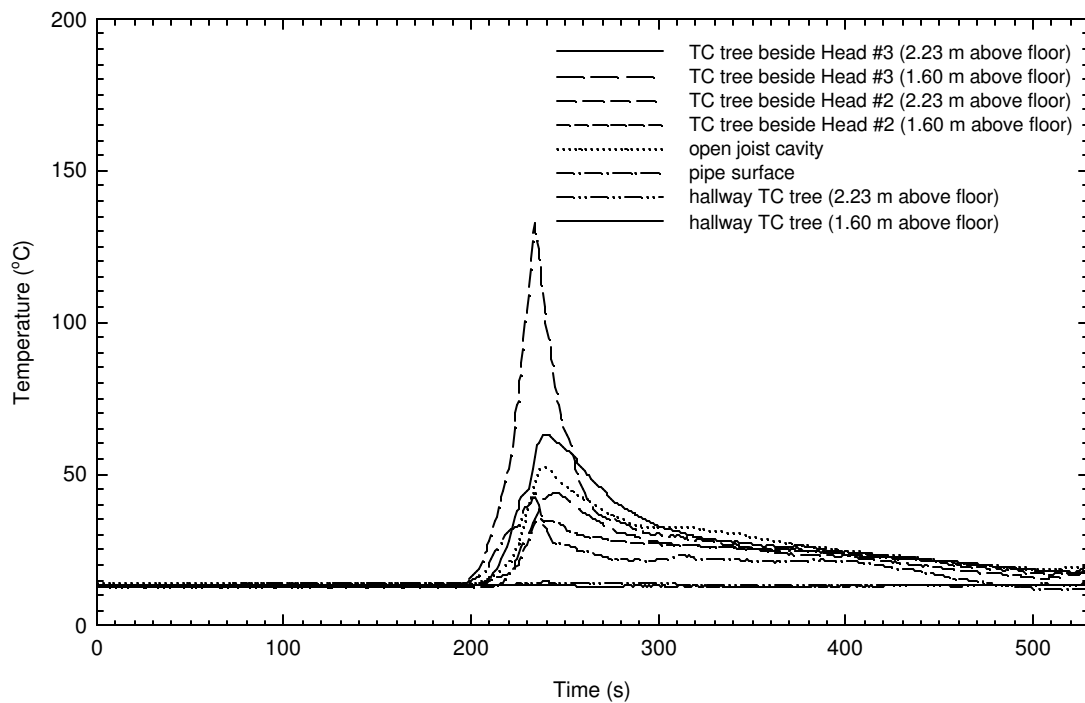
Figure 2. Temperature profiles for sprinkler Test 1 (fuel ignited at 120 s).

Figure 2 shows that the sprinkler quickly controlled the fire and that the room was cooled down to below 20°C during the water spray. The plastic pipe surface temperature at the position closest to the fire was below 50°C during the test. The exposed pipes and fittings had no visible damage during this experiment. The CO concentration inside the room was 100 ppm at the beginning of the water spray and 500 ppm at the end of the water spray.

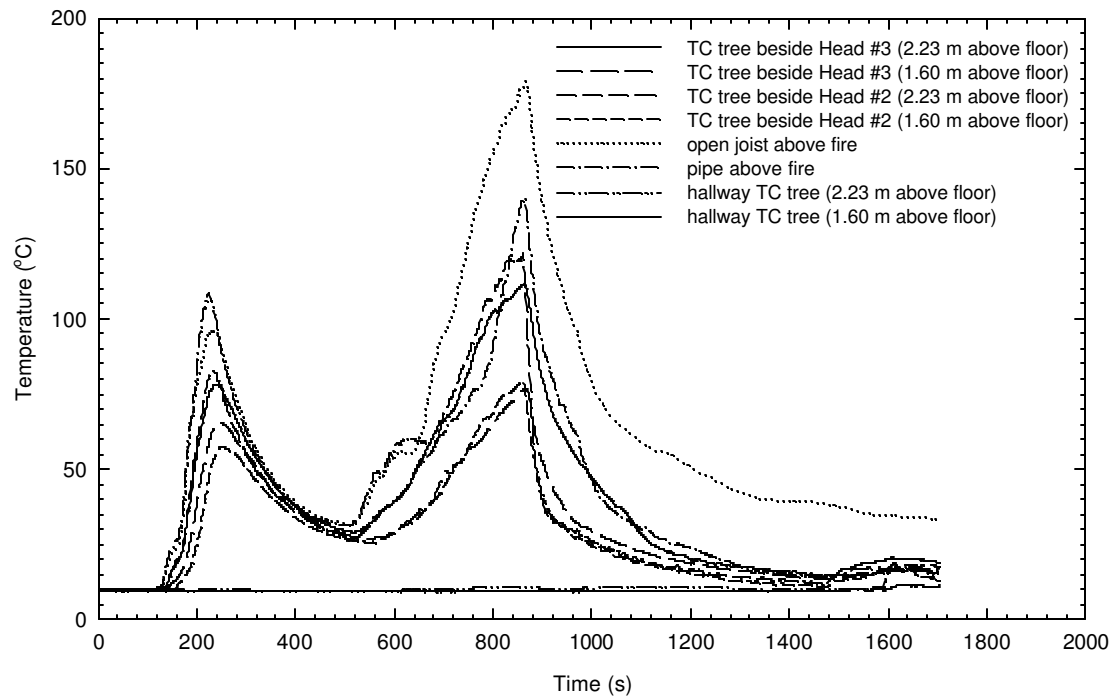
Figure 4. Temperature profiles for sprinkler Test 2 (fuel ignited at 120 s).

Afterwards, the fire was slowly built up again for another 7 minutes as indicated by the rising temperature profiles shown in Figure 4. The peak temperatures finally reached 178°C in the open joist space and 140°C on the plastic pipe right above the chair. One sprinkler head (#2) actuated 740 s after the ignition. This single sprinkler head (#2) controlled and contained the fire. Fire was quickly knocked down within 1 minute of the sprinkler activation.

During the experiment, the plastic pipes and fittings were exposed twice to the temperature of above 93°C, the first for 40 s and the second for 100 s, with the peak exposure of 140°C. It was observed after this test that the exposed pipes and fittings were not visibly damaged. The same pipes and fittings continued to be used in the subsequent experiment.

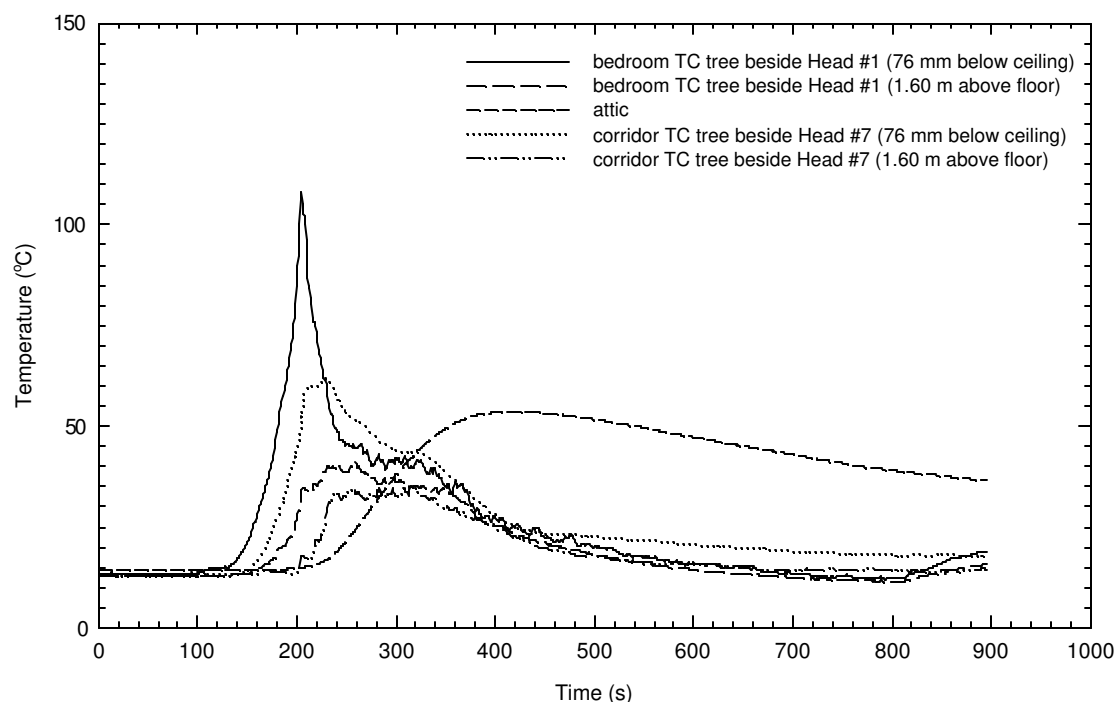
Figure 6. Temperature profiles for sprinkler Test 3 (fuel ignited at 120 s).

Figure 6 shows temperature profiles at various locations during the experiment. The sprinkler head (#1) inside the bedroom actuated 84 s after the ignition. This single sprinkler head controlled and contained the fire under the bed in 1 minute. A few seconds later, visibility was lost in the bedroom and the nearby corridor. Temperatures measured by a thermocouple installed in the attic space (6 mm inside the drywall ceiling) right above the fire, were 54°C at the maximum.

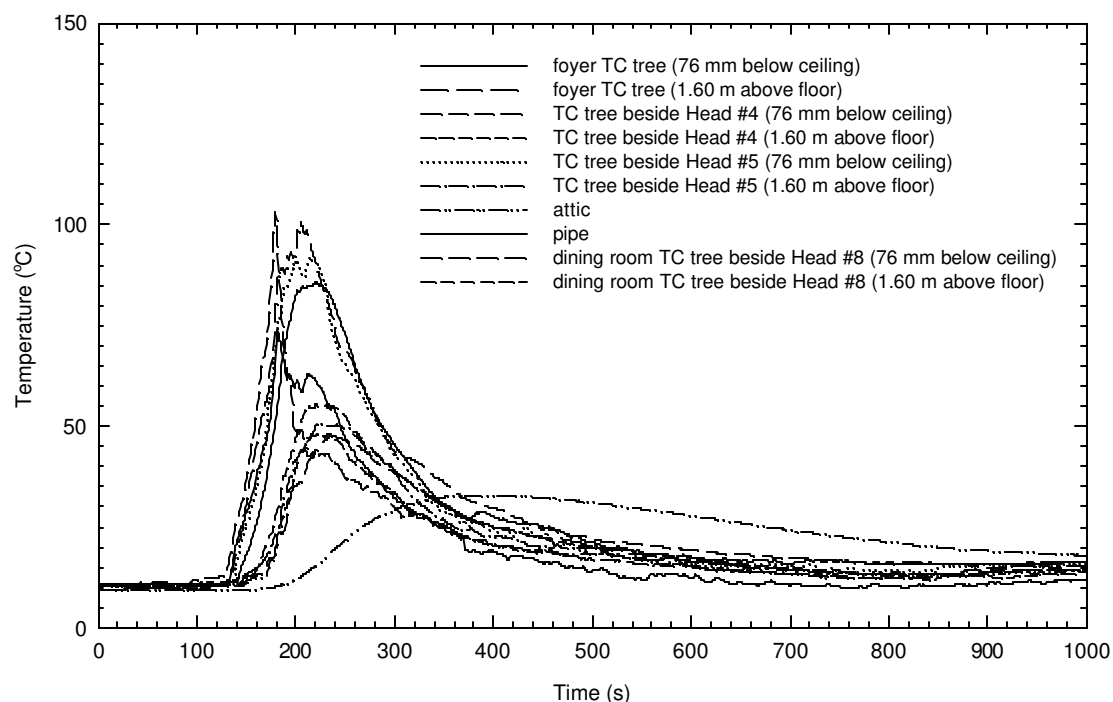
Figure 8. Temperature profiles for sprinkler Test 4 (fuel ignited at 120 s).

Figure 8 shows temperature profiles at various locations during the experiment. A vertical run of the plastic pipe from the attic space to the basement was exposed in the living room and was exposed to a maximum temperature of 74°C during the fire experiment, not exceeding its rated temperature yet. The maximum temperature in the attic space, measured by a thermocouple inside the gypsum board ceiling (6 mm inside) right above the fire, was 33°C, indicating no structural damage [2].
