Performance of partition walls between attached residential units: airtightness, fire and acoustical testing

Bartko, Michal; Mueller-Trapet, Markus; Leroux, Patrice; Ganapathy, Gnanamurugan; Nichols, Mike; Moloughney, Ryan; Moore, Travis; Macdonald, Iain

Client Report (National Research Council of Canada. Construction); no. A1-018032.2, 2023-11-03

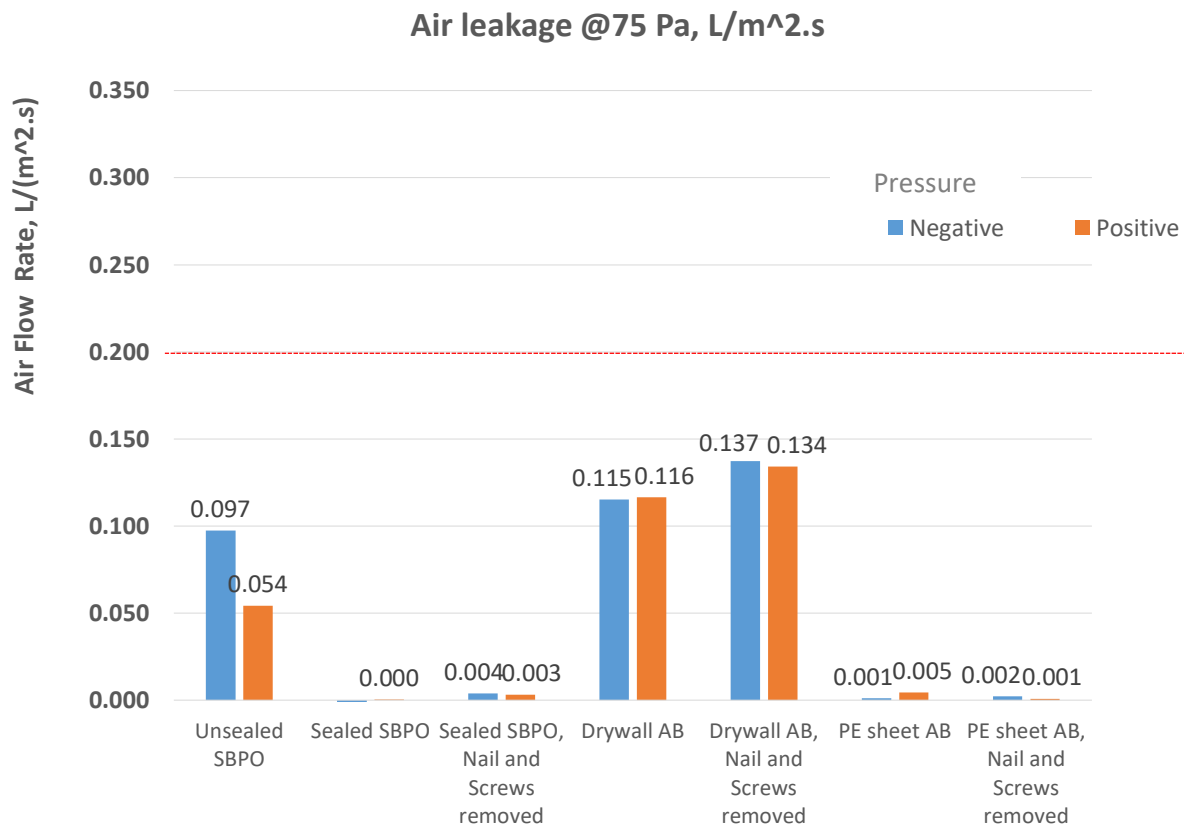
Figure 9. Air leakage test results at pressure difference 75 Pa

The air flow rate test results @ $\Delta p=75$ Pa, $L/(m^2 \cdot s)$ were calculated using the equations (1) and (2). The positive and negative chamber pressure results are presented in Tables 1 and 2, respectively. The graphical interpretation of both the positive and negative pressure test results are presented in Figure 9. The values shown in the tables and the diagram are the average values of the three independent tests.

Given today’s construction practices, the partition wall specimen with airtight drywall air barrier system (Specimen 4) can be considered as a benchmark value. For this specimen, at a 75 Pa pressure difference, the air leakage rate was 0.115 $L/(m^2 \cdot s)$ and 0.116 $L/(m^2 \cdot s)$ for negative and positive pressure differences respectively. The air leakage rates in the airtight drywall system with nail and screw penetrations (Specimen 5) increased to 0.137 $L/(m^2 \cdot s)$ and 0.134 $L/(m^2 \cdot s)$ for negative and positive pressures differences respectively, which represents a 17% increase.

The air flow rates at pressure 75 Pa for an unsealed SBPO sheet specimen (Specimen 1) were 0.097 L/(m²·s) and 0.054 L/(m²·s) for negative and positive pressure differences respectively.

The air leakage for both sealed specimens (SBPO- Specimen 2, and PE membranes- Specimen 6) were essentially non-existent; the flow rates values were 0 L/(m²·s). For both membrane air

The red line at the value of 0.2 L/(m²·s) represents the limit value for airtightness of building envelope assemblies in NBC 2020 and serves for comparison purposes only. The detailed air leakage test results are presented in Appendix B - Air Leakage Test Results.

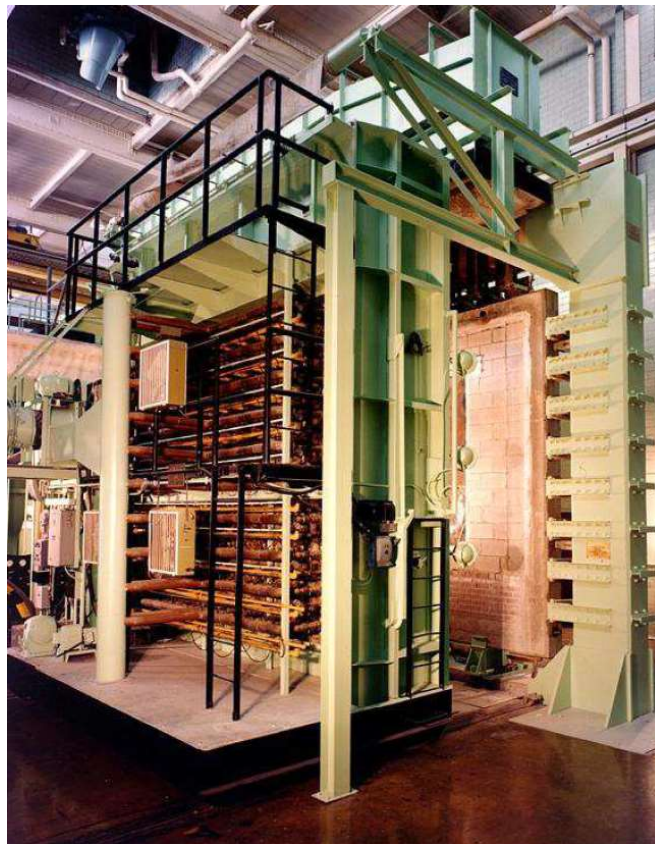
Figure 10. NRC Wall Furnace Test Facility

Preparation and testing of specimens were undertaken at the NRC Construction Research Centre campus on Montreal Road in Ottawa. The Wall Furnace Test Facility shown in Figure 10 was used for this purpose. The chamber size is 12 ft x 10 ft (3.658 m x 3.048 m).

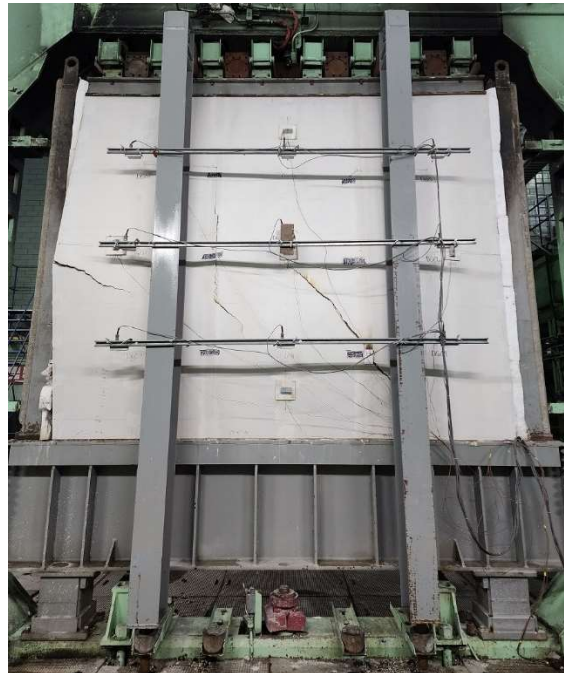
Figure 12. Fire test specimens' failure

The summary of the fire test results for each specimen is shown in Figure 12 and summarized in Table 3. The detailed results are presented in Appendix D - Fire Test Results.

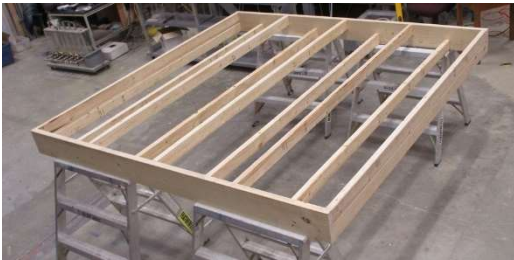
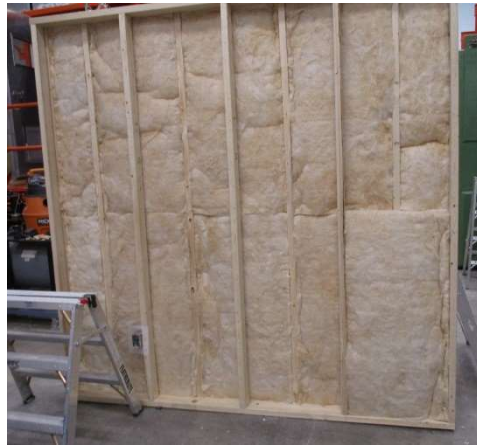
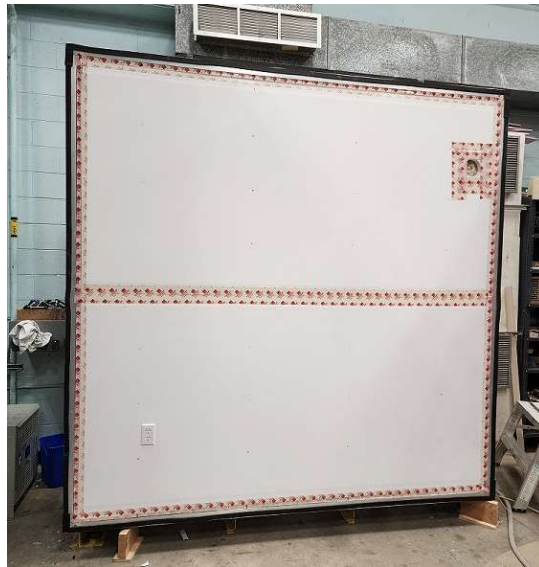
A.1 Specimen 1: Double wood stud wall fragment with two unsealed SBPO membranes AB behind drywall

Figure 15. Specimen 1 construction photos

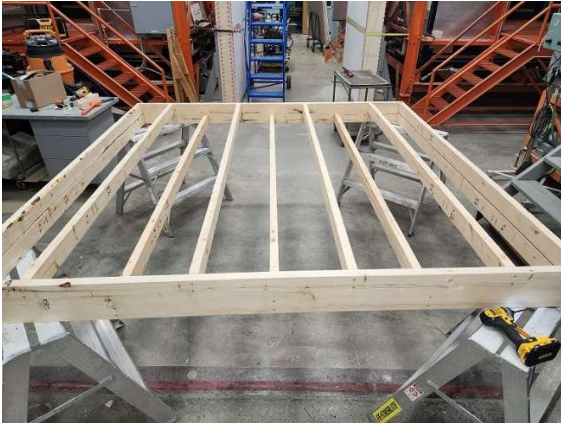
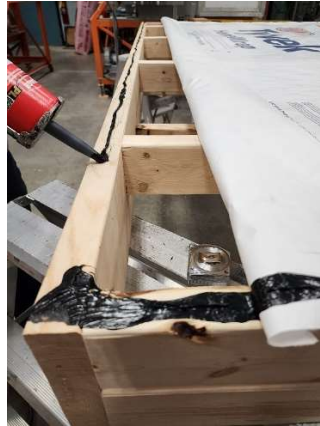
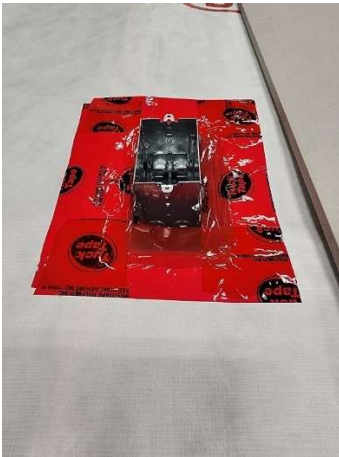
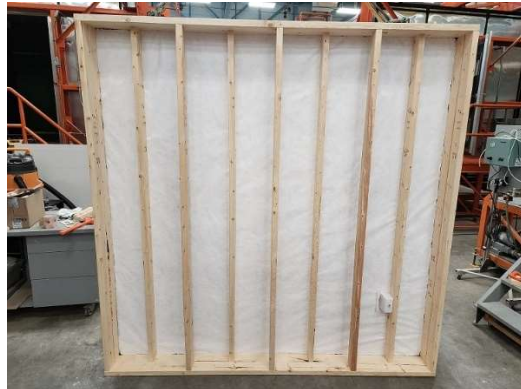
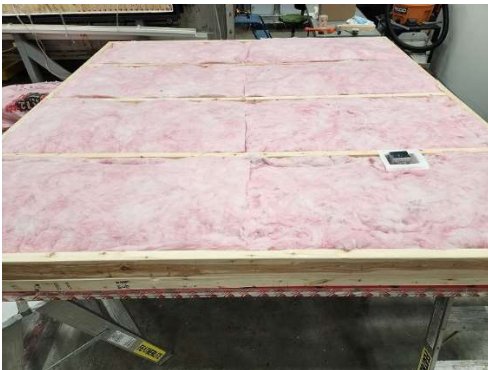
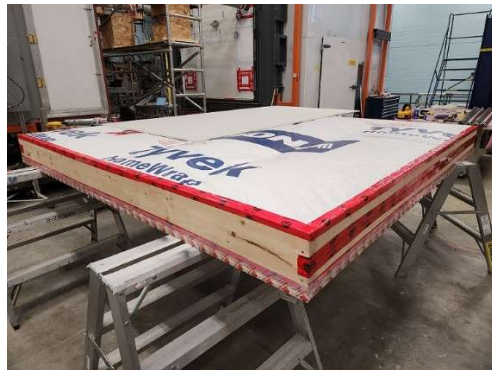
A.2 Specimen 2: Double wood stud wall fragment with two sealed SBPO membranes AB behind drywall

Figure 16. Specimen 2 construction photos

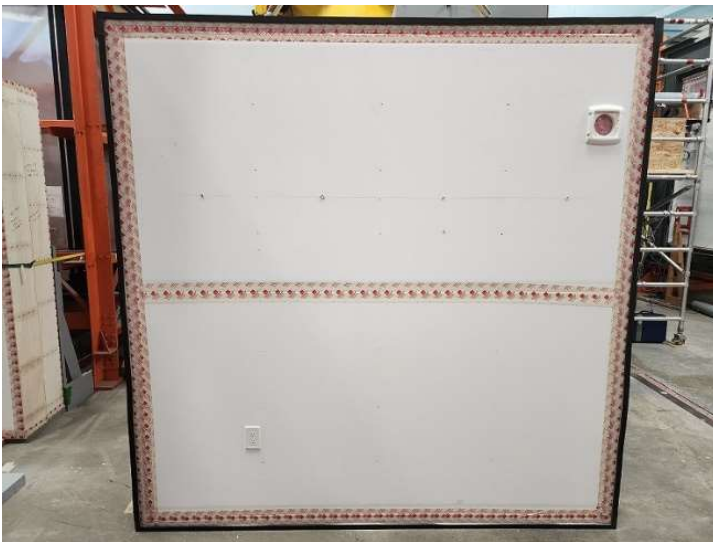
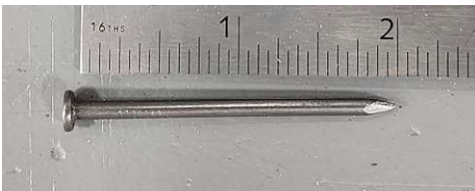
A.3 Specimen 3: Double wood stud wall fragment with two sealed SBPO membranes AB behind drywall with penetrations from nails and screws

Figure 17. Specimen 3 construction photos

Note: Specimen 2 was used to prepare Specimen 3 by making the fasteners penetrations

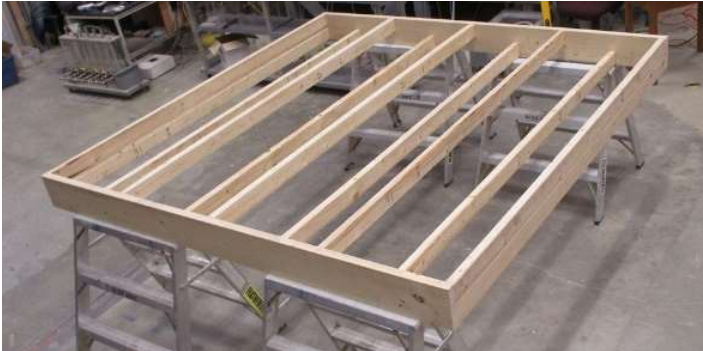
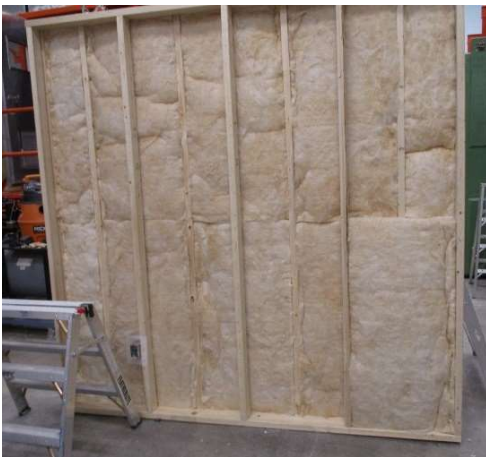
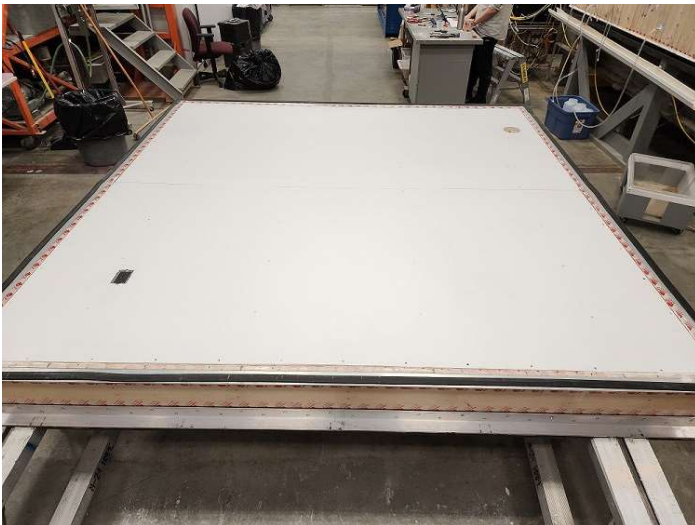
A.4 Specimen 4: Double wood stud wall fragment with airtight drywall AB

Figure 18. Specimen 4 construction photos

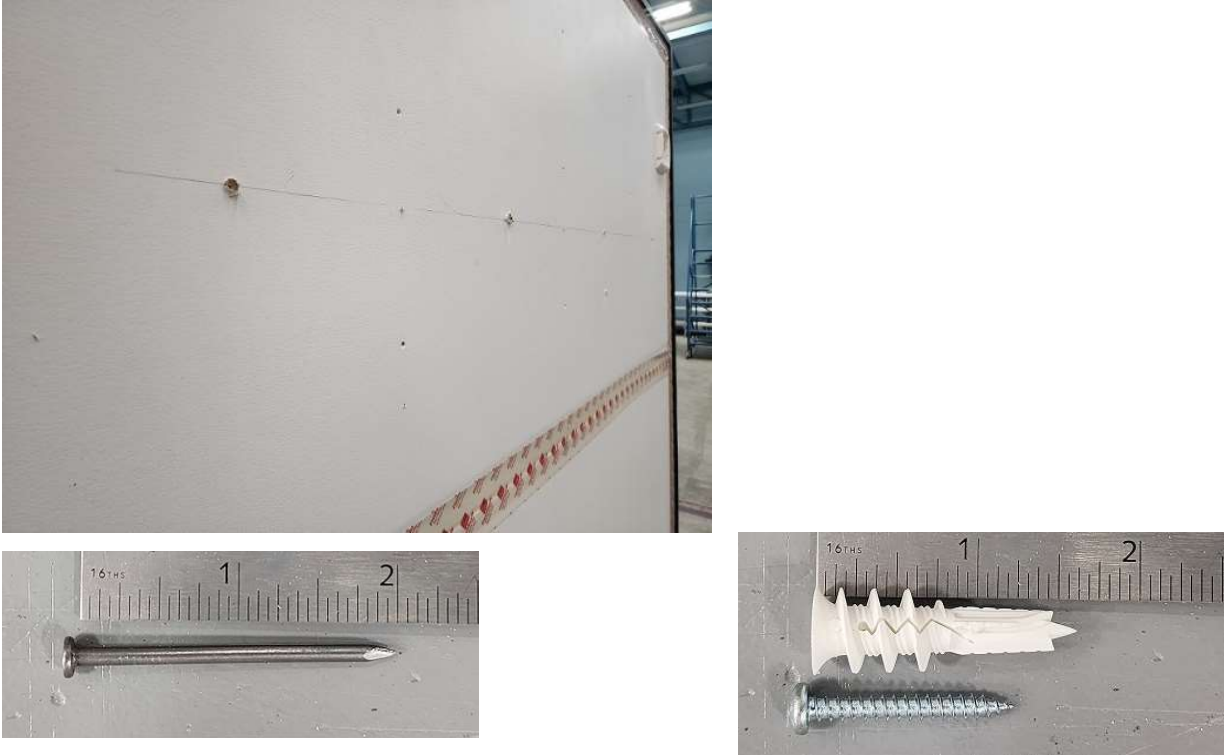
A.5 Specimen 5: Double wood stud wall fragment with airtight drywall AB with penetrations from nails and screws

Figure 19. Specimen 5 construction photos

Note: Specimen 4 was used to prepare Specimen 5 by making the fasteners penetrations

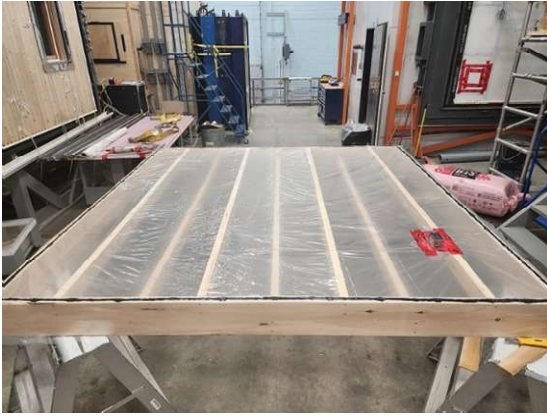
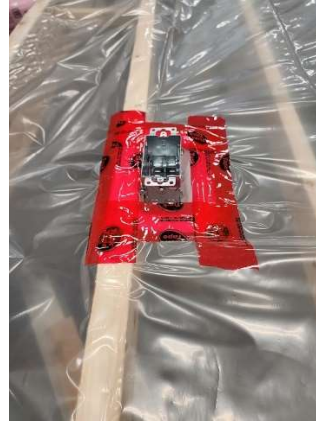
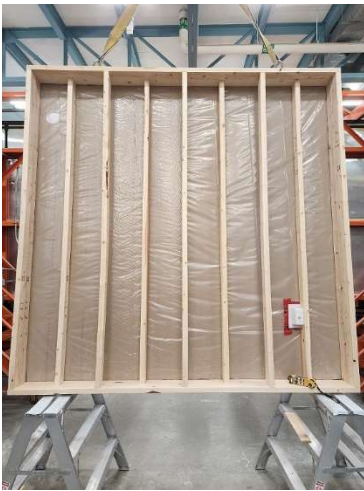
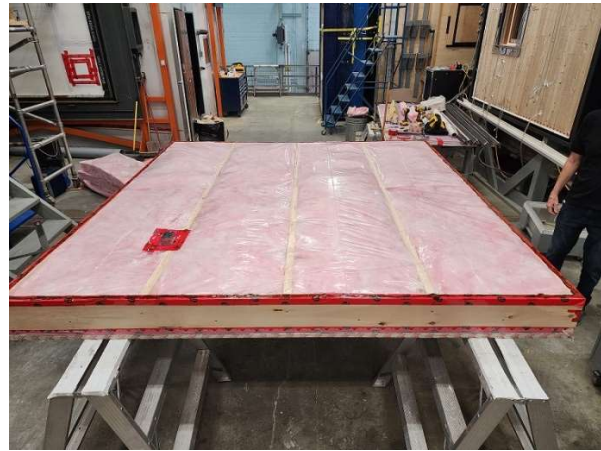
A.6 Specimen 6: Double wood stud wall fragment with two sealed PE membranes AB behind drywall

Figure 20. Specimen 6 construction photos

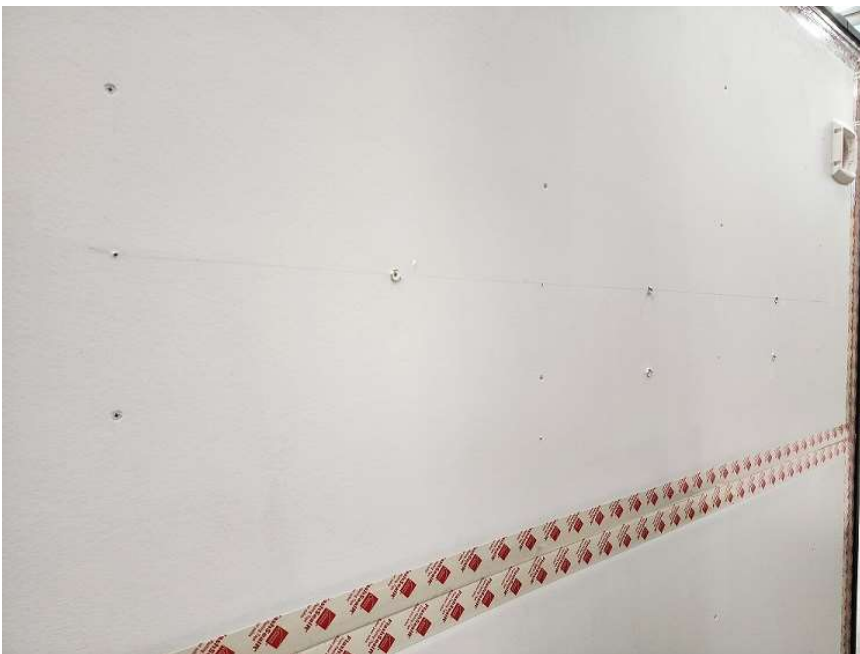
A.7 Double wood stud wall fragment with two sealed PE membranes AB behind drywall with penetrations from nails and screws

Figure 21. Specimen 7 construction photos

Note: Specimen 6 was used to prepare Specimen 7 by making the fasteners penetrations

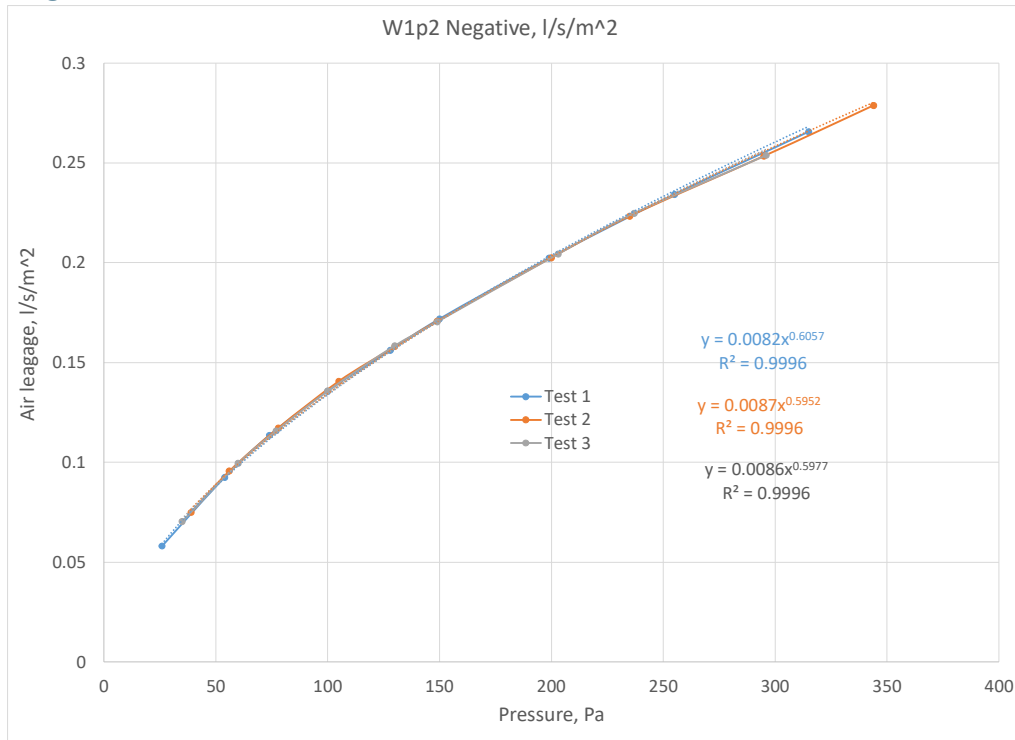
Figure 23. Specimen 1 Negative pressure test results. Top: gross leakage; Bottom: perimeter extraneous leakage

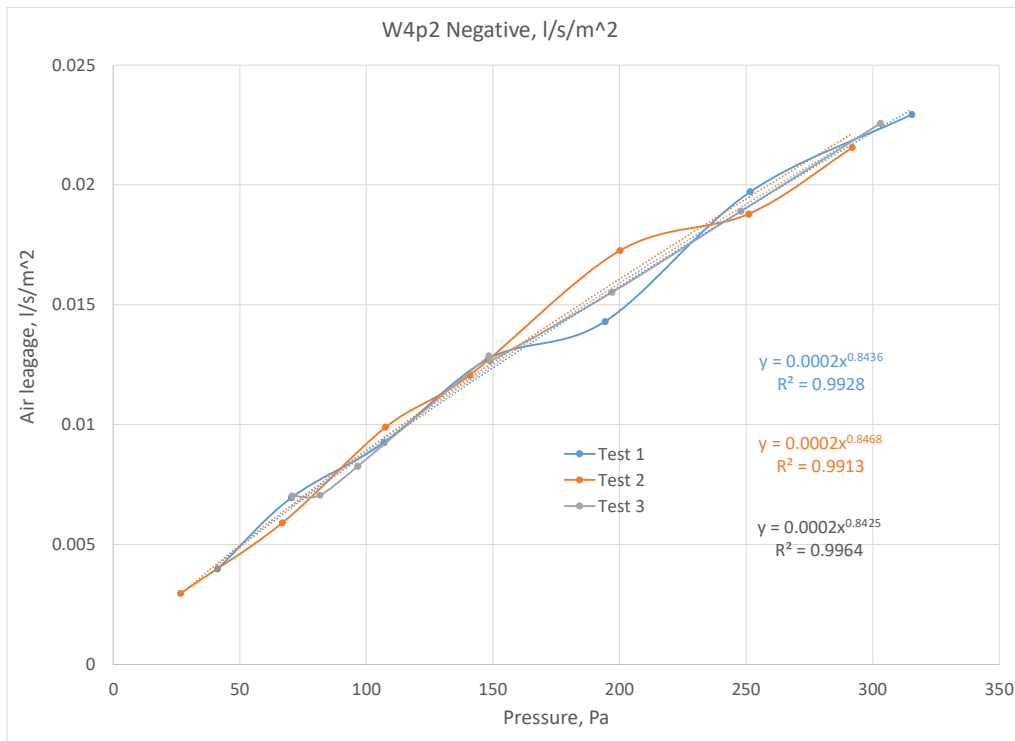
Figure 29. Specimen 4 Negative pressure test results. Top: gross leakage; Bottom: perimeter extraneous leakage

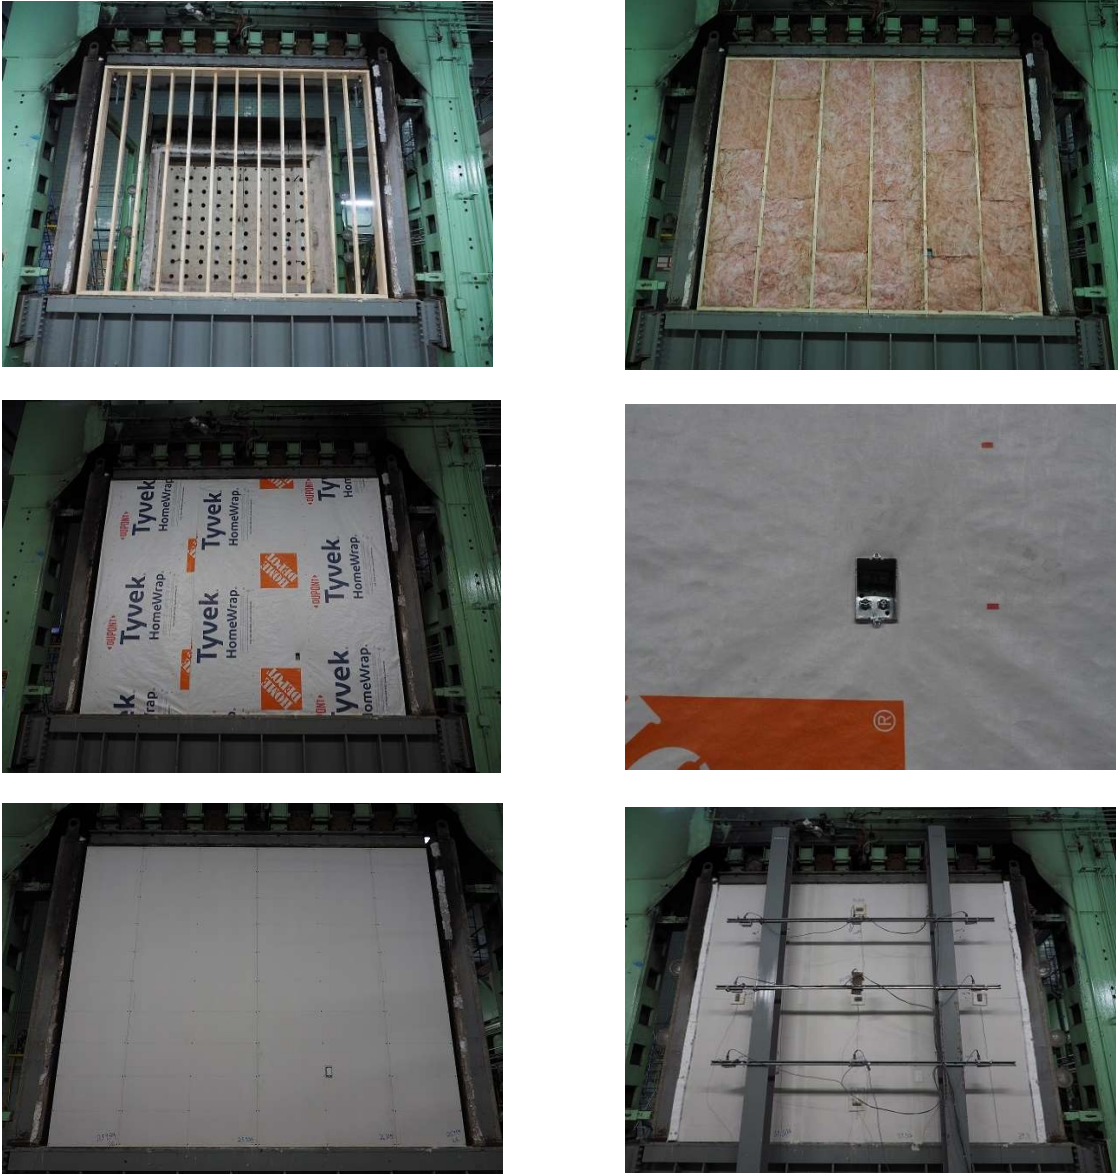
C.2 Specimen F2: Unsealed SBPO membrane AB

Figure 37. Specimen F2 construction photos

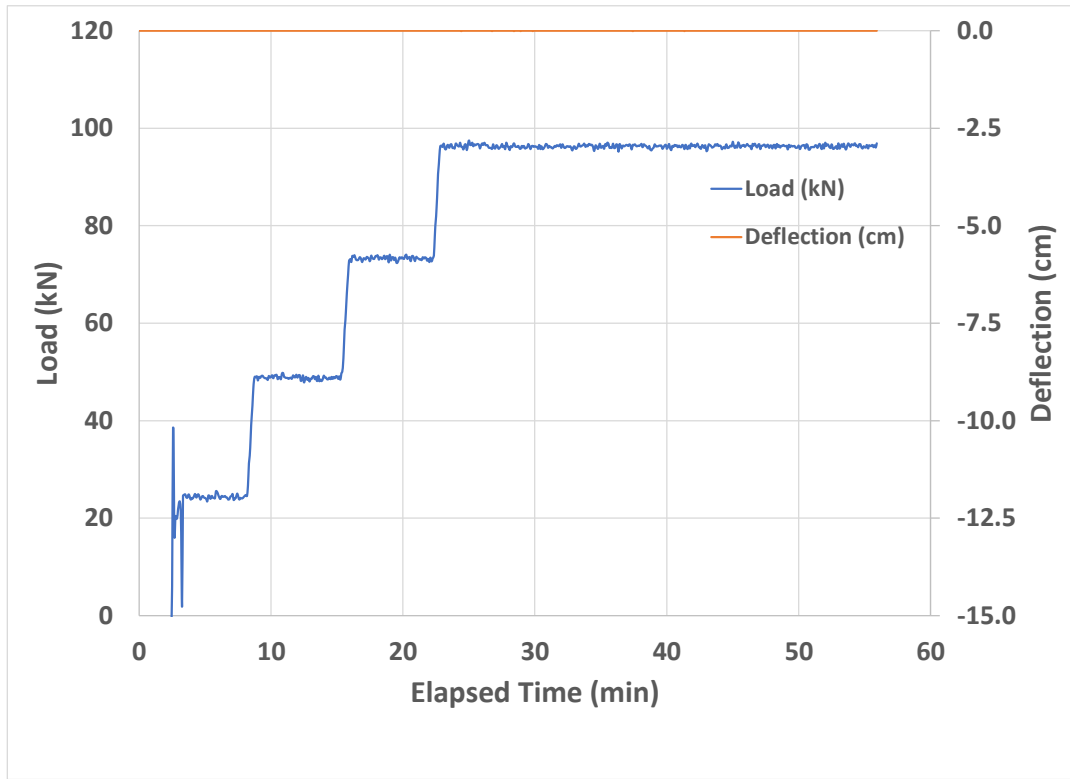
Figure 42. Specimen F2- Pre-load and deflection

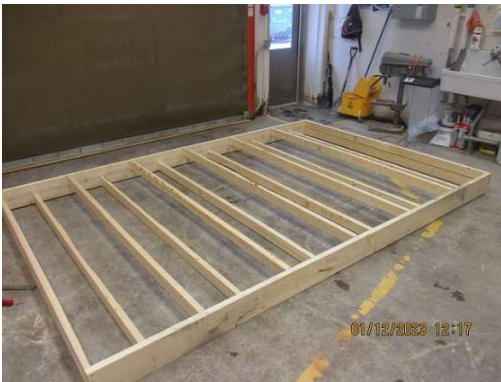
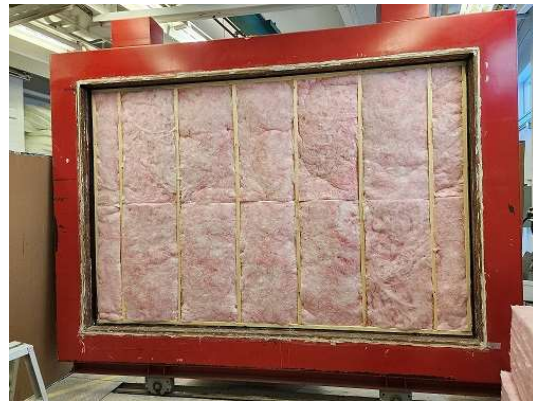
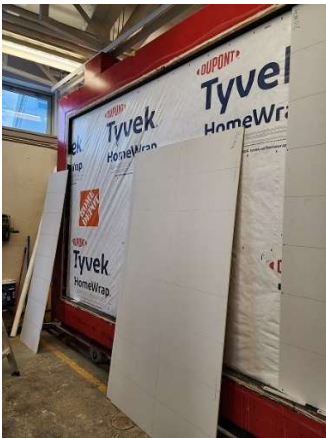
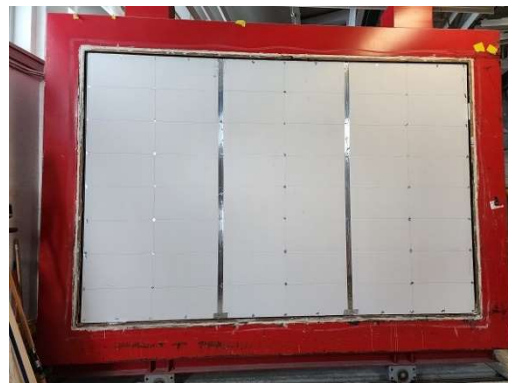
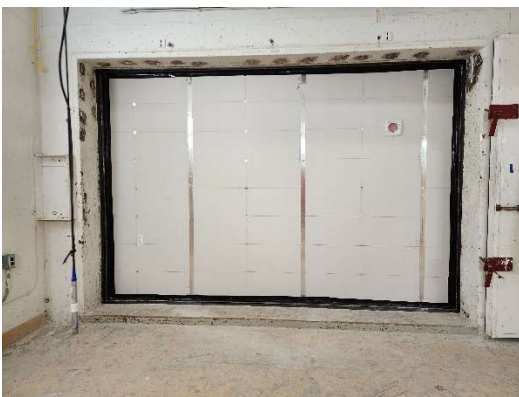
F.1 Specimen A1, A2: Unsealed SBPO membrane AB

Figure 46. Specimen A1 and A2 construction photos

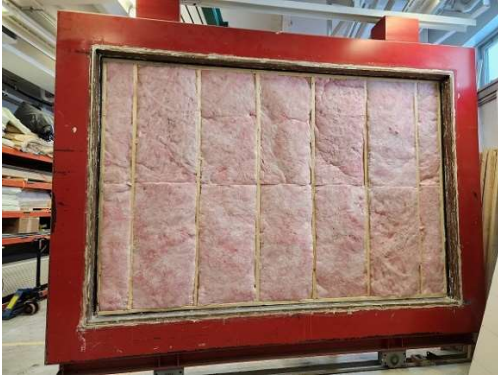
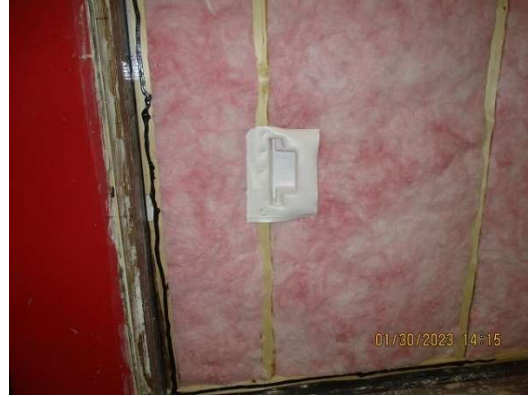
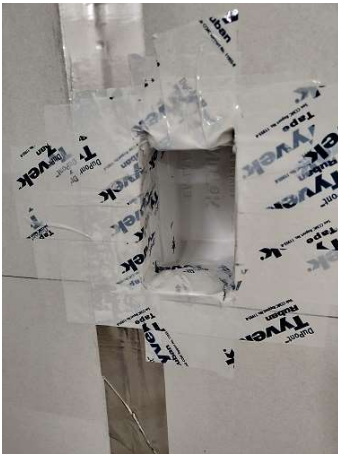
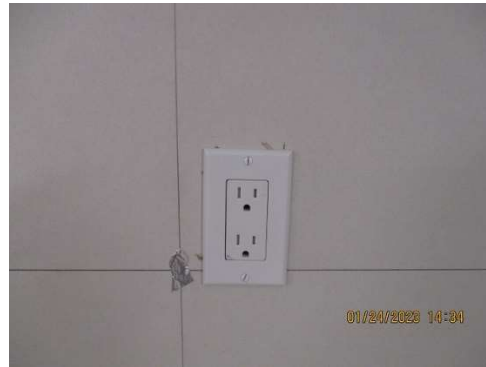
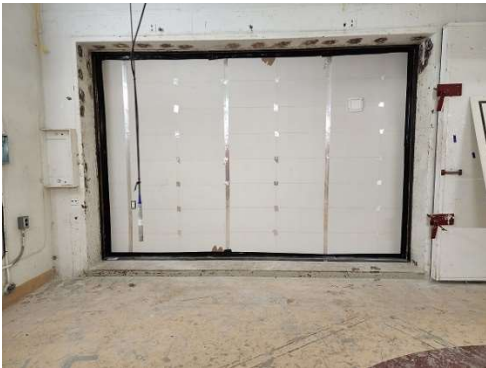
F.2 Specimen A3, A4: Sealed SBPO membrane AB

Figure 47. Specimen A3 and A4 construction photos
