### **Solutions for mid-rise wood construction: full-scale standard fire test for exterior wall assembly using lightweight wood frame construction with gypsum sheathing: Test EXTW-1: report to Research Consortium for Wood and Wood-Hybrid Mid-Rise Buildings**

# **REPORT TO RESEARCH CONSORTIUM FOR WOOD AND WOOD-HYBRID MID-RISE BUILDINGS**

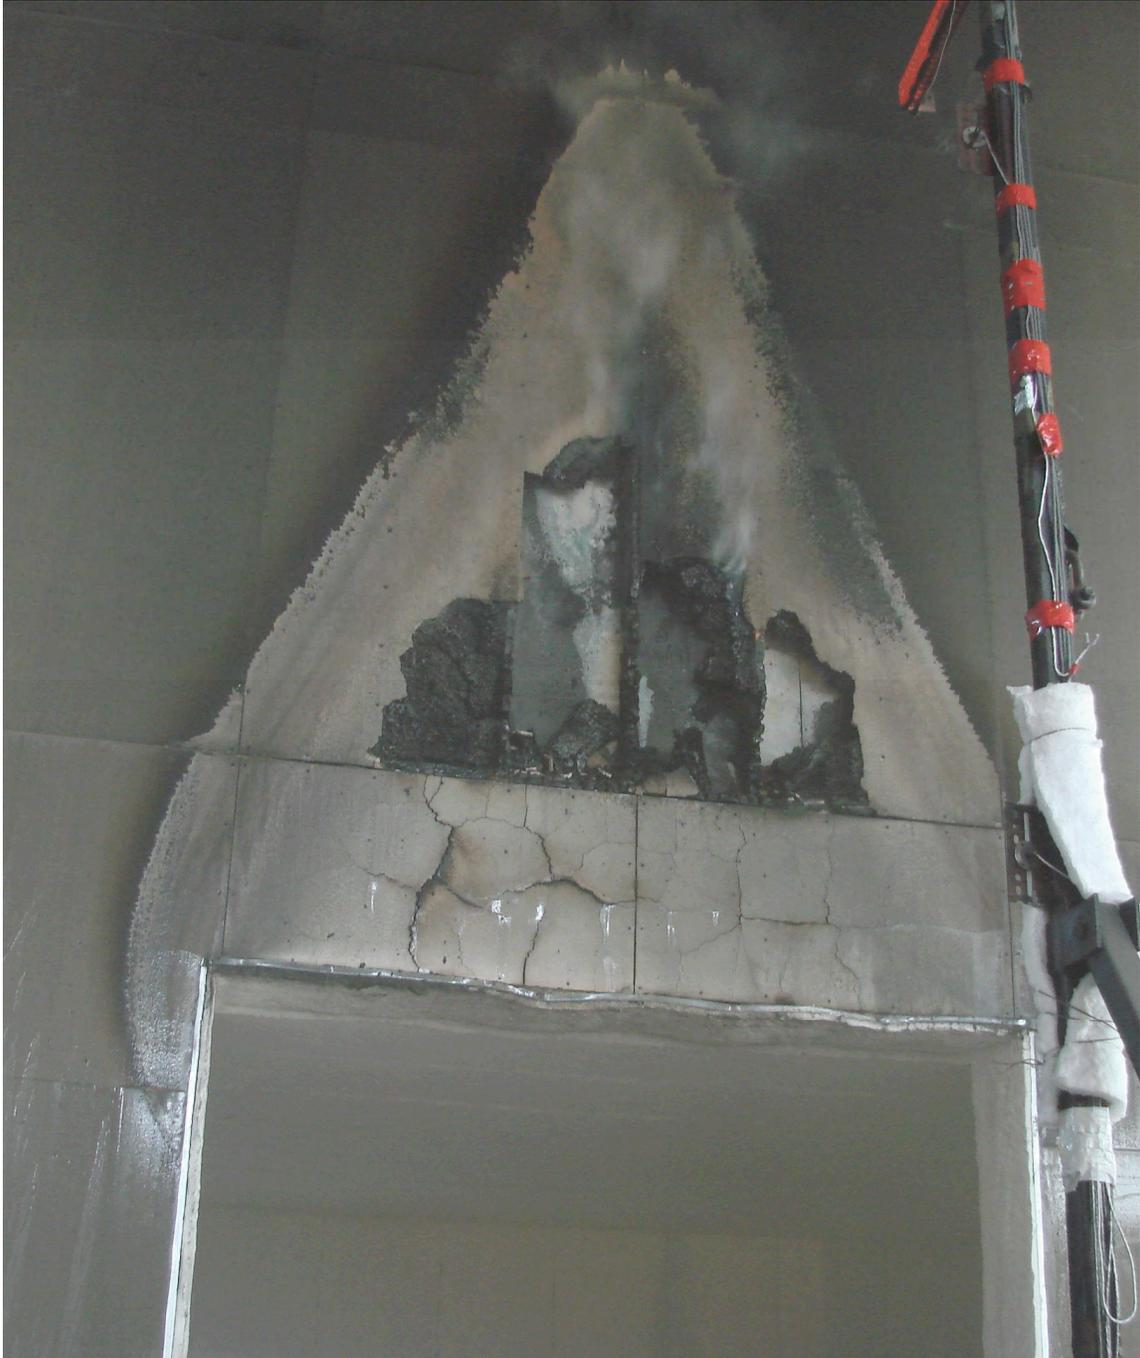
**Figure 13. Wall Assembly after Fire Exposure.**

Figure 13 shows the extent of the damage to the wall assembly after the test.

The primary area of damage was limited to the lower portion of the first wall section above the window opening. This is the area where the gypsum sheathing fell off 60 min after the start of the test. The stud located at the center of the assembly and the two adjacent studs were heavily charred at their base. However, much of this damage occurred as a result of the fire involvement after 60 min.

There was some loss of SPF insulation in the damaged area of the wall. However, outside this area the insulation was not affected by the fire.
