## **Fire Demonstration –**

### **Cross-Laminated Timber Stair/Elevator Shaft**

Author: Joseph Z. Su, Ph.D. and Saša Muradori

Report No: A1-006010.1  
Report Date: January 30, 2015  
Contract No: A1-006010  
Program: Mid-Rise Wood Buildings

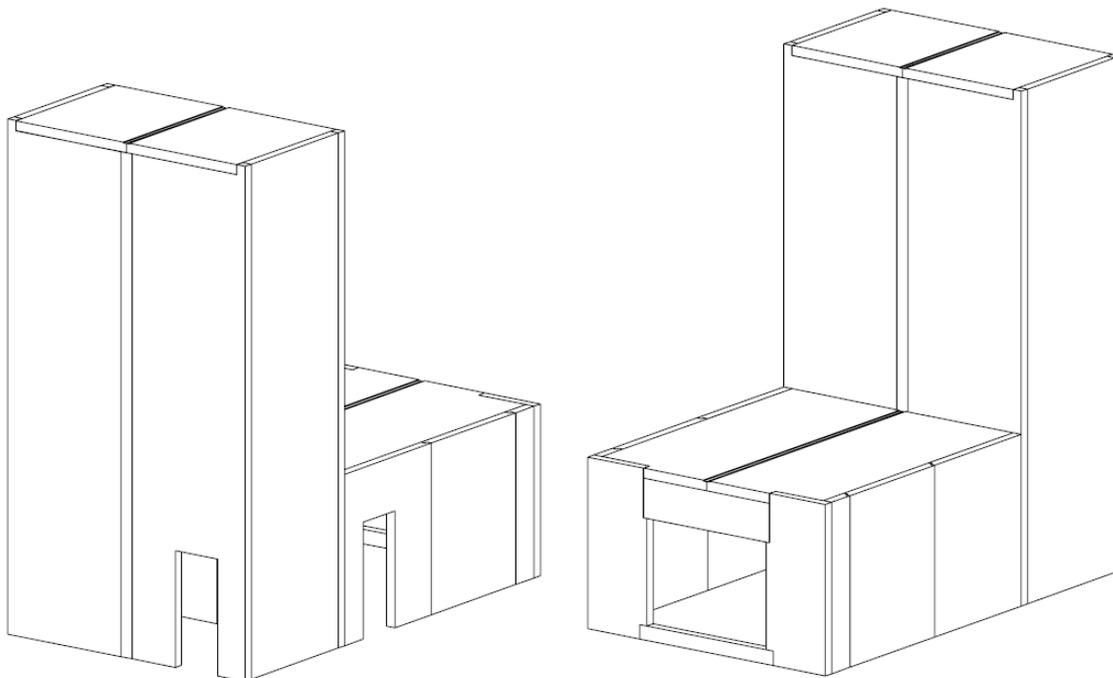
**Figure 1. Schematic of large-scale fire demonstration setup.**

A large-scale setup was constructed to represent a section of the proposed 13-storey residential building of mass timber construction. This involved construction of a 9-meter high stair/elevator shaft and an adjacent apartment unit using CLT structural panels which conformed to ANSI/APA PRG-320 standard [8]. The dimensions of the setup resembled the actual size of the building section of interest.

Figure 1 shows a schematic of the setup. Figure 2 to Figure 6 show construction details of the setup. Figure 7 shows photographs of the setup. A description of the structural assemblies and their arrangement is provided in the following sections.

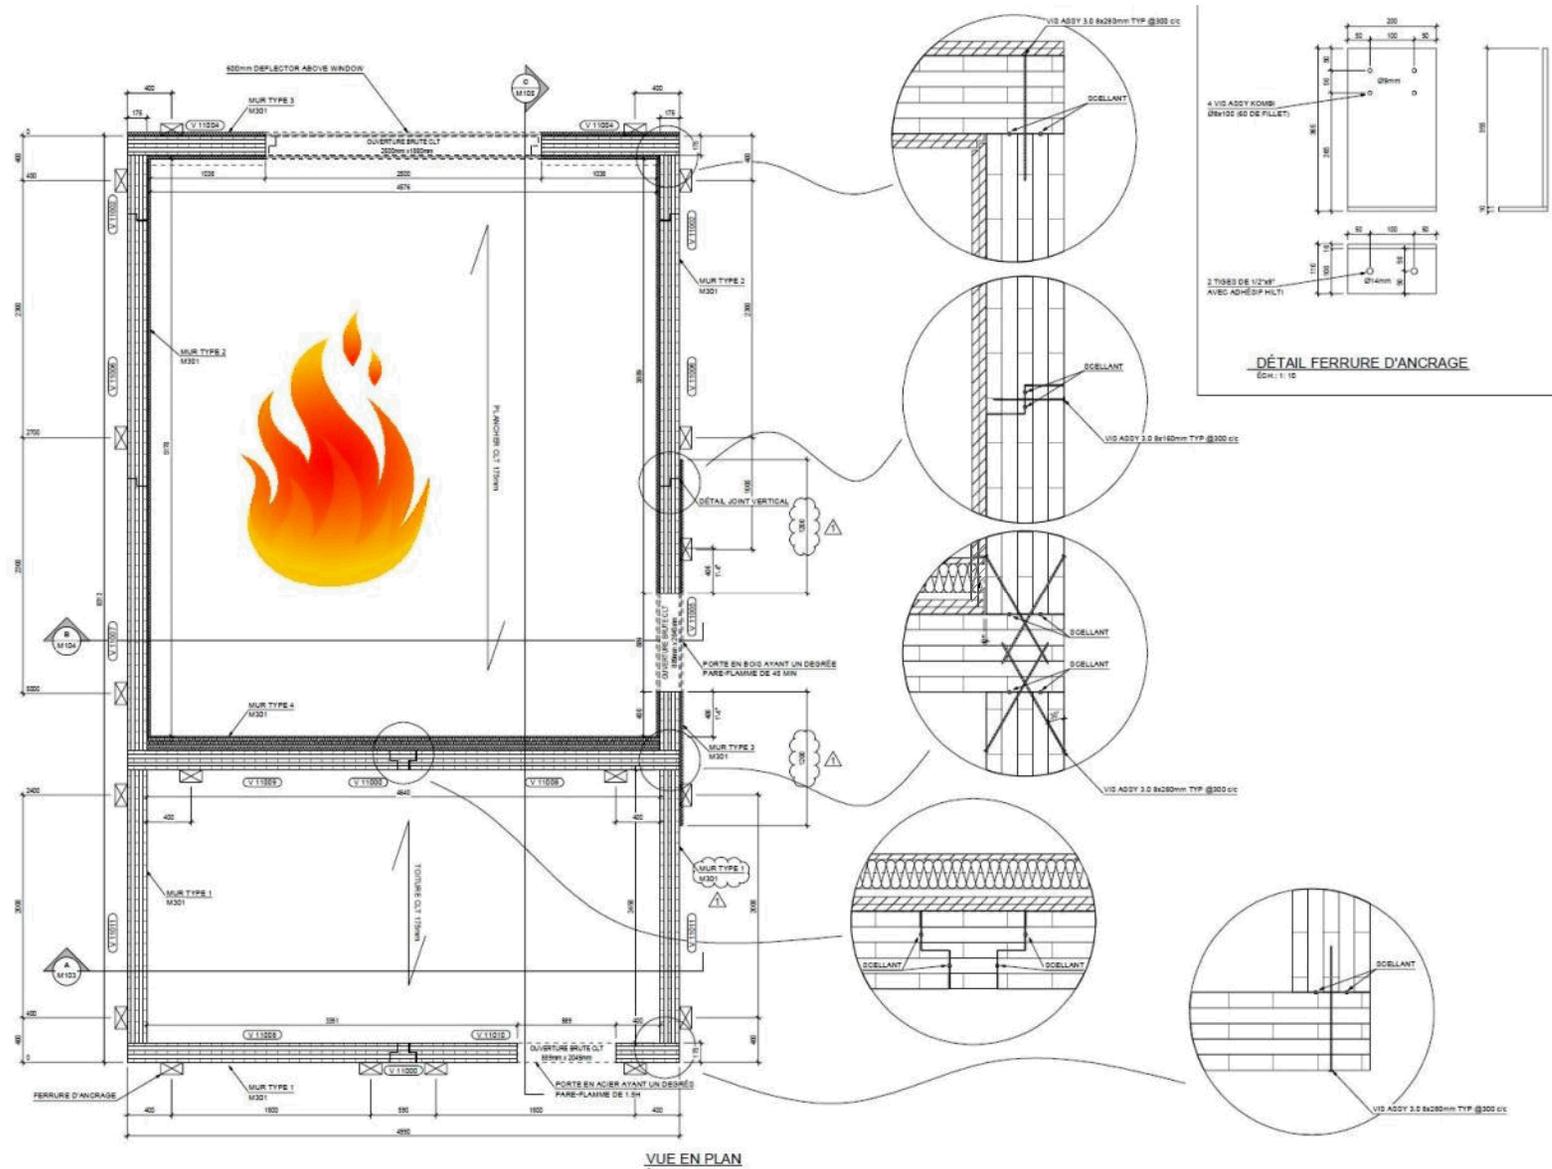
Figure 2. Plan view of the large-scale fire demonstration setup.

To compensate the lacking of gypsum board on the CLT panels in the shaft in this fire demonstration setup and to prevent smoke from potentially leaking to the shaft because of the lacking, a common construction adhesive was used as the sealant at the joints of the CLT panels for the shaft as shown in Figure 2 and Figure 3.

A fire-rated caulking was used as the sealant in the apartment (fire room) at the CLT panel-to-panel joints for the walls and ceiling and at the CLT panel-to-ledger joints as shown in Figure 2, Figure 4 and Figure 5, except the shared wall with the shaft where the CLT panel-to-panel joints were sealed using the common construction adhesive as mentioned in Section 0. The purpose of using the sealants was to compensate for eliminating gypsum board on most surfaces outside the apartment in this fire demonstration setup in order to prevent smoke from potentially leaking through the joints because of the elimination of gypsum board on the outside. However, the horizontal spline connection of the two CLT ceiling panels in the middle (see Figure 4) was joined on the top side (unexposed to fire) with strips of 12 mm thick, 120 mm wide plywood glued with two 6-mm wide lines of a construction adhesive and nailed on each side of the panels every 50 mm with common 76-mm nails.

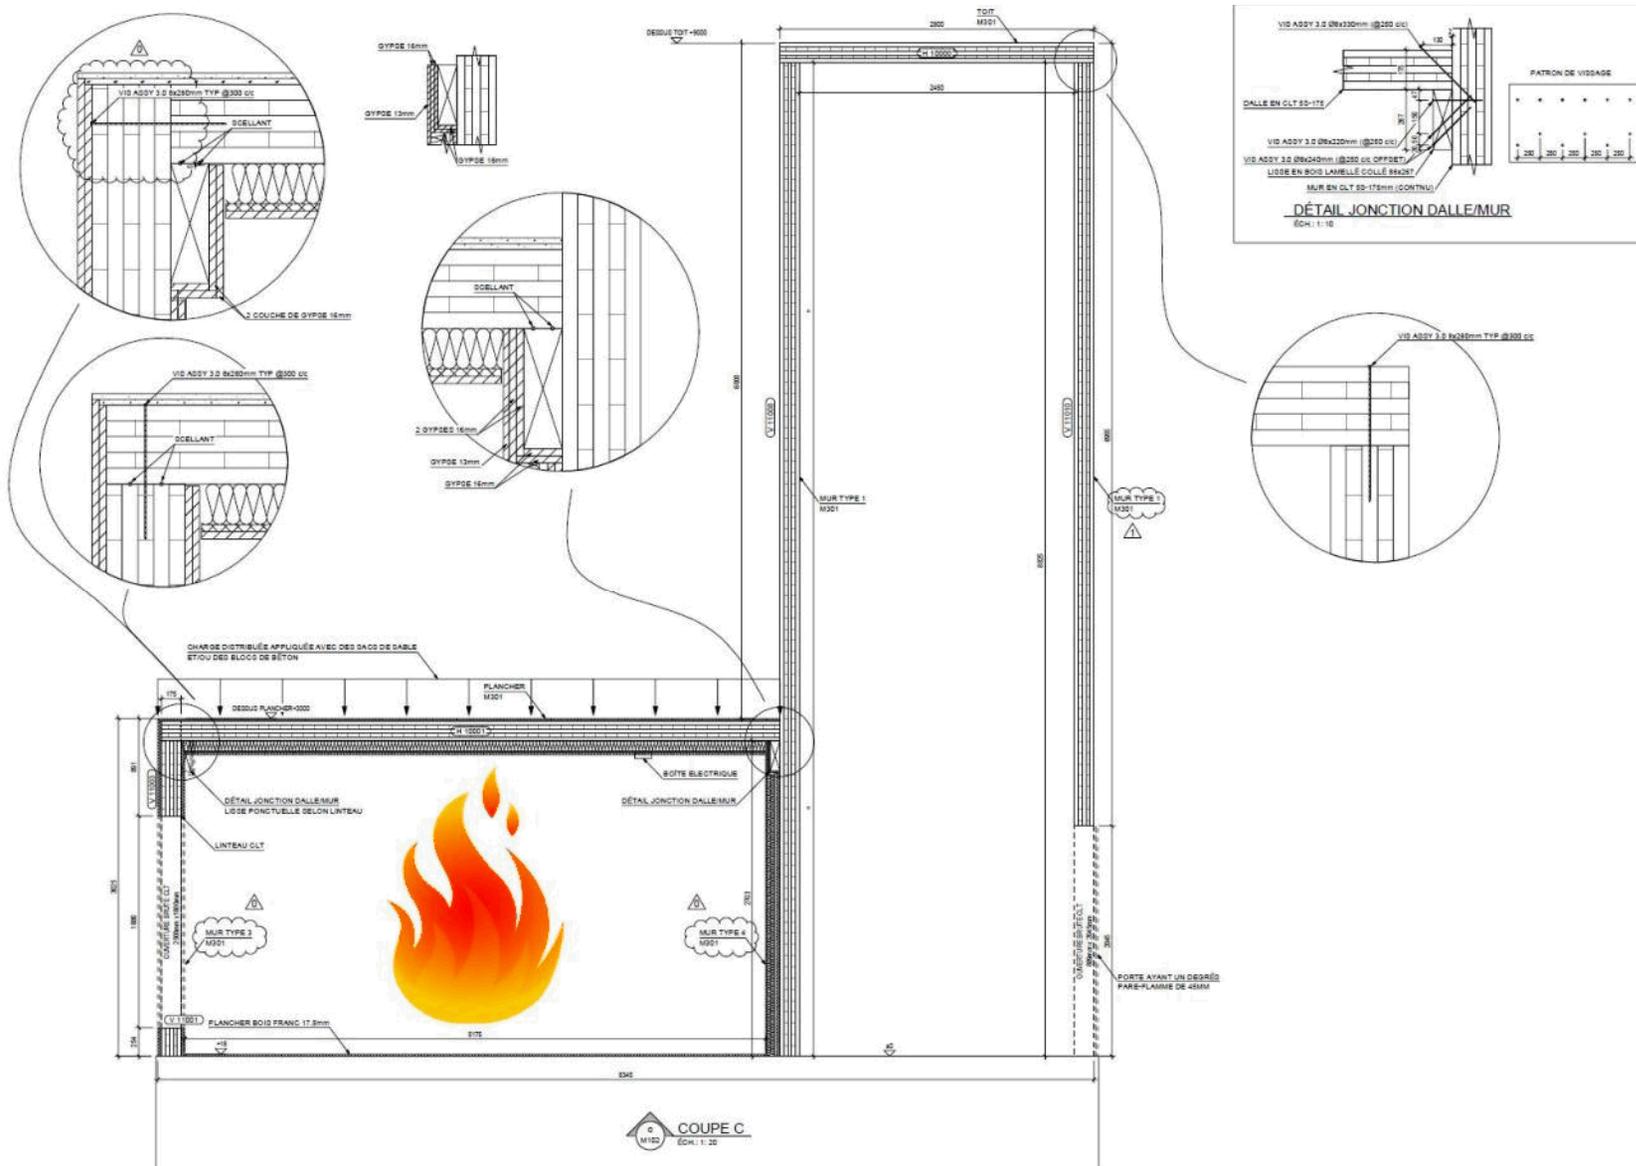
Figure 5. Vertical view: cross section C.

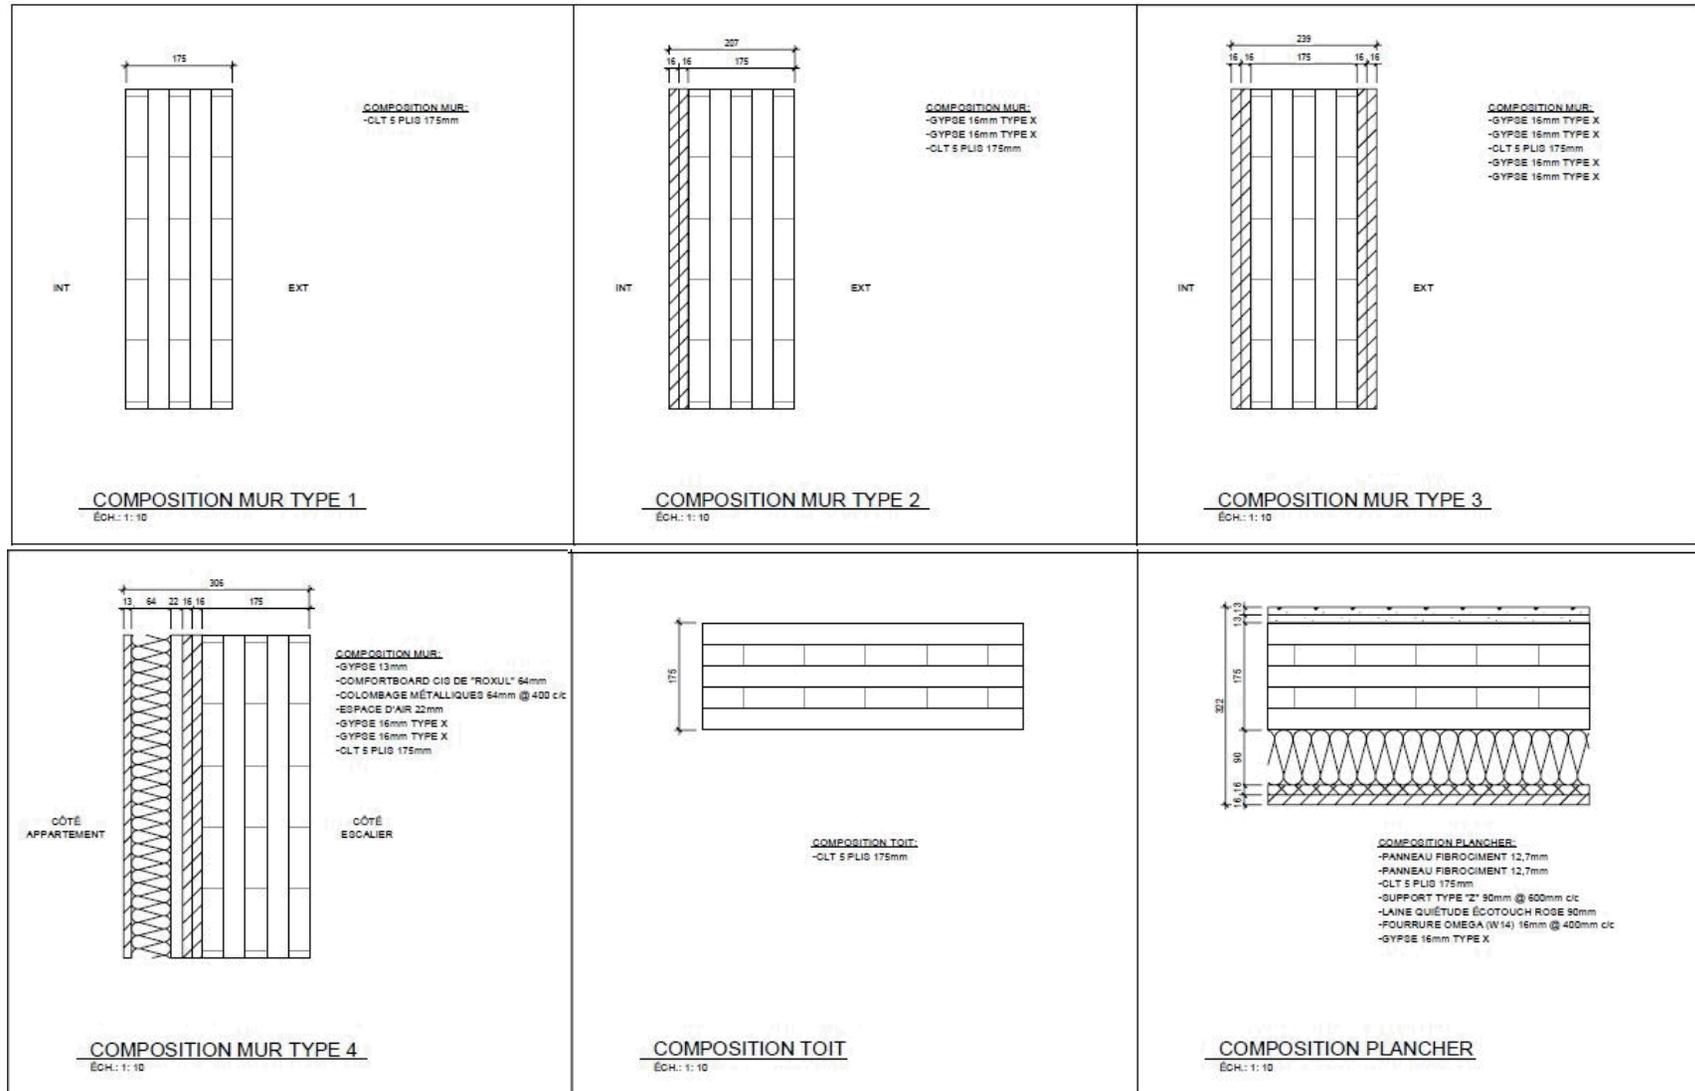
Figure 6. Details of components for CLT wall and ceiling assemblies.

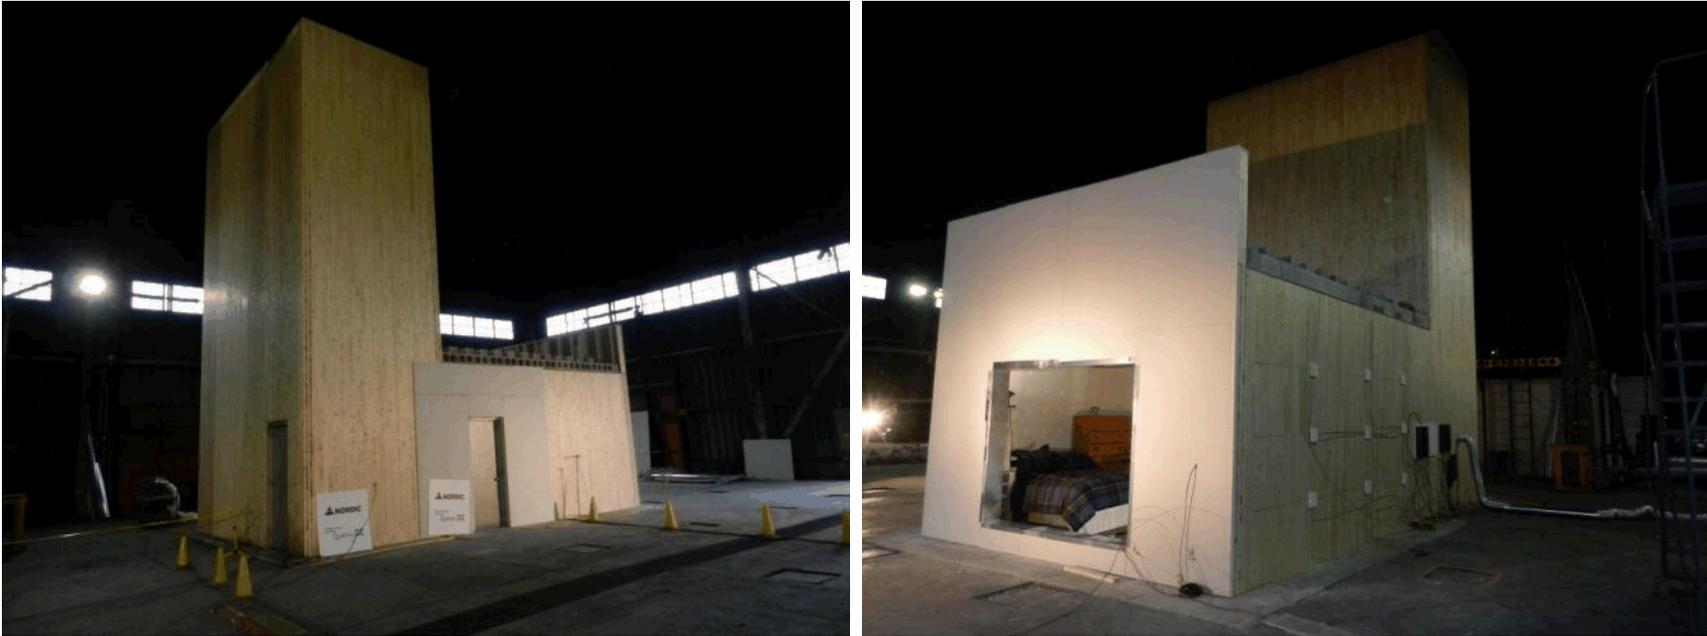
Figure 7. Outside of the large-scale fire demonstration setup.

It was assumed that a fire that originated in the adjacent apartment unit would have little effect on the CLT shaft and would not penetrate through the CLT panels into the shaft during the fire demonstration. Therefore, the CLT panels were left fully exposed on the inside (see Figure 8) and outside (see Figure 7) of the stair/elevator shaft to reduce its construction time and to allow better observation of any fire impact on the CLT panels. It should be noted that the actual design for the "Origine" project includes two layers of 16 mm (5/8") thick Type X gypsum board on the interior side of the walls of the stair/elevator shaft.

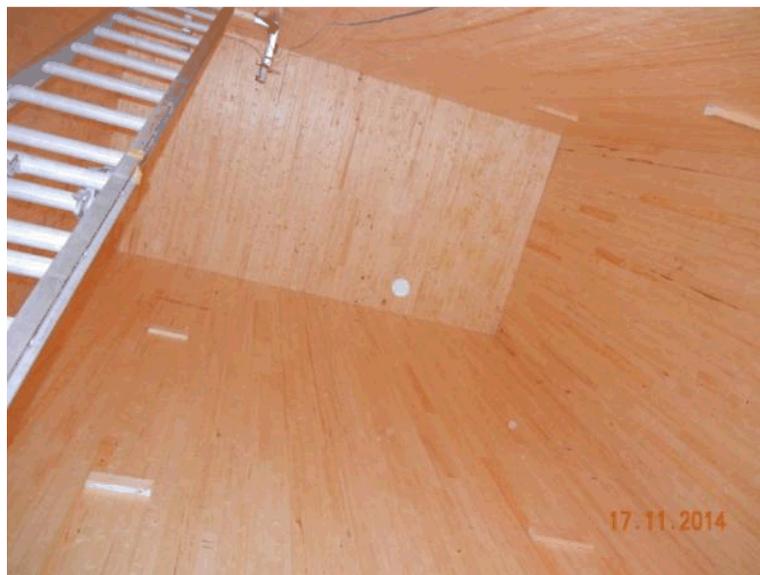
**Figure 8. Interior of the stair/elevator shaft.**

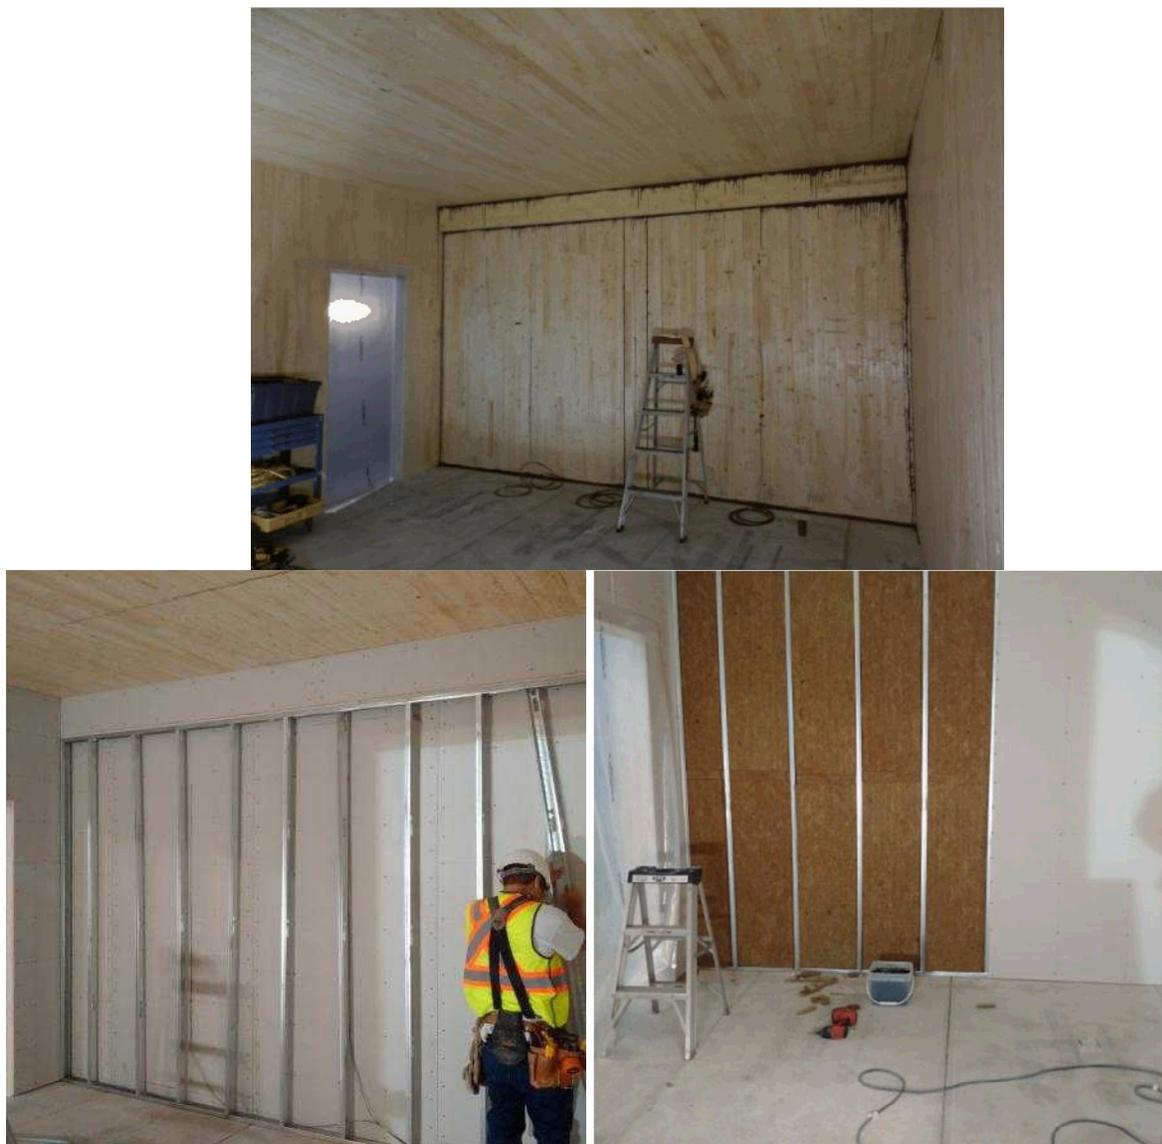
**Figure 9. Components of the shared wall in the fire compartment.**

For the wall shared with the stair/elevator shaft, additional components including noncombustible rigid mineral wool fibre insulation were added to this shared wall on the apartment side to meet the code requirements for sound insulation [1, 2]. The additional

components included a lightweight steel stud frame that was added to the shared wall after the CLT panels and glulam ledger were lined with two layers of 16 mm thick Type X gypsum board. The steel studs were 64 mm deep and spaced at 400 mm on centre. A 22-mm air gap was kept between the steel stud frame and the gypsum board-lined wall such that the gypsum board-lined ledger was flush with the steel frame (see Figure 9). The cavity formed by the steel studs was filled with 64 mm thick rigid mineral wool fibre insulation. A layer of 13 mm (1/2") thick regular gypsum board was installed on the ledger and the lightweight steel frame with 32 mm (1-1/4") long type S screws spaced at 300 mm on centre, starting at 150 mm from the edges of the assembly. Screws were placed at a minimum distance of 38 mm (1 1/2") from the edges of all gypsum board sections. Joints between the gypsum board sections were covered with tape and joint compound and all screw heads were covered with joint compound. Figure 9 shows the components of the shared wall in the fire compartment.

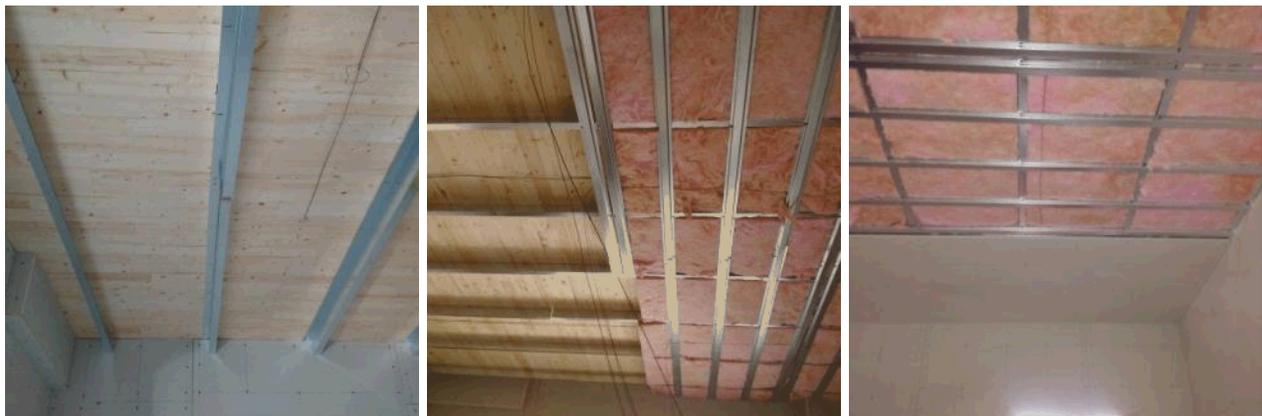
**Figure 10. Components of the ceiling assembly in the fire compartment.**

16 mm (5/8") deep furring strips made of 25-gauge galvanized steel were installed perpendicular to the Z-channels and were spaced at 400 mm on centre. The furring strips were fastened to the Z channels using 25 mm (1") pan head self-tapping metal screws of size 6. The screws were spaced 600 mm apart on each side of the furring strips. Double furring strips were used every 1200 mm to facilitate the subsequent installation of gypsum board. The space between the Z channels and behind the furring strips was filled with 90 mm thick noncombustible fiberglass insulation.

A single layer of 16 mm (5/8") thick Type X gypsum board was attached to the metal furring strips, covering the fiberglass insulation. The gypsum board was attached using 32 mm (1 ¼") long type S screws spaced at 300 mm on centre starting at 150 mm from the edges of the assembly. Screws were placed at a minimum distance of 38 mm (1½") from the edges of all gypsum board sections, which was accommodated with the use of the double furring strips at the gypsum joints. Joints between board sections were covered with tape and joint compound. All screw heads were covered with joint compound. Figure 10 shows the components of the ceiling assembly in the fire compartment.

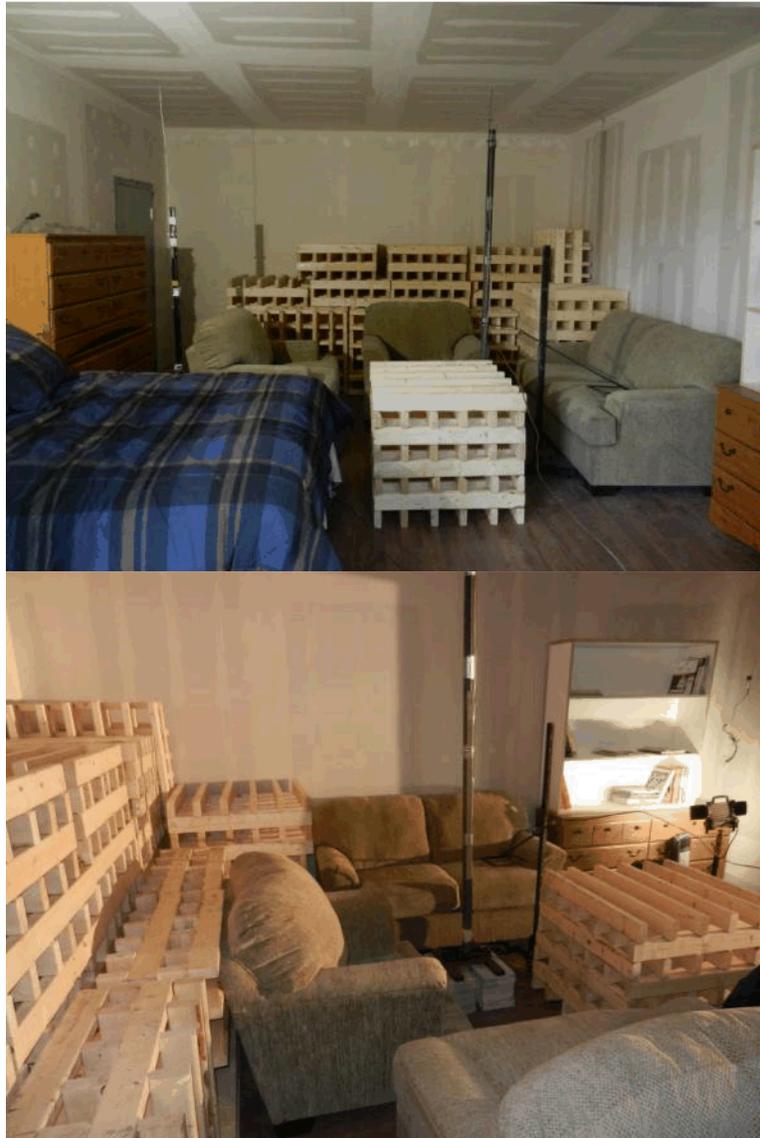
**Figure 12. Photographs of fuel arrangement in the fire compartment.**

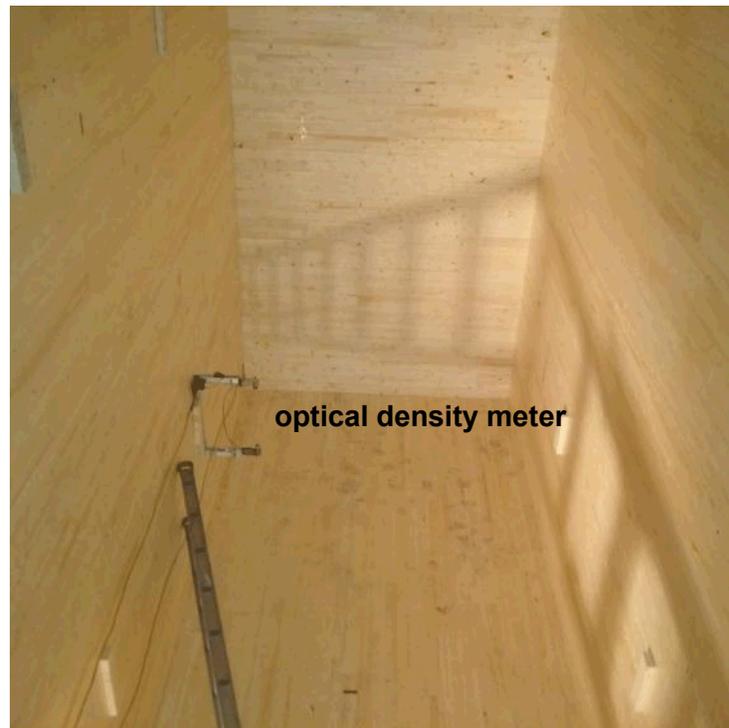
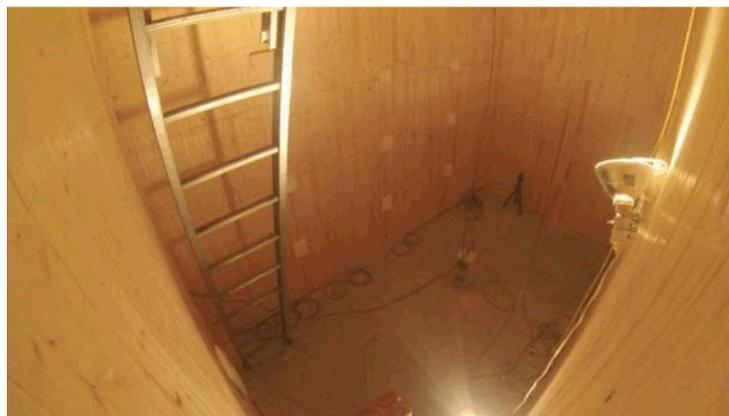
**Figure 13. Instrumentation inside the stair/elevator shaft.**

An array of nine thermocouples was installed at the center of the stair/elevator shaft at one meter intervals along the 9-m height starting 1 m above the floor to measure the temperature at the different heights. There were also nine thermocouples covered with pads used in standard fire resistance tests [11] on the unexposed side of the CLT wall section adjacent to the apartment.

An optical density meter was installed in the stair/elevator shaft at the 7 meter height to monitor if any smoke leaked into the shaft during the demonstration. Figure 11 and Figure 13 show the instrumentation inside the stair/elevator shaft.

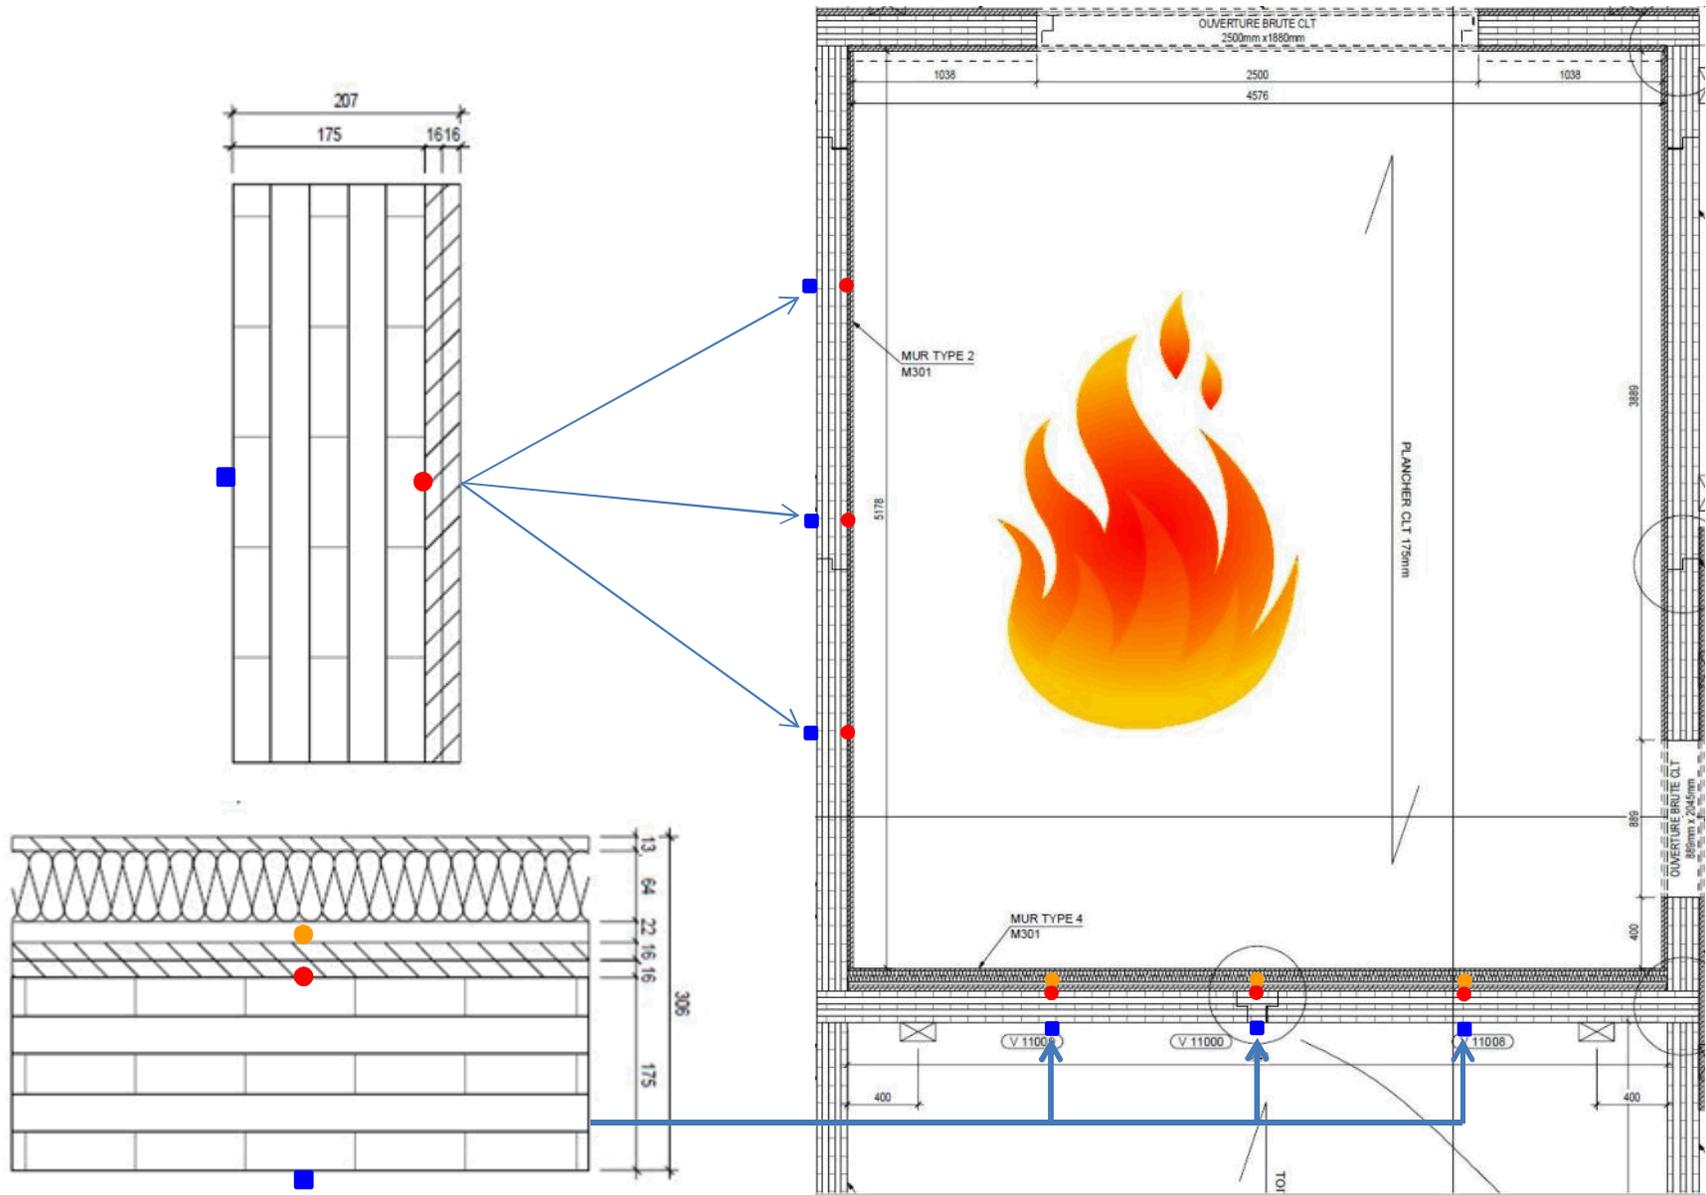
Figure 14. Thermocouples installed at interfaces across TYPE-2 and TYPE-4 walls (birds eye view).

Eighteen thermocouples were installed at the interfaces across the TYPE 2 wall assembly that had no door. As shown in Figure 14 and Figure 15, nine thermocouples were installed at interface between the gypsum board based layer and the CLT, and nine thermocouples covered with pads used in standard fire resistance tests were installed on the exterior surface of the CLT. The thermocouples were positioned at quarter and mid points of the wall assembly in horizontal and vertical directions.

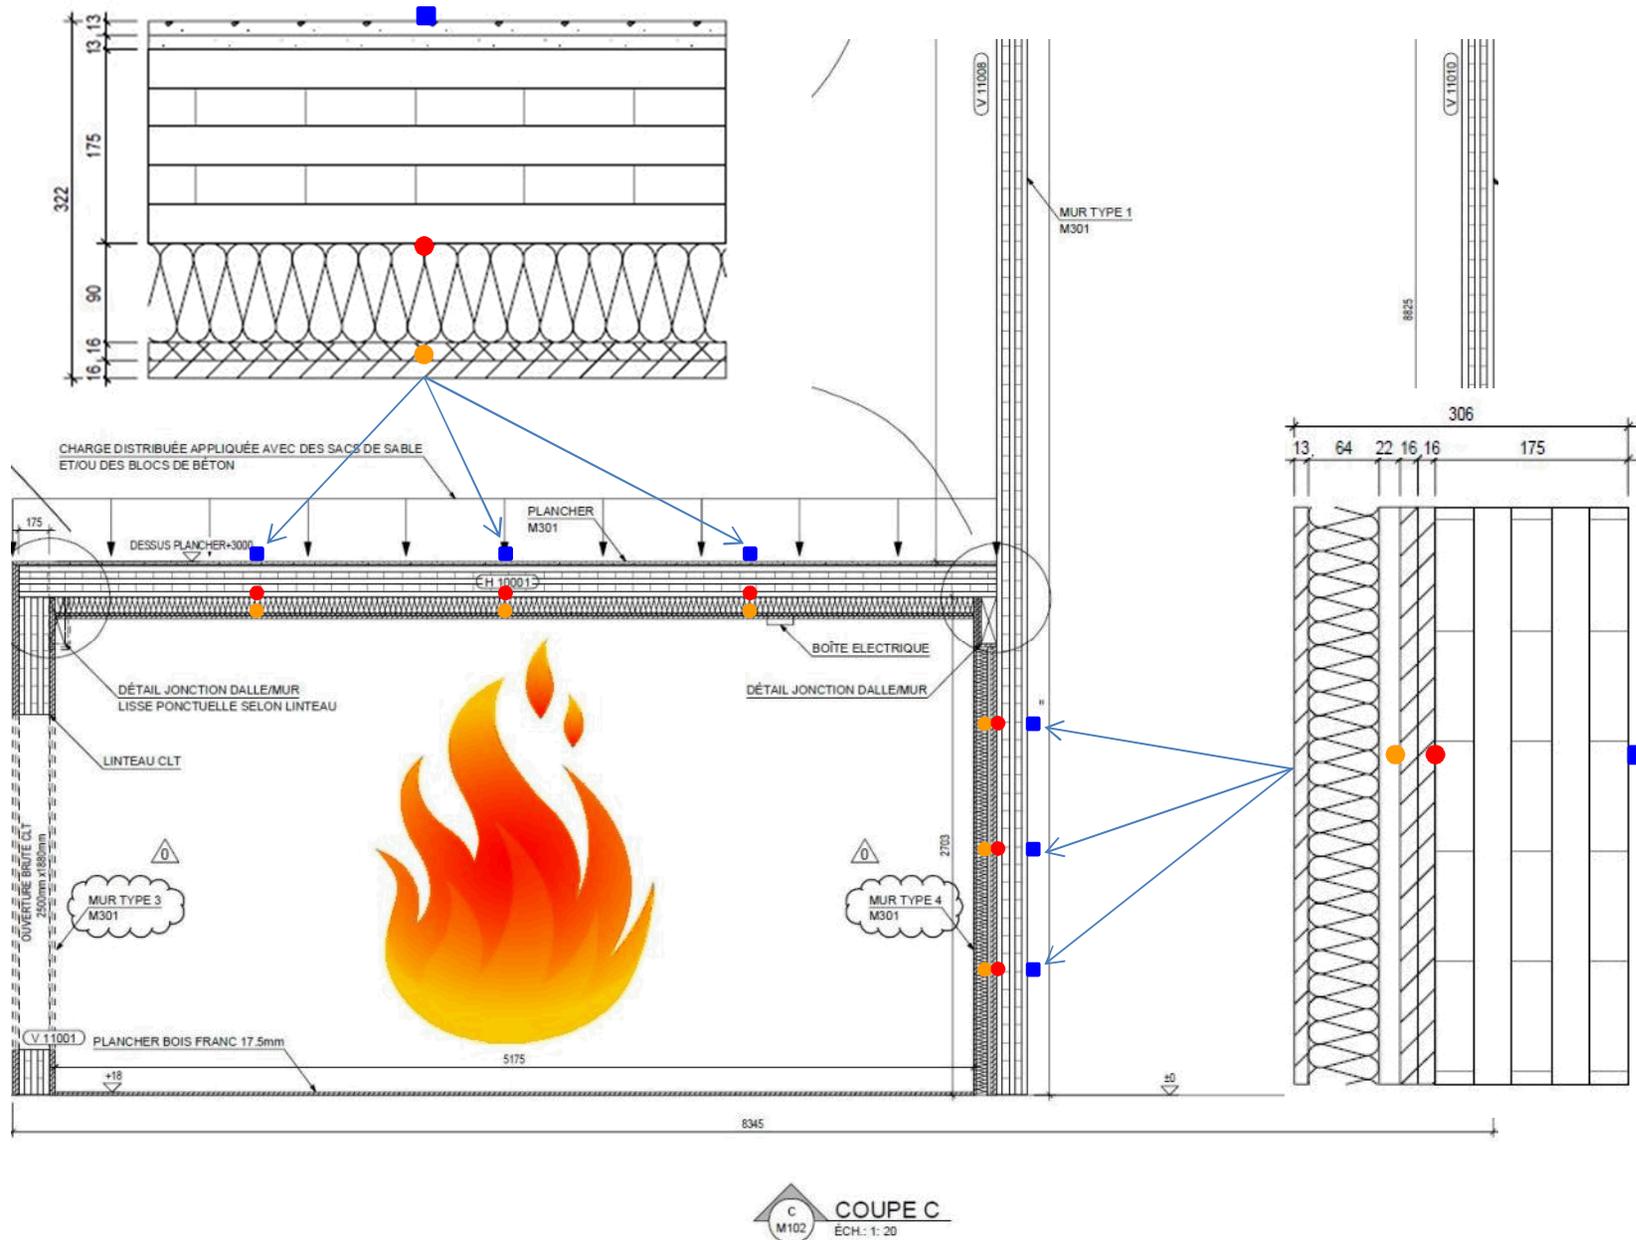
Figure 16. Thermocouples installed at interfaces across TYPE-4 wall and ceiling assembly (vertical view).

Twenty seven thermocouples were installed at the interfaces across the ceiling assembly. As shown in Figure 15 and Figure 16 nine thermocouples were installed above the gypsum board on the metal furring strips, nine thermocouples were installed at the interface between the insulation and CLT, and nine thermocouples covered with pads used in standard fire resistance tests were installed on the top of the ceiling assembly. The thermocouples were positioned at quarter and mid points of the ceiling assembly in the two horizontal directions perpendicular to each other.

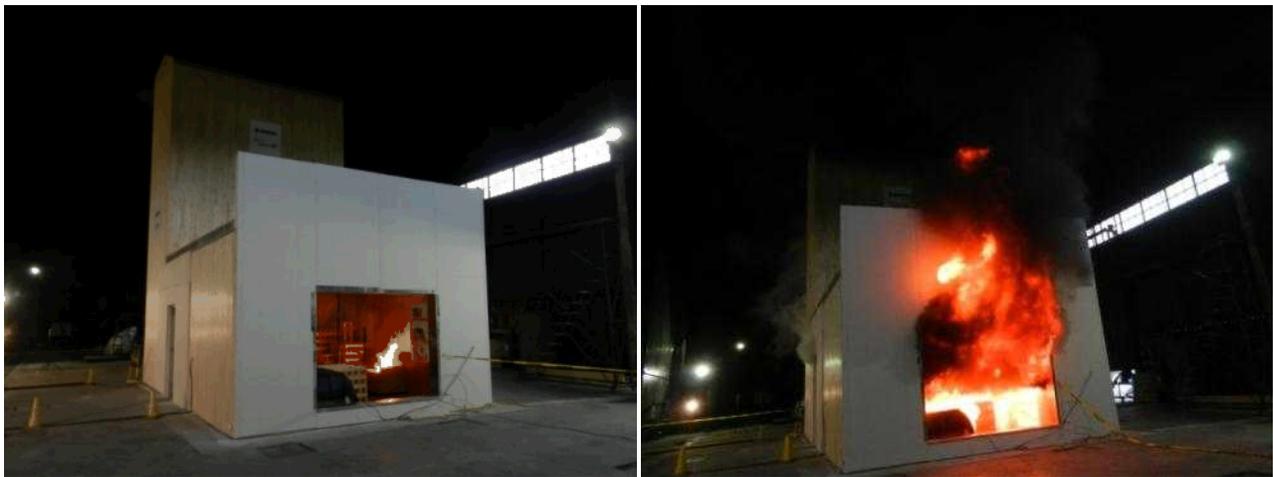
**Figure 17. Ignition of the upholstered loveseat followed by flashover at 2 min 35 s.**

The loveseat was ignited using a square burner in accordance with the ASTM E1537 [12] protocol. Smoke started to issue through the rough window opening at 30 s. Flames started to issue through the rough window opening at 2 min 20 s. Flashover occurred at 2 min 35 s. A high-intensity fast growing fire was produced in the apartment. Figure 17 shows the ignition of the loveseat and the flashover of the apartment.
