## **Fire Demonstration –**

### **Cross-Laminated Timber Stair/Elevator Shaft**

Author: Joseph Z. Su, Ph.D. and Saša Muradori

Report No: A1-006010.1  
Report Date: January 30, 2015  
Contract No: A1-006010  
Program: Mid-Rise Wood Buildings

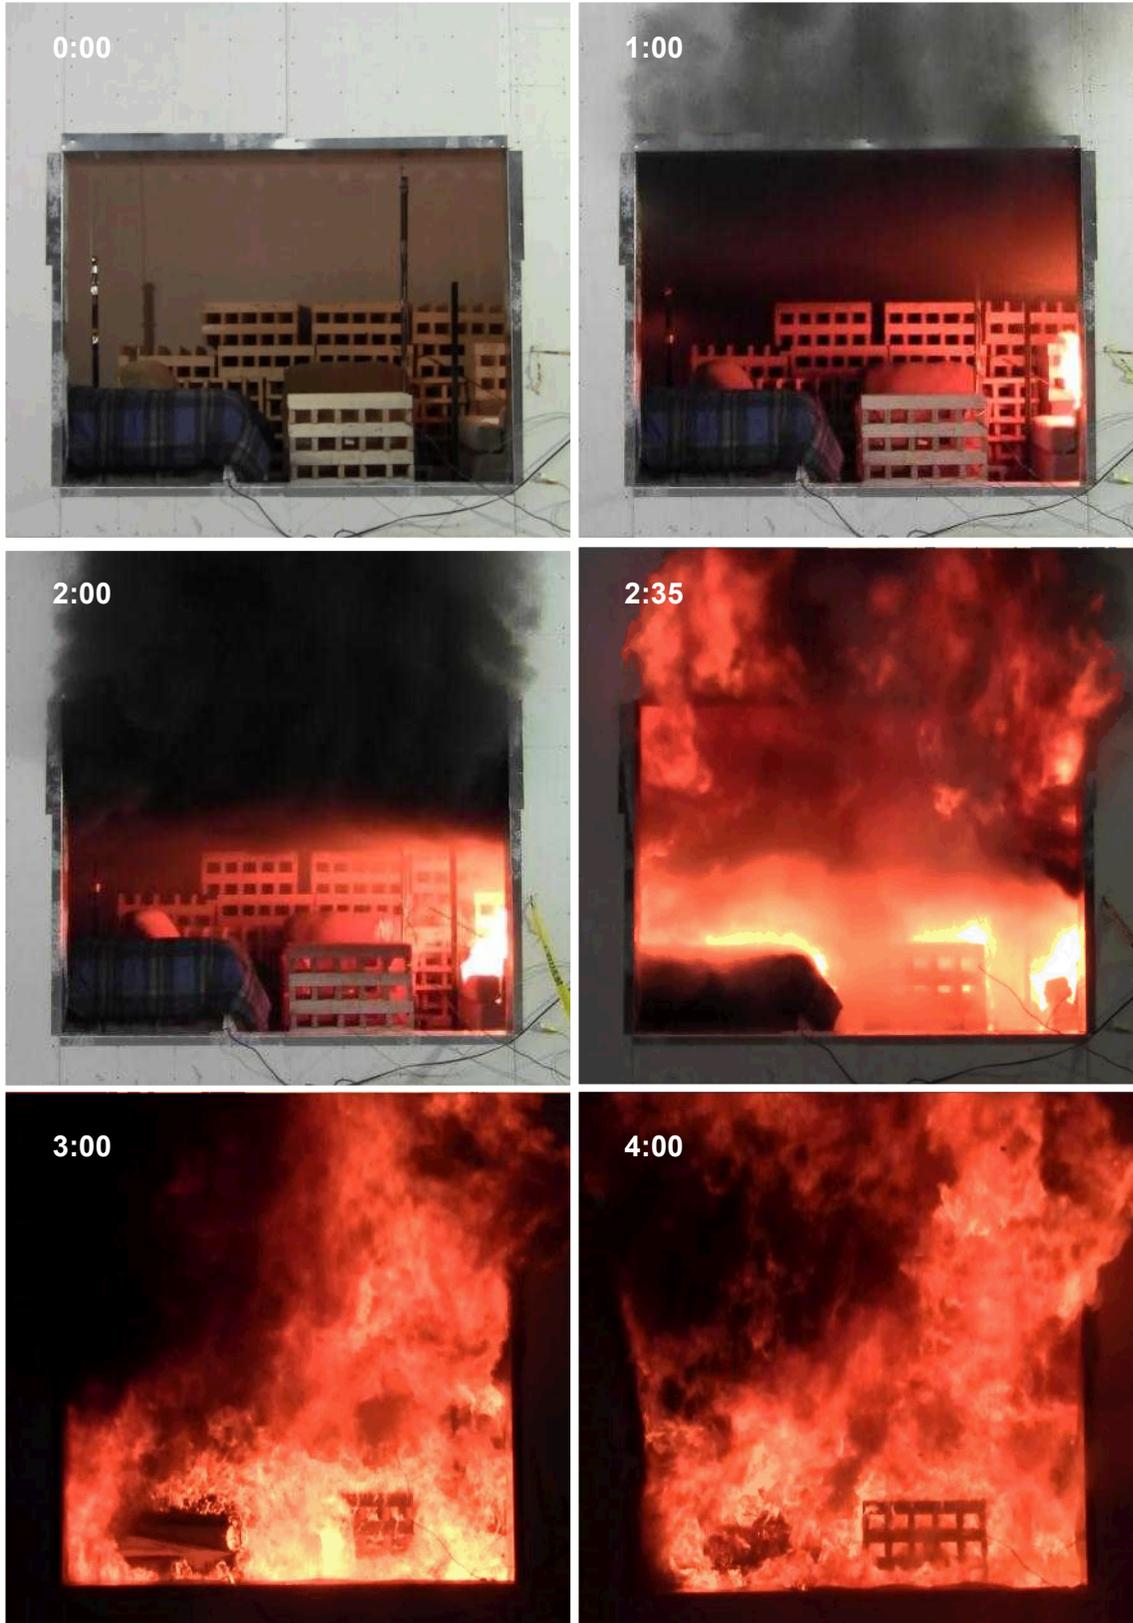
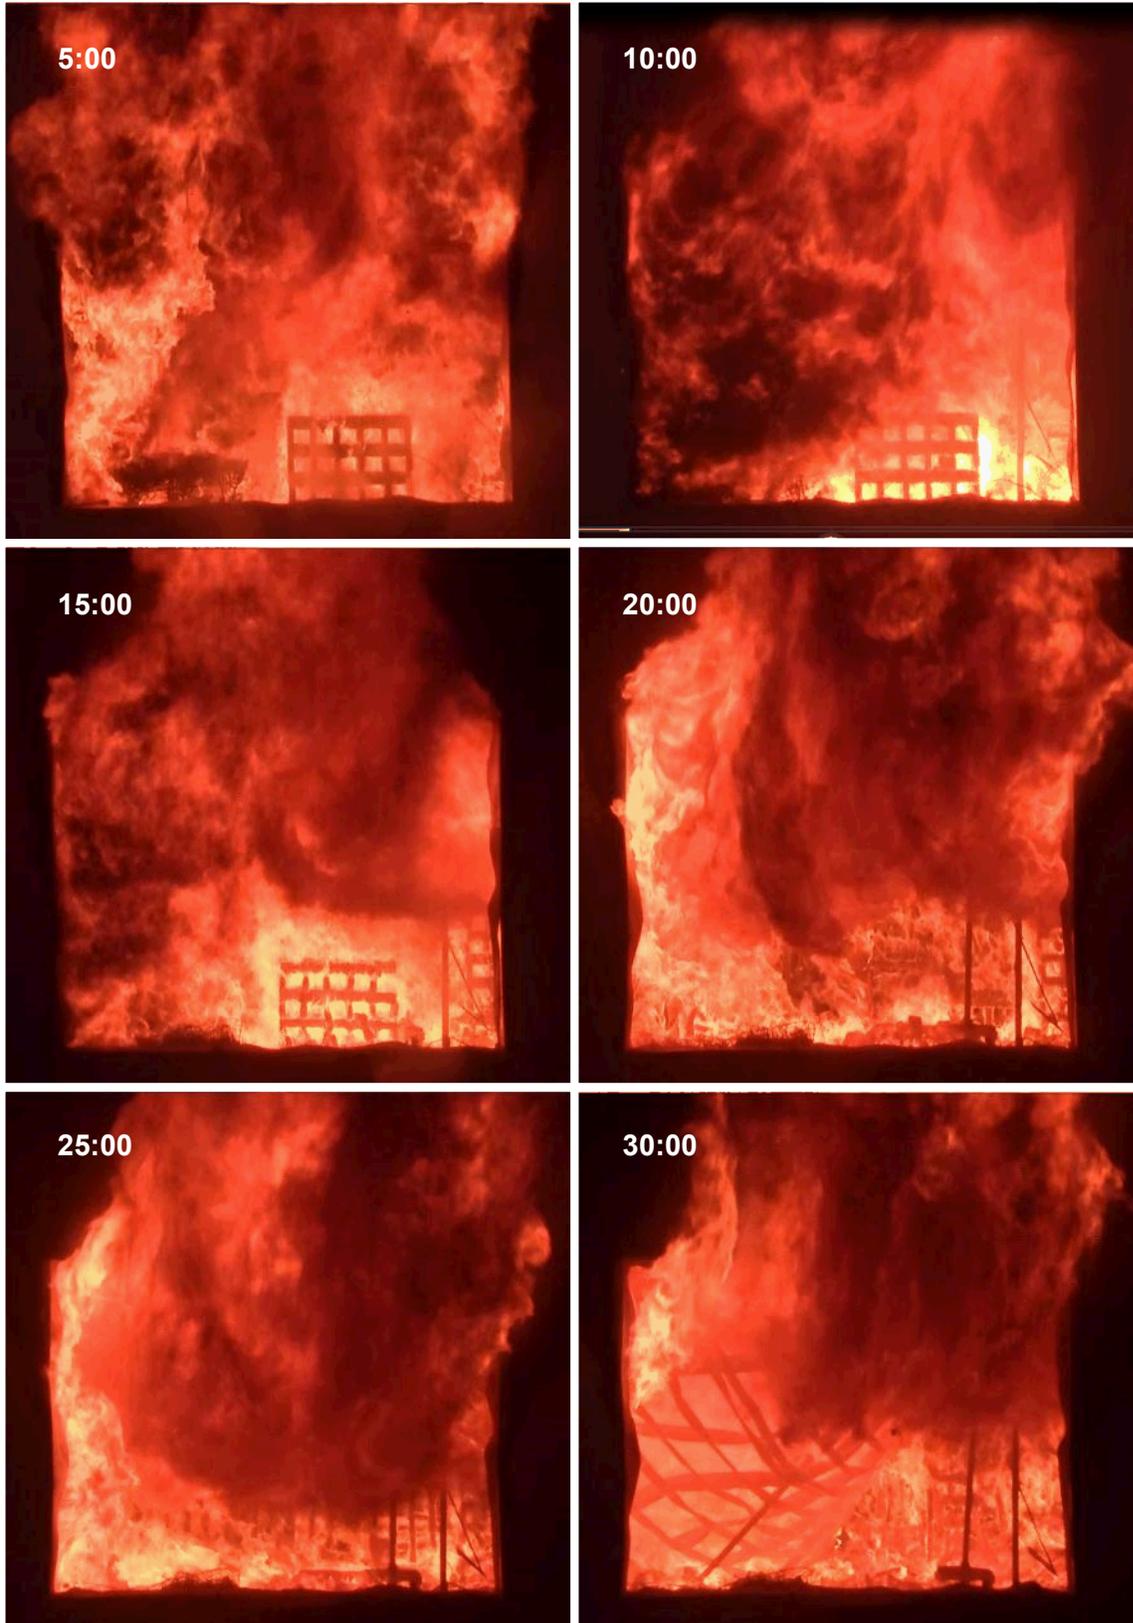
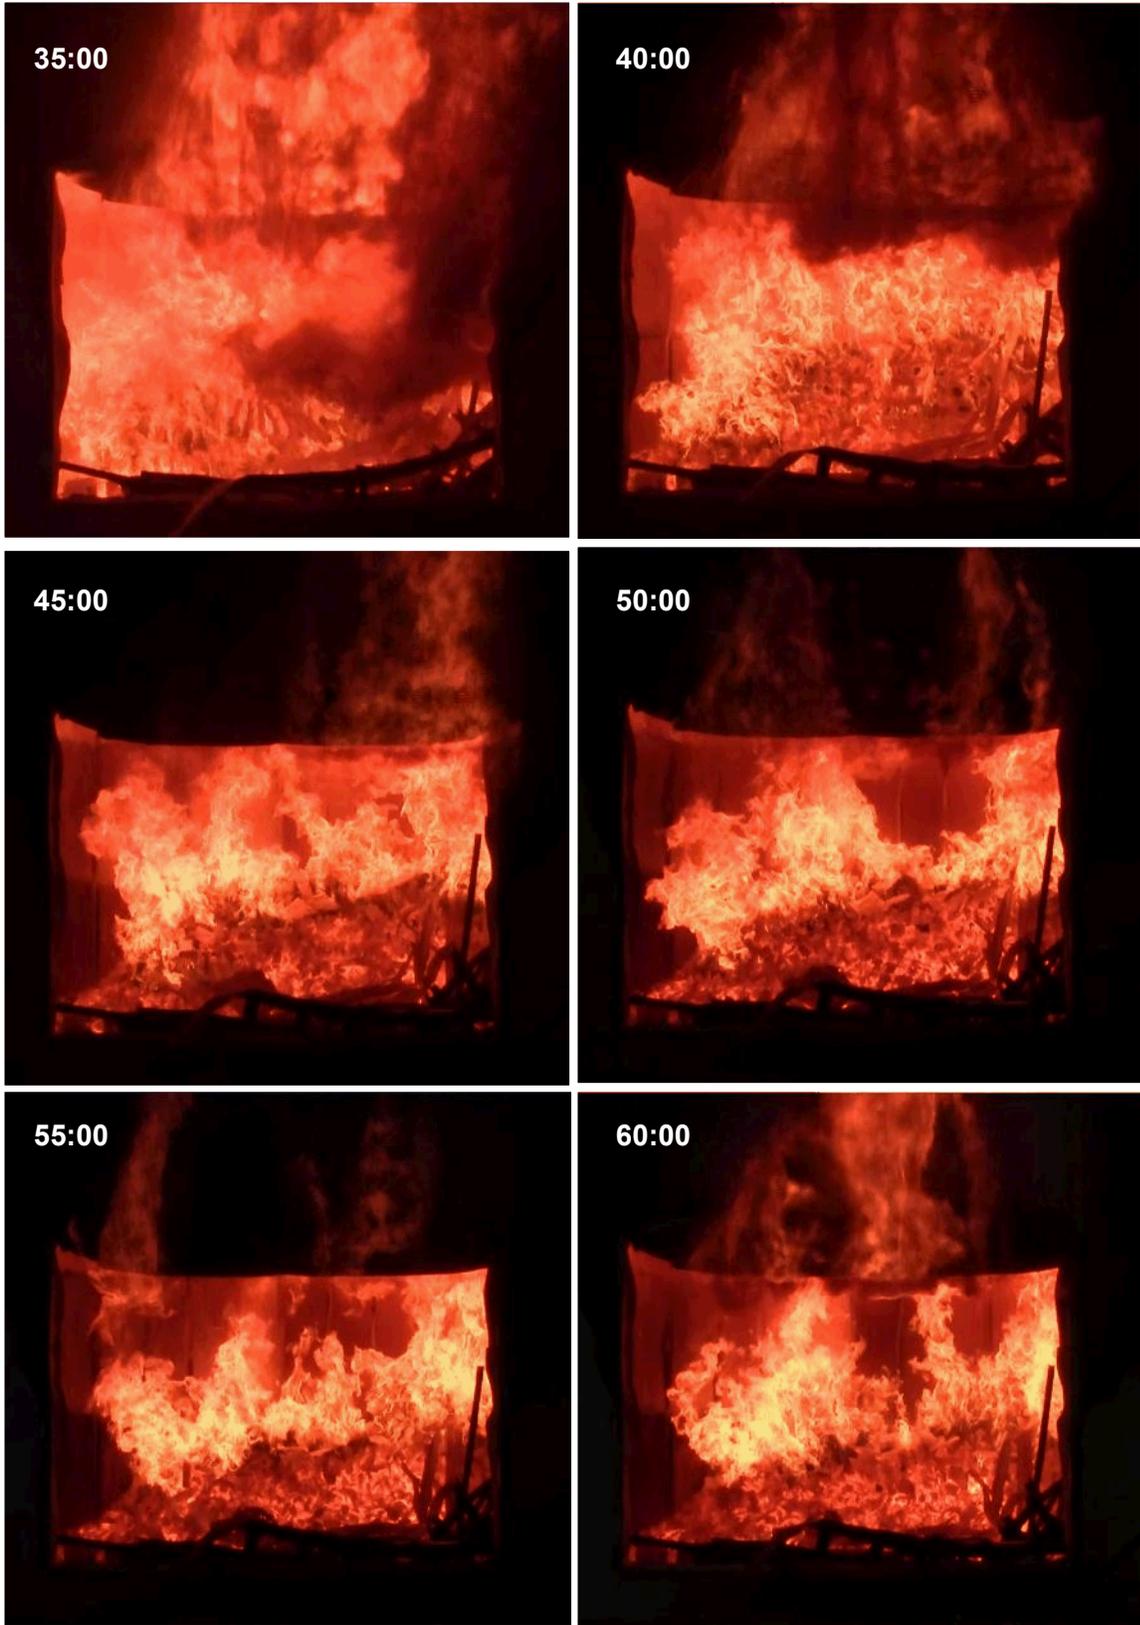
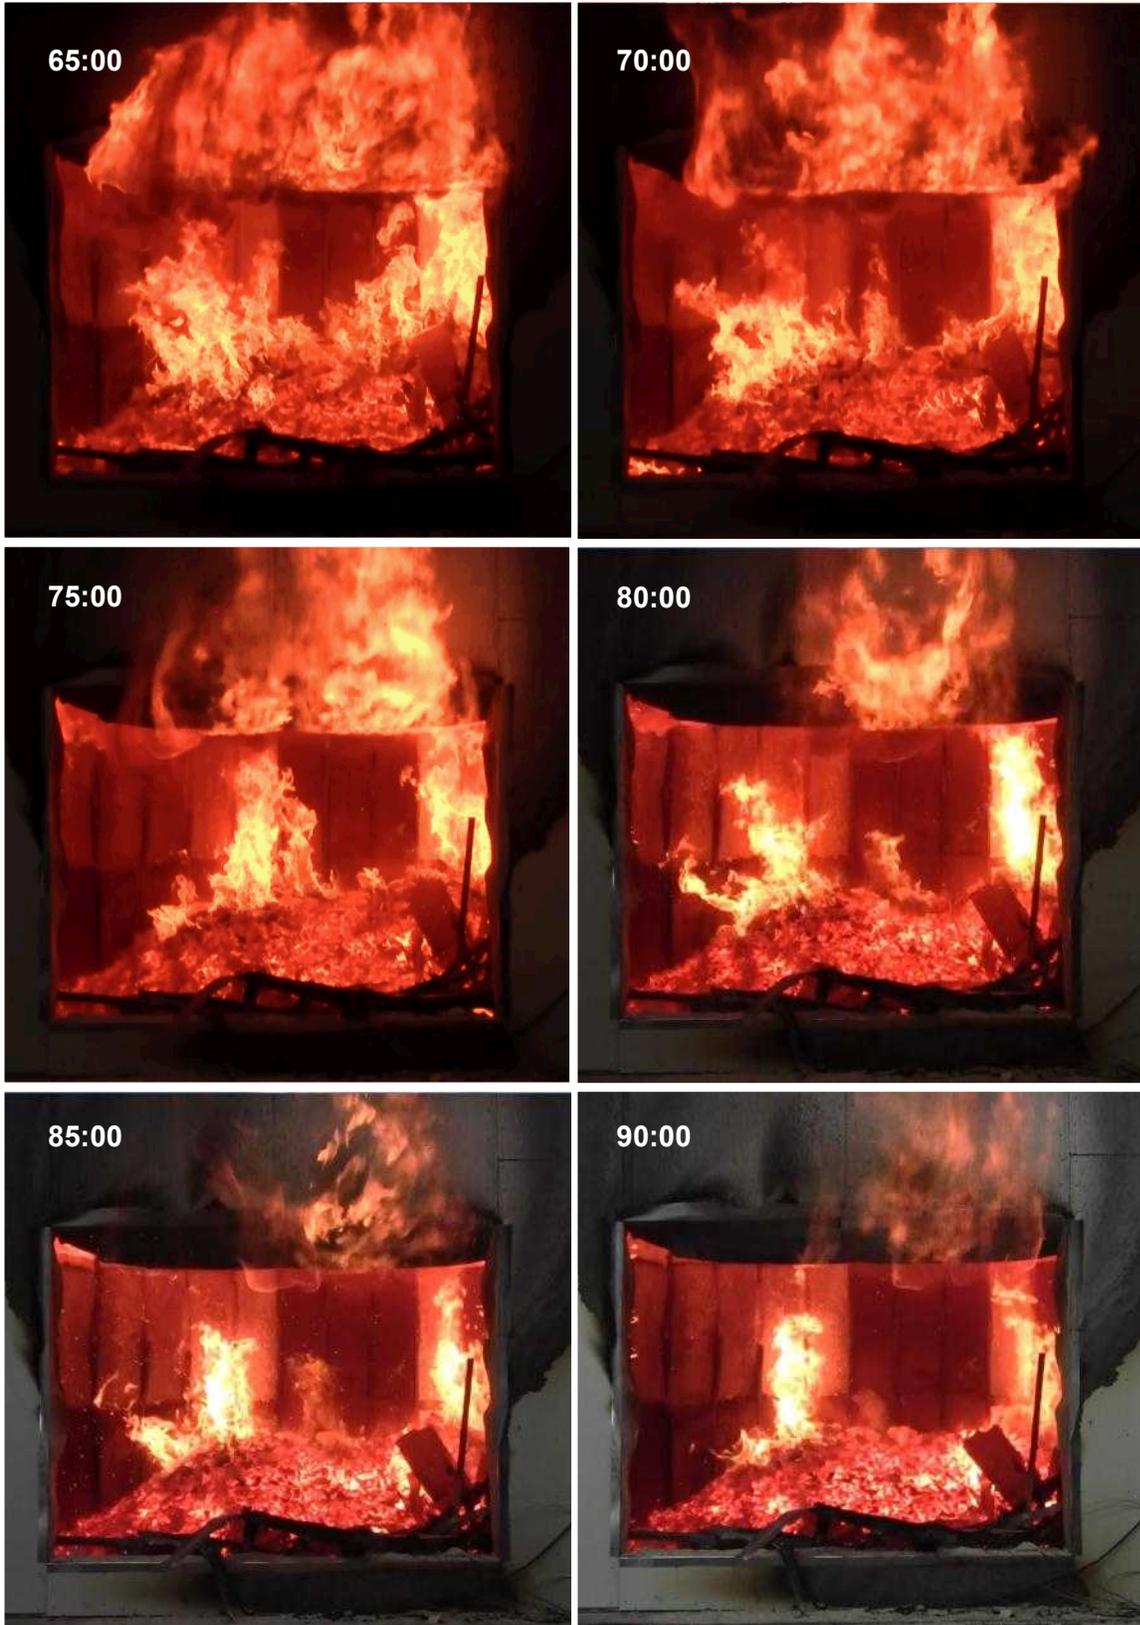
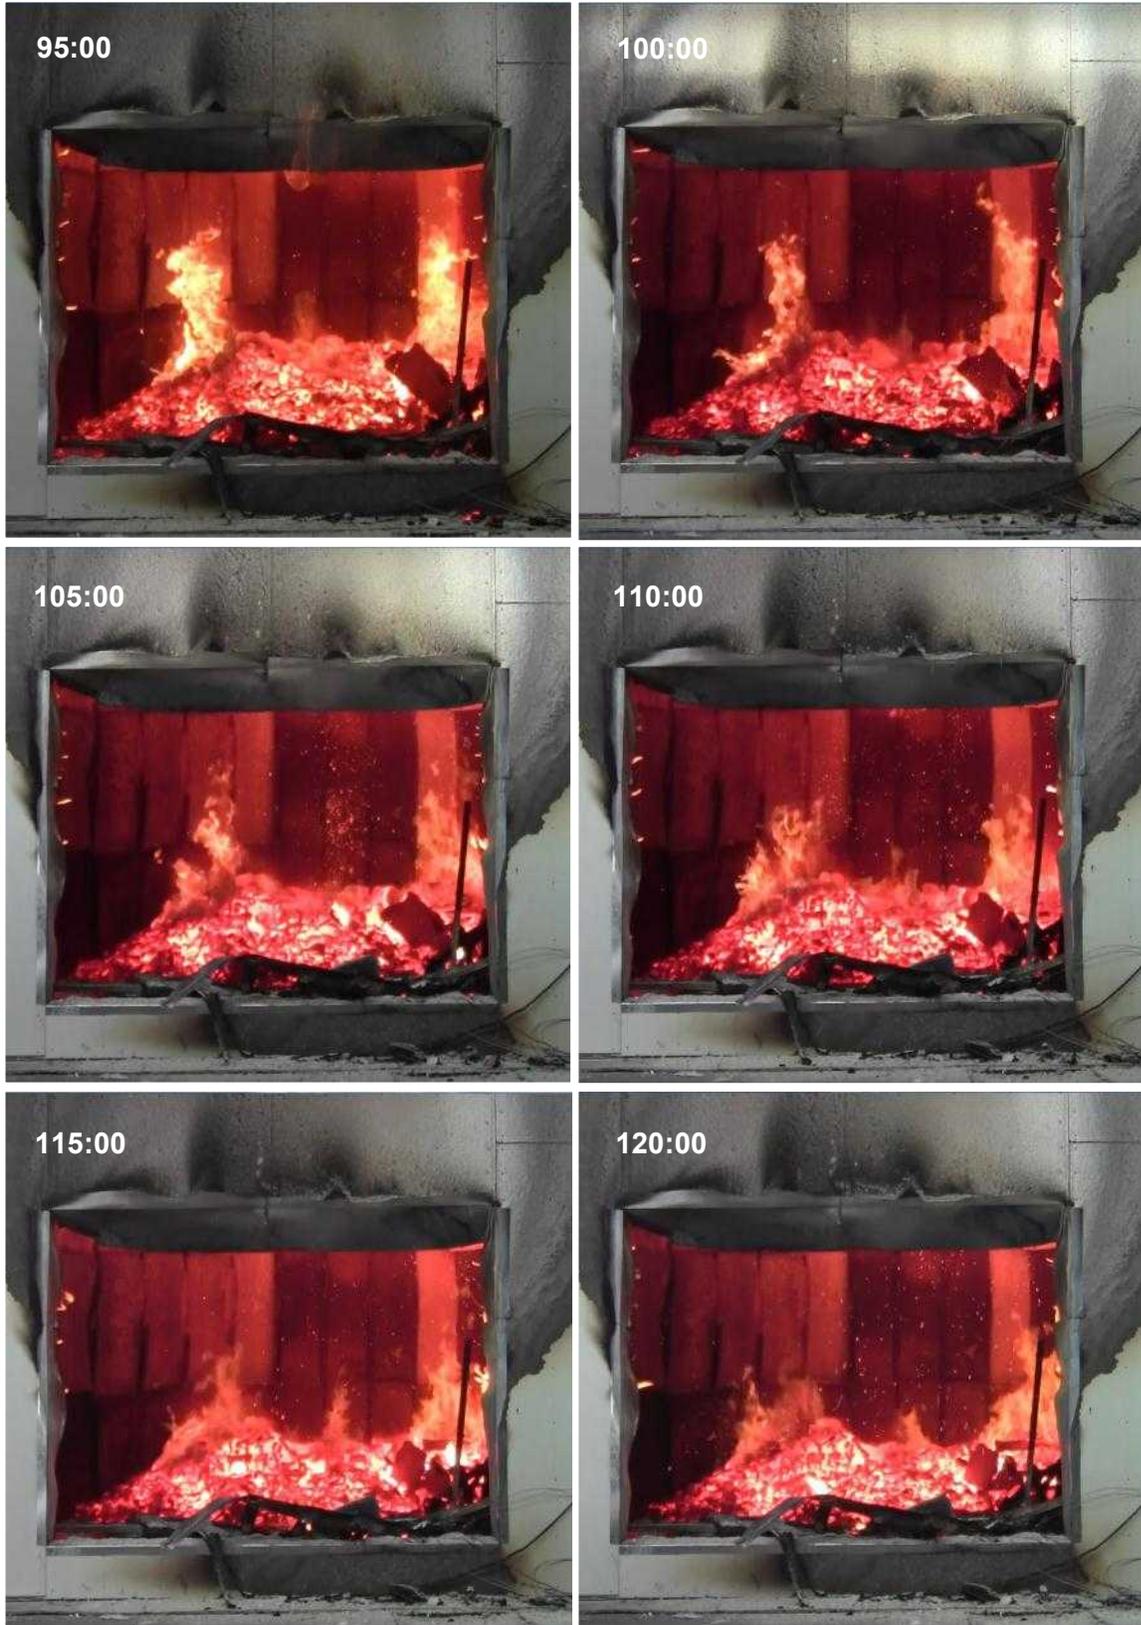
Figure 18. Video graphic captures of fire development (0-4 min).

Figure 19. Video graphic captures of fire development (5-30 min).

Figure 20. Video graphic captures of fire development (35-60 min).

Figure 21. Video graphic captures of fire development (65-90 min).

Figure 22. Video graphic captures of fire development (95-120 min).

Figure 18 to Figure 22 are video graphic captures of the fire development during the fire demonstration. The video indicated that, after flashover, fresh air mostly entered the fire compartment at the right half of the rough window opening and the fire plume mostly exited at the left half of the opening.

From 40 to 60 min, the fire plume that issued from the opening reduced in intensity. This could be due to the char layer formed on the ceiling CLT surface that slowed down the burning of the CLT panels on the ceiling. During this period, the wood cribs located in the apartment reduced to a pile of glowing debris on the floor. Some charred pieces started to fall from the CLT ceiling.

At approximately 60 min, many pieces of char fell from the CLT ceiling and more vigorous burning occurred on the ceiling, indicating the fall off of the charred first ply and involvement of the second ply of the uncharred CLT ceiling panels. The fire plume through the opening increased in size.

After 90 min, no fire plume issued through the opening. The fire in the apartment continued to decrease in size until the end of the fire demonstration.

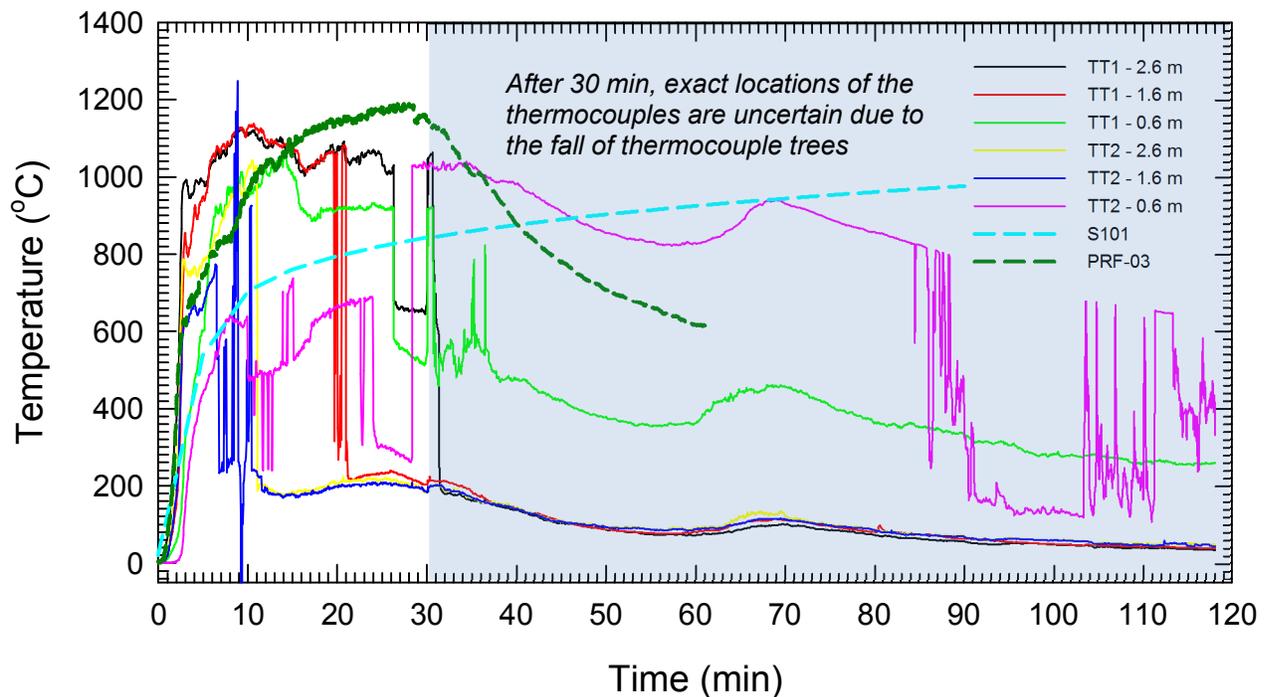
**Figure 23. Temperatures at 0.6 m, 1.6 m and 2.6 m heights measured using the two thermocouple trees (TT1 and TT2) in the apartment.**

Figure 23 shows the temperatures measured in the apartment by the thermocouples located on the two thermocouple trees. The temperatures were uniform with height in the upper portion of the room (the temperature at the 2.6 m height was similar to the temperature at the 1.6 height). However, the fire did not develop uniformly throughout the entire area, as is illustrated in the figure.

Peak temperatures of 1000-1100°C were reached by 10 min during the demonstration. After 10 min, the temperatures stayed at or above 1000°C in the upper portion of the apartment.

Unfortunately at 30 min, the two thermocouple trees were knocked down to the floor by the fall of the entire steel Z channels and metal furring strips installed as part of the ceiling system. After 30 min, the exact locations of the thermocouples became uncertain. In some cases, the thermocouples could be buried under the debris, and the temperatures shown in Figure 23 are mostly indicative of the temperatures in the lower portion of the apartment. Nevertheless, the general trend of these temperature measurements is consistent with the graphic captures (Figure 18 to Figure 22) of the fire development.

Also shown in Figure 23 is the standard CAN/ULC-S101 time-temperature curve used in fire-resistance tests [11]. The peak temperatures in the apartment were much higher than the standard time-temperature curve used in fire-resistance tests. For the first hour of the demonstration, the fire in the apartment was more severe than the standard fire used in fire-resistance tests, providing a severe challenge to the structure. After 75 min, the temperatures

Figure 23 also shows a time-temperature curve derived from a previous fire test (PRF-03) in a fully furnished bedroom of noncombustible construction as part of a project to develop data for establishing design fires for multi-suite residential occupancies [13]. The PRF-03 curve was the average ceiling temperature in that bedroom. The ceiling temperature profiles measured in the studio apartment in this fire demonstration were similar to, but higher in the initial 15 min than, the PRF-03 curve.

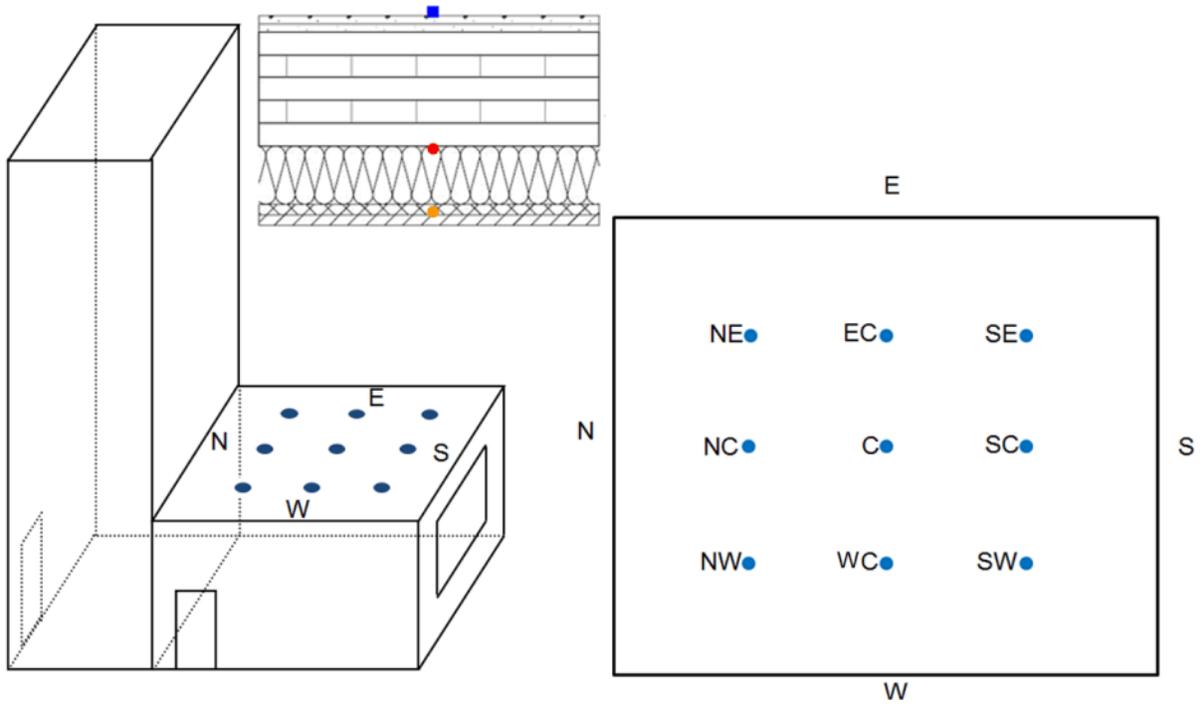
**Figure 24. Thermocouples at interfaces in the apartment ceiling assembly at  $\frac{1}{4}$ ,  $\frac{1}{2}$  and  $\frac{3}{4}$  of length and width.**

Figure 24 illustrates the thermocouples installed, and Figure 25 shows the temperature profiles measured, at various interfaces in the ceiling assembly.

The nine thermocouples covered with pads used in standard fire resistance tests on the top of the ceiling assembly show less than 6°C temperature rise except the thermocouple located at the center of the ceiling assembly which measured a temperature rise of 46°C. (Note that the horizontal spline connection of the CLT ceiling panels in the middle was joined with strips of plywood glued with a construction adhesive.) All the temperature rises were well below the 140°C average and 180°C single point temperature increases prescribed in CAN/ULC-S101 [11].

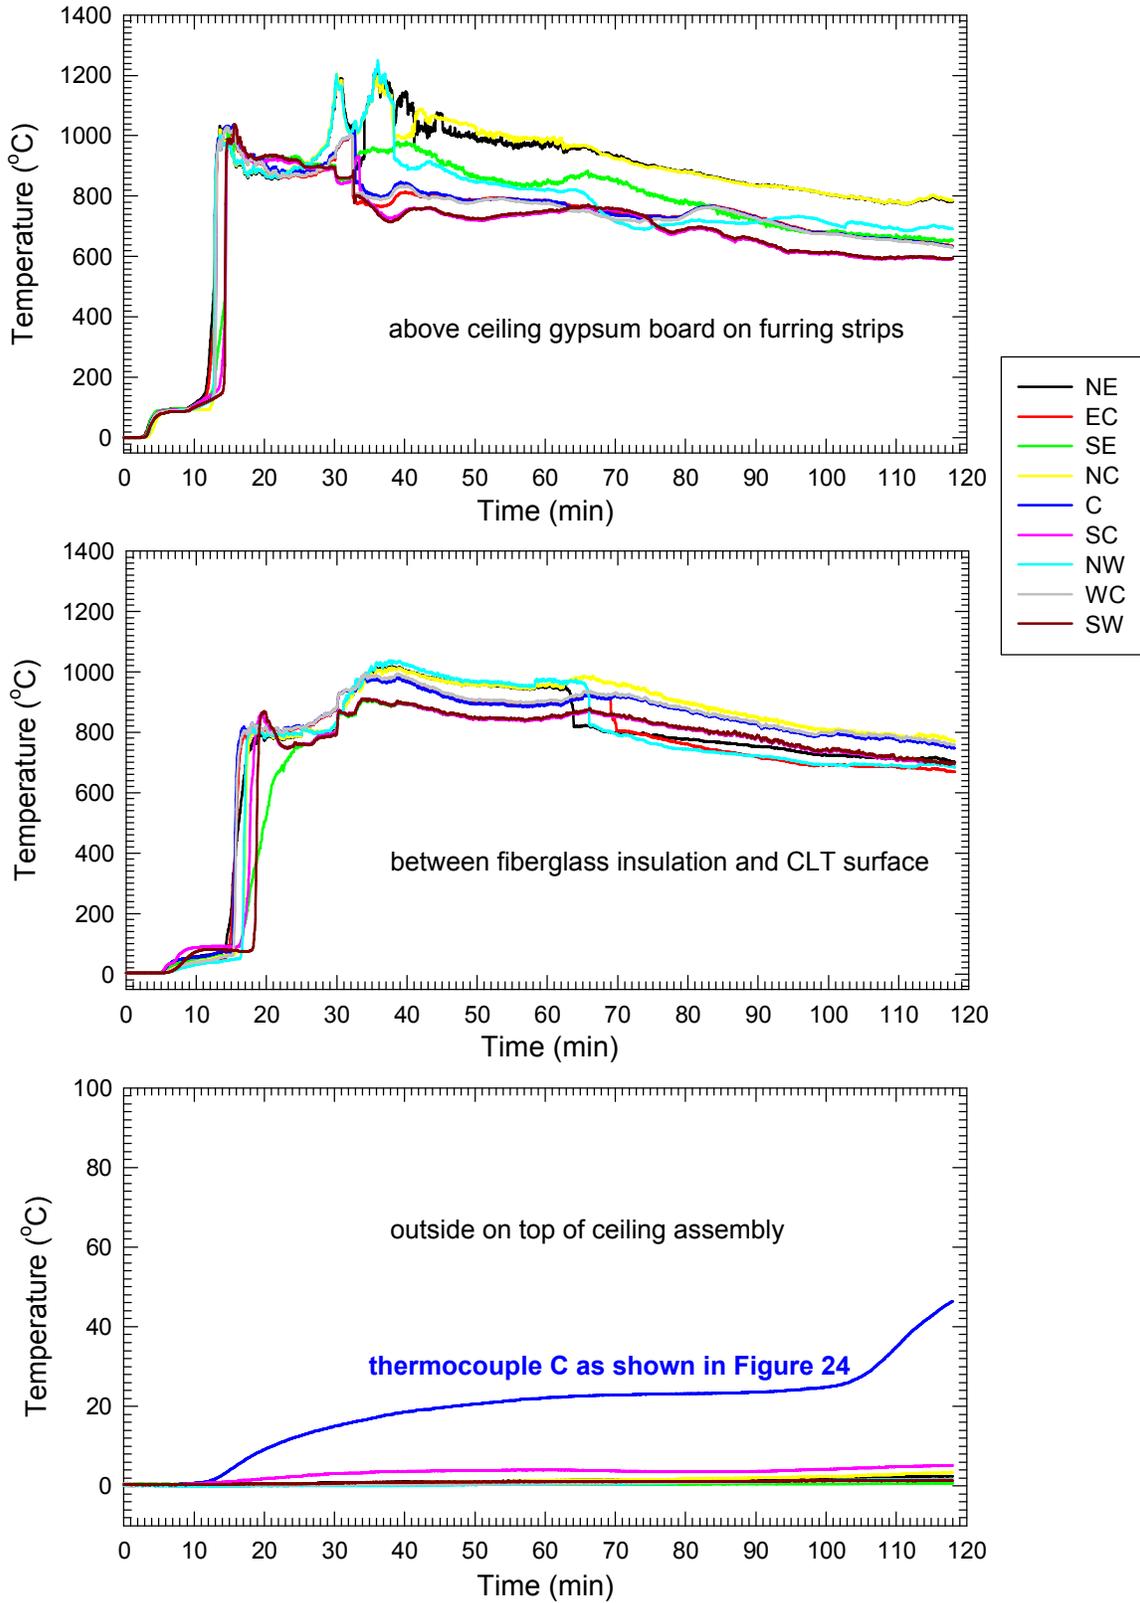
Figure 25. Temperatures at various interfaces in the apartment ceiling assembly.

It was observed after the demonstration that two plies of the CLT ceiling panels were charred and consumed in the fire, but fell off after applying the water hose stream to extinguish the fire. The remaining plies of the CLT ceiling panels were not significantly affected by the fire. The third ply charred at some locations, but remained mostly unaffected.

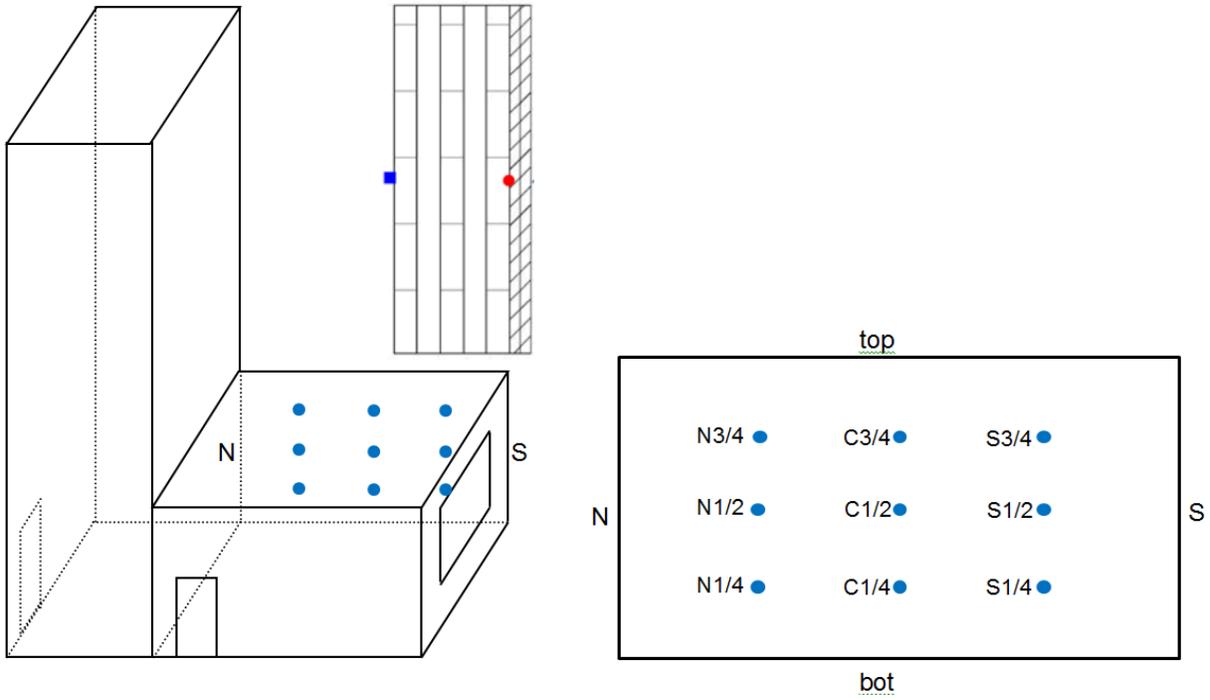
**Figure 26. Thermocouples at various interfaces in TYPE-2 wall of the apartment at  $\frac{1}{4}$ ,  $\frac{1}{2}$  and  $\frac{3}{4}$  of length and height.**

Figure 26 illustrates the thermocouples installed, and Figure 27 shows the temperature profiles measured at various interfaces in the wall assembly.

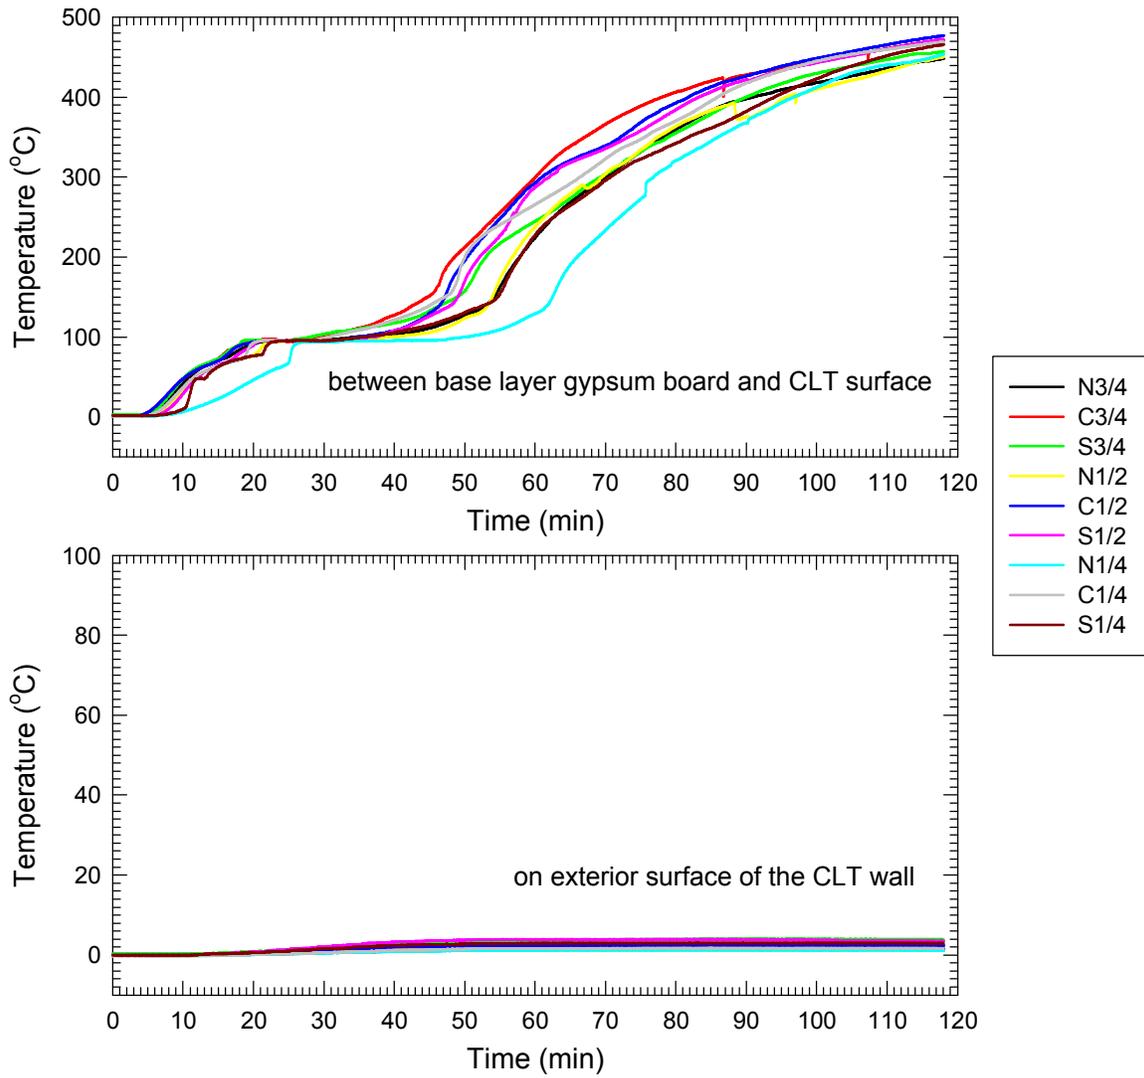
**Figure 27. Temperatures at various interfaces in TYPE-2 wall assembly of the apartment.**

The encapsulation time for the CLT wall panels was 56.9 min based on a single point temperature rise or 60.9 min based on the average temperature rise for the nine thermocouples. After these times, the interfacial temperatures reached 300°C and the CLT panels started to develop char. However, the interfacial temperatures remained below 500°C as the double layer of gypsum board remained on the walls until the end of the demonstration as shown in Figure 28, indicating no flaming combustion in the CLT wall assemblies. The three walls did not contribute to the growth of fire in the apartment. The gypsum board fell off only after water hose was used to extinguish the fire.

There was no flame penetration through the CLT wall panels during the demonstration. The temperatures measured using the nine thermocouples covered with pads on the exterior side of the CLT wall increased by less than 4°C during the demonstration. All the temperature rises were well below the 140°C average and 180°C single point temperature increases prescribed in CAN/ULC-S101 [11].

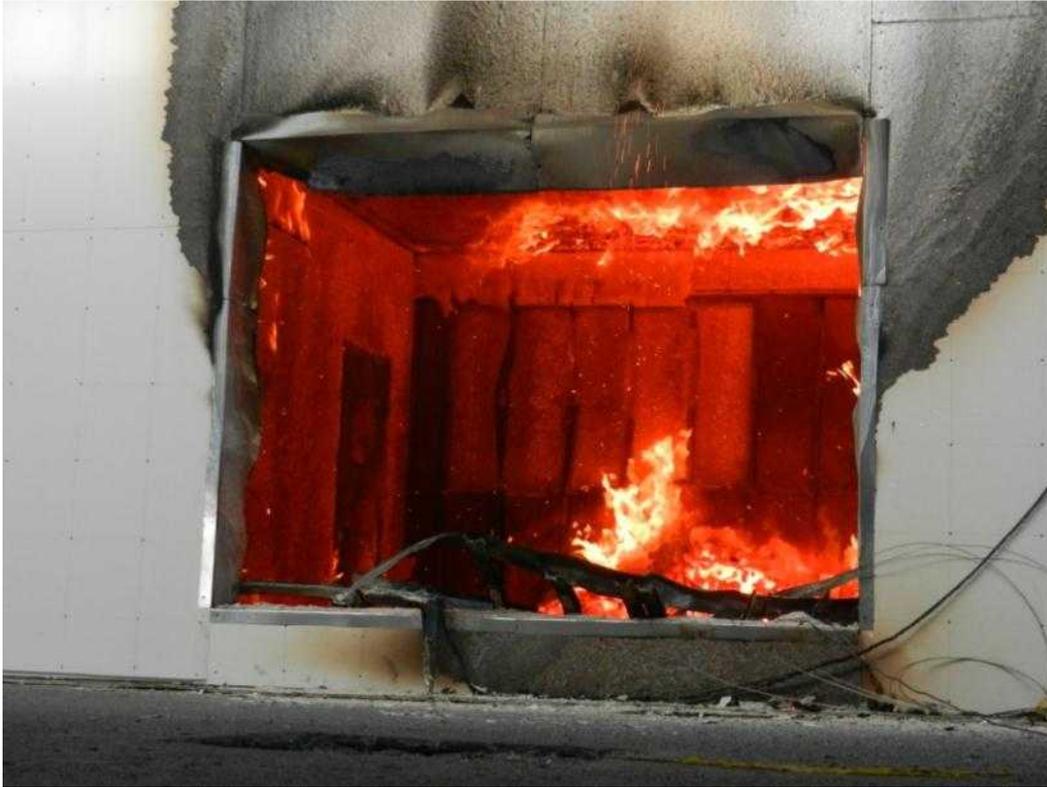
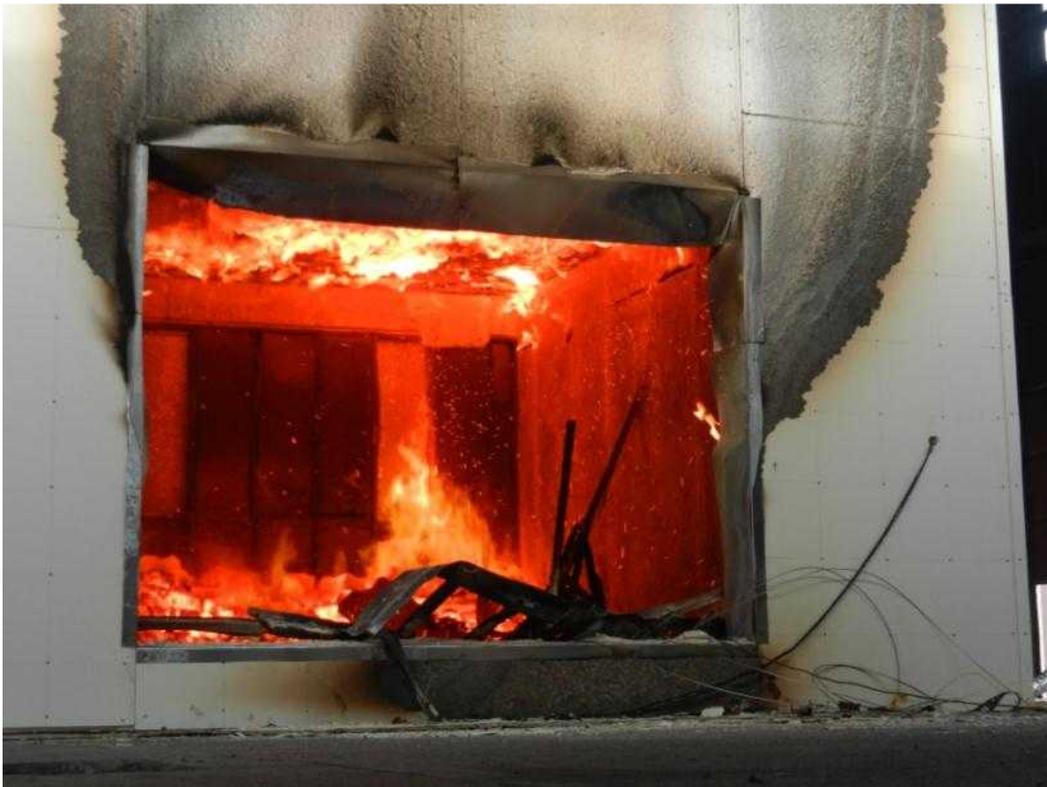
**Figure 28. Double layer of gypsum board and rigid mineral wool fibre insulation remained on the apartment wall until end of demonstration.**

The temperatures measured by the nine thermocouples located on the face layer of gypsum board behind the insulated steel stud wall show that the temperature rise value reached 270°C at a single point at 22.2 min, and the average temperature rise value for the nine thermocouples reached 250°C at 30.5 min. The insulated steel stud wall provided extra protection by at least these times for the CLT shaft panels. It was observed that the rigid mineral wool fibre insulation remained in place until the end of the demonstration (see Figure 28).

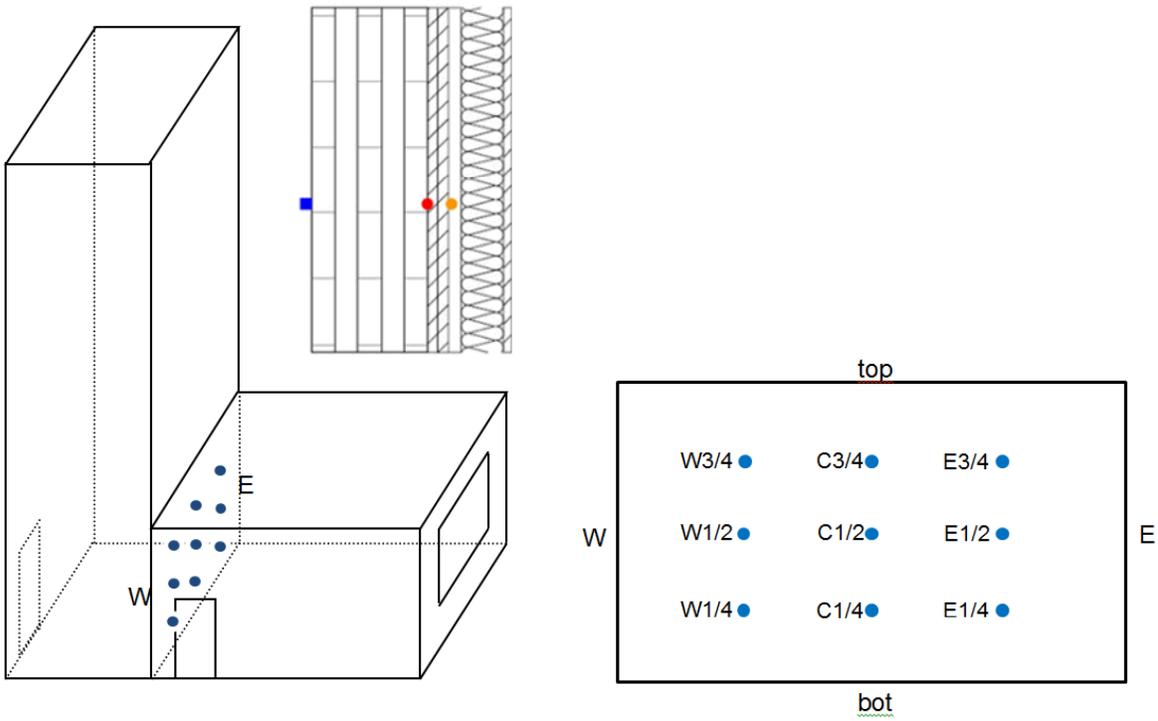
**Figure 29. Thermocouples at various interfaces in the wall assembly shared by the stair/elevator shaft and apartment at  $\frac{1}{4}$ ,  $\frac{1}{2}$  and  $\frac{3}{4}$  of width and height.**

Figure 29 illustrates the thermocouples installed in the wall assembly, and Figure 30 shows the temperature profiles measured, at various interfaces of the wall assembly shared by the apartment and stair/elevator shaft.

The temperatures measured using the nine thermocouples installed at the interface between the base layer of gypsum board and the CLT panels show a similar heat transfer process as observed in other assemblies: an initial temperature rise to 100°C followed by the gypsum calcination at a steady temperature of 100°C. Complete calcination of the gypsum board only occurred in the upper left quarter (near the apartment door) as indicated by the more rapid temperature increase in this quarter. The temperatures measured at the other three quarters remained at 100-130°C until the end of the demonstration. The average temperature rise of 250°C was not reached during the demonstration in these areas.

Based on the single point temperature rise of 270°C, the encapsulation time for the CLT shaft wall panels was determined to be 91.0 min. The average temperature increase criterion was not exceeded for the temperatures measured by the nine thermocouples at this location. The CLT interfacial temperatures in the upper left quarter reached 300°C at 95 min or later but remained below 400°C. As shown in Figure 28, the two layers of gypsum board and the rigid mineral wool fibre insulation remained on the wall until the end of the demonstration (before water hose was used to extinguish the fire).

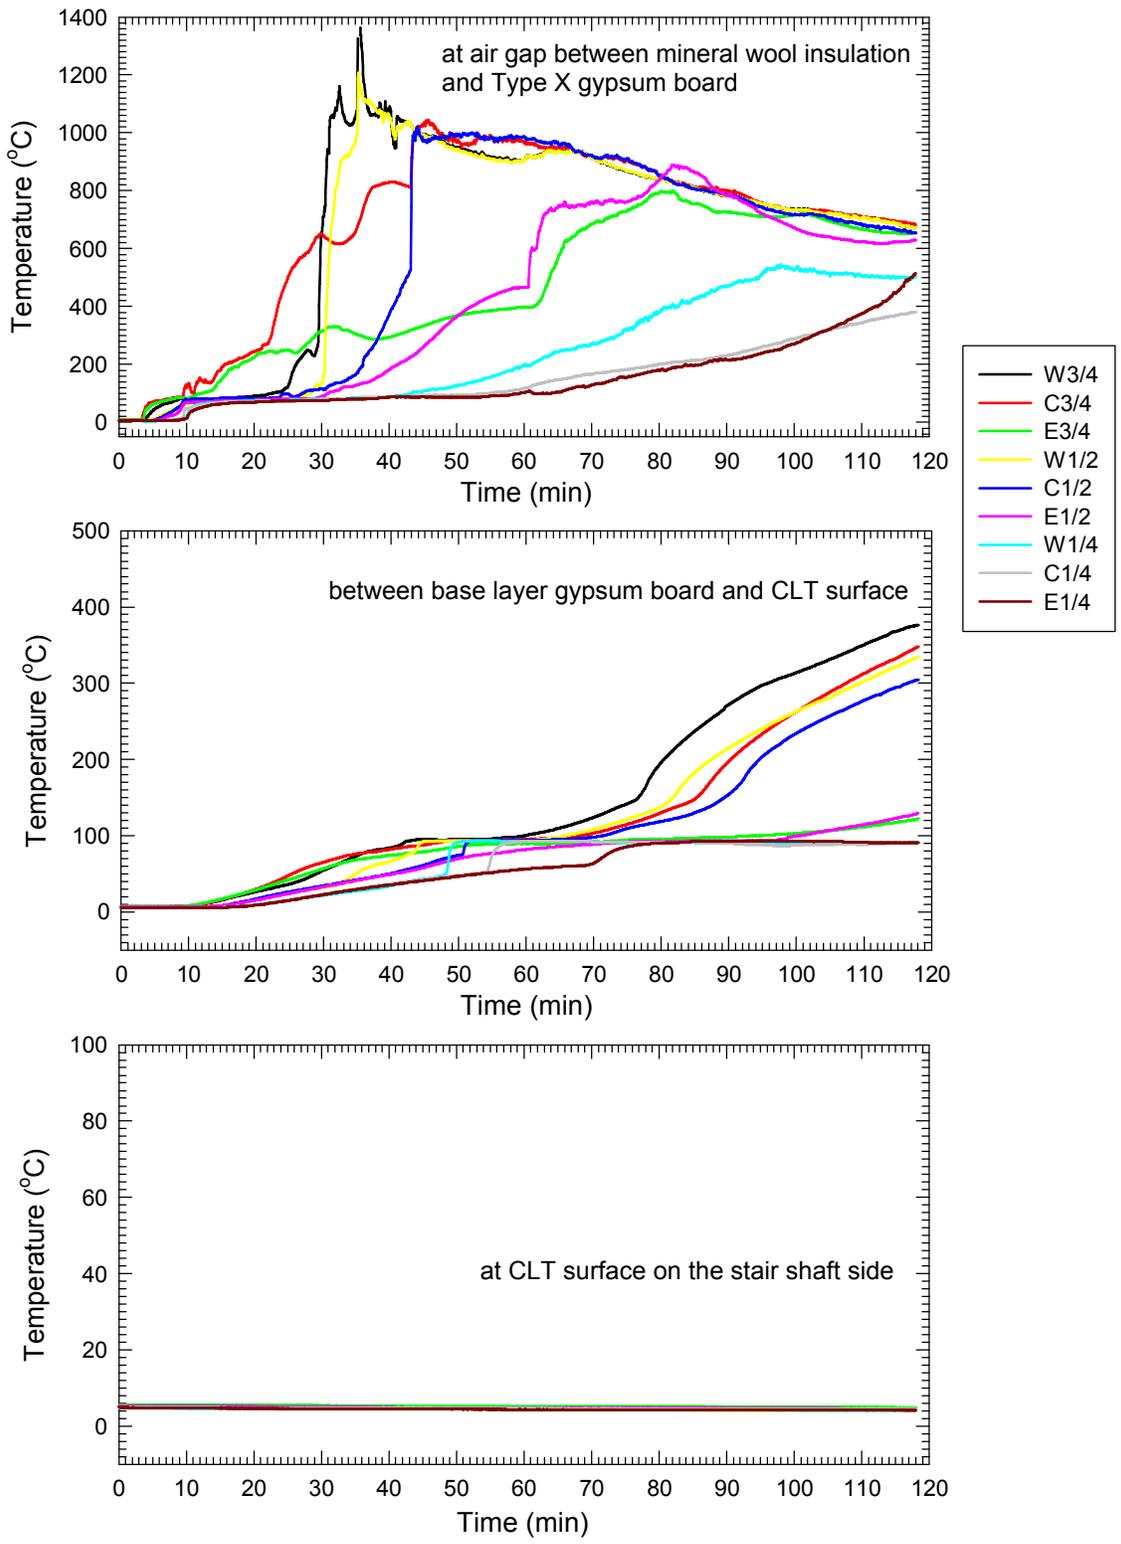
**Figure 30. Temperatures at various interfaces in the wall assembly shared by the apartment and stair/elevator shaft.**
