## **Fire Demonstration –**

### **Cross-Laminated Timber Stair/Elevator Shaft**

Author: Joseph Z. Su, Ph.D. and Saša Muradori

Report No: A1-006010.1  
Report Date: January 30, 2015  
Contract No: A1-006010  
Program: Mid-Rise Wood Buildings

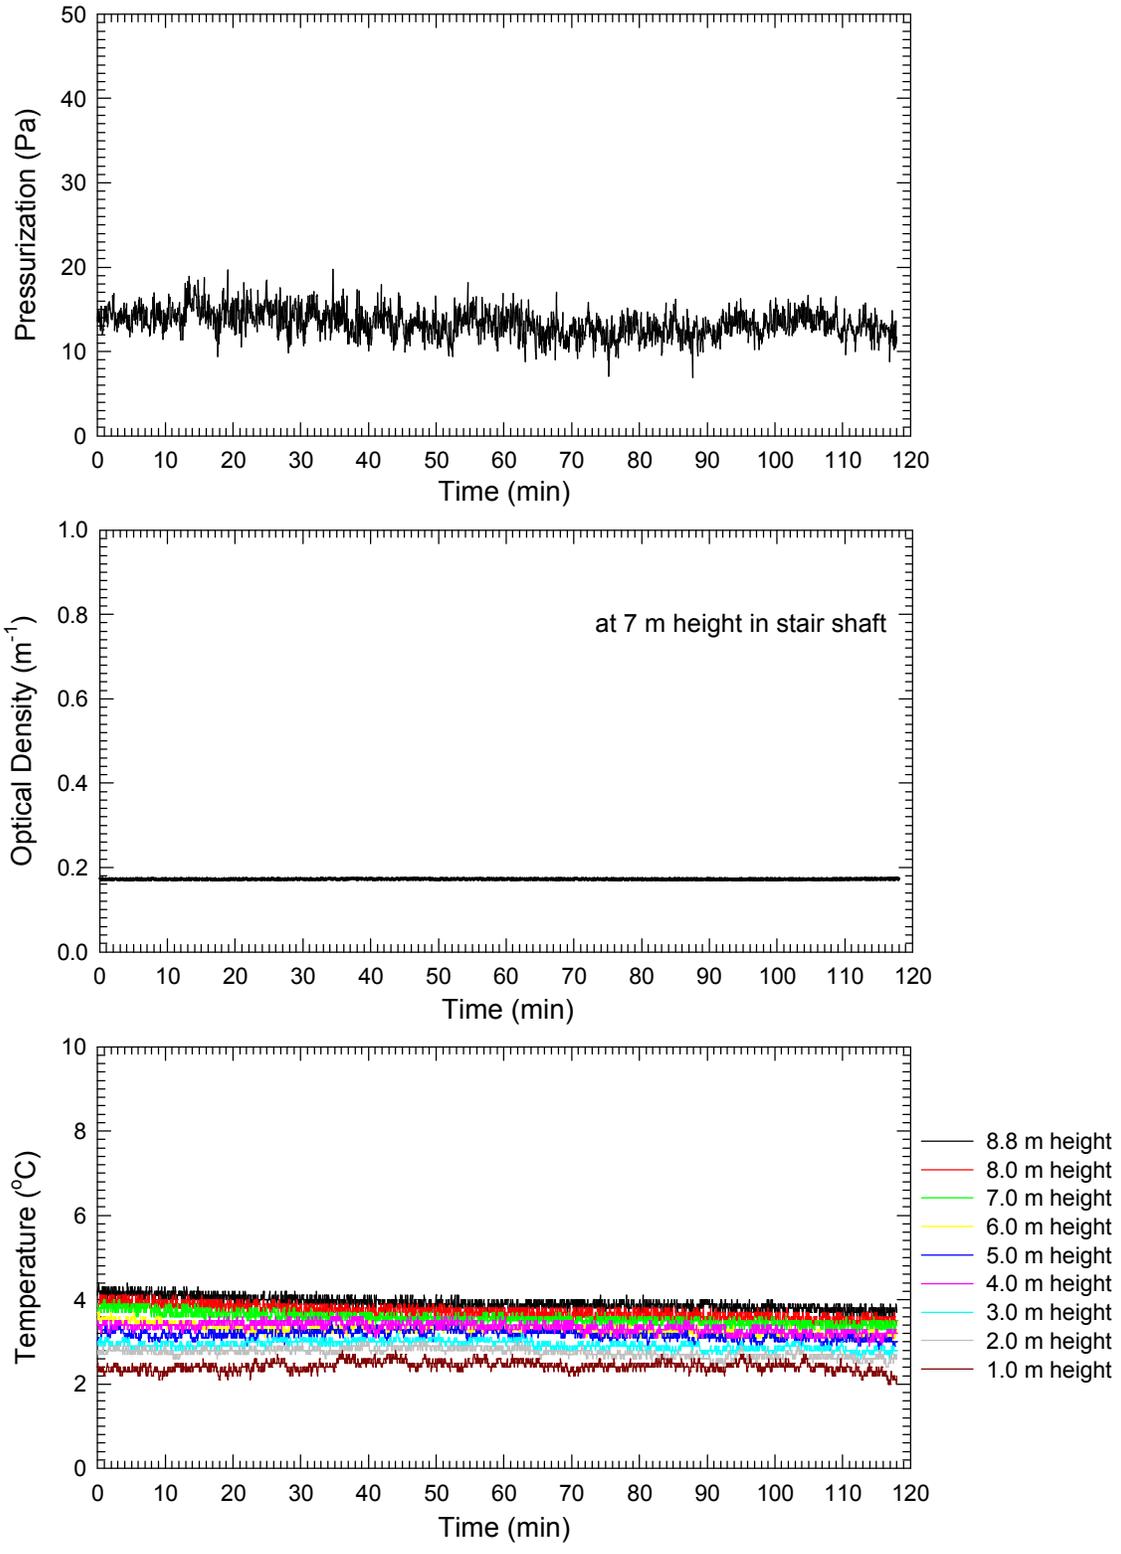
Figure 31. Temperatures, differential pressure and optical density in the shaft.

Figure 31 shows measurements in the stair/elevator shaft during the fire demonstration. The stair/elevator shaft was pressurized with fresh air supply to 12 Pa above the ambient. This is the design pressurization for the stair and elevator shafts in the "Origine" project. The array of nine thermocouples provided temperature measurements at the center of the stair/elevator shaft at different heights. No temperature increases were measured in the stair/elevator shaft during the demonstration.

The optical density was measured at the 7 m height. There was no change in smoke optical density measured in the stair/elevator shaft, demonstrating that no smoke leaked into the stair/elevator shaft. There was no sign of any impact of fire or smoke on the safety conditions in the stair/elevator shaft.

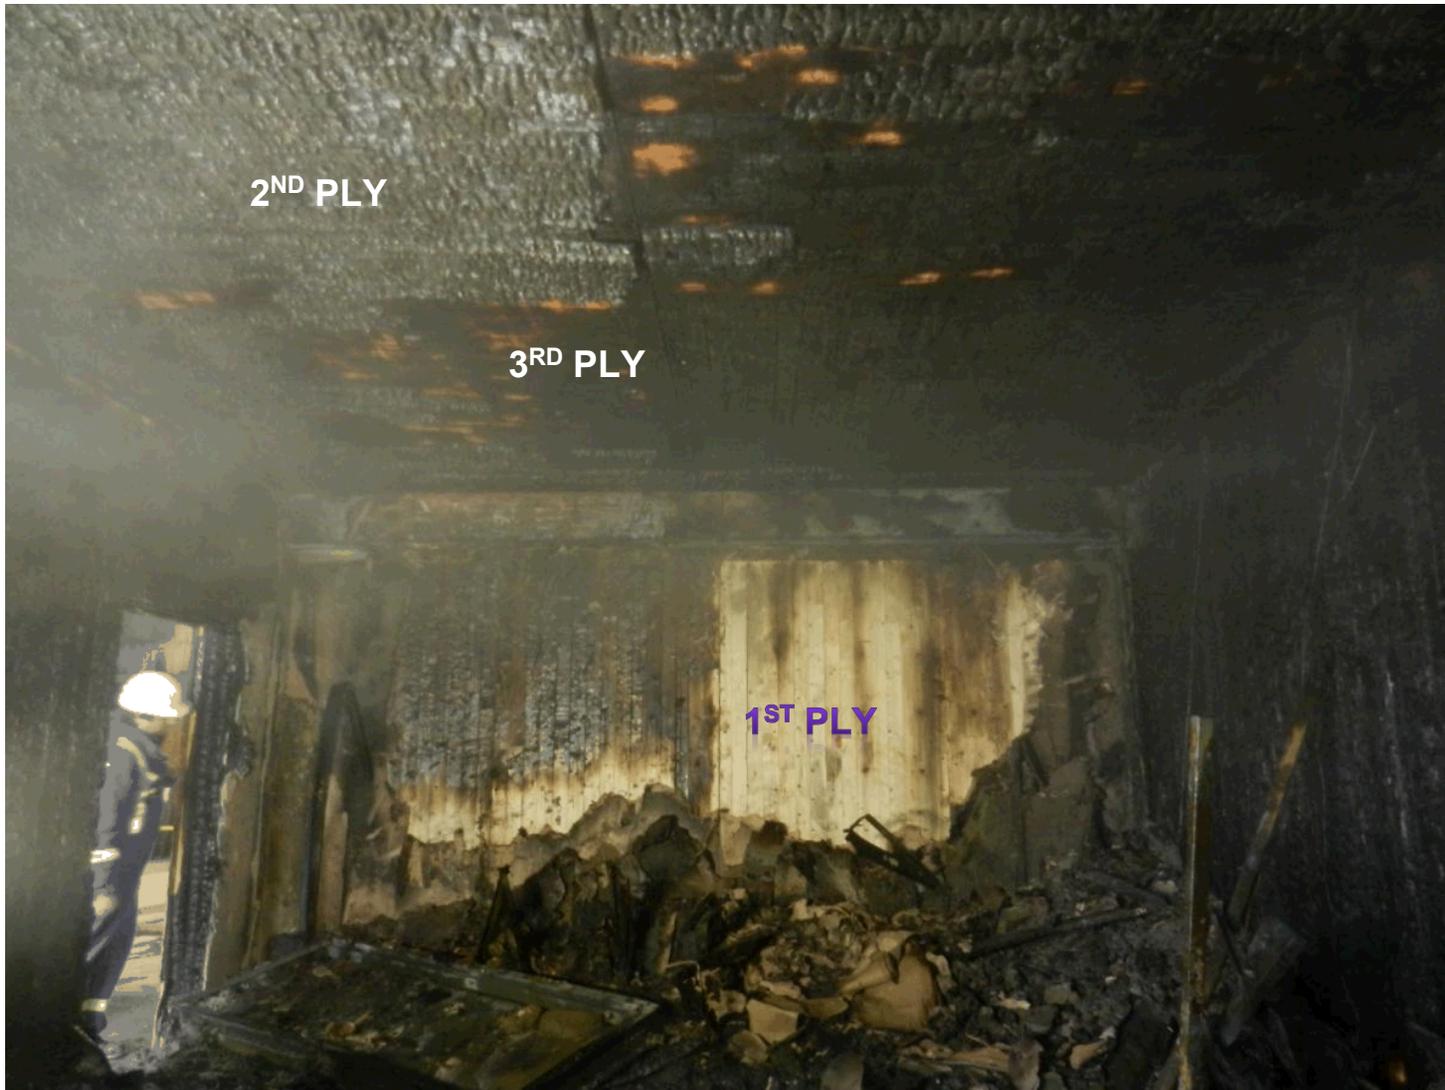
Figure 32. Inside of the fire compartment after the fire demonstration.

It was observed after the demonstration that two plies of the CLT ceiling panels were charred and consumed in the fire, but fell off after applying the water hose stream to extinguish the fire. The remaining plies of the CLT ceiling panels were not significantly affected by the fire. The third ply charred at some locations, but remained mostly unaffected.

After the fire demonstration, it was observed that only the surface ply of the CLT wall panels inside the apartment was charred. The four inner plies of the CLT wall panels were not affected by the fire. The exterior side of the CLT panels had no char.

Figure 32 and Figure 33 show the inside and outside of the apartment and the stair/elevator shaft after the fire demonstration.

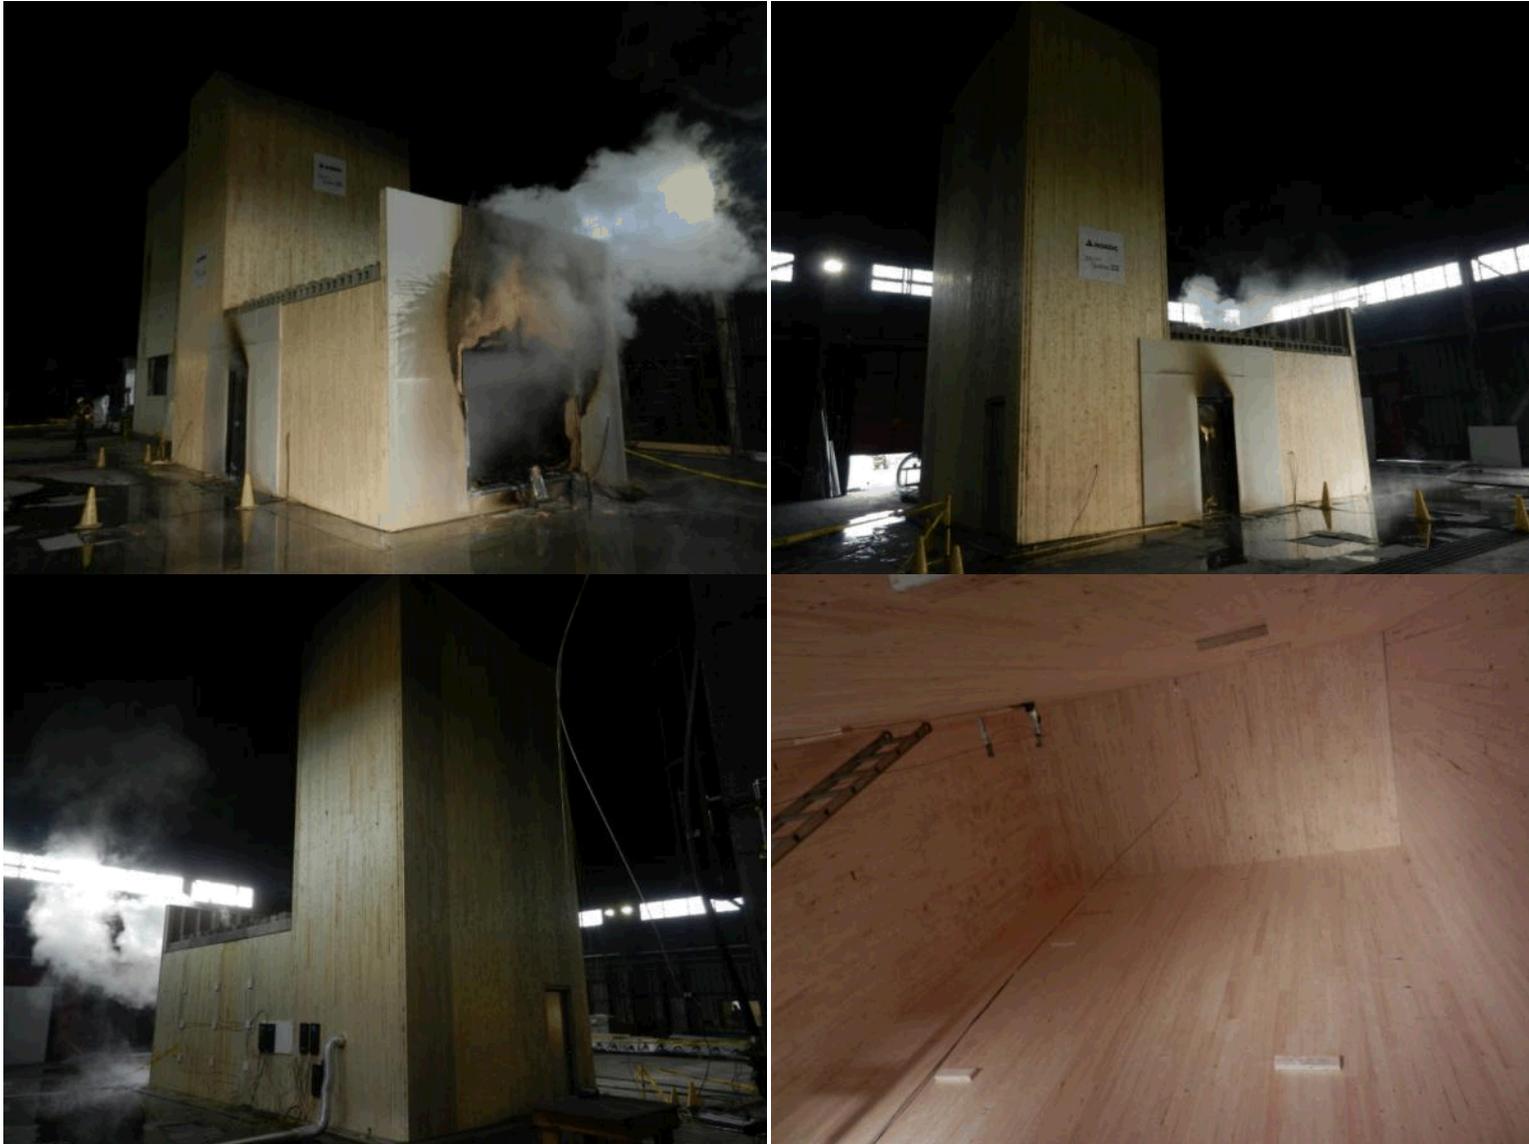
Figure 33. Outside of the demonstration structure and inside of the stair/elevator shaft after the fire demonstration.

The stair/elevator shaft was pressurized to 12 Pa above ambient. Measurements show that no smoke or heat was transferred into the stair/elevator shaft. The temperatures measured on the shaft side of the shared CLT wall had no temperature increase during the demonstration. There was no sign of any impact of fire or smoke on the safety conditions in the stair/elevator shaft.
