Icing flight tests of a fluid rotor blade ice protection system on a Bell HU-1 helicopter Gibbard, G.A.

Aeronautical Report (National Research Council Canada. National Aeronautical Establishment); no. LR-317, 1961-10

LR - 317

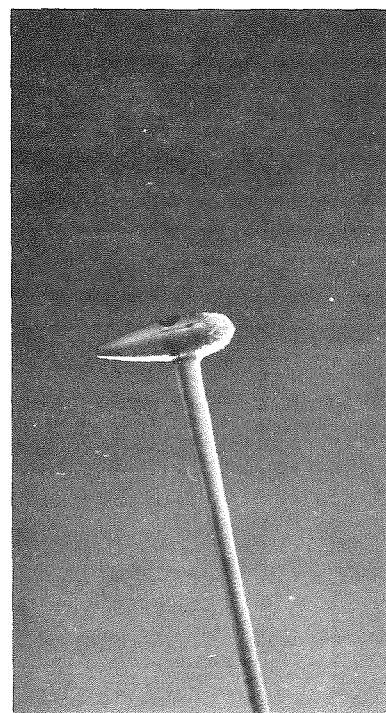
FIG. 6
LR-317

ROTOR BLADE ICING
RUN 9-12

STABILIZER BAR AND
BOB-WEIGHT ICING
RUNS 12-16 AND 12-17

ENGINE INLET SCREEN ICING
RUNS 12-16 TO 12-18

TAIL BOOM ICING
RUNS 18-24 TO 18-26

ICE ACCRETIONS ON HELICOPTER

On the few accretion runs, it was verified that ice was readily built up on the main and tail rotor blades and vibrations were produced when self-shedding of this ice occurred. On long duration flights in the cloud, ice was also picked up on unprotected areas of the helicopter such as the engine intake screen, stabilizer bar and bob-weights and the tail boom. None of this secondary icing caused any adverse effects on the operation of the aircraft. Examples of ice accretions on various parts of the helicopter are shown in Figure 6.
