Kemano Fire Studies: Part 2: response of a residential sprinkler system Su, J. Z.; Crampton, G. P.; Carpenter, D. W.; McCartney, C. J.; Leroux, P.

Kemano Fire studies – Part 2: Response of a Residential Sprinkler System

IRC-RR-109

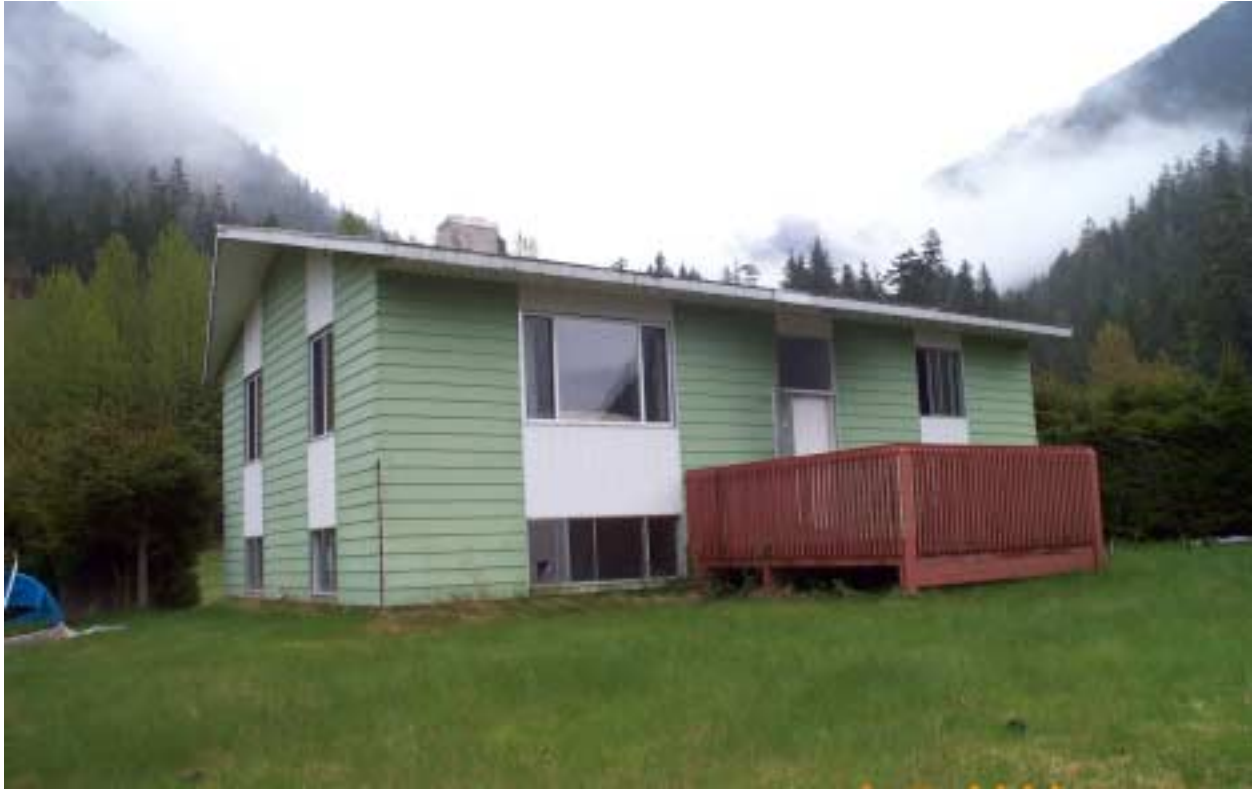
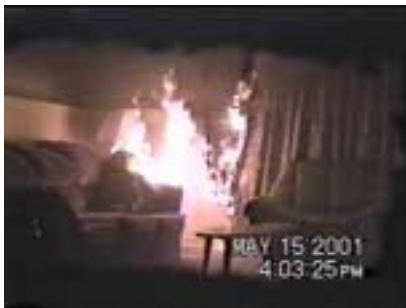
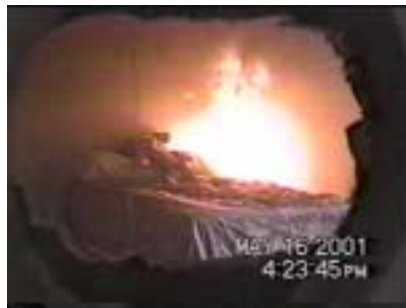
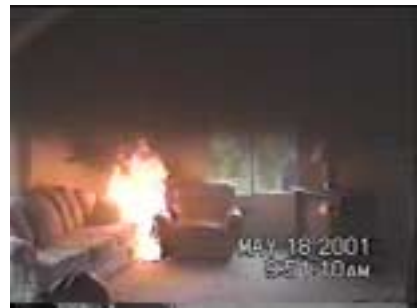
Figure 1. Family dwelling for fire experiments.

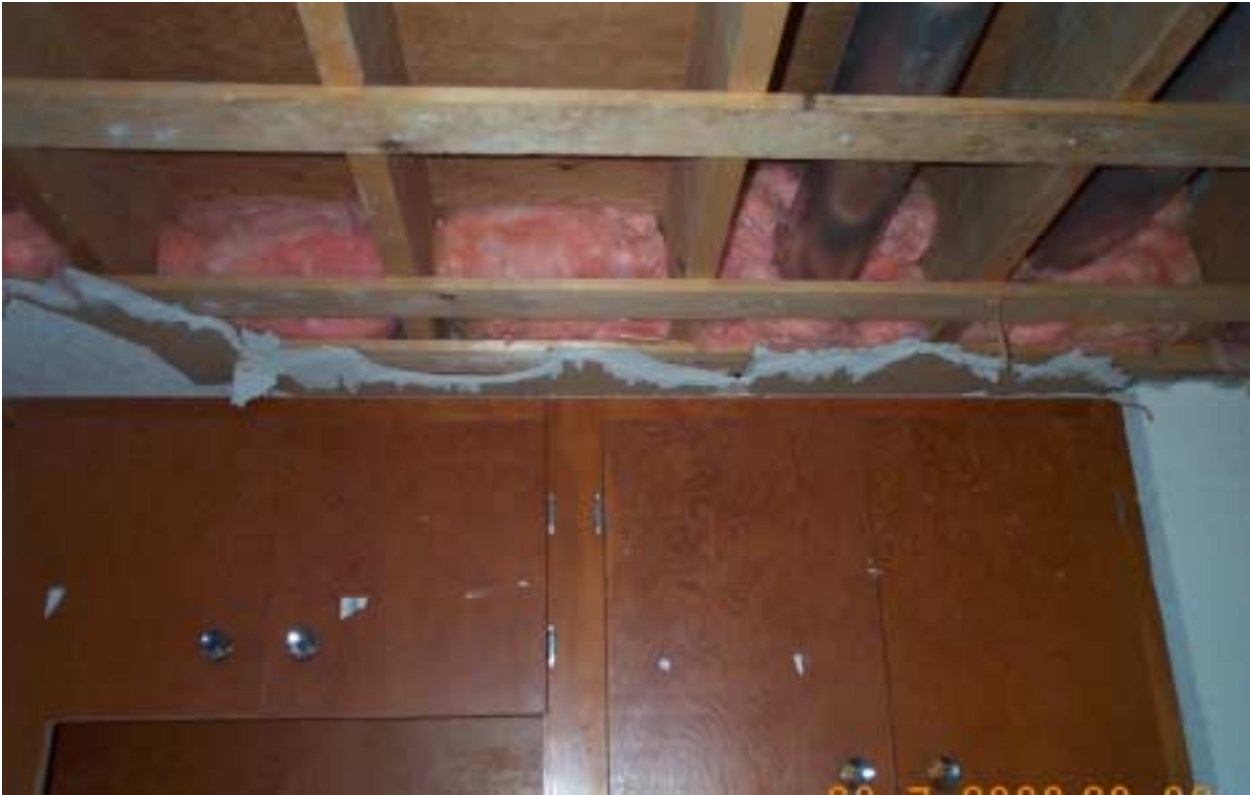
Figure 3. Recreation room ceiling torn down to expose wood joists.

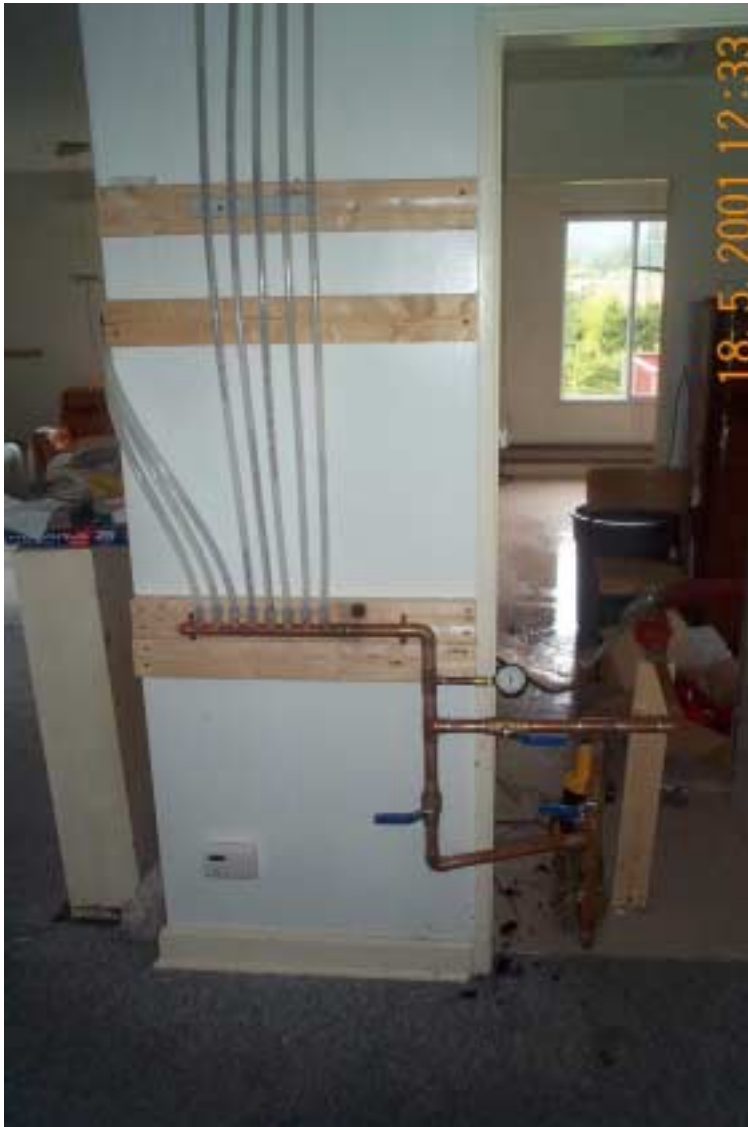
Figure 4. Sprinkler water supply and system manifold.

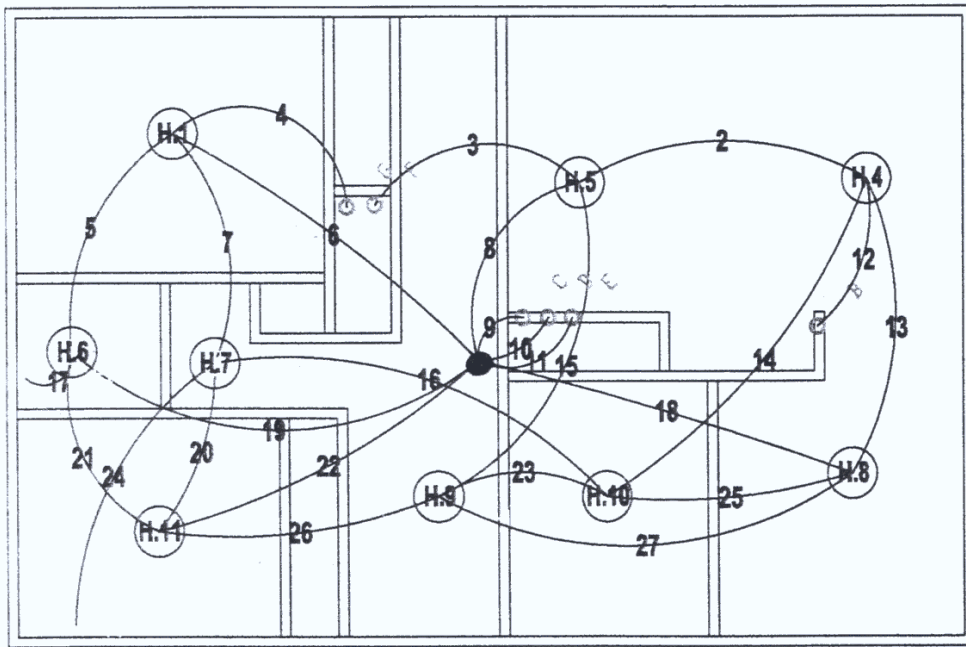
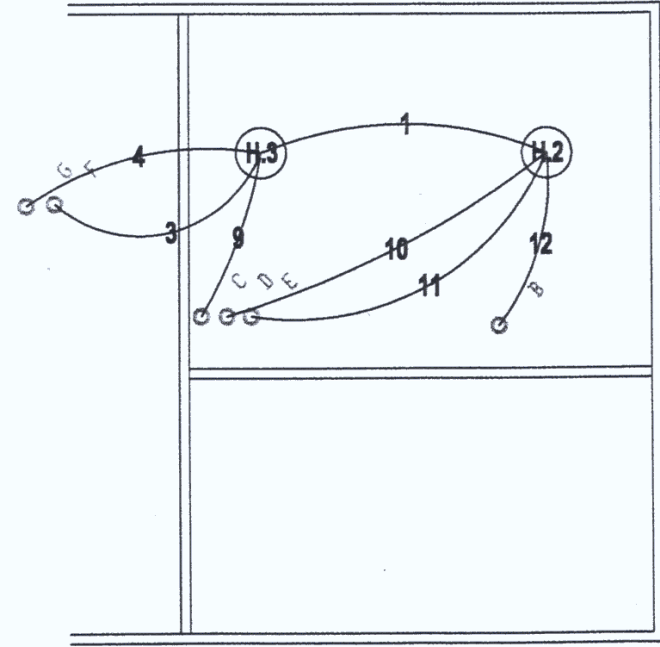
MOST HYDRAULICALLY REMOTE HEADS			
	HEAD #	GPM#	PRESSURE AT MANIFOLD
1 HEAD	# 10	10 GPM	21 PSI
2 HEAD	4 & 5	16 GPM	20 PSI

Figure 5. Schematic drawing of the sprinkler system.

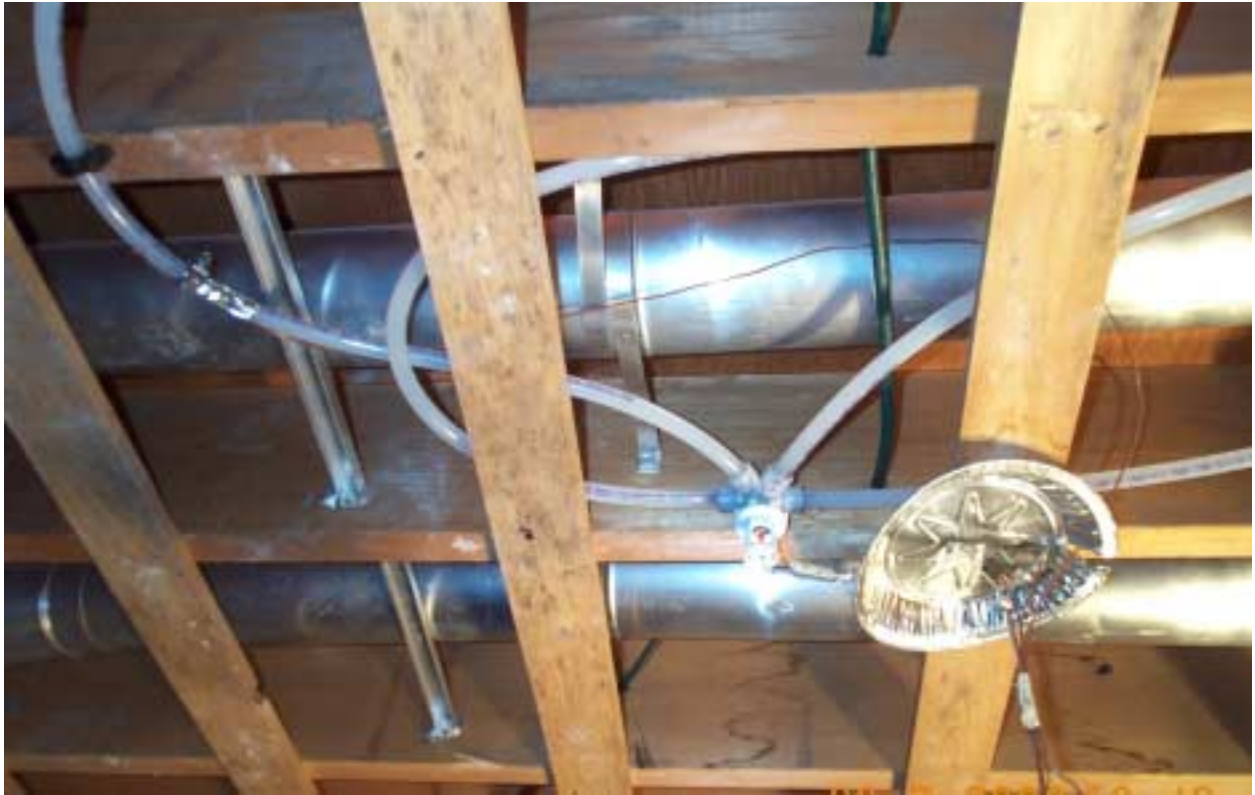
Figure 6. Pipes and fittings on open wood joists in recreation room.

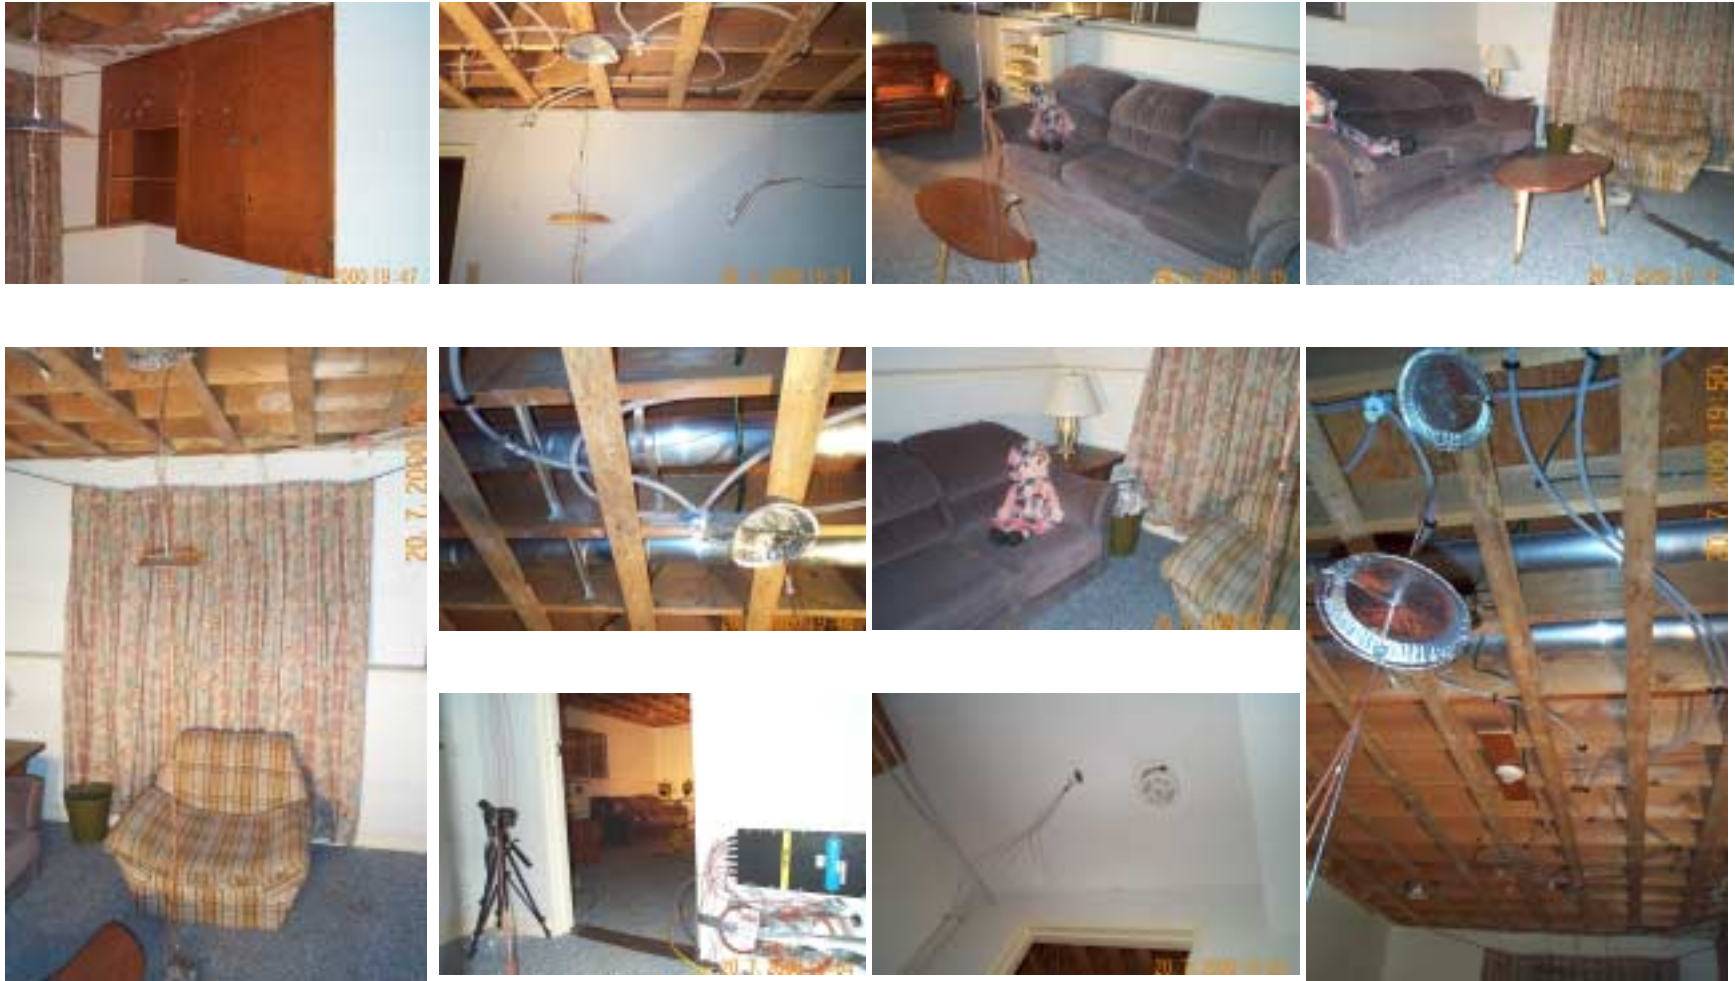
Figure 8. Clockwise snapshots of recreation room and Test 1 set-up.

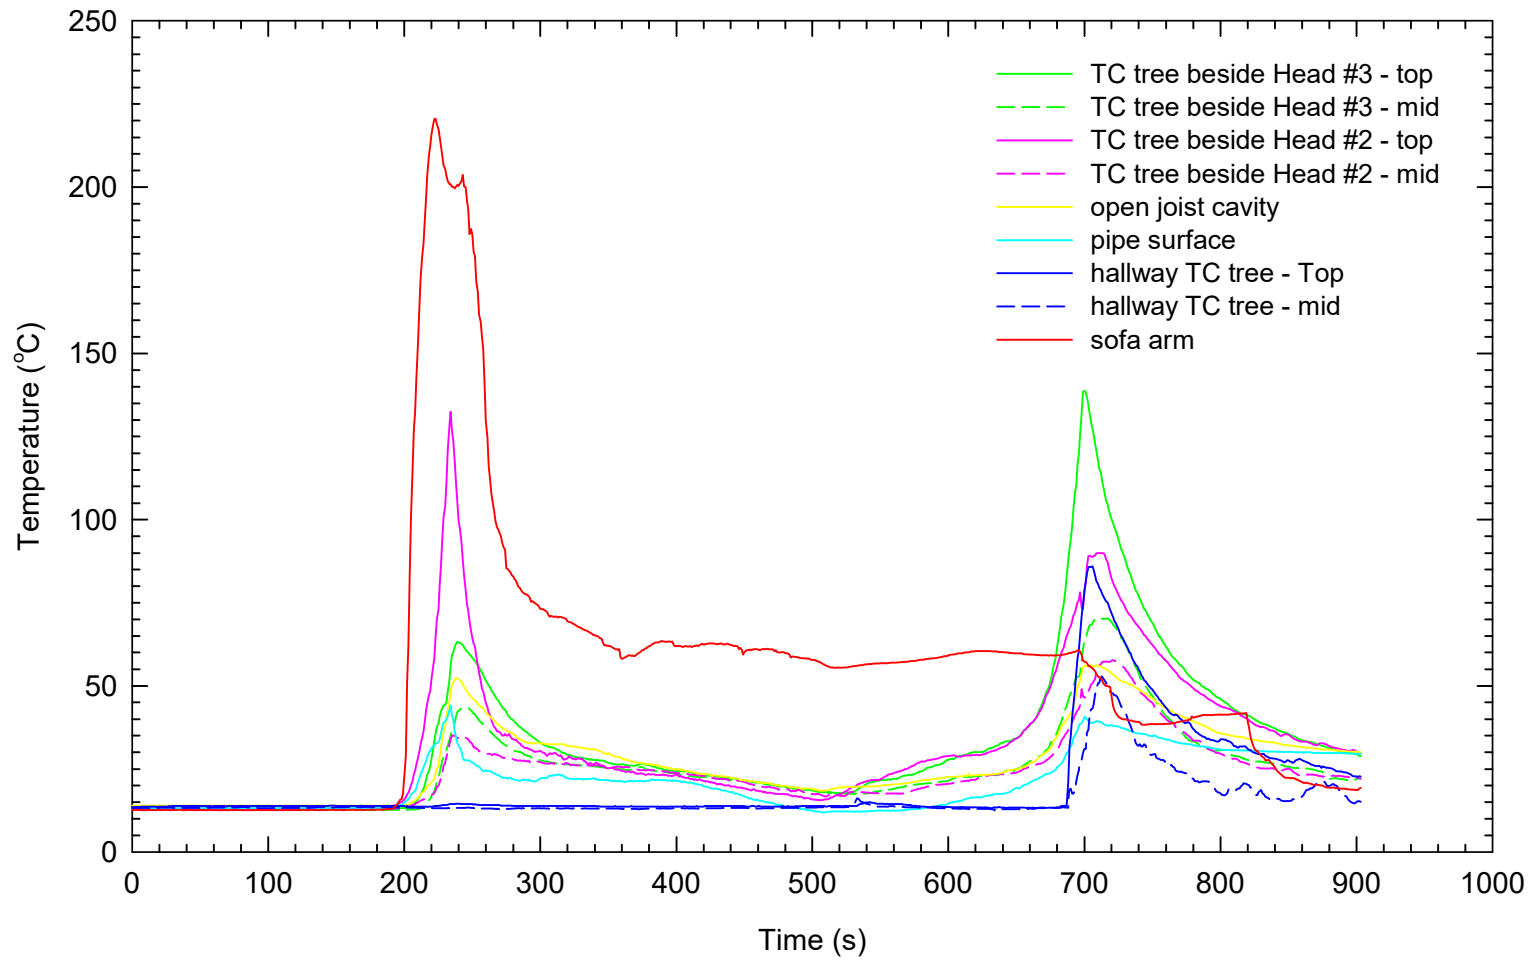
Figure 9. Temperature profiles for Test 1.

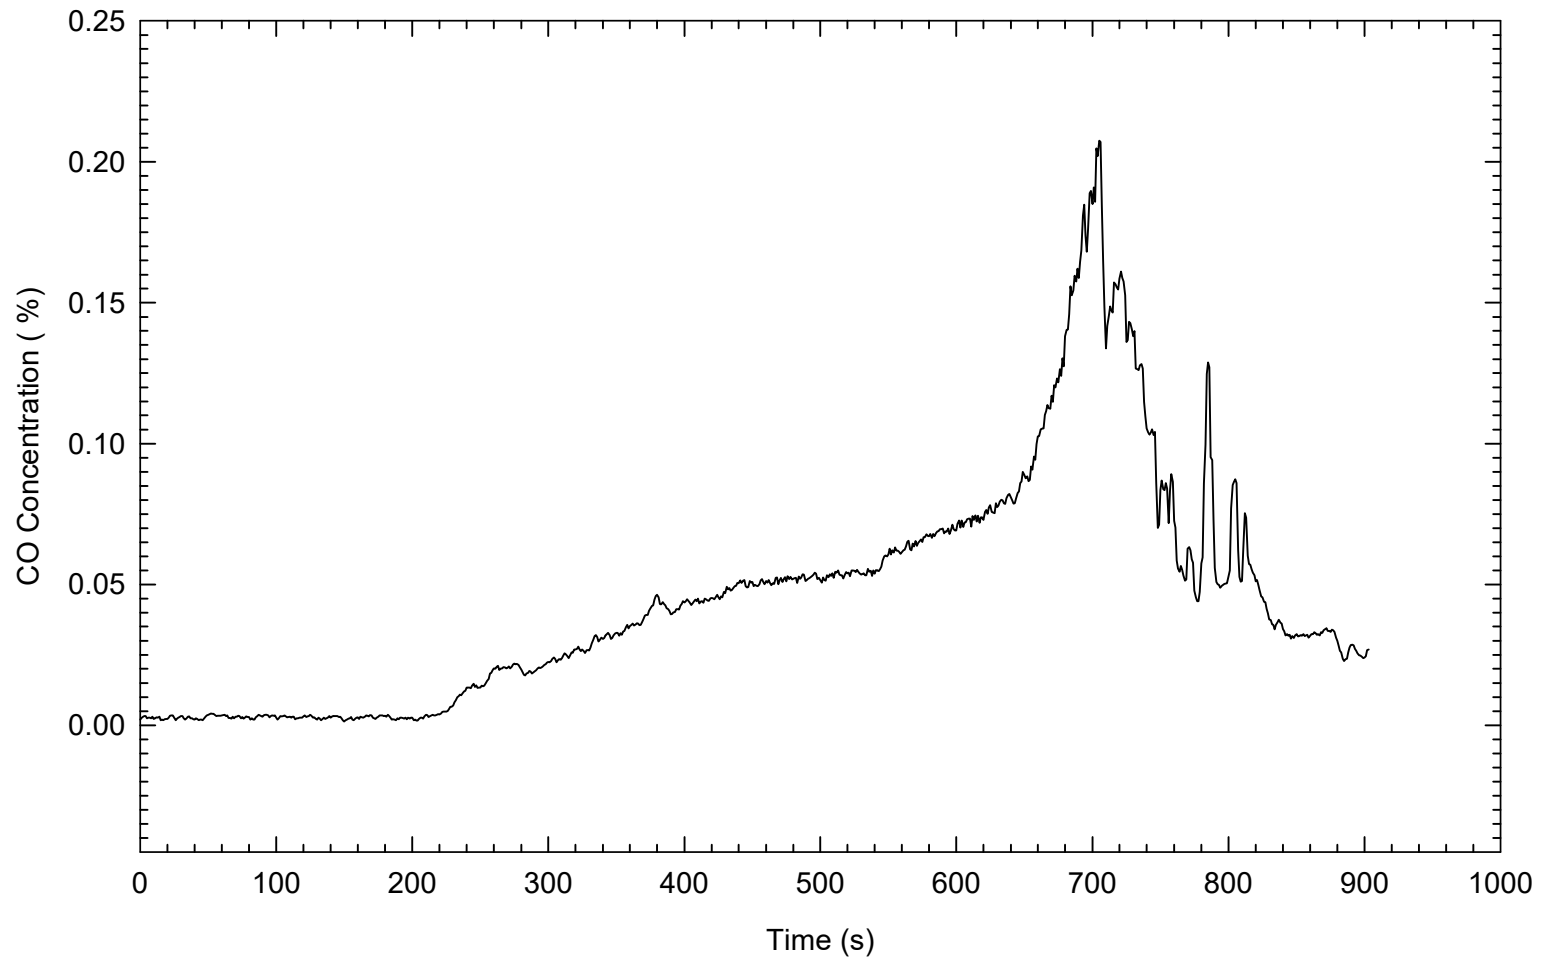
Figure 10. CO concentration inside the recreation room (Test 1).

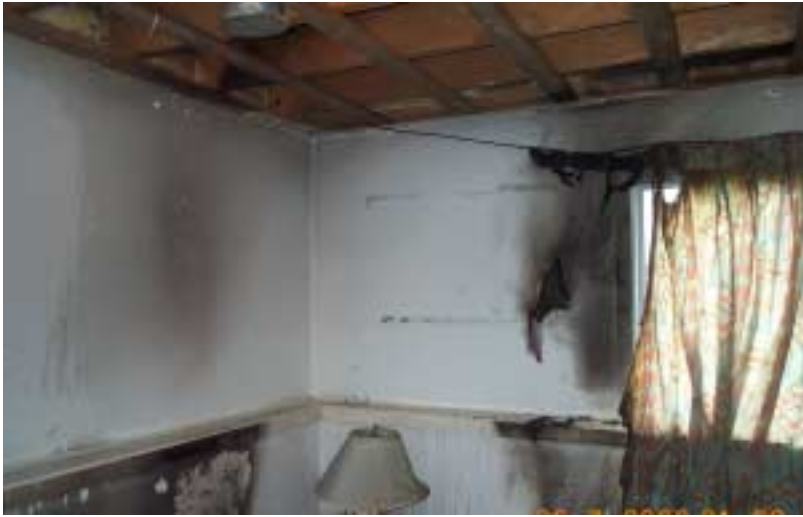
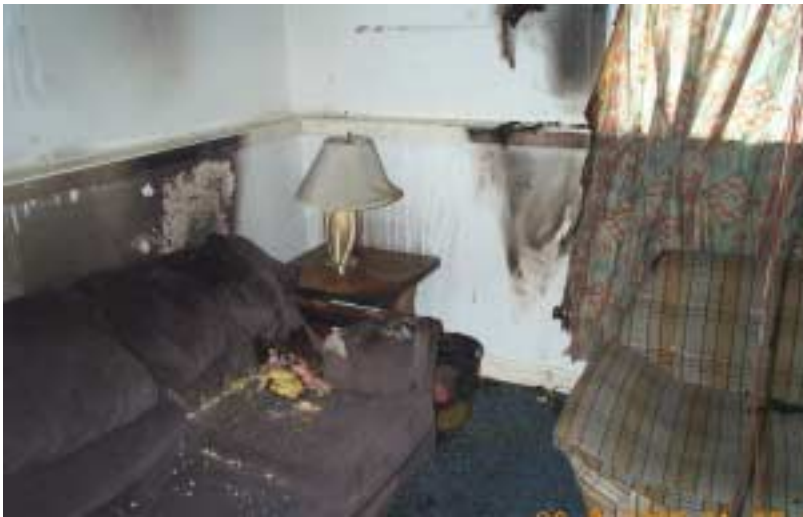
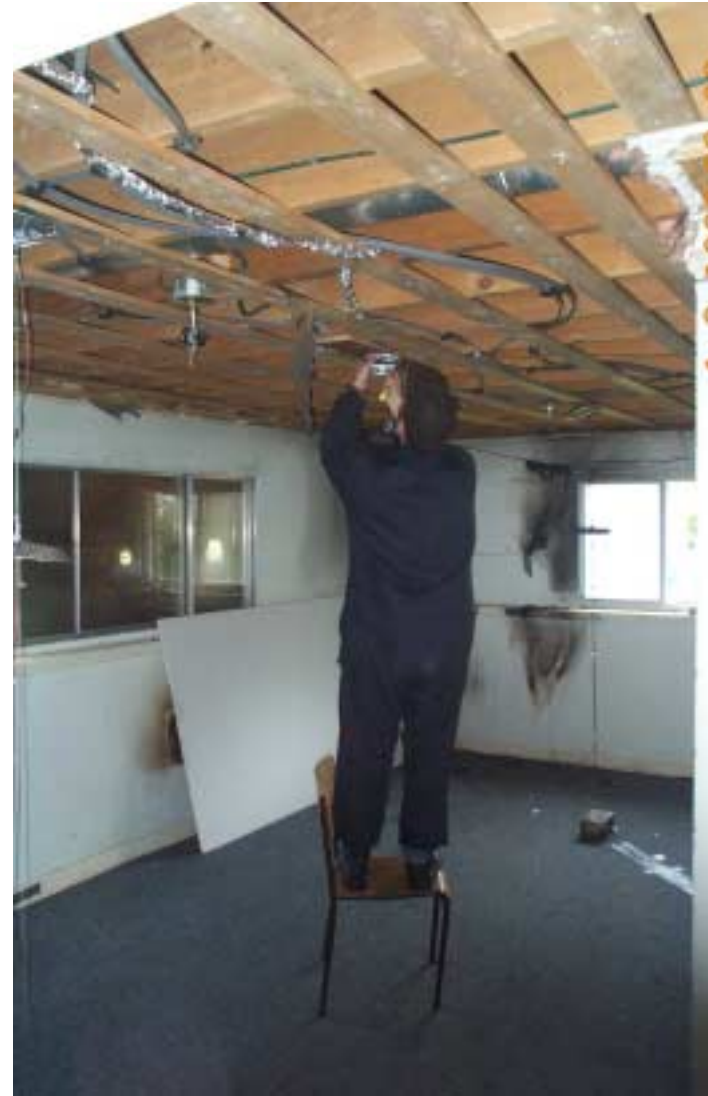
Figure 11. Photographs of the recreation room after Test 1.

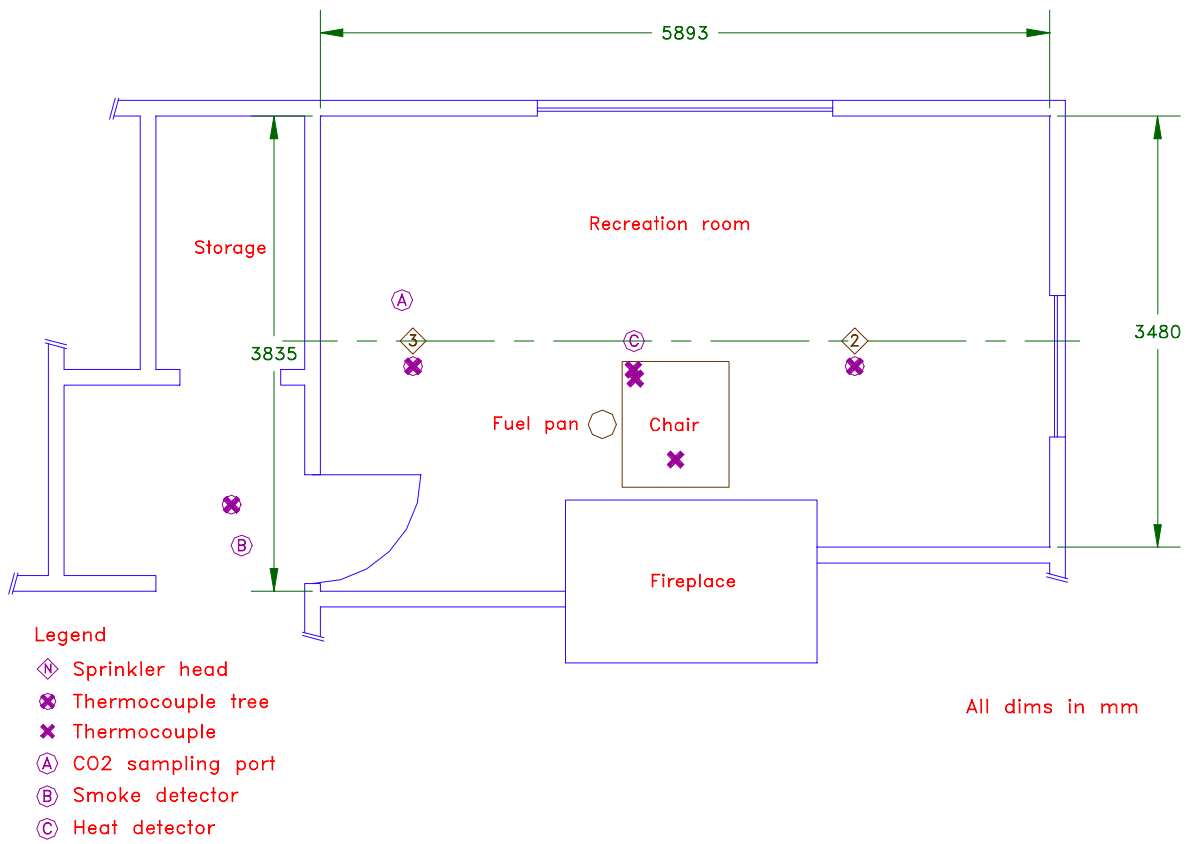
Figure 12. Experiment set-up of Test 2.

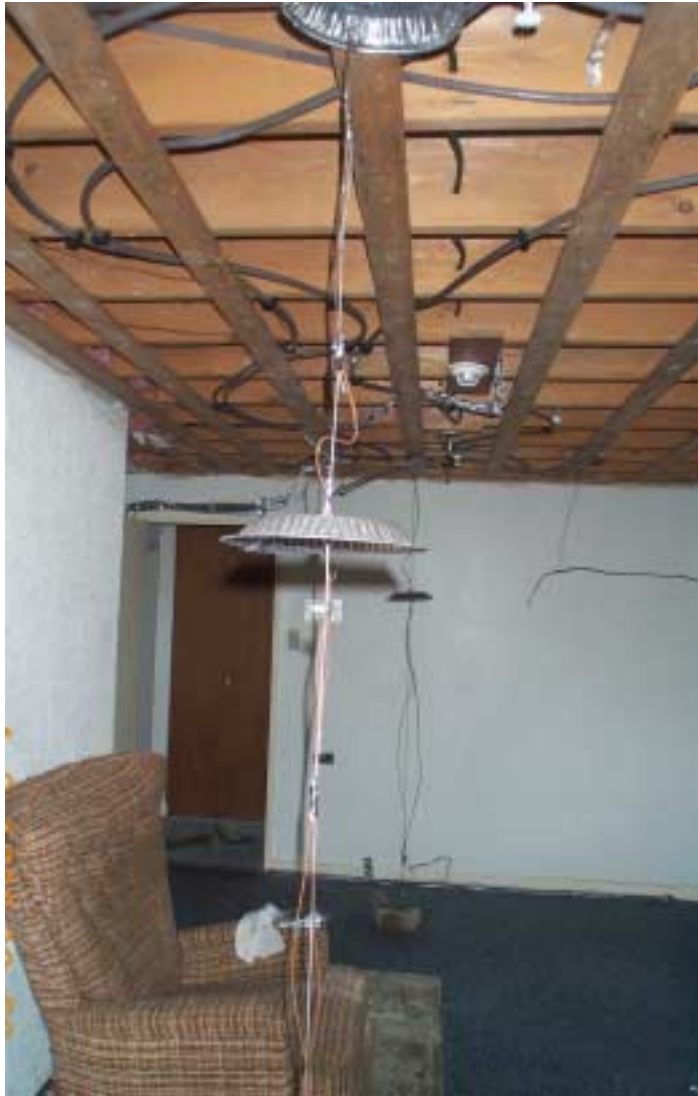
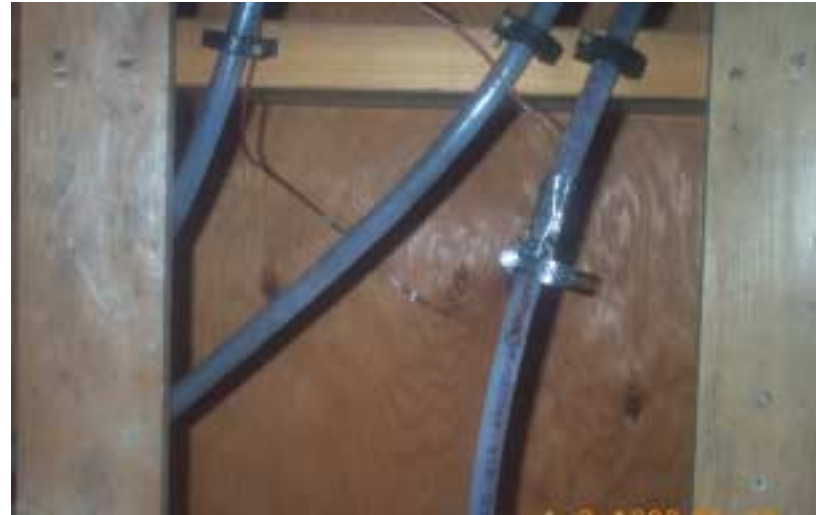
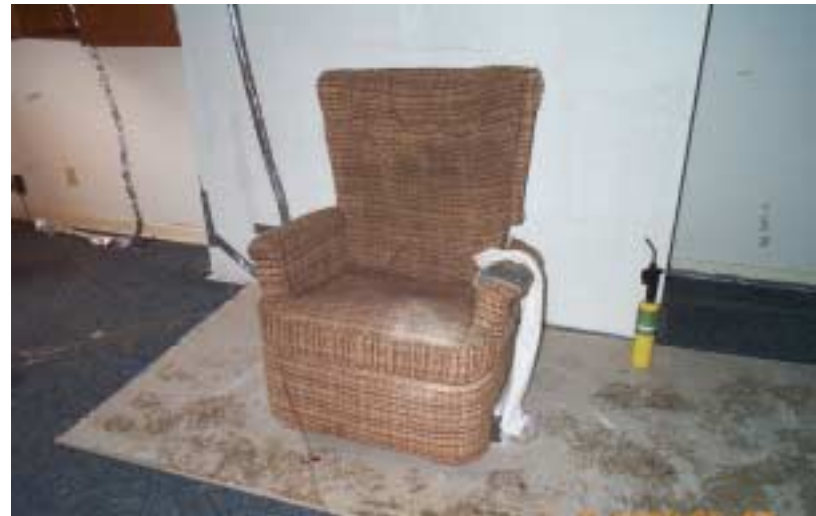
Figure 13. Chair directly under exposed pipes, with thermocouples installed on the chair, unprotected pipe and in the cavity of open wood joist and with diesel dripped onto the arm, cloth and fuel pan (Test 2).

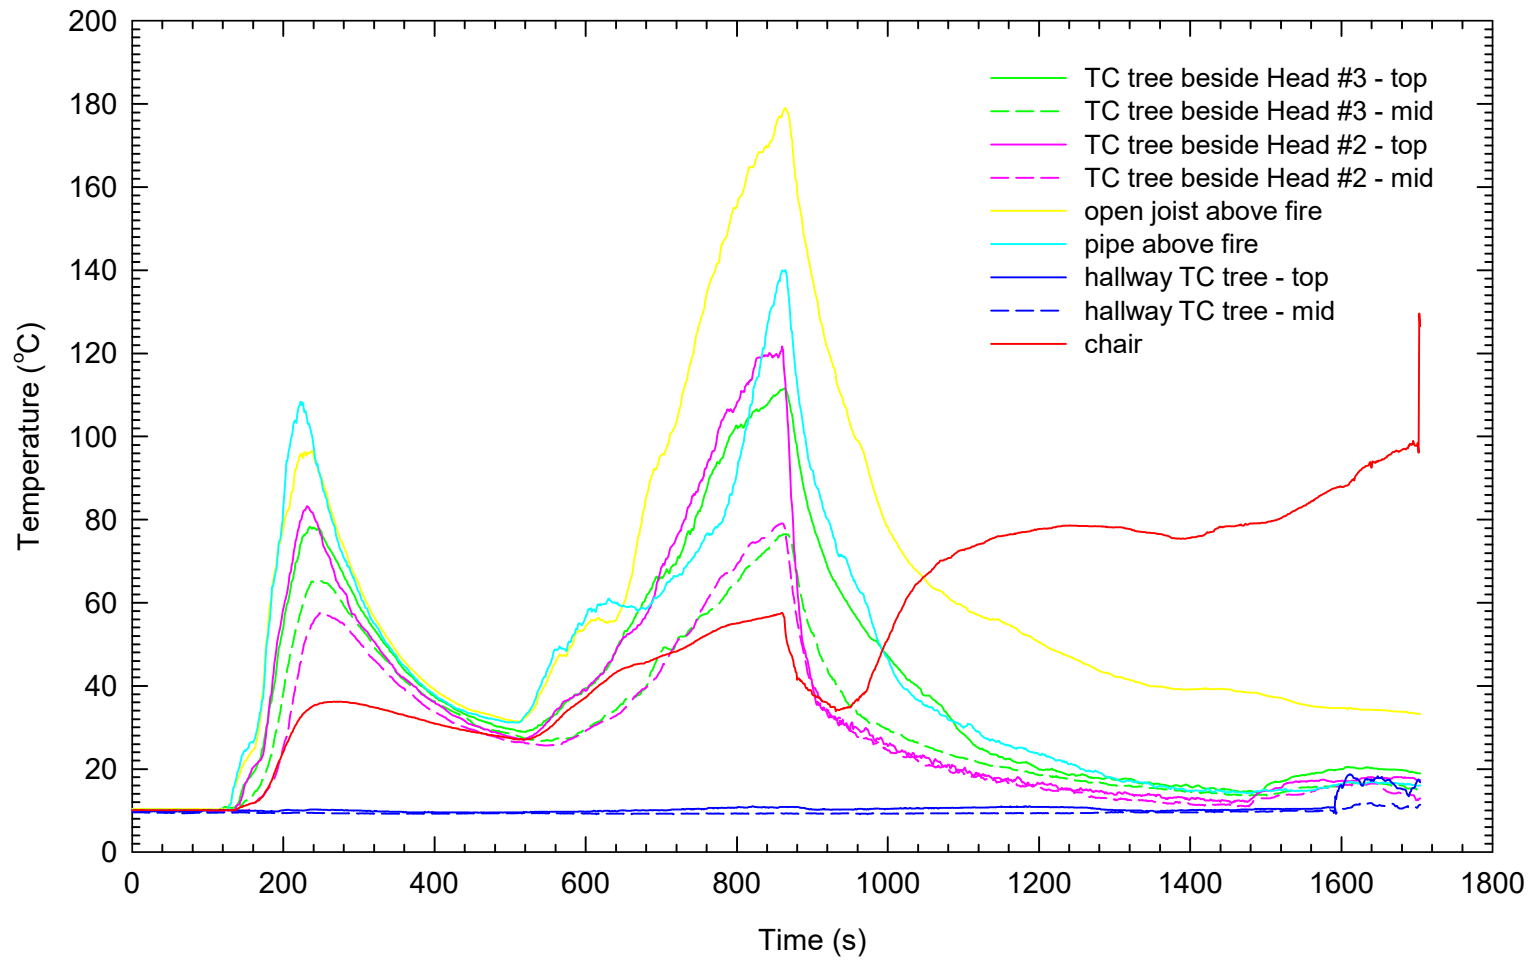
Figure 14. Temperature profiles for Test 2.

Afterwards, the fire was slowly built up again for another 7 minutes as indicated by the rising temperature profiles shown in Figure 14. The peak temperatures reached 178°C in the open joist space and 140°C on the plastic pipe when one sprinkler head (#2) actuated 740 s after the ignition. This single sprinkler head (#2) controlled and contained the fire. Fire was quickly knocked down. Within 1 minute of the sprinkler activation, flame was not visible on the surface of the chair. However, the thermocouple on the chair indicated there was still fire inside the back cushion.

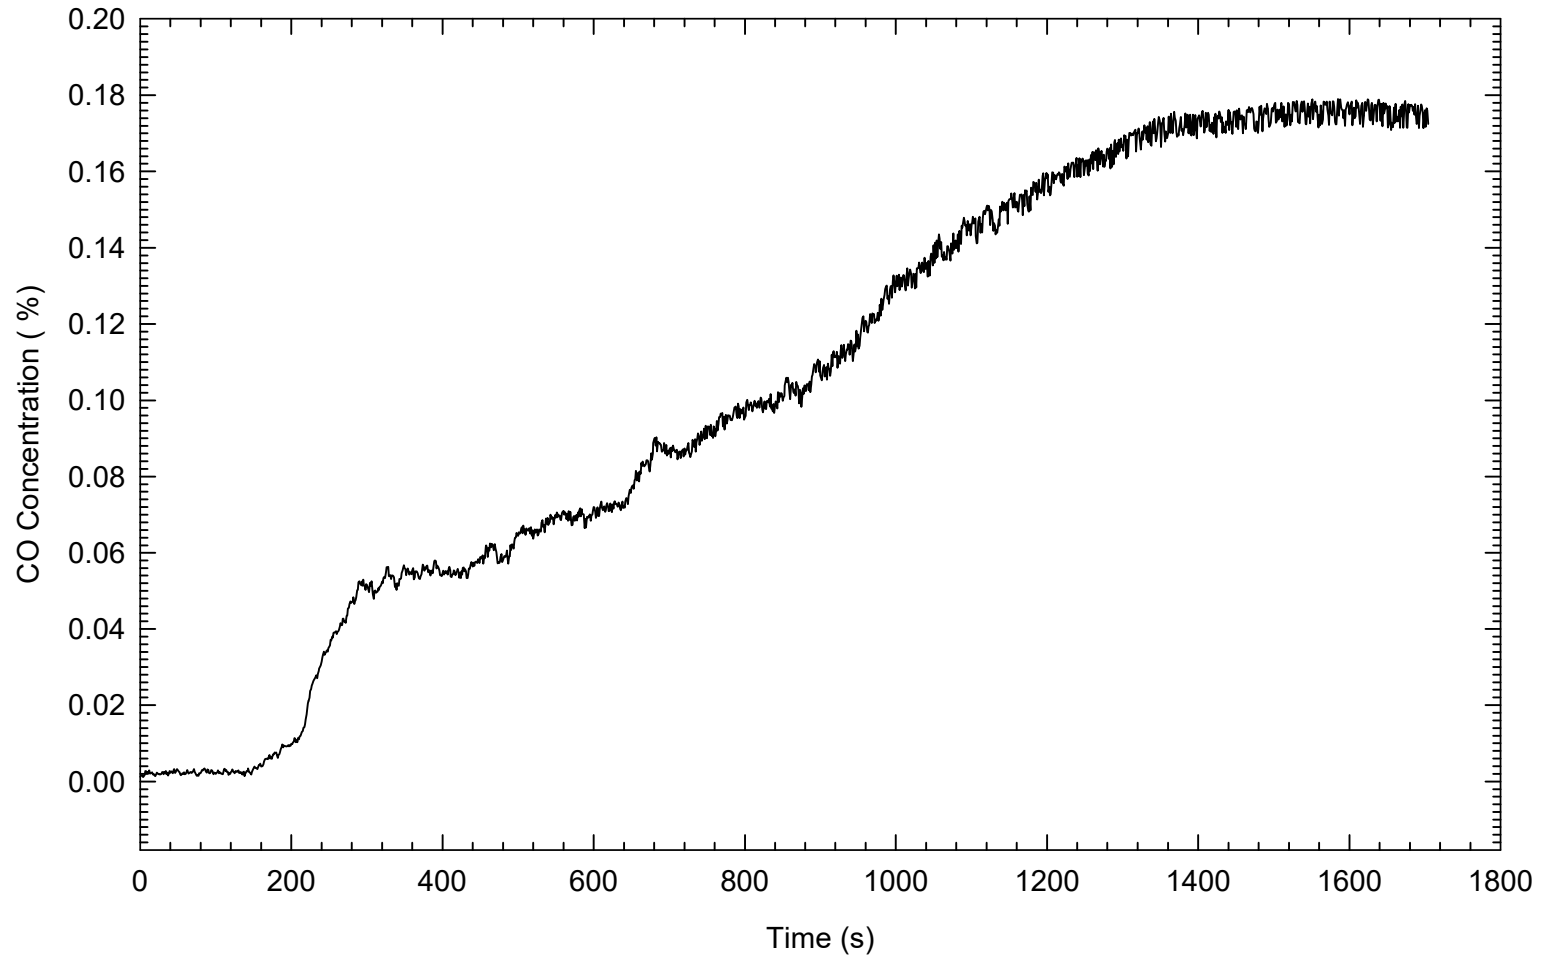
Figure 15. CO concentration inside the recreation room (Test 2).

Figure 15 shows a CO concentration profile inside the room. The CO concentration was 1000 ppm when the sprinkler was actuated. A CO concentration above 1500 ppm is considered to be immediately dangerous to life and health [2]. The maximum CO concentration was 1800 ppm at the end of the experiment.

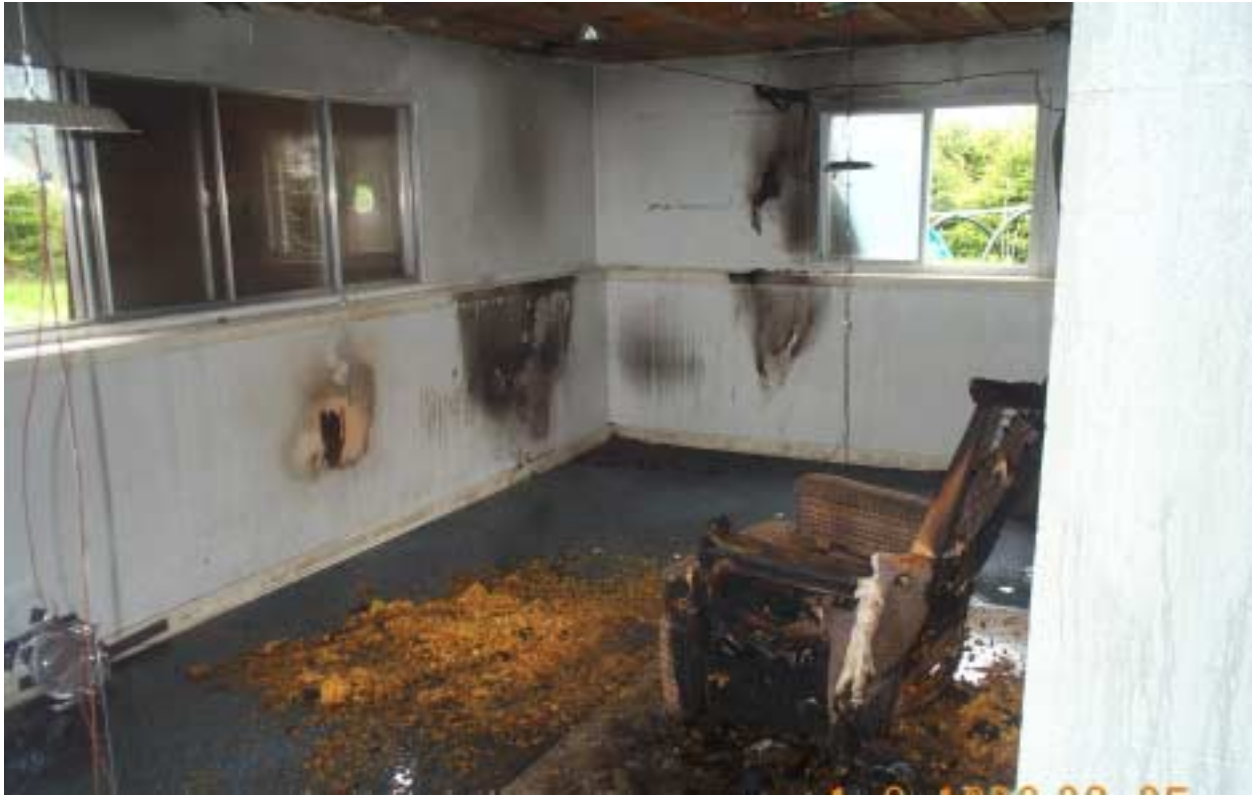
Figure 16. Photograph of the recreation room after Test 2.

After the sprinkler sprayed for a total of 10 minutes, the water supply to the sprinkler was shut off and firefighters were sent into the room. The firefighters vented the room and manually extinguished the fire that was still smouldering inside the back cushion. Figure 16 shows a photograph taken after the experiment.

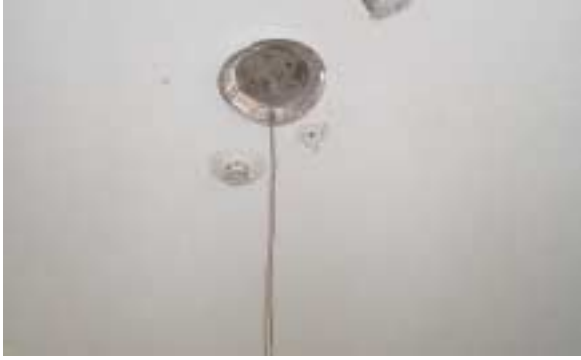
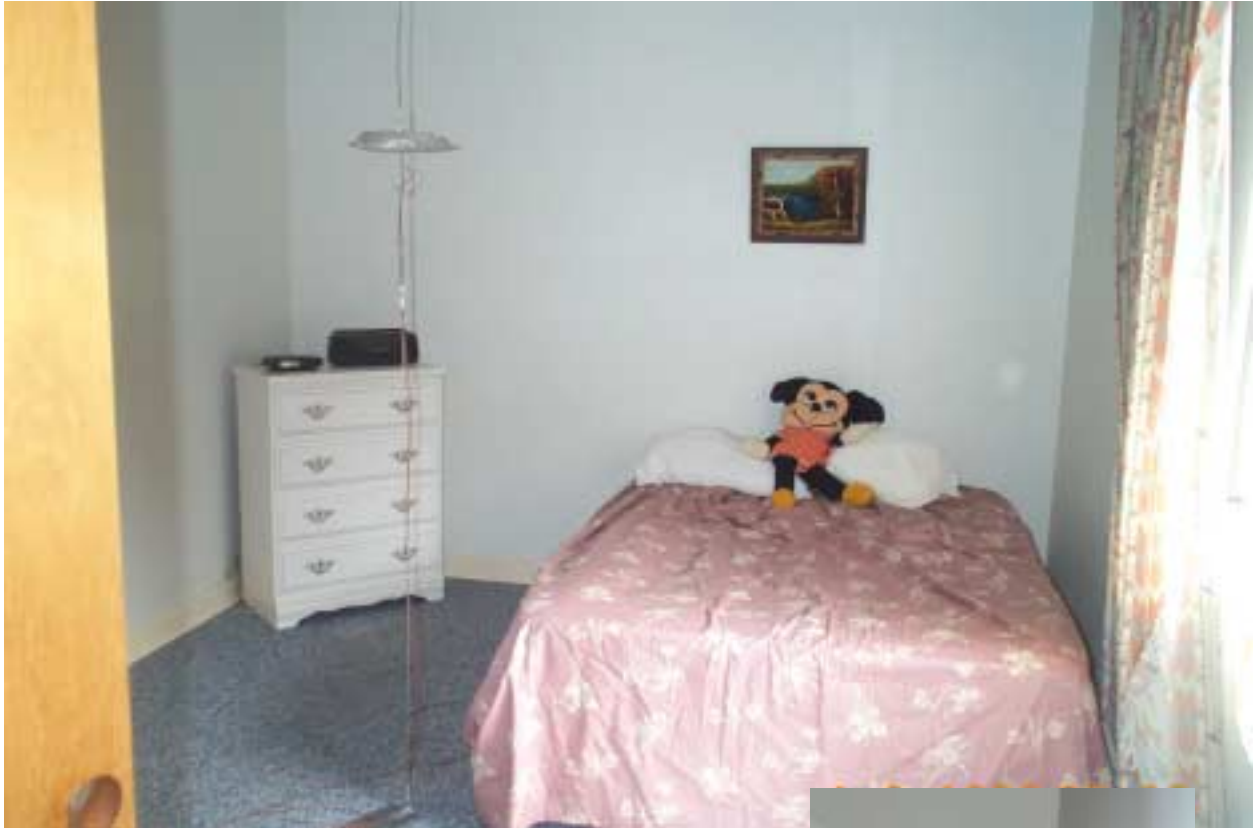
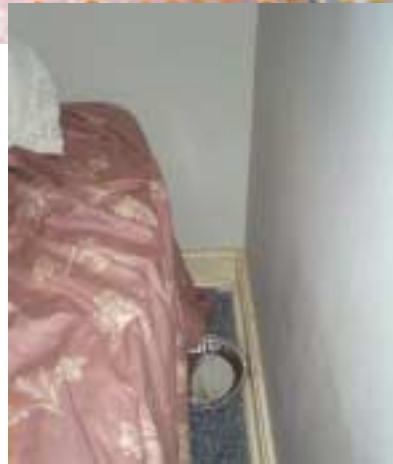
Figure 18. A queen-size bed ignited with a small amount of diesel in the fuel pan.

A queen size bed was placed 0.15 m from a wall. A small fuel pan was placed under the bed, with the bedspread touching the pan, as shown in Figure 18. A small amount of diesel (150 ml) was poured into the pan as an ignition source.

As shown in Figure 18, a TC tree and a heat detector were installed 0.20 m beside the sprinkler head in the bedroom. The TC tree consisted of 2 thermocouples, one at the height of 2.36 m and the other at the height of 1.60 m above the floor (the top TC was 76 mm below the ceiling).

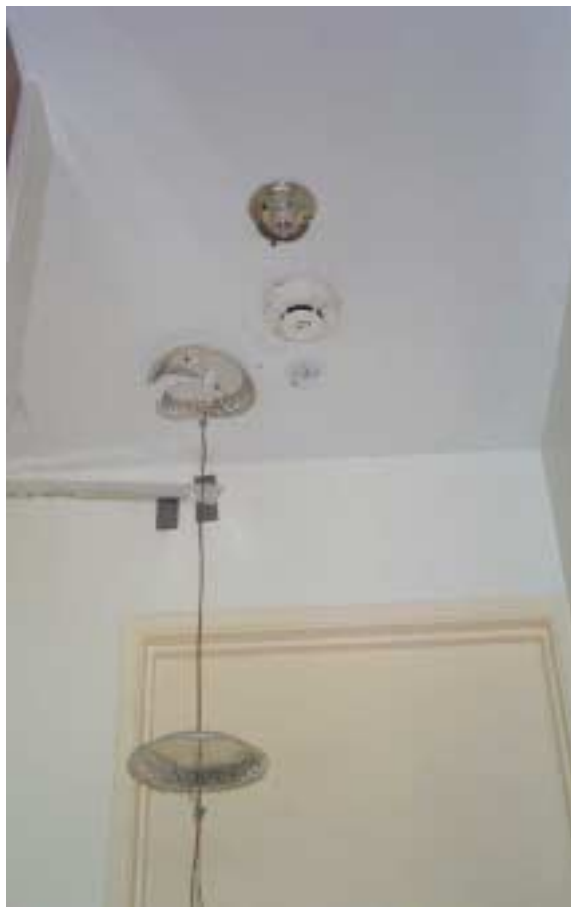
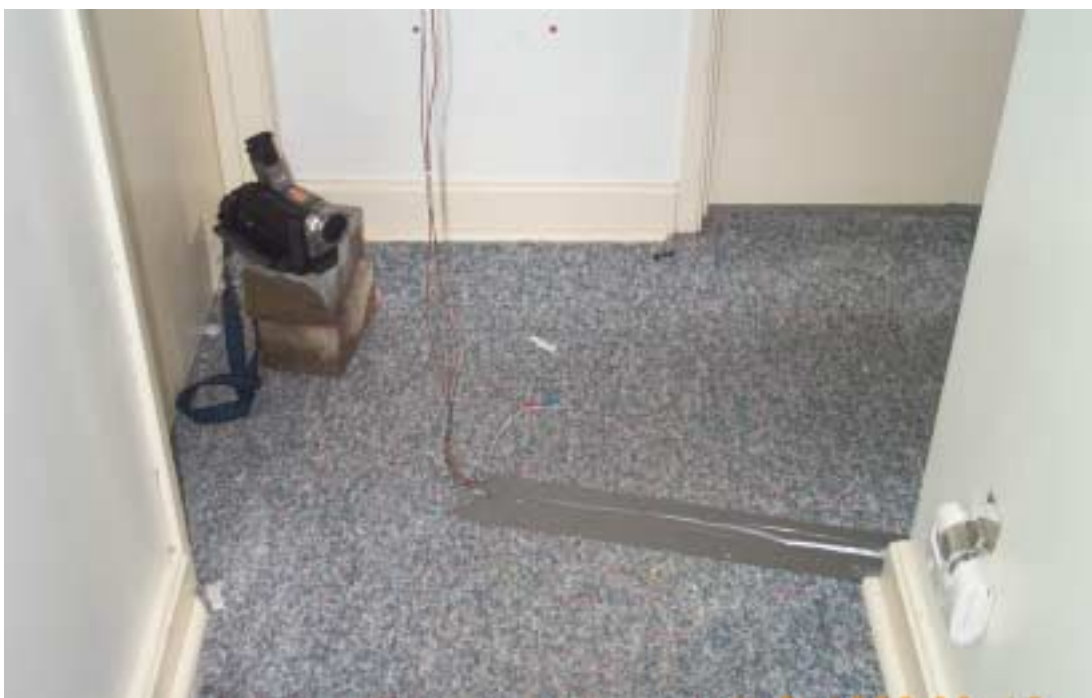
Figure 19. Sprinkler head, TC tree, photoelectric smoke detector and carbon monoxide detector in the corridor.

Another TC tree and a photoelectric smoke detector were installed 0.2 m beside the sprinkler head in the corridor, as shown in Figure 19. A commercial carbon monoxide detector was also installed in the corridor at the 0.30 m height. The CO detector continuously monitored for CO and displayed the CO level (range from 0 to 999 ppm) every minute. The CO alarm would sound an alarm immediately when the CO concentration reached 600 ppm and above.
