Kemano Fire Studies: Part 2: response of a residential sprinkler system Su, J. Z.; Crampton, G. P.; Carpenter, D. W.; McCartney, C. J.; Leroux, P.

Kemano Fire studies – Part 2: Response of a Residential Sprinkler System

IRC-RR-109

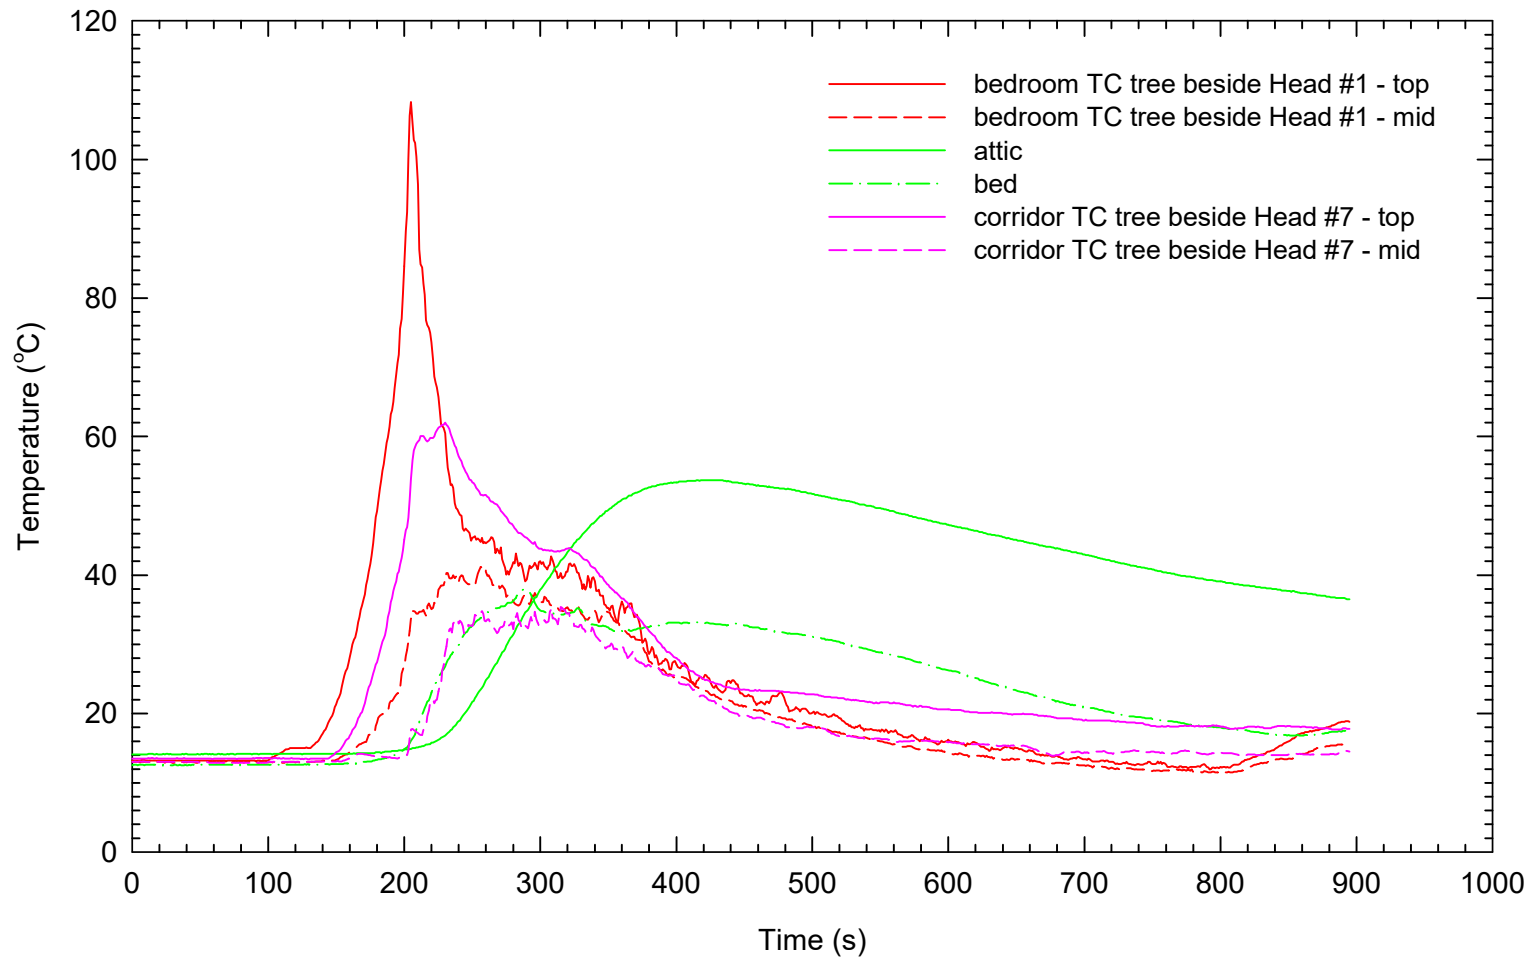
Figure 20. Temperature profiles for Test 3.

Figure 20 shows temperature profiles at various locations during the experiment. Table 6 shows the temperatures at various locations when the sprinkler inside the bedroom was actuated. The sprinkler head (#1) inside the bedroom actuated 84 s after the ignition. This single sprinkler head controlled and contained the fire under the bed in 1 minute. A few seconds later, visibility was lost in the bedroom and the nearby corridor.

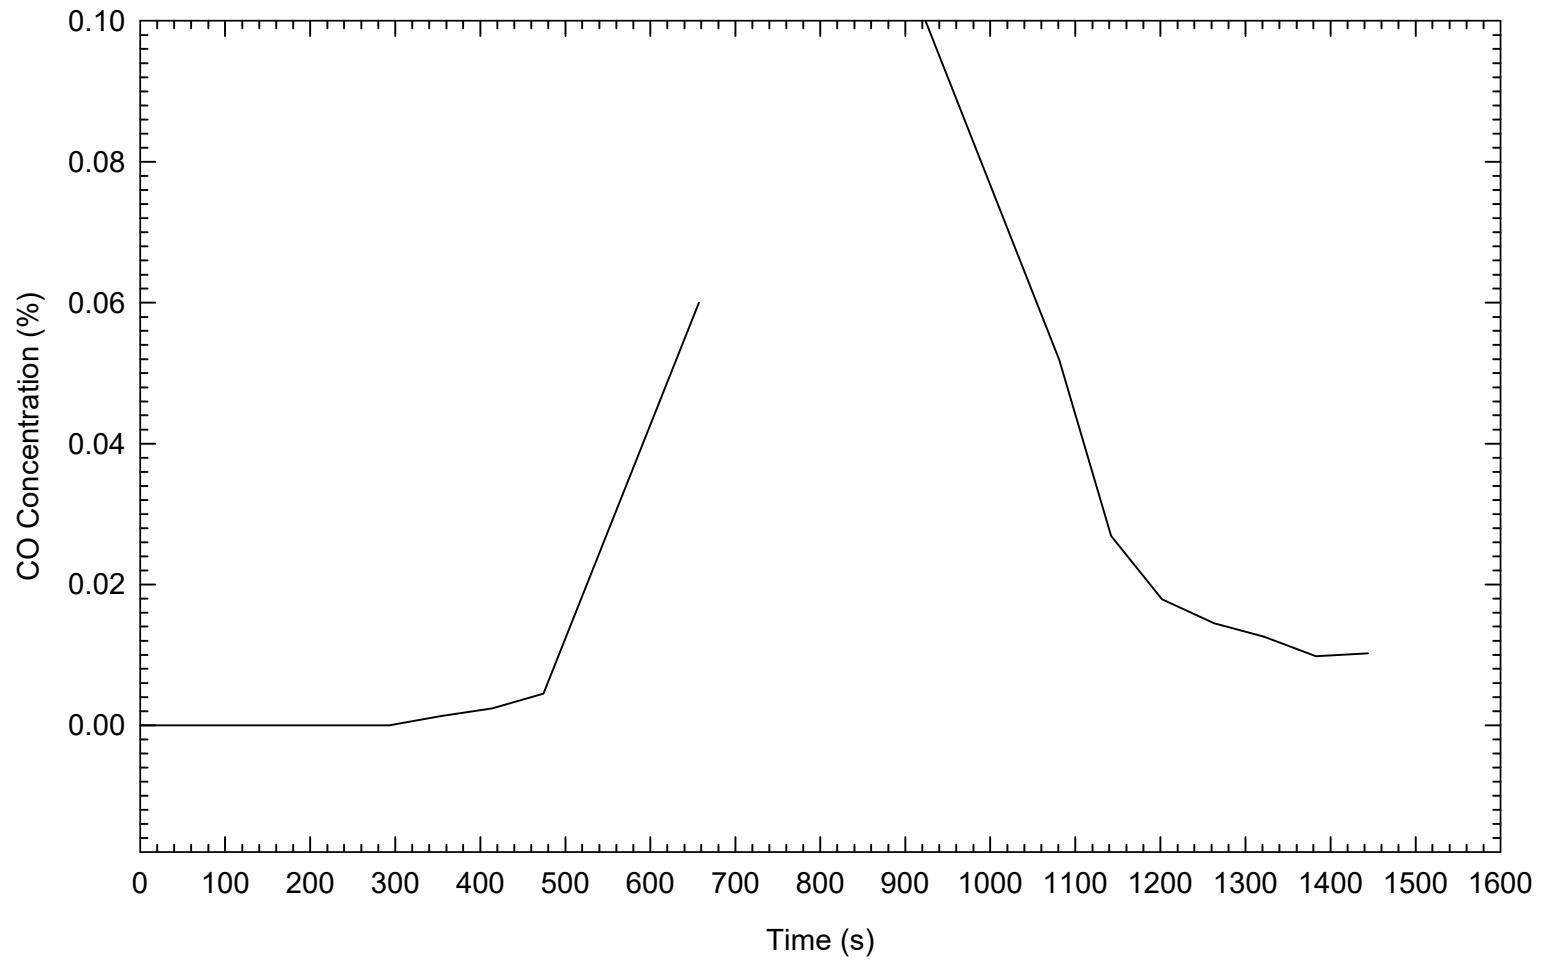
Figure 21. CO concentration in the corridor (Test 3).

The water supply to the sprinkler was shut off 10 minutes after the sprinkler activation. Firefighters entered the house, opened the bedroom window and used a fire hose to spray water onto the bed. After the visibility in the house improved, the display on the CO detector was seen as 999 ppm, which was the upper limit of this device. This means that the CO concentration had gone beyond 1000 ppm at the detector location during the experiment. Figure 21 shows the CO concentration profile at the CO detector location in the corridor.

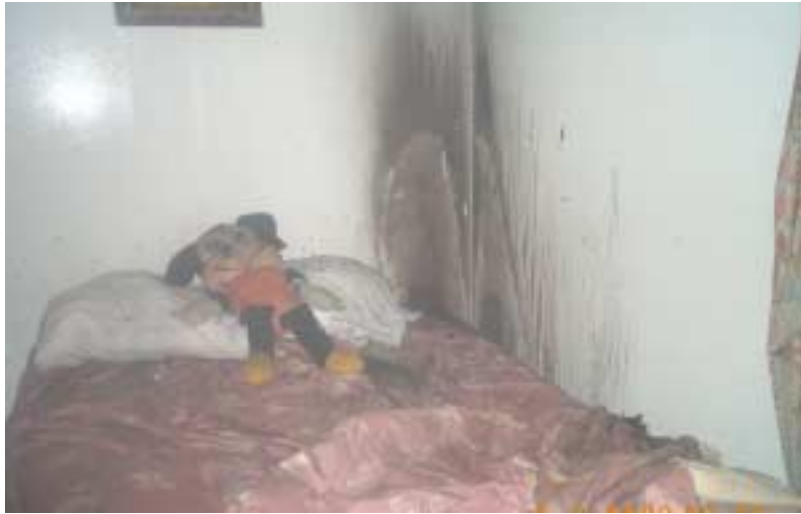
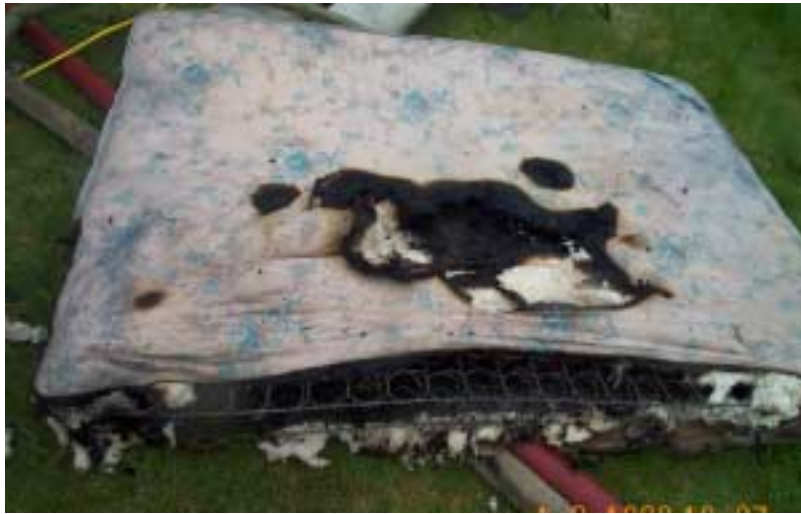
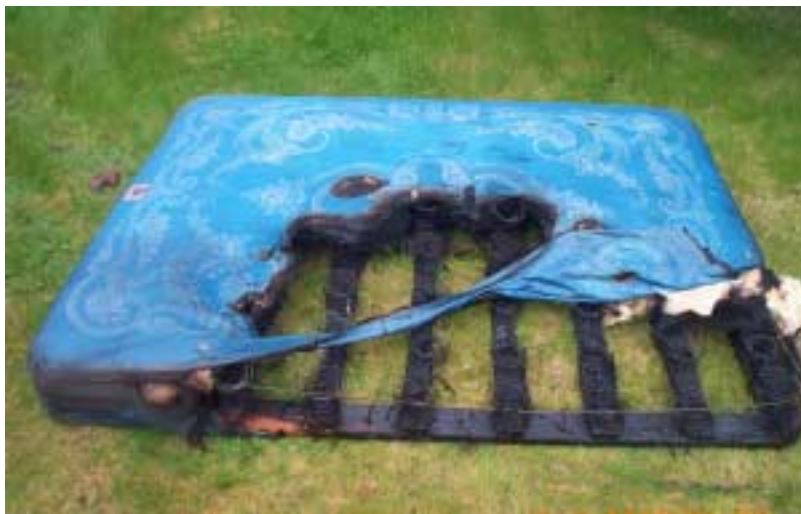
Figure 22. Photograph of the bedroom, underside of the mattress and the boxspring after Test 3.

Figure 22 shows a picture of the aftermath. Since the sprinkler contained the fire under the bed, the top of the bed was not burnt. The major damage was underneath the bed (the box and the underside of the mattress). It should be noted that, after the experiment, the mattress and the box continued to smoulder, which triggered the smoke alarm again. Smoke was seen to arise in the bedroom corner underneath the bed. Firefighters were called in again to extinguish the smouldering fire inside the mattress and box and to remove them from the house.

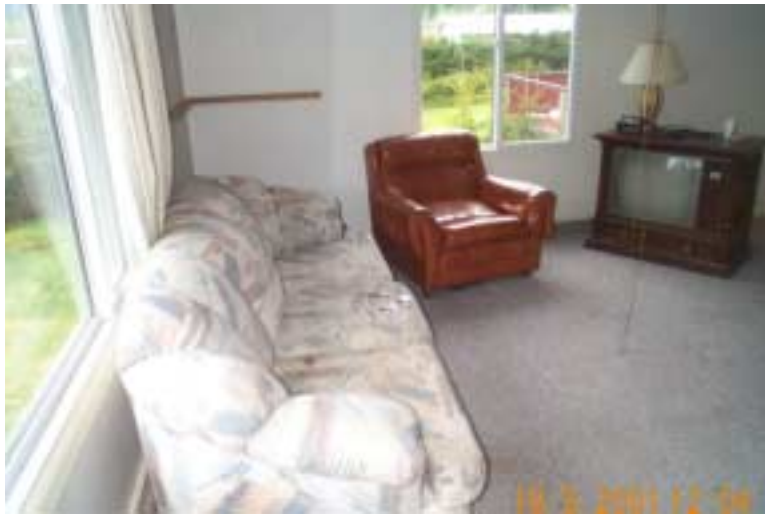
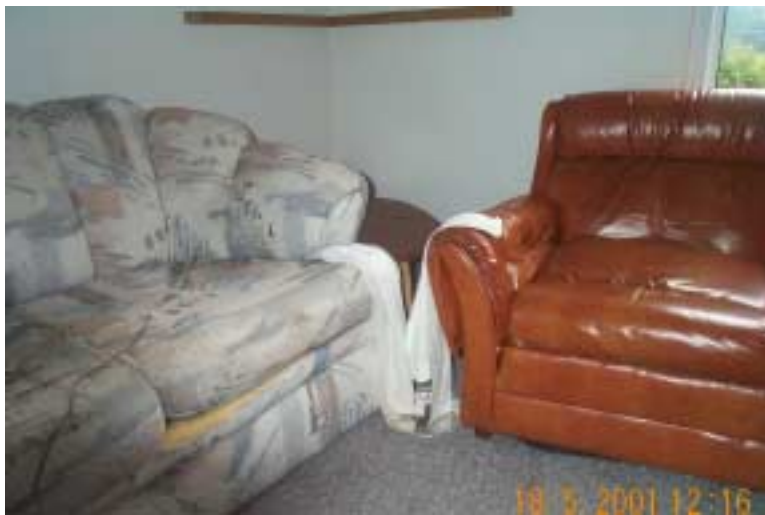
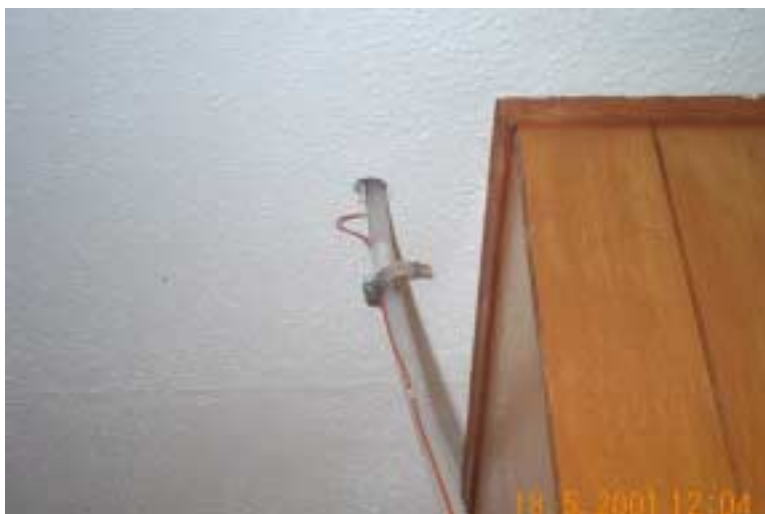
Figure 24. Furniture, ignition source and exposed pipe in the living room.

As shown in Figure 24, furniture in the living room included a TV set, a leather chair, a wooden end table and a sofa with a curtain behind. A cloth was hung on the chair and on the sofa, reaching down to a fuel pan placed in between. A small amount of diesel (125 ml) was dripped onto the cloth and the pan for ease of ignition. A TC was placed on the sofa near the ignition point to measure the temperature near the fire. A TC was installed in the attic space inside the drywall ceiling (6 mm inside the gypsum board) right above that ignition point as outlined in the UL standard to check for structural damage [3].

A vertical run of the plastic pipe from the attic space to the basement was exposed in the living room. A TC was installed on the pipe surface 25 mm below the ceiling to measure the exposing temperature, as shown in Figure 24.

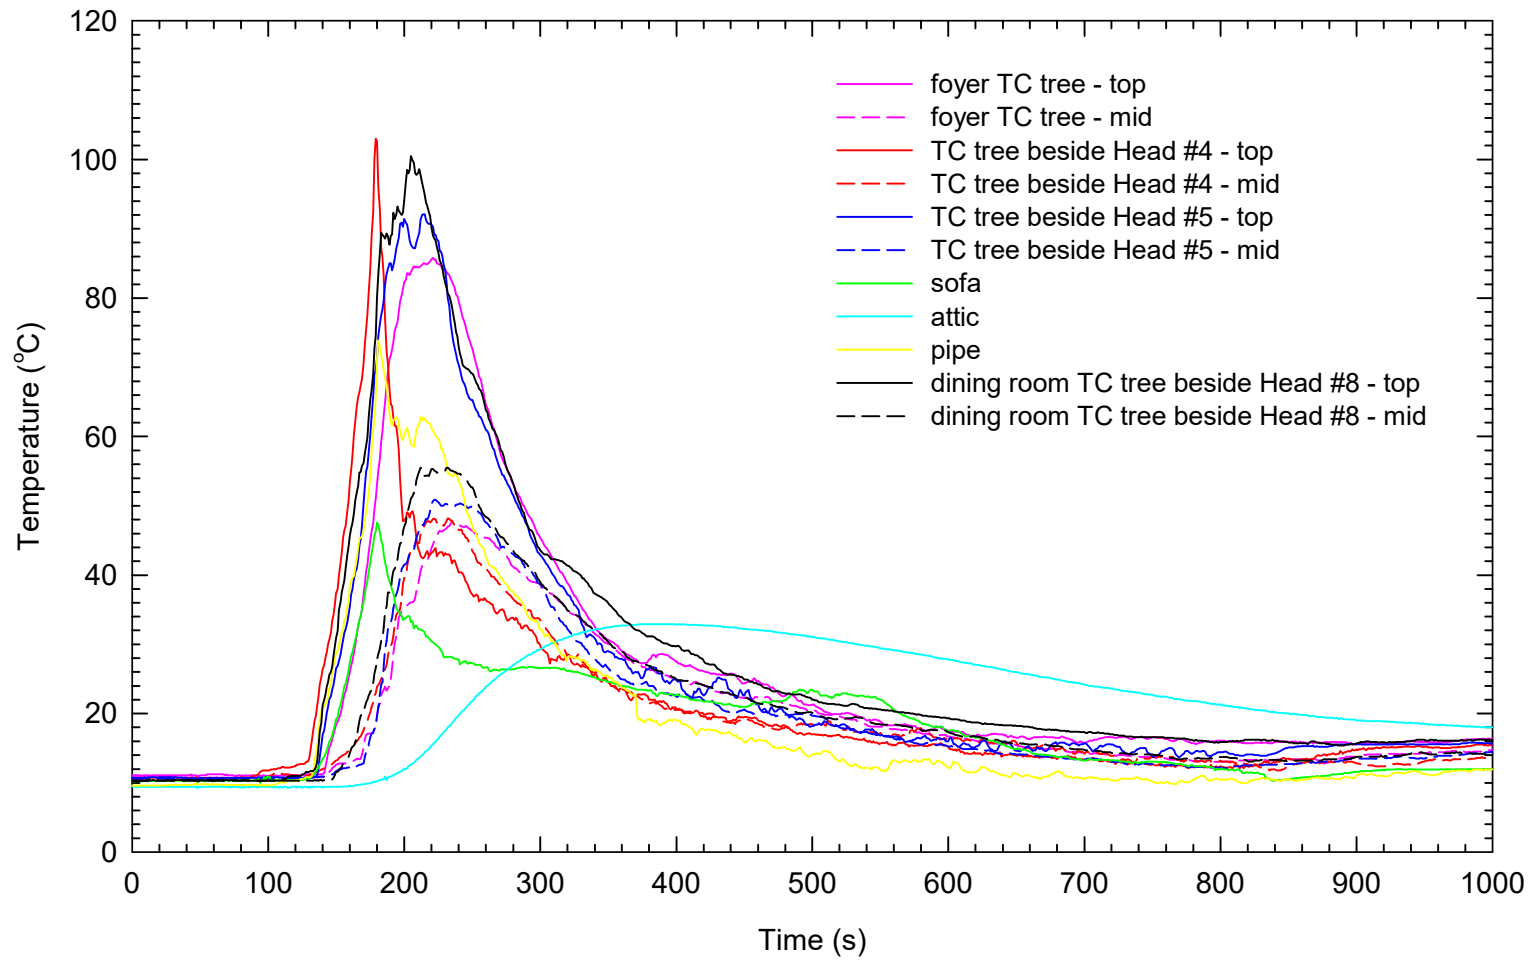
Figure 25. Temperature profiles for Test 4.

Figure 25 shows temperature profiles at various locations during the experiment. The temperatures when the sprinkler actuated are shown in Table 7.

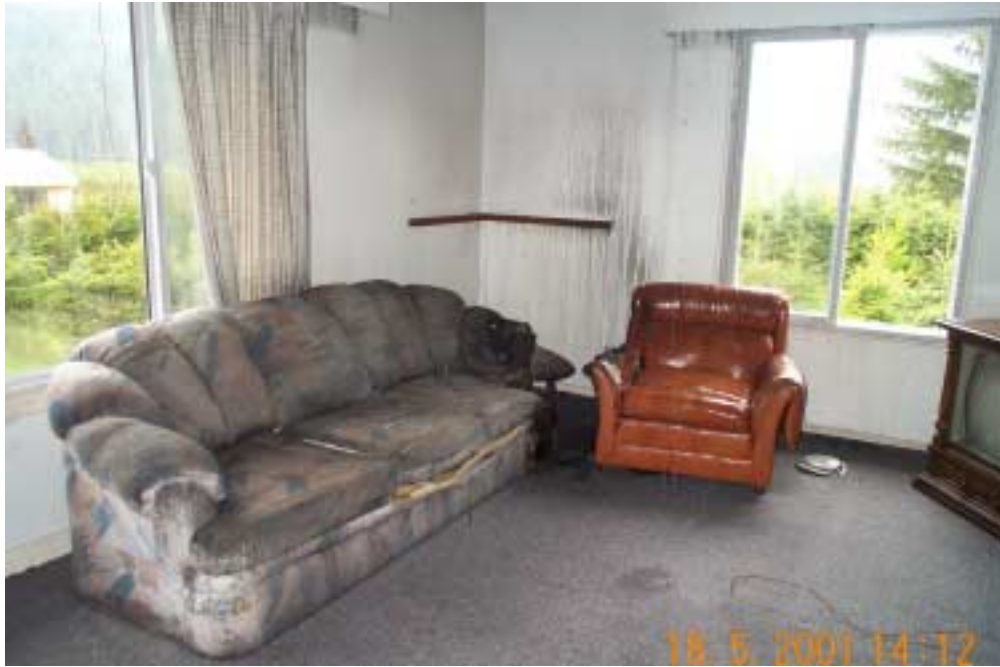
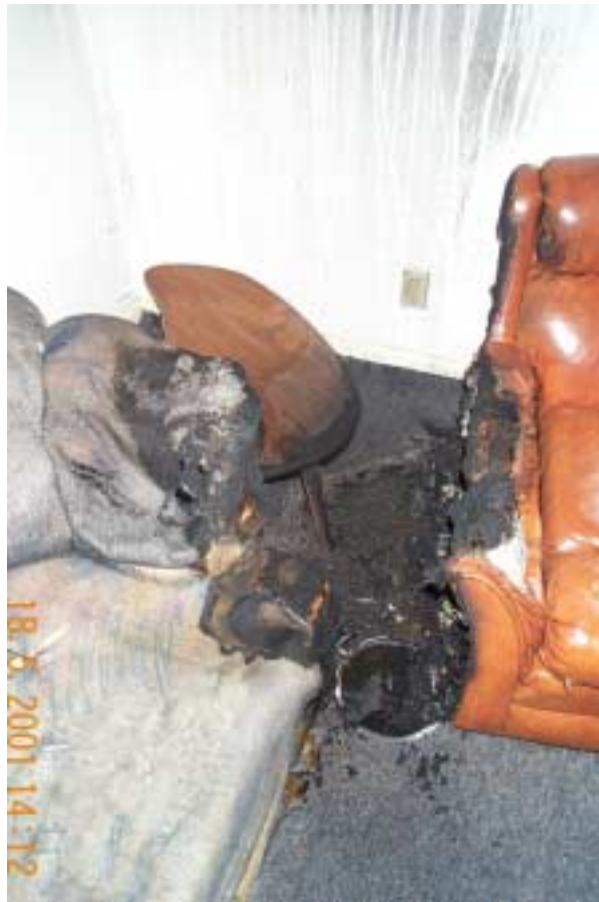
Figure 26. Pictures of the living room after Test 4.

- Figure 26 Pictures of the living room after Test 4

Figure 26 shows the living room after the experiment. Since the sprinkler successfully contained the fire in the room corner, the fire damage was limited to one arm of each sofa and chair. The vertical pipe in the living room was exposed to a maximum temperature of 74°C during the fire experiment, not exceeding its rated temperature yet. It was observed after this test that the exposed pipe had no visible damage.
