### **DynaMAC: Molikpaq ice loading experience**

Hardy, M.; Jefferies, M.; Rogers, B.; Wright, B.

*PERD/CHC Report; no. 14-62, 1996-07*

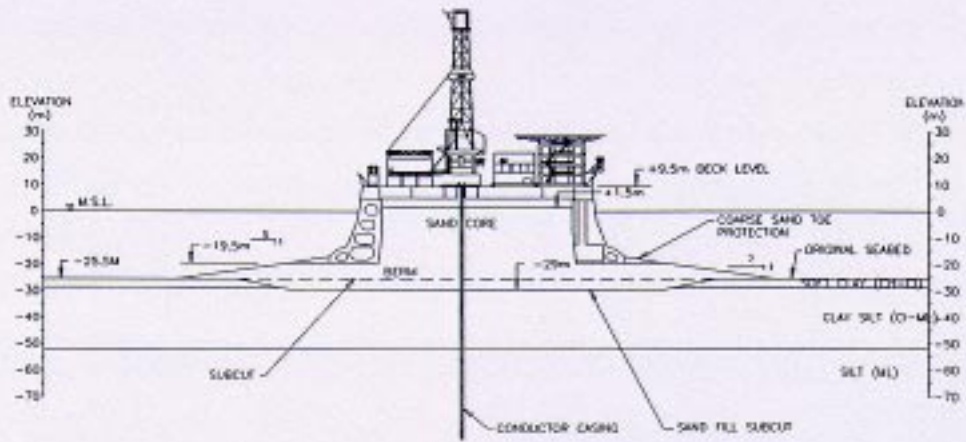
Figure 1.3: Molikpaq at Tarsiut P-45 1984-1985.

At the Molikpaq's first two well sites at Tarsiut P-45 (Figure 1.3) in 1985/85 and at Amauligak I-65 in 1985/86 (Figure 1.4), the caisson was deployed on a sand berm at a set down draft of 19.5 m from mean sea level. As anticipated during design, there was no permanent accumulation of grounded ice rubble around the Molikpaq and the structure was directly exposed to moving pack ice throughout the 1984/85 and 1985/86 winter periods. However, at the third and fourth locations, Amauligak F-24 in 1987/88

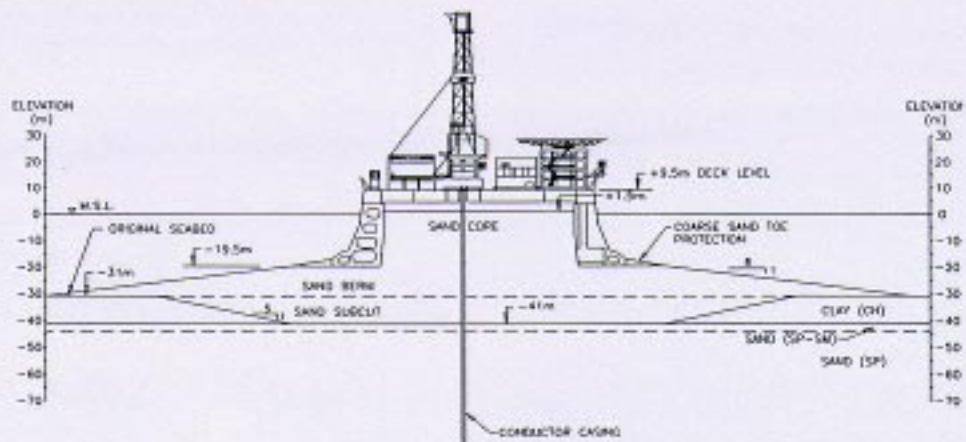
Figure 1.4: Molikpaq at Amaulik I-65 1985-1986.

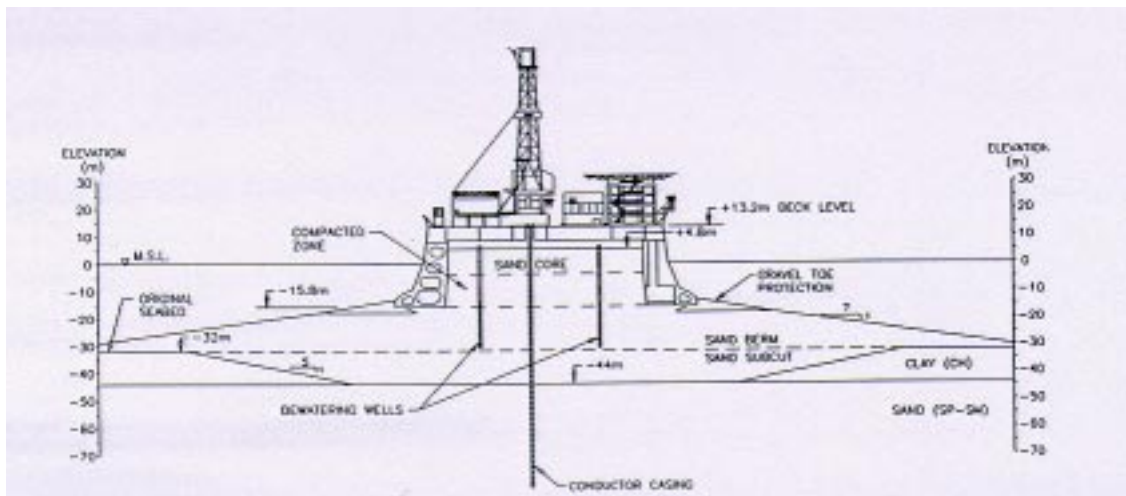
Figure 1.5: Molikpaq at Amaulikak F-24 1987-1988.

(Figure 1.5) and Isserk I-15 in 1989/90 (Figure 1.6), the Molikpaq was deployed at shallower set down drafts which impeded ice clearance and resulted in the formation of grounded rubble around the structure. These rubble formations remained stable over the course of the winter precluding further direct ice interactions with the caisson. At these last two locations, the ice cover around the Molikpaq was also largely stationary during the two winter seasons, limiting the exposure of both the structure and the surrounding rubble field to moving ice.

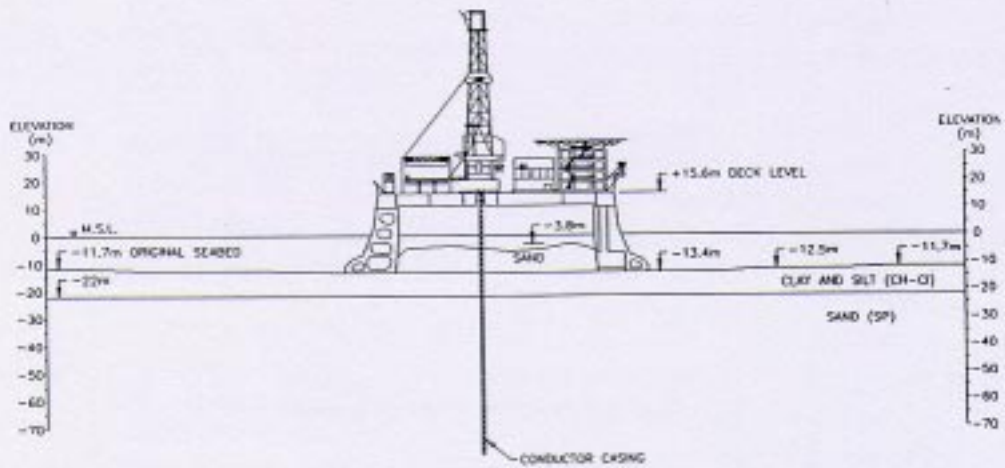
Figure 1.6: Molikpaq at Isserk I-15 1989-1990.

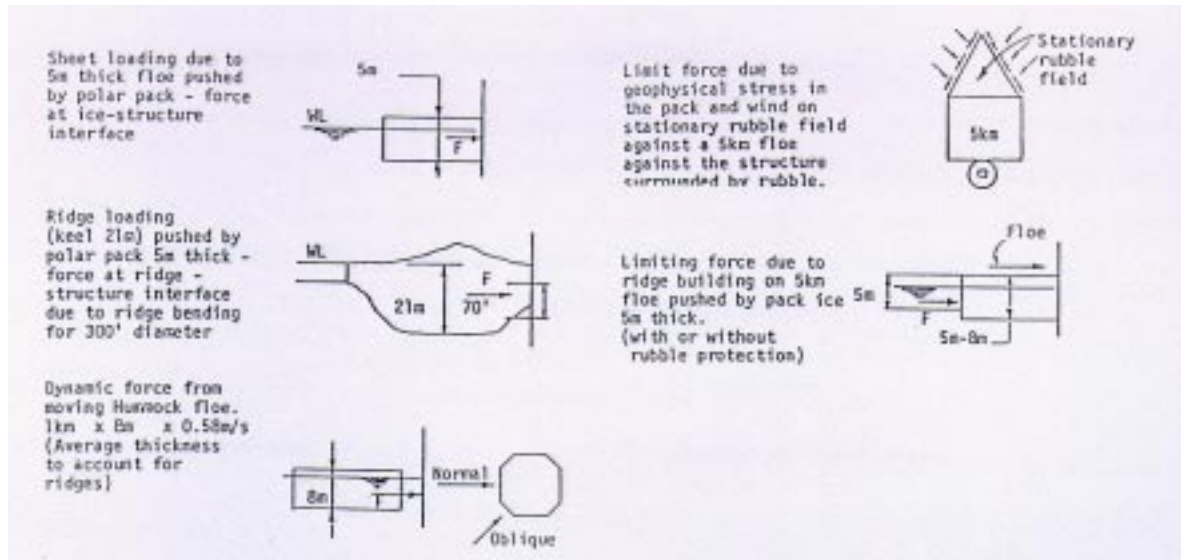
Figure 2.1: Summary of the key ice - structure interaction scenarios that were considered for the Molikpaq's global ice loading design.

To develop global ice load criteria for the Molikpaq, the approach taken was to define a number of expected ice-structure interaction scenarios, establish the maximum ice loads for these scenarios and in turn, select the governing design load. These scenarios were subdivided into summer and winter cases and considered in terms of normal and extreme ice loading events. Analyses were carried out from both a deterministic and probabilistic perspective, supplemented with some limited model testing. The ice-structure interaction scenarios that were considered are shown in Figure 2.1 and the associated global load levels used as design criteria are summarized in Table 2.1. Based upon this information, a global design load of 620 MN was selected for the Molikpaq design.

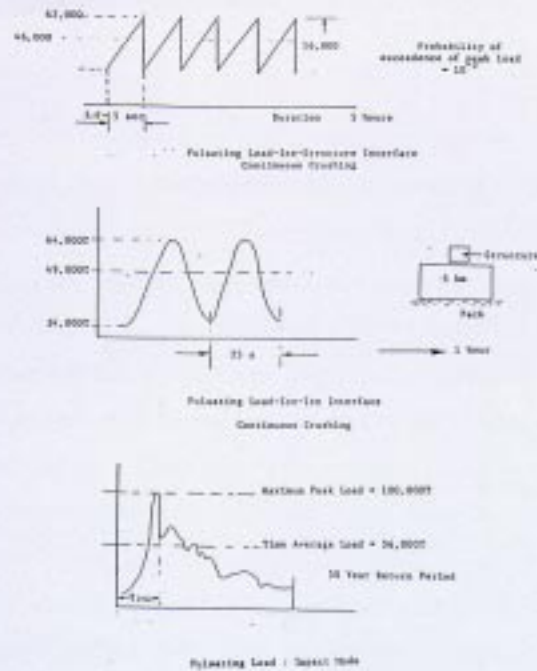
Figure 2.2: Summary of the dynamic ice loading criteria that were used for the Molikpaq's original design work, subdivided by interaction scenario.

Dynamic ice load criteria were a difficult consideration since there was essentially no experience with dynamic loading on deep, wide Arctic structures that were exposed to moving ice. The dynamic loading criteria developed were largely based on judgement and covered pulsating loads that could occur during continuous ice crushing and during thick ice impacts. The dynamic ice load criteria that were defined for the Molikpaq's design are summarized in Figure 2.2, subdivided by the particular interaction scenario assumed.

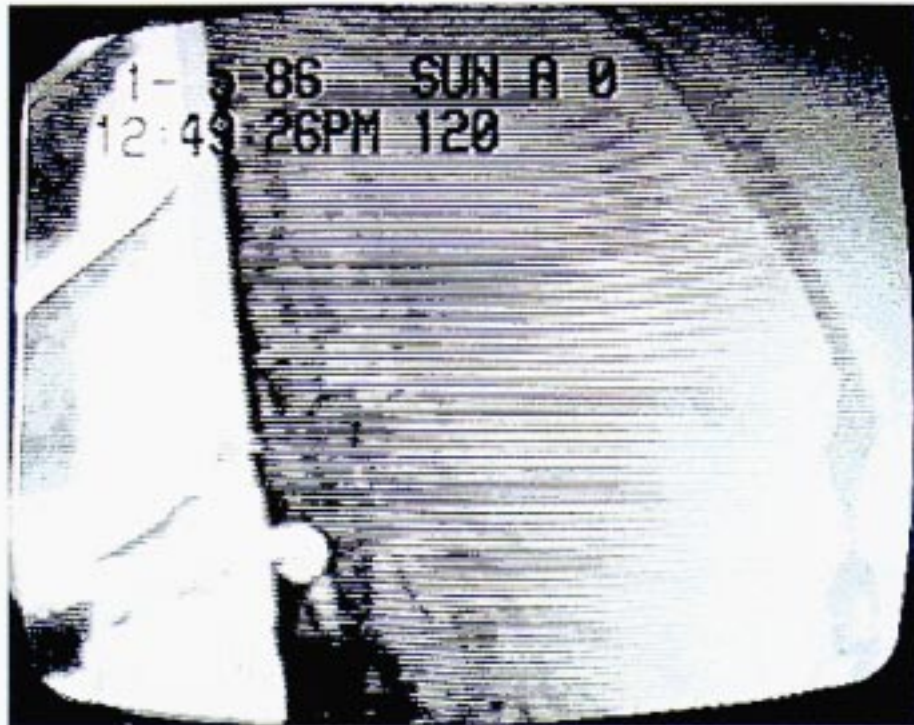
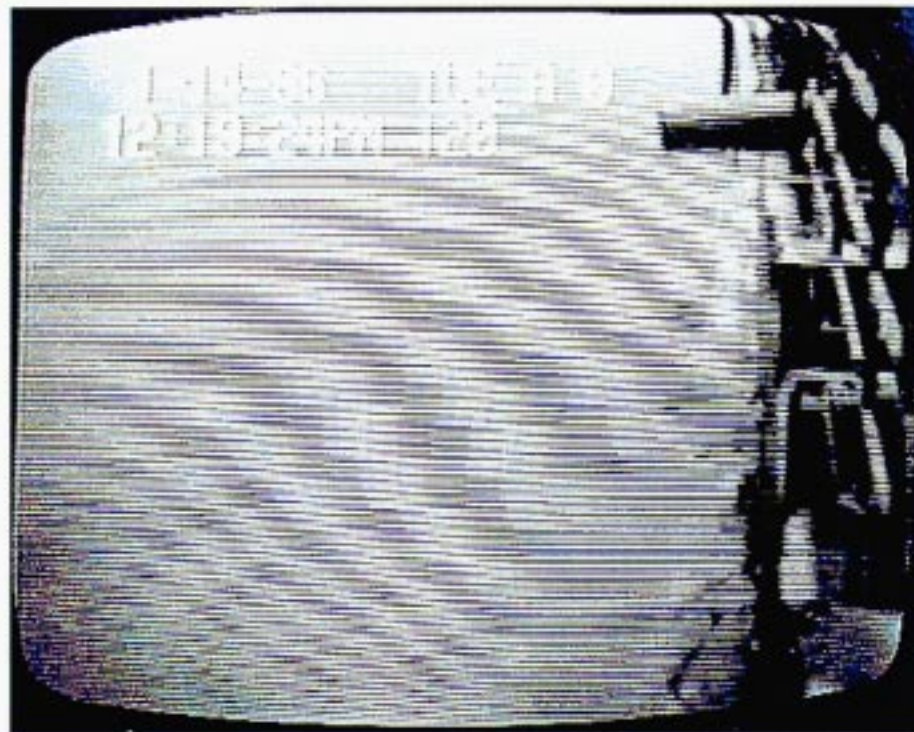
Figure 3.1: Example of video documentation of ice-structure interaction.

Video documentation included both time lapse recordings from cameras mounted on the derrick and the northeast flare boom, as well as portable video recordings. Both types of recordings provide information on failure modes and ice contact with the structure. The time annotation of the time lapse recordings makes it possible to compare structural response concurrent with ice conditions. An example of the video documentation is shown on Figure 3.1.

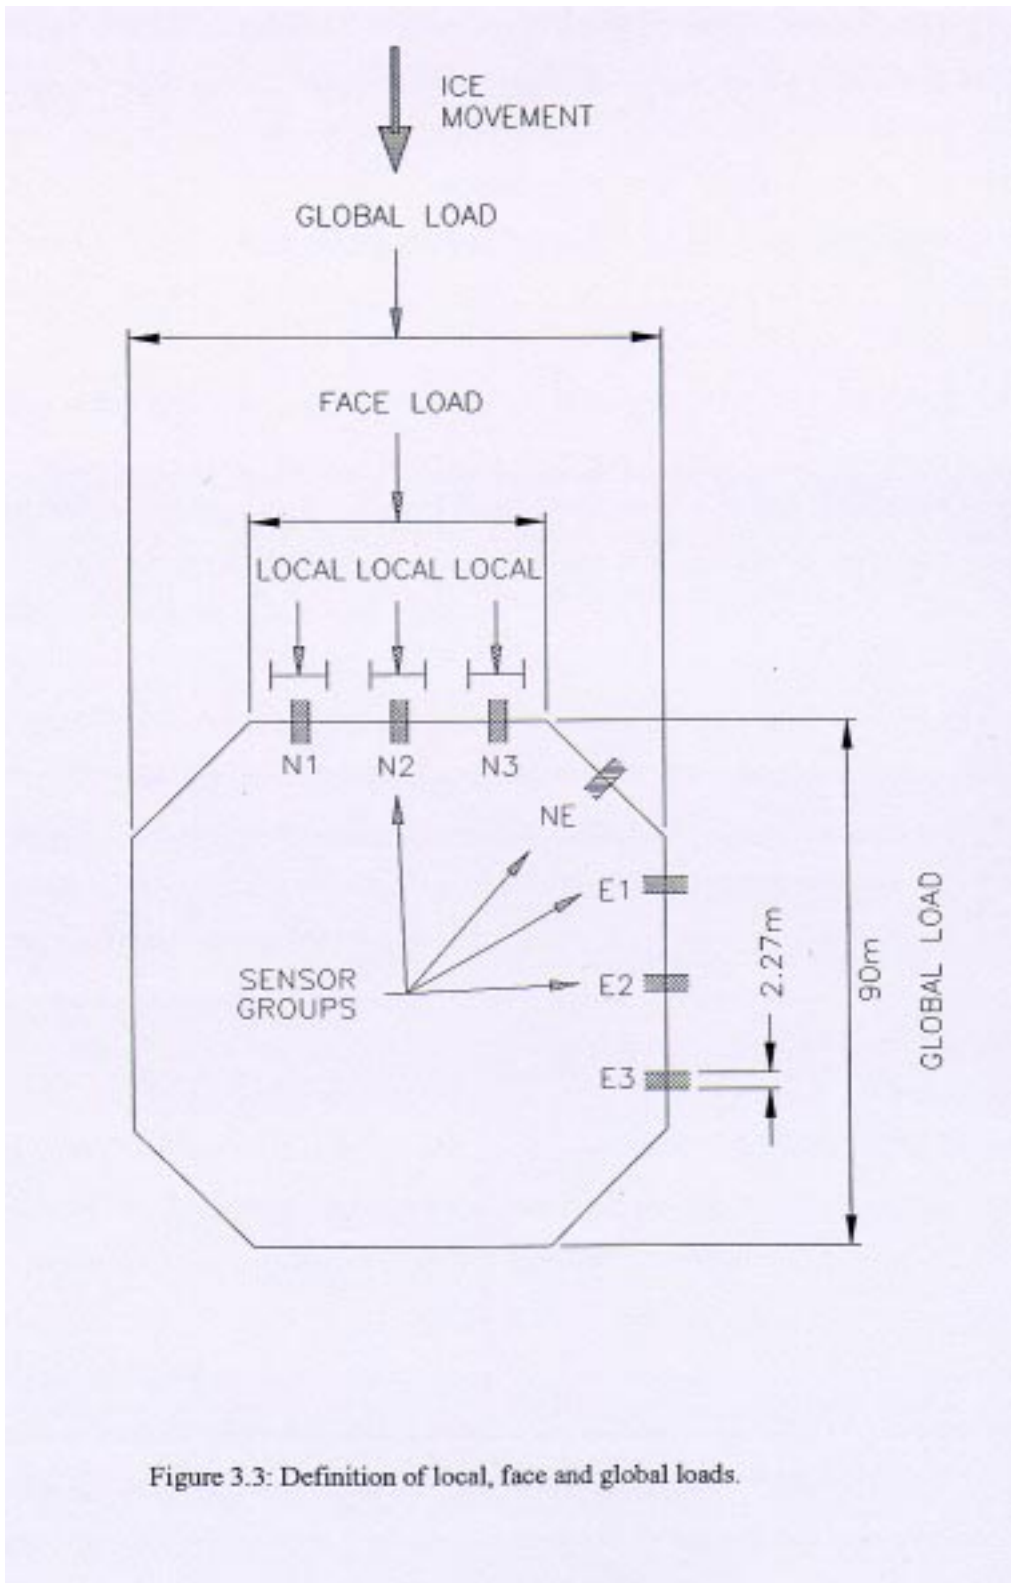
Figure 3.3: Definition of local, face and global loads.

As illustrated on Figure 3.3, the primary load information is derived from three Medof panel groups on the north and east long faces respectively and one Medof panel group on the northeast short face. The loads from any of these seven groups can be treated as a local load, and it is the comparison of these local load synchronizations that allow issues such as non-simultaneous or phase-locked failure to be addressed from measurements.

Each Medof panel sensor group has a sensing width of two panels, each 1.135 m wide. The long face of the Molikpaq at the operating interlines is approximately 60 m, and so the coverage of the sensing groups is about 10% of the long face. Face loads are estimated by assuming that the pressures measured by each group correspond to the pressures acting over the adjacent part of the face; comparison of the synchronization between each of the three sensor groups and load variation experienced by each allow determination of the uncertainty inherent in the calculated face load because of the assumption.

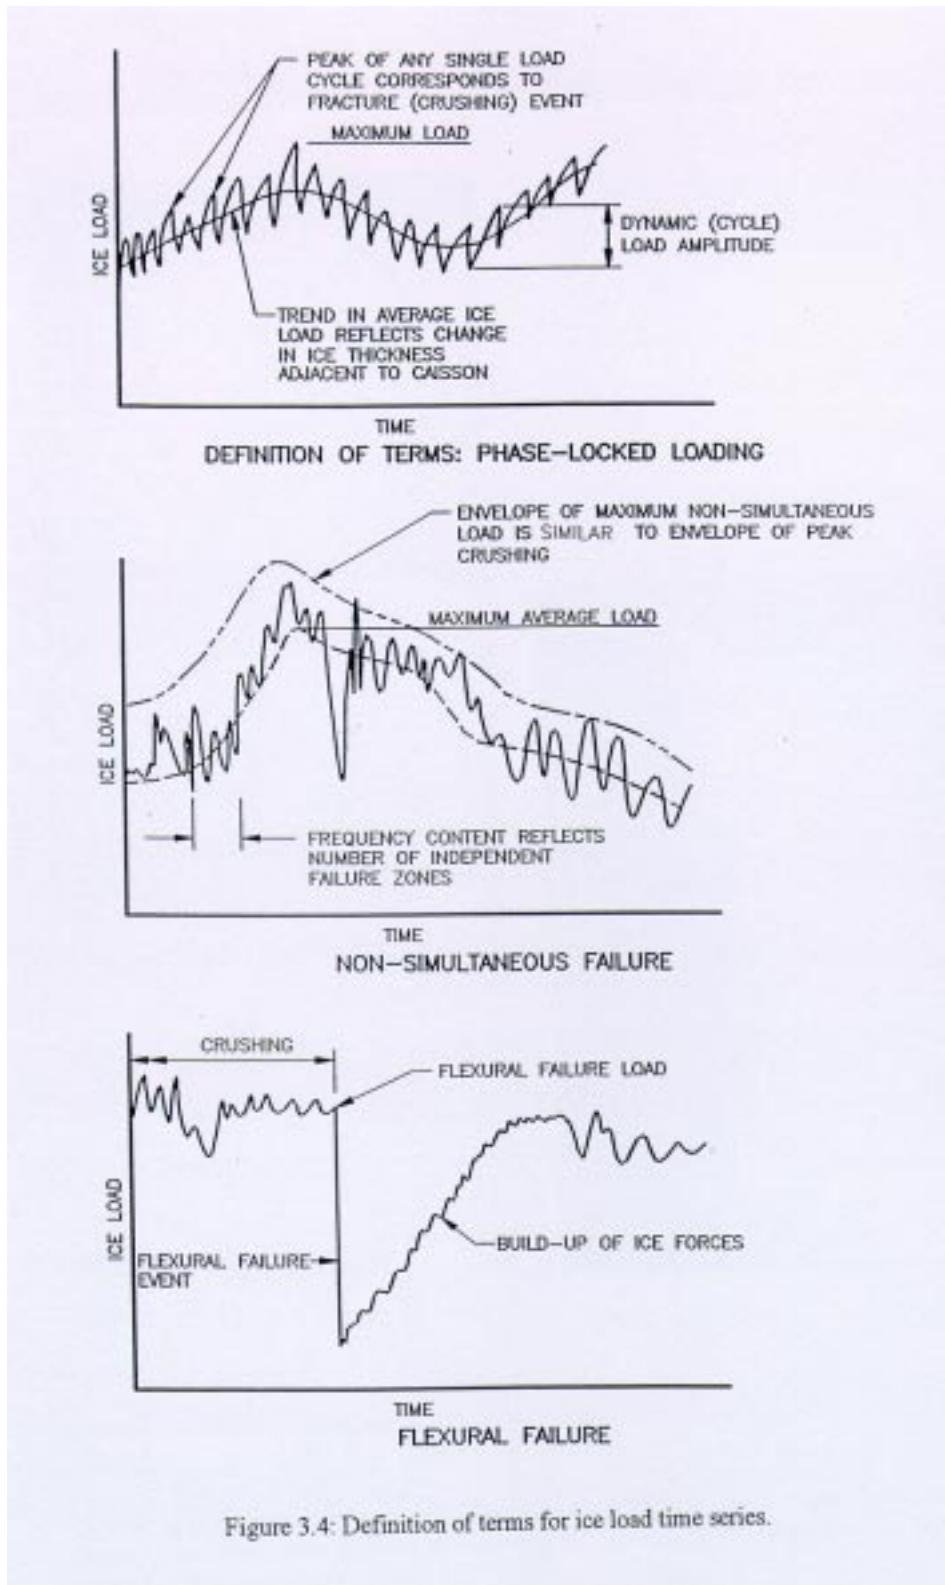
Figure 3.4: Definition of terms for ice load time series.

Within the concept of ice load, it is also important to appreciate that ice load varies with time. There are several scales of time variation, and the ideas behind these time-related variations affect what is meant by "maximum" or "peak" load. The various ideas and corresponding definitions have been summarized on Figure 3.4. As indicated, failure mode is an important factor when discussing load-time series.

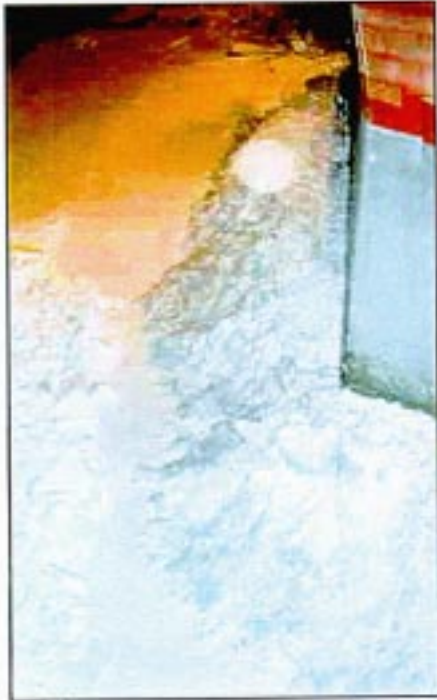
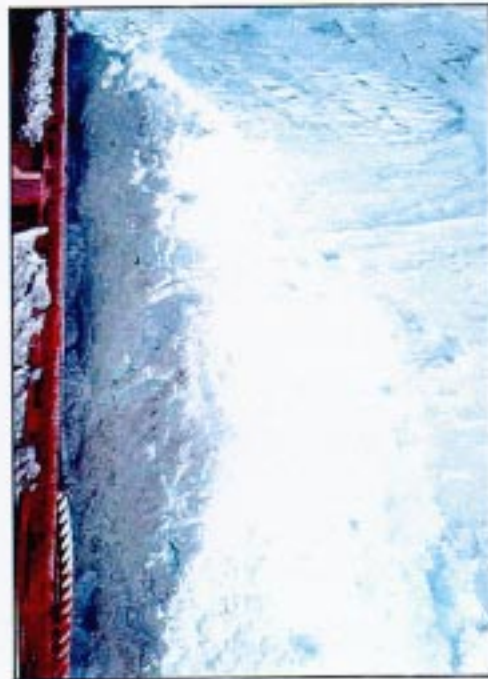
Figure 3.5: Representative examples of ice crushing. The top figure suggests non-simultaneous crushing while the lower figure is characteristic of crushing with pulsating loads. In this case a paste-like ice extrusion is evident.

Although some ice crushing with the Molikpaq was expected, the most surprising observation from Tarsiut P-45 and Amauligak I-65 was the extent of the continuous crushing that actually took place during an event, often across the entire width of the caisson. This type of ice failure behaviour had been considered in the original ice design criteria but had never been observed on such a large scale and over such substantial widths. Figure 3.5 shows a typical example of level ice crushing against the Molikpaq, with compressive ice failures localized at the caisson wall. This crushing process resulted in granular, powder like ice rubble across the interaction front, part of which was piled on top of the oncoming ice sheet, with the remainder pushed beneath and/or cleared around the caisson corners. The lateral extent of the crushed ice zone sometimes covered the entire width of the caisson but more often occurred across shorter portions of its face, frequently in combination with other failure modes. After some crushing had occurred and crushed ice debris had built on top of the moving ice cover, the oncoming ice sheet normally collapsed because of flexural failures away from the caisson wall. With this type of sudden flexural ice failure, the crushing ice loads would drop suddenly, sometimes resulting in accelerations that could be felt on the structure. With continued ice movement, flexural failures would continue at the rubble boundary for a short time period, then the intact ice

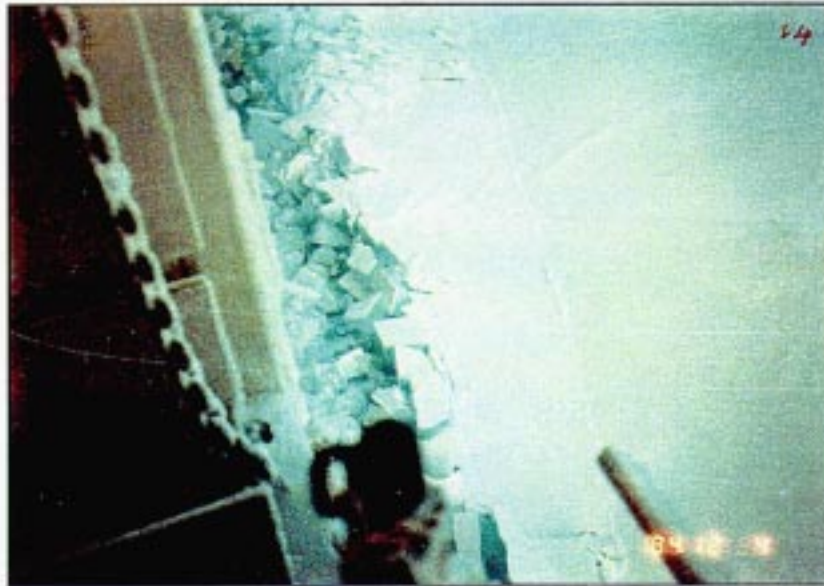
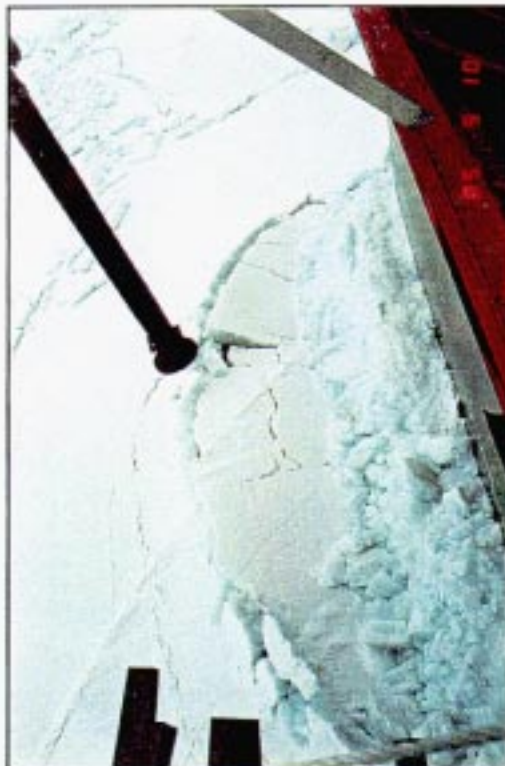
Figure 3.7: Typical examples of flexural ice failures. The upper figure shows bending failures at the ice sheet's leading edge, while the lower figure shows downwards bending due to the weight of the rubble debris at the caisson wall.

Flexural failure of the ice sheet was quite common, particularly in thin ice moving at moderate to high speeds, and took place when the leading edge of the oncoming ice cover was bent either upwards or downwards. Depending upon the ice thickness and to a lesser extent, the ice speed, flexural ice failures were initiated in one of two ways. As shown in Figure 3.7, thin ice sheets often bent up or down, depending upon the configuration of broken ice adjacent to the caisson wall. This resulted in ice pieces of variable size and often led to the formation of floating rubble piles that moved the ice failure zone away from the caisson wall. The second type of bending failure involved downward flexural failure of

the oncoming ice sheet that was initiated by the weight of crushed ice debris, as described earlier. This second type of flexural failure was more typical when the ice was thicker and drift speeds were slower. Often, flexural cracks were observed to form across the entire width of the caisson, followed by a sudden collapse of the ice sheet and a reduction in ice load.

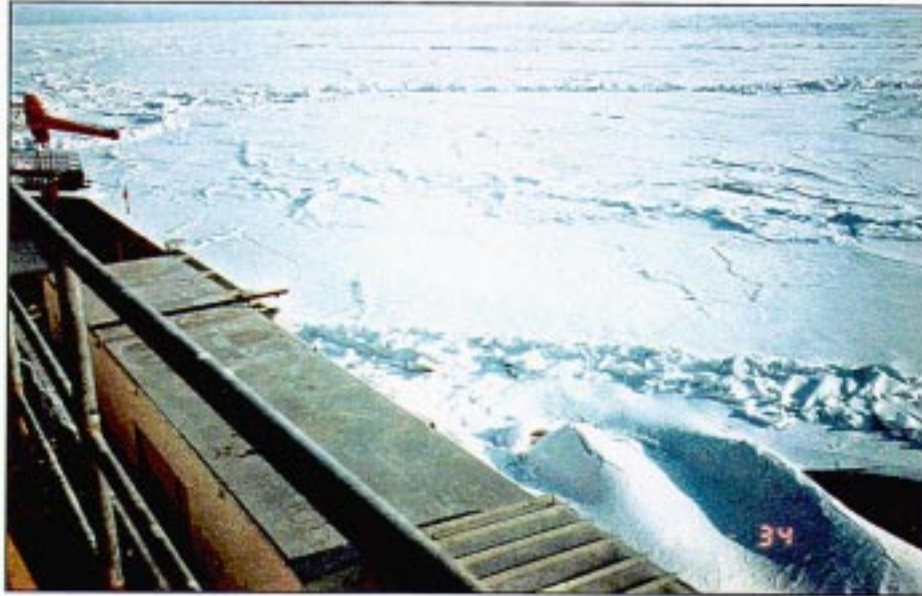
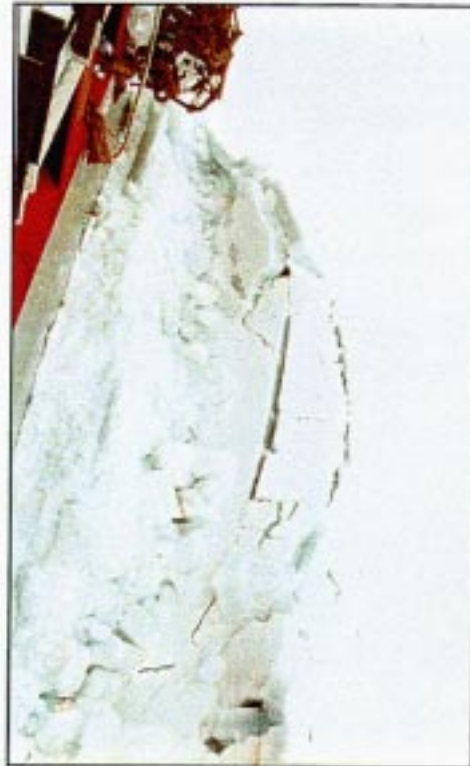
Figure 3.8: Typical examples of buckling. The upper figure shows creep buckling while the lower figure shows flexural buckling that was common at higher ice interaction speeds.

Buckling was quite common, and was most frequent when the ice was thin. This type of ice failure was usually observed across limited widths of the interaction front and often resulted from an eccentricity in the leading edge of the ice sheet. An example of buckling is shown in Figure 3.8. Buckling normally involved failures that were sudden and resulted from instability due to excessive in plane stresses. However, creep buckling was also a frequent failure mode at very low drift speeds which lead to a lower apparent modulus of elasticity.

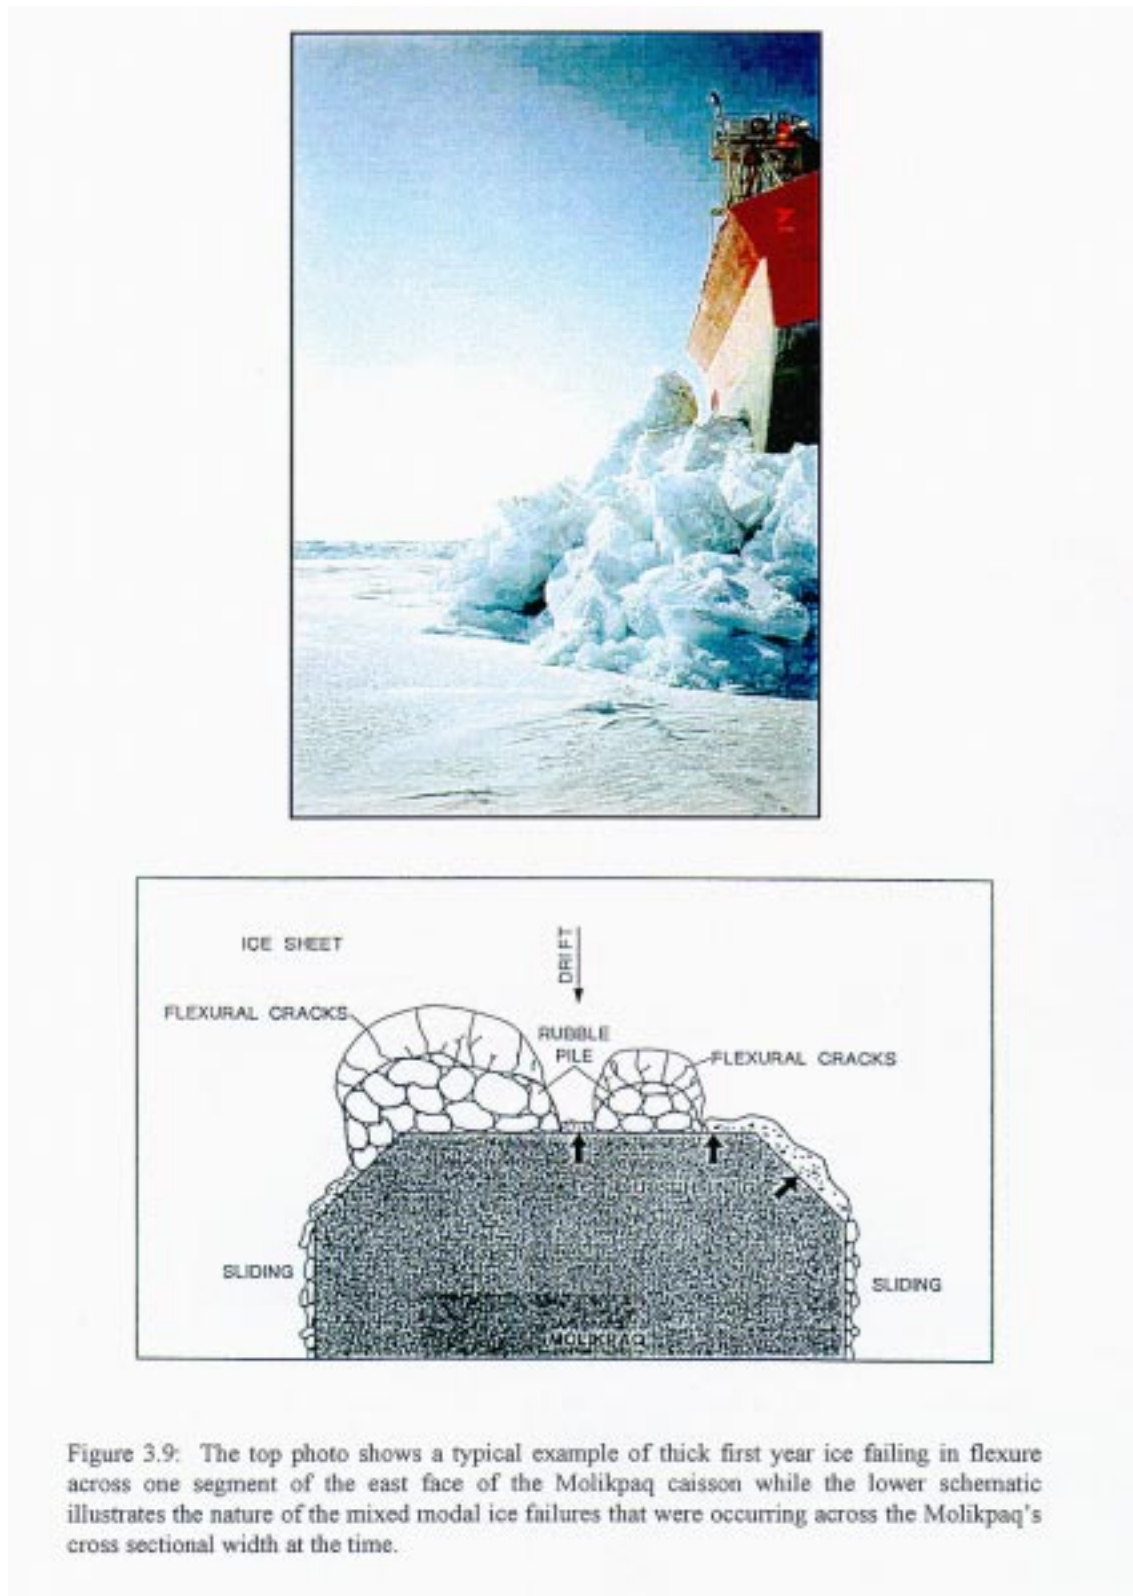
Figure 3.9: The top photo shows a typical example of thick first year ice failing in flexure across one segment of the east face of the Molikpaq caisson while the lower schematic illustrates the nature of the mixed modal ice failures that were occurring across the Molikpaq's cross sectional width at the time.

The vast majority of the ice interactions with the Molikpaq involved a combination of two or more of these failure modes, occurring simultaneously across different parts of the loaded caisson wall as illustrated in Figure 3.9. Combinations of flexural, buckling and crushing failures resulted in an averaging of different pressure levels across the interaction front and loads that were low in comparison with continuous crushing.

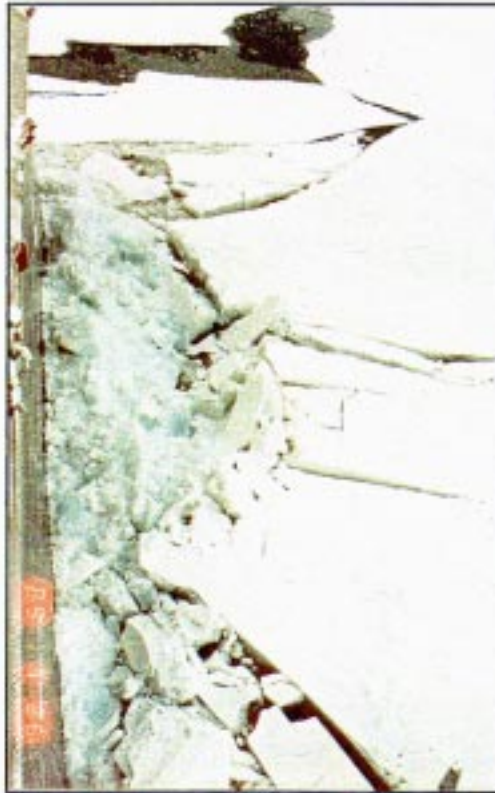
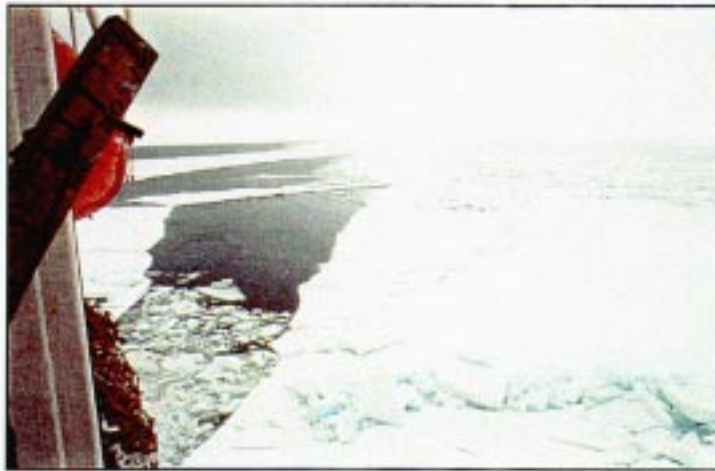
Figure 3.10: Typical examples of large scale fractures propagating out from the Molikpaq's ice interaction front. The top photo shows a number of cracks that in this case were associated with bending ice failures against floating rubble debris adjacent to the caisson wall, while the lower photo shows a crack that formed off one of the caisson's corners and has opened into a small lead. Often, cracks were observed to form at the corners between the Molikpaq's long and short faces and propagate out into the oncoming ice cover.

Under certain conditions, instead of ice failure immediately adjacent to the caisson wall, cracks propagated away from the Molikpaq, anywhere from tens of metres to several kilometres into the oncoming ice cover. An example is shown in Figure 3.10. This tended to be most common in cases of low confinement in the surrounding pack ice cover, such as the impact of individual ice floes, separated from each other by open water or large leads. Cracking and large scale fracturing was favoured during periods of high ice drift speeds when the ice behaved in a more brittle manner and in thick, non uniform ice conditions. The loads associated with this type of failure behaviour were relatively low. Sometimes, cracking would follow periods of high ice loading events and there would be a rapid transition, and a sudden reduction in load levels.

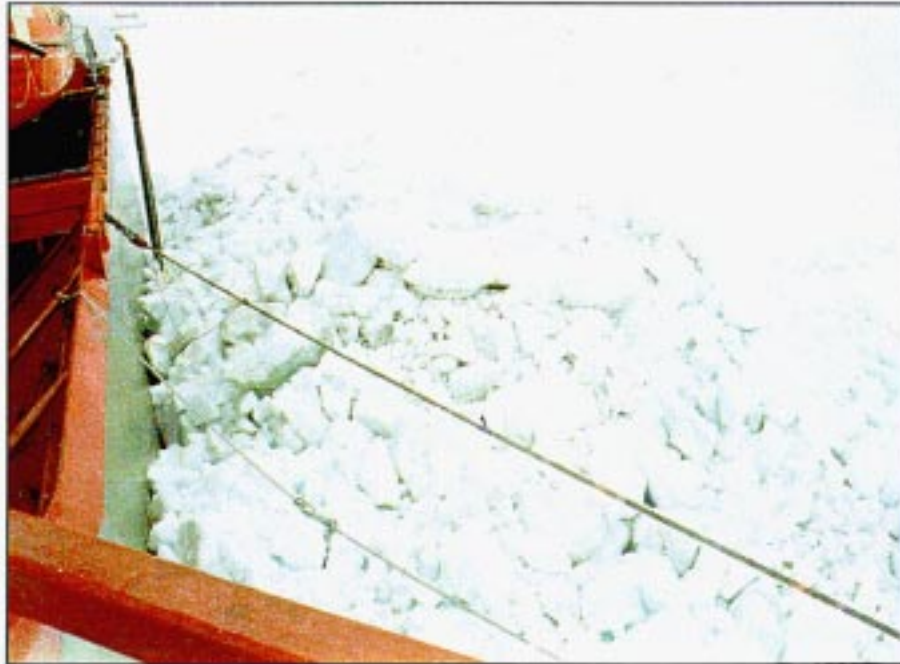
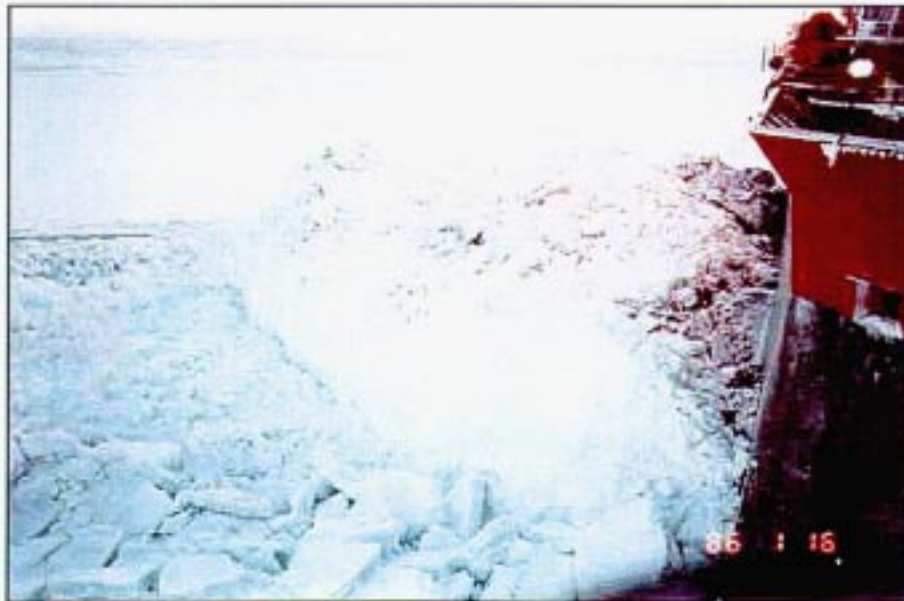
Figure 3.11: Typical examples of ice rubble that formed off the Molikpaq caisson. The upper photo shows a floating rubble formation while the lower photo shows a grounded rubble pile. When the Molikpaq's deployment draft was deep, the occurrence of grounded rubble piles was very rare and they would be swept away by subsequent ice movements anywhere from a few hours to a few days after they had formed.

In most cases, the rubble caused by ice failure tended to quickly clear around the structure, aided by the current flow around it. However, large temporary rubble piles sometimes formed on the upstream side of the Molikpaq, as shown in Figure 3.11. These pile-ups tended to occur when the ice was moving perpendicular to one of the long faces of the caisson. These pile-ups were most common when the ice was more than 0.5 m thick with no cracks or leads in the oncoming ice cover to disrupt the continuity of rubble formation. The dominant failure mode observed during these pile-up events was flexural failure at the floating rubble boundary, either upwards or downwards. The ice pressures and loads on the caisson walls during pile-up events were typically low.

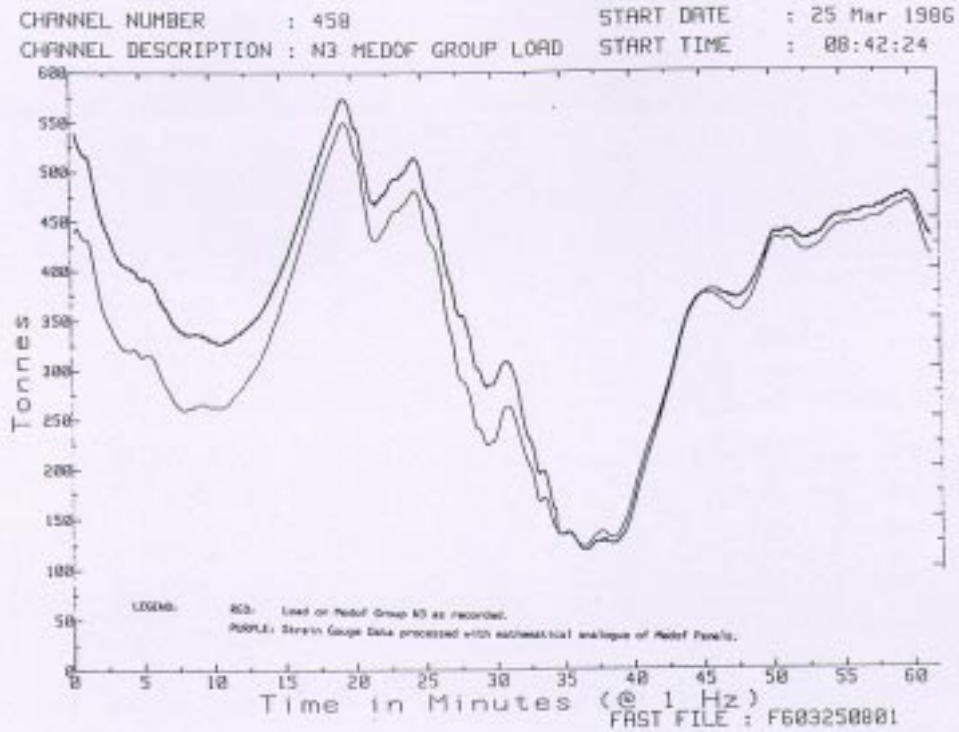
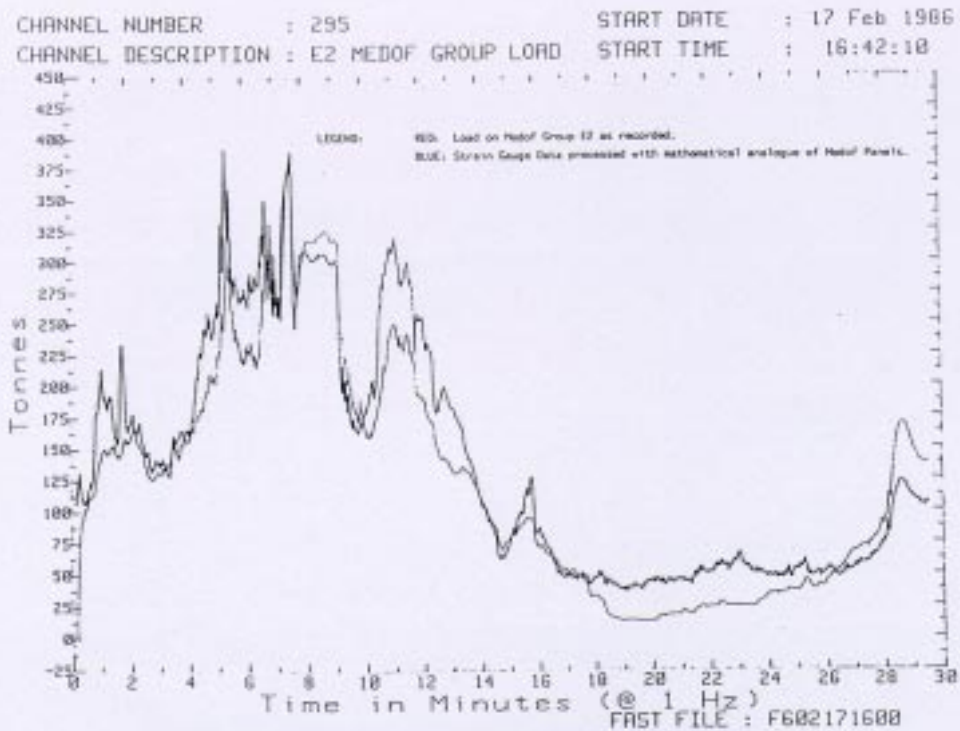
(a) Comparison for March 25, 1986 - 2m thick ice

(b) Comparison for February 17, 1986 - 0.5m to 0.8m thick ice

Figure 4.1: Strain gauge calibration against Medof Panels.

Examples of the '09 series' strain gauge calibration against the Medof panels is illustrated on Figure 4.1 for a creep and a dynamic load event. Excellent correspondence is evident. Also shown on Figure 4.2 is the Medof response during a dynamic load event, from which it can be seen how the Medof panel response causes under-reading of ice fracture peak loads by about 30%.

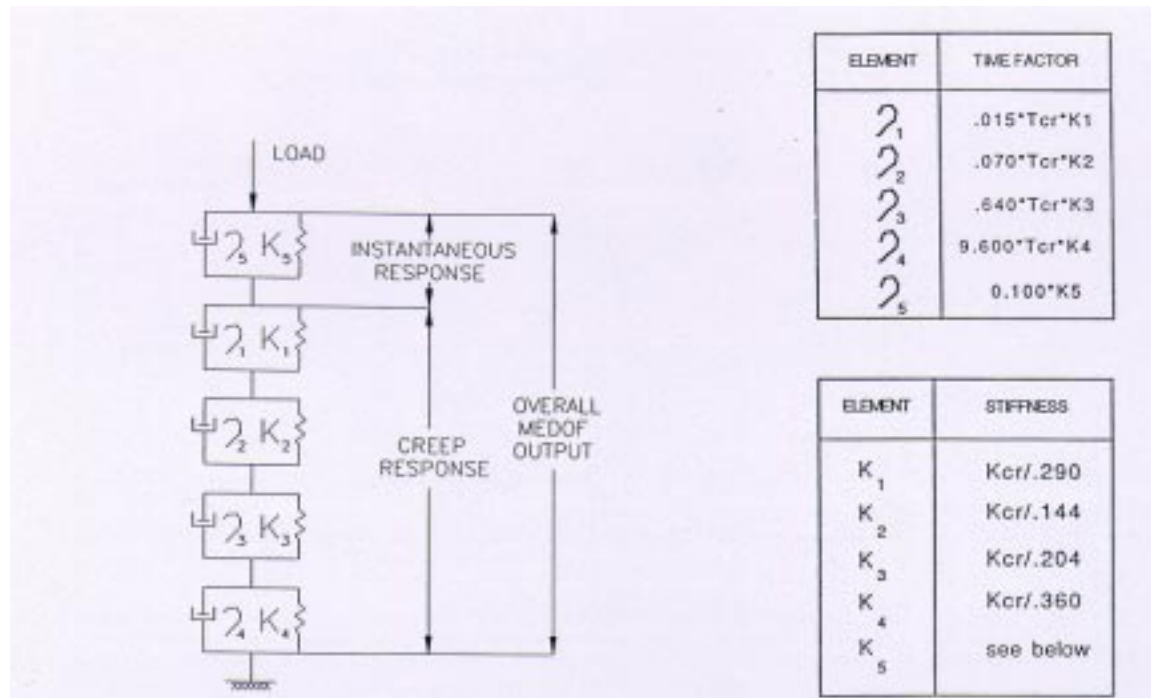
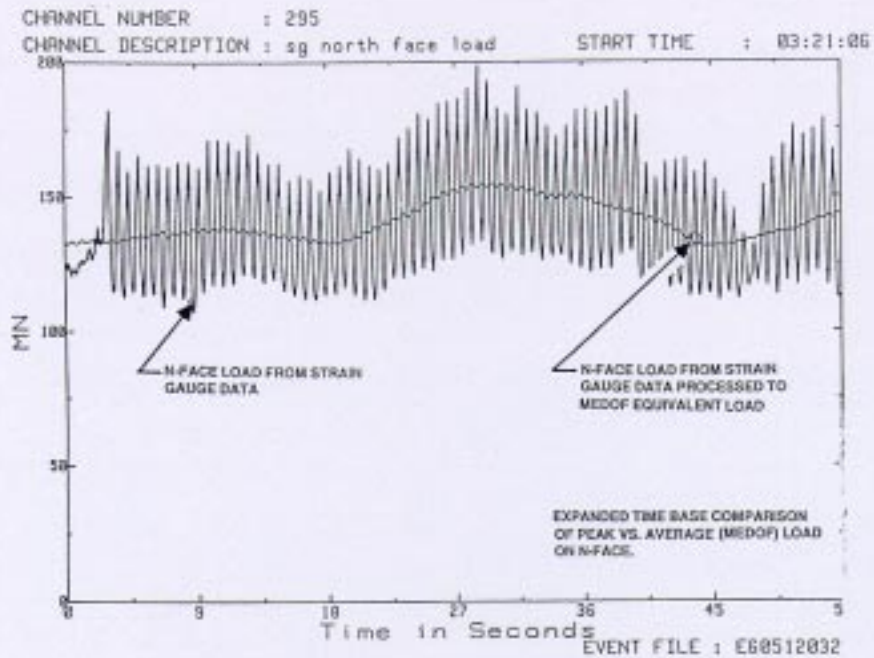
Mathematical analogue of Medof Panels

Figure 4.2: Strain gauge calibration against Medof Panels.

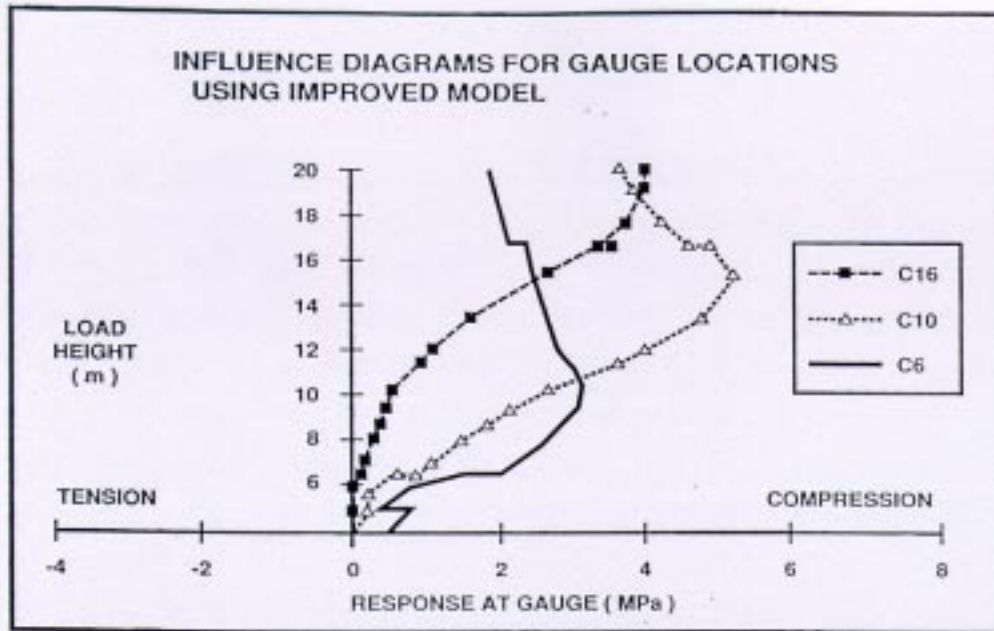
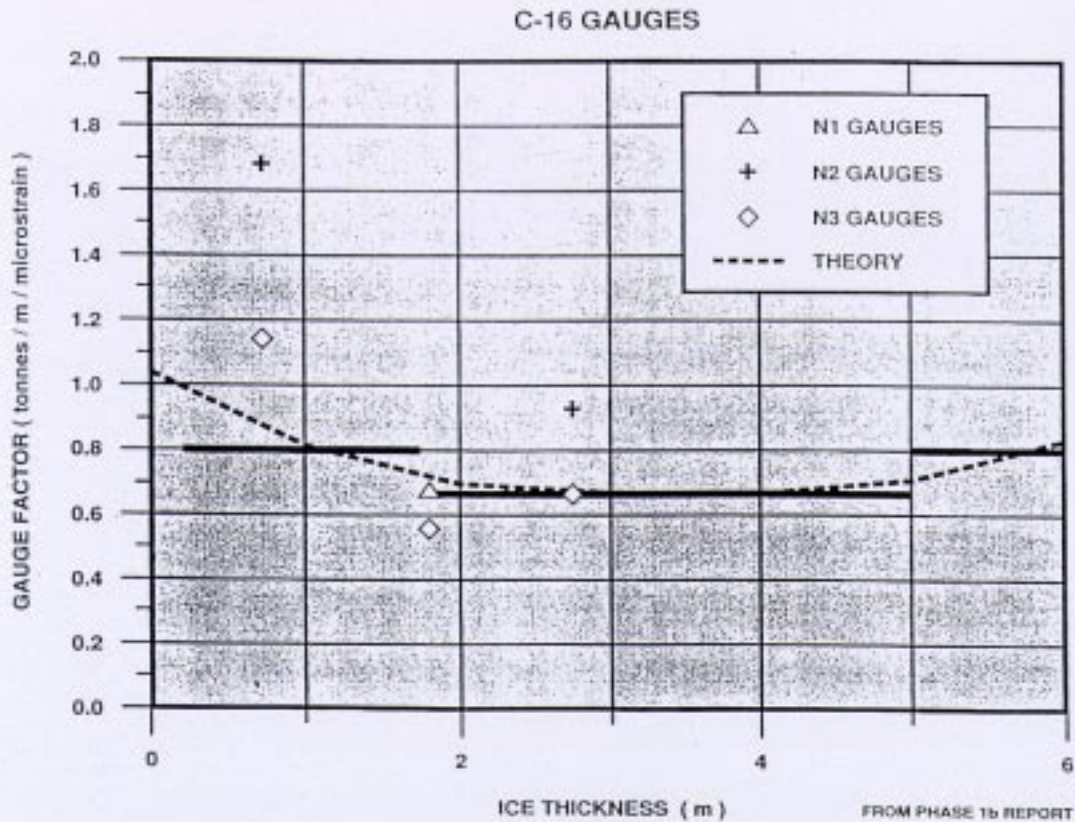
Artec Canada Ltd. FEM results

Figure 4.3: Effect of ice thickness and point load application on strain gauge calibration factor.

Finite element modelling was used to understand gauge response and in particular explore the response of gauges to ice thickness. Figure 4.3 summarises the results of the finite element studies in terms of effective gauge factor, and compares the calculations with factors inferred from calibration against the Medof panels. For the regular bulkheads there is reasonable agreement for ice thickness in the range 1 m to 5 m; for thinner ice, the calibration against the Medof panel suggest gauge factors should be stiffer.

Based on the calibration work, the Molikpaq analysis typically used a constant gauge factor for each bulkhead for ice thicknesses up to 5 m. This approach is pragmatic and necessary because there was no real time monitoring of ice thickness. The approach has the effect that ice loads estimated from 09 series strain gauges may be too low for ice thicknesses less than 1 m and greater than 4 m. Strain gauge factors used as the default values in the DynaMAC program are documented in Table 4.1.

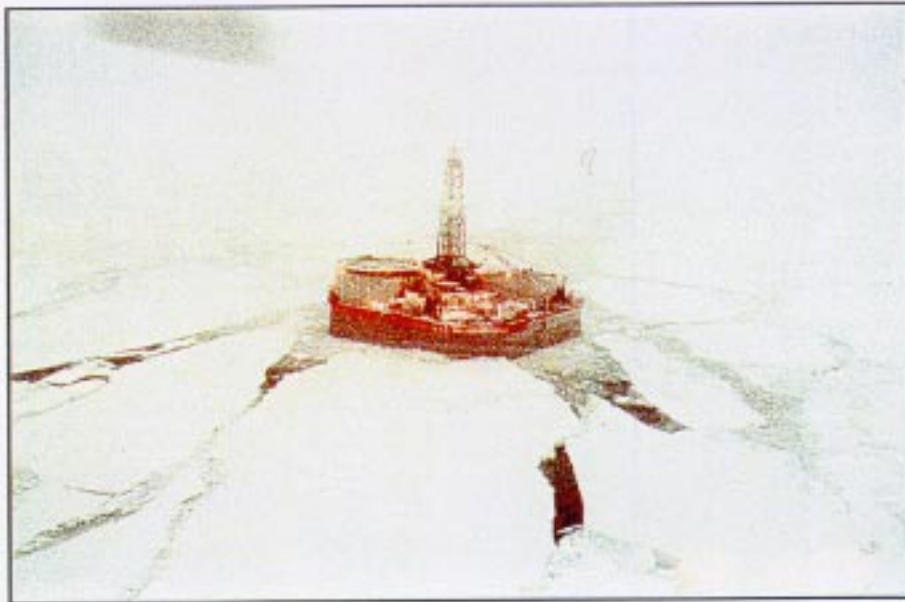
Figure 5.1: The Molikpaq at Tarsiut P-45.

The first Molikpaq deployment was at the Tarsiut P-45 wellsite, as seen in Figure 5.1, where the structure was set down late in the summer of 1984 after it had been towed from Japan to the Canadian Beaufort Sea. This deployment site was located about 75 km offshore, in about 26 m of water. The design and construction activities related to the deployment have been described by Jefferies et al, 1985 in a paper titled "Molikpaq Deployment at Tarsiut P45", ASCE Conference Civil Engineering in the Arctic Offshore, San Francisco.
