### **DynaMAC: Molikpaq ice loading experience**

Hardy, M.; Jefferies, M.; Rogers, B.; Wright, B.

*PERD/CHC Report; no. 14-62, 1996-07*

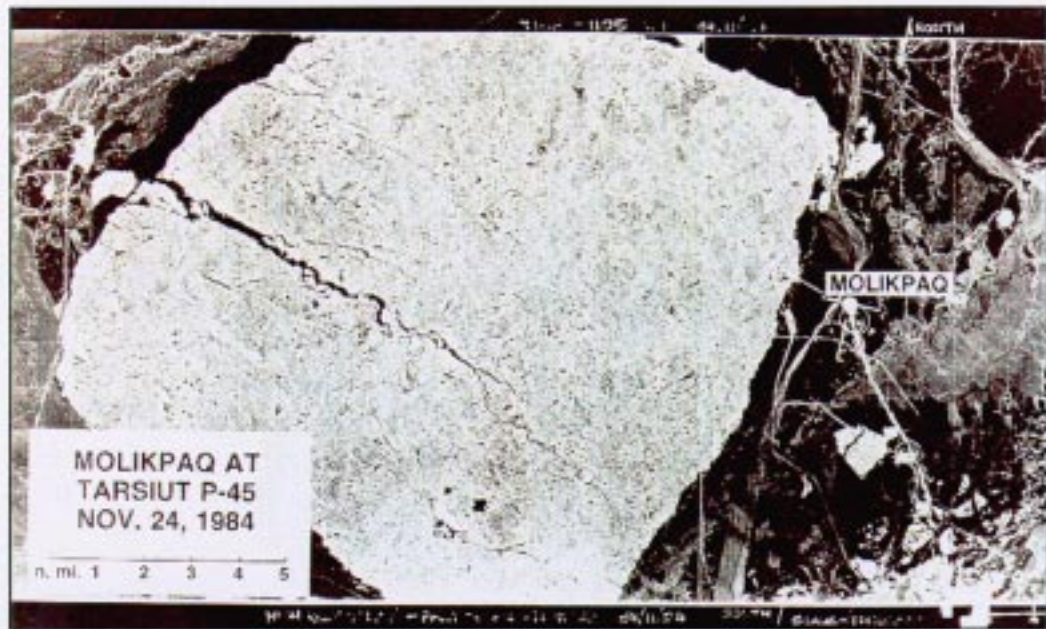
Figure 5.3: In late November, a large second year ice flow about 10 km in extent (referred to as Pacman) approached the Molikpaq from the northwest, but stopped about a kilometre west of the structure, due to the constraining influence of the landfast ice zone on the moving pack. It drifted off to the west several days later and never impacted the Molikpaq. This figure shows a radar image (SAR) of the general area at this time, where the radar reflection from the second year ice is white and the first year ice appears black. The Molikpaq's location is shown as a white circle. A broken ice wake (white line) created as the ice moved past the structure can also be seen.

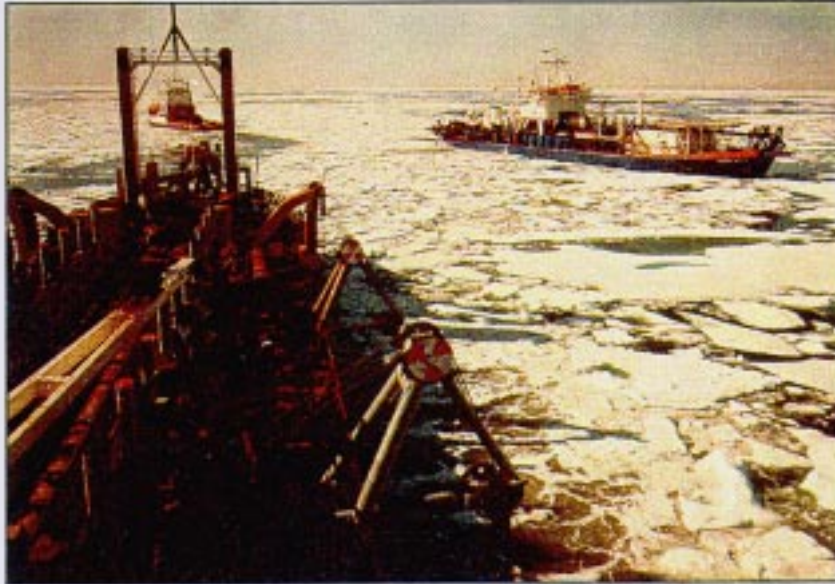
Figure 5.4: Variable concentrations of first year ice hampered the dredging activities that were associated with the construction of the Amauligak I-65 subcut and berm. Ice management support was provided by BeauDril's Arctic Class IV icebreakers which proved very effective in allowing continued dredging activities when significant ice was present.

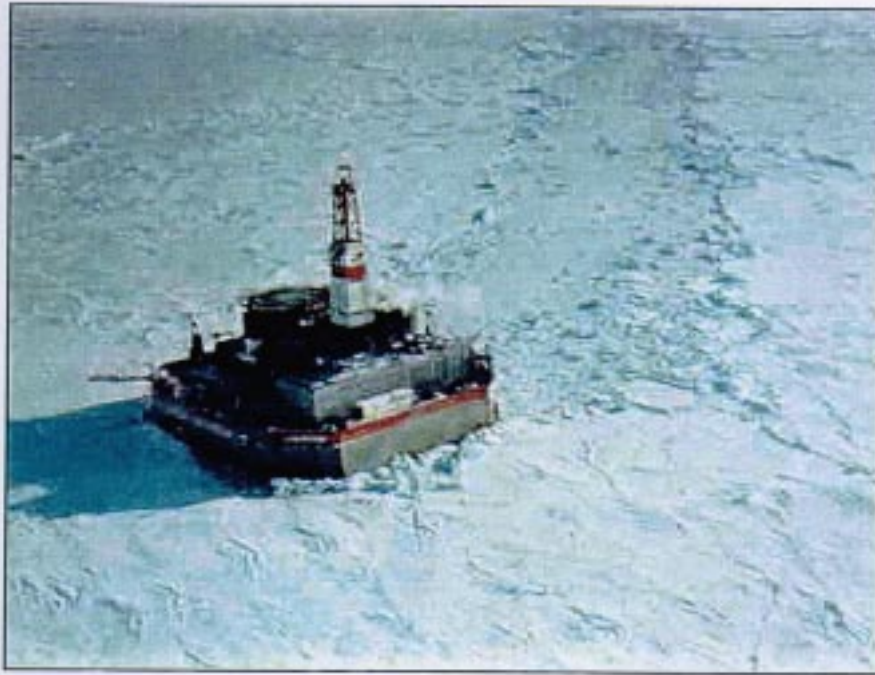
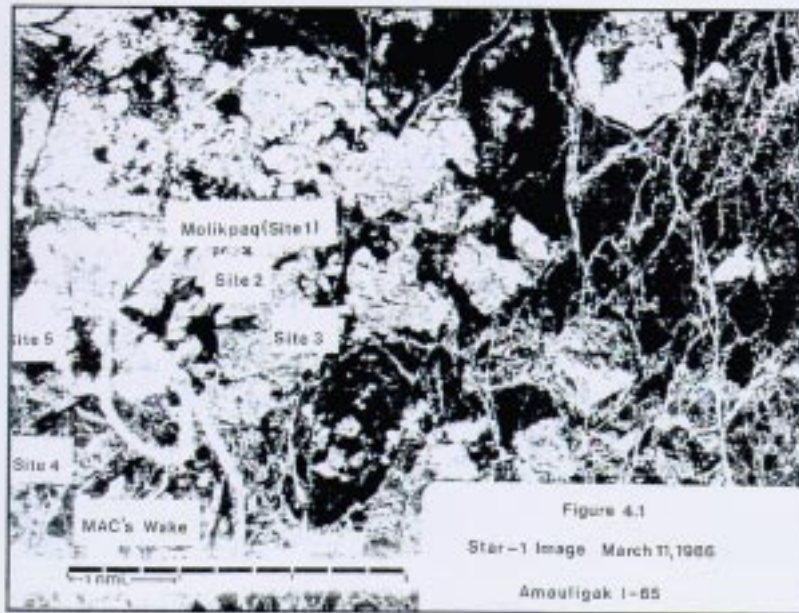
Figure 5.6: The upper figure shows a large multi-year ice flow moving against the Molikpaq on March 8th, 1986. The lower figure is a radar image of the general ice conditions around the Molikpaq in mid March with old ice floes indicated as white radar reflections and first year ice typified by black returns. The Molikpaq's wake that was created as the result of ice moving past it is evident in both figures.

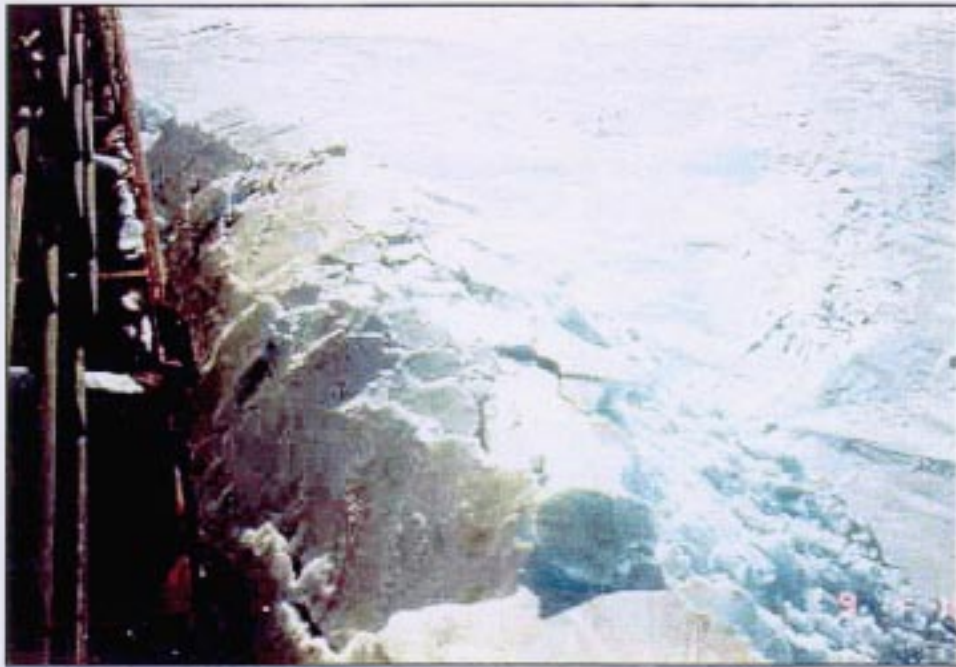
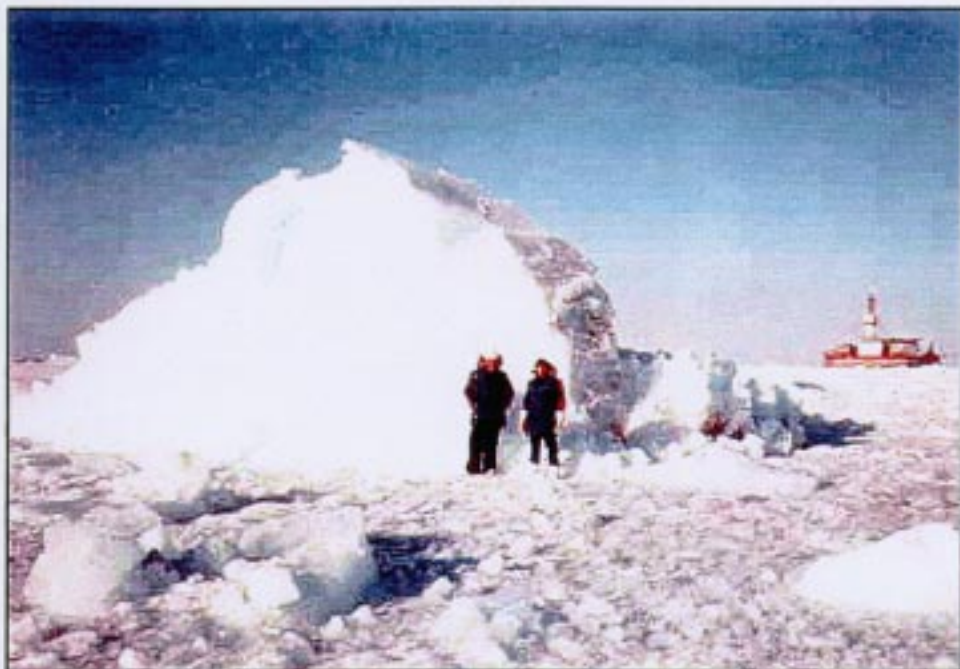
Figure 5.7: The upper photo shows multi-year ice crushing against the Molikpaq on April 12th where the ice extrusions caused by ice clearance can be seen, while the lower photo shows representative ice extrusion debris that has been turned back by the ice deflector.

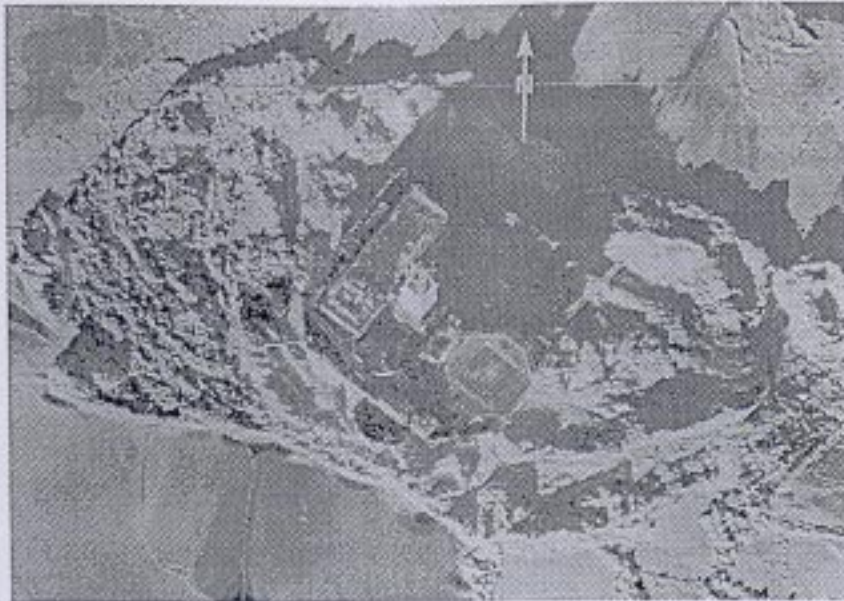
Figure 5.12: This figure shows an aerial photograph of the grounded rubble field that formed around the Molikpaq at the 1987/88 Amauligak F-24 drilling location. The rubble formation was roughly 200m x 300m in extent and was solidly grounded on the submerged berm.

Figure 5.12 shows a plan view of the Molikpaq rubble field. The rubble was formed in a series of discrete rubble building events, with the effective cross section of the Molikpaq and rubble hybrid increasing with each event. As this cross section increased, drifting pack ice was obstructed over progressively larger widths, which led to a higher likelihood of more rubble generation, because of reduced clearance. In terms of maximum extent, the rubble field grew to about 200 x 300 m in size, including the central area of Molikpaq itself. During the initial build up of rubble adjacent to the caisson, there were no incidents that posed any threat in terms of ice overtopping.

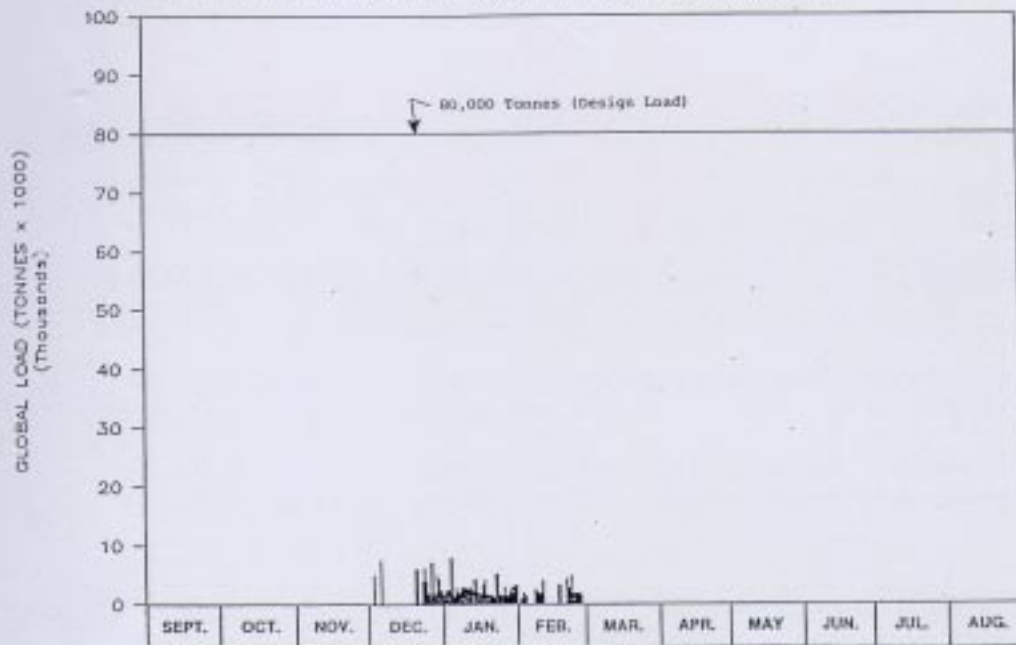
Figure 5.13: Peak daily global ice loads that were measured on the Molikpaq during the 1987/88 operating season. The ice loads imposed at the boundary of the grounded rubble formation were (in all likelihood) higher than the values shown, but were not transmitted through to the caisson itself. Obviously, the ice loads acting at the outer edge of the rubble were transmitted to the foundation through grounded portions of the rubble field and were adequately resisted.

Over the course of the Molikpaq's 1987/88 deployment at Amauligak F-24, maximum ice load levels were no more than 80 MN as shown in Figure 5.13. This is only 10% of the 800 MN global design load that was used for the Amauligak F-24 deployment design. Because of this, the Molikpaq's overall performance behaviour was excellent and the range of measured responses were very low. Geotechnical monitoring indicated that no significant loads or deformations occurred in the Molikpaq's core, its berm, or its foundation. Measurements from instrumentation on the caisson itself showed that no significant structural responses occurred, either static or dynamic.

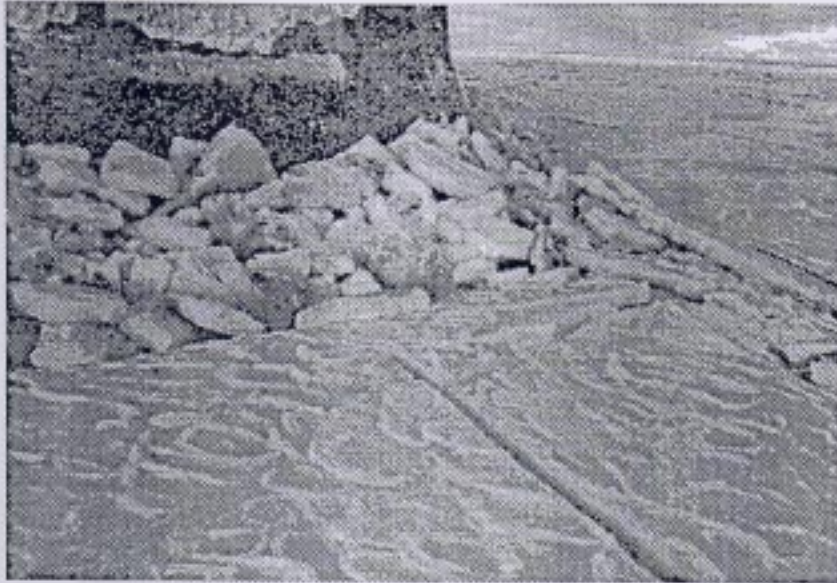
Figure 5.16: Prior to the formation of grounded ice rubble around the caisson and prior to the onset of landfast ice conditions, the moving ice cover failed against the Molikpaq's sloped sides in bending, at low load levels.

During the freeze-up period, thin mobile ice failed in bending against the Molikpaq's sloped face at low load levels, as had been the case at the Amauligak F-24 deployment. Thicker rafted ice areas that moved past the Molikpaq at this time failed in a similar manner. No crushing was observed. Direct ice action on the sides of the caisson that were not protected by the rubble resulted in bending ice failures, as shown in Figure 5.16. However, since only small, slow landfast ice movements over periods of hours occurred, this ice action was not significant and usually involved considerable creep components, and low load levels. Once the rubble field formed, mixed modal ice failures were seen around its outer edge. After the formation of the grounded ice rubble, ice pressure panels were installed to monitor ice loads outside the structure. A typical photograph taken during monitoring is shown in Figure 5.17.

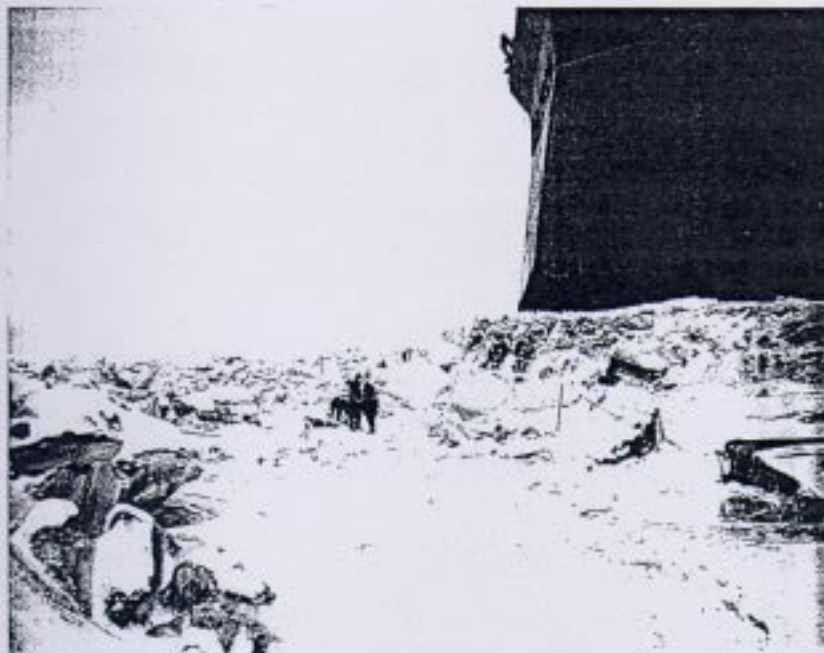
Figure 5.17: After the formation of the grounded ice rubble, ice pressure panels were installed to monitor ice load outside the structure.

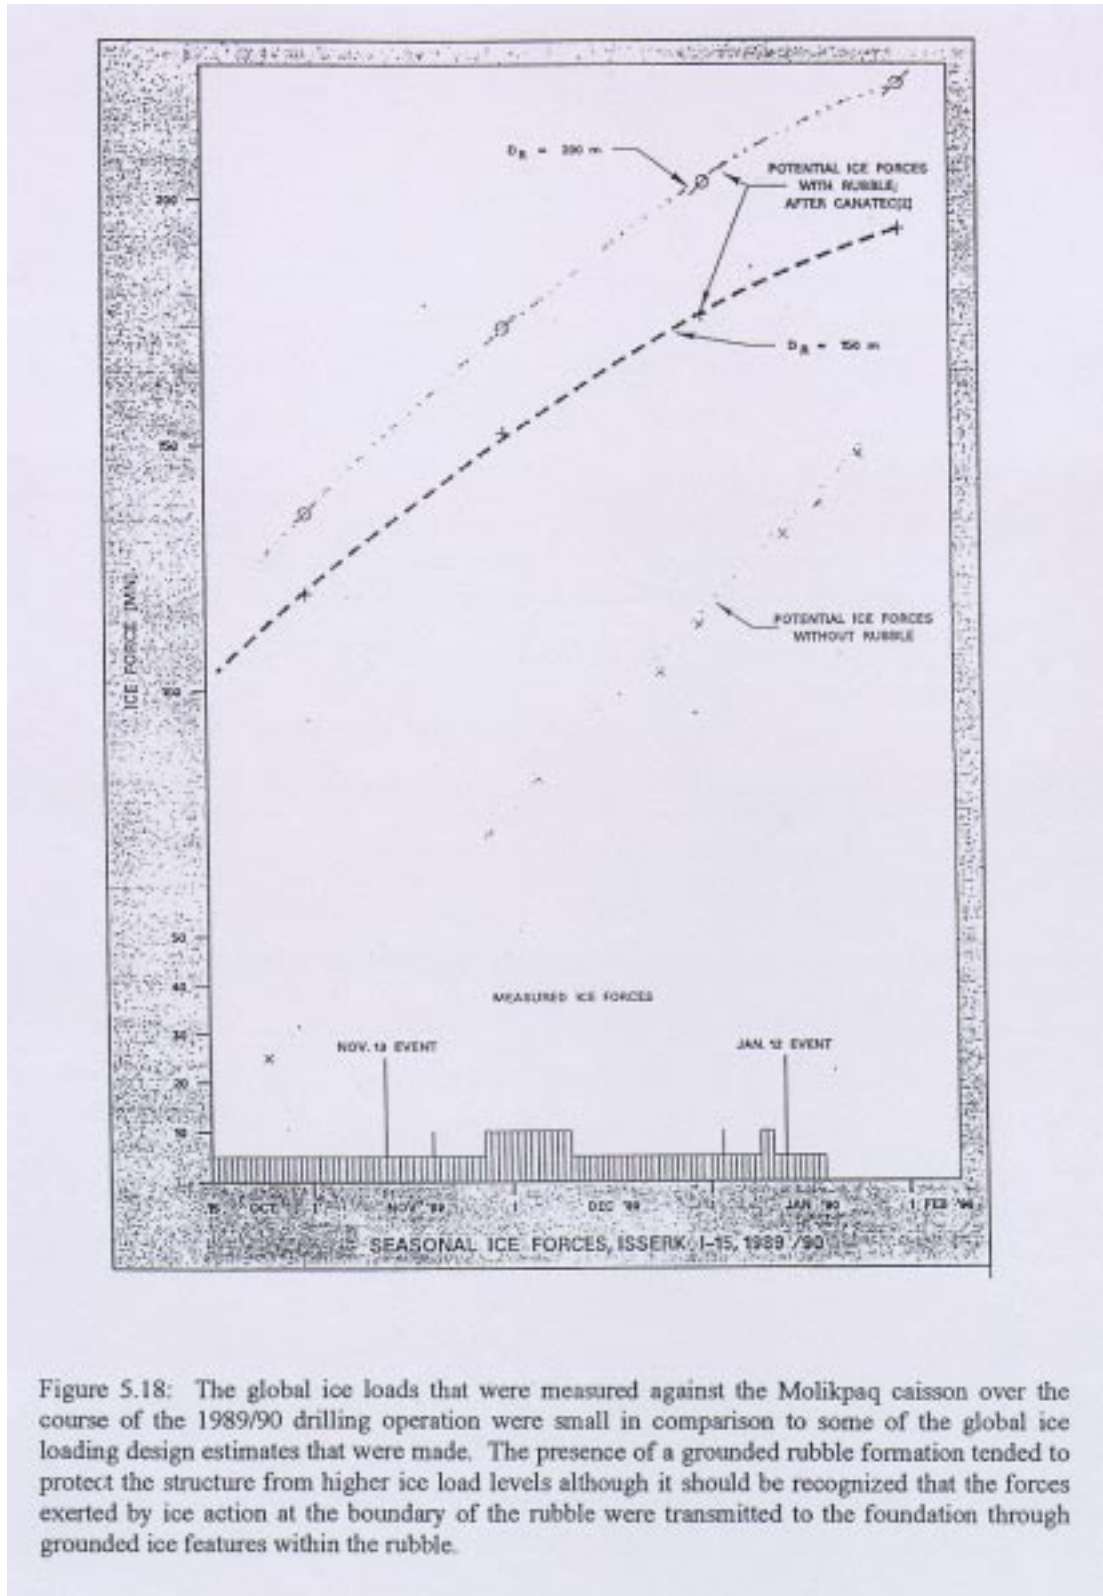
Figure 5.18: The global ice loads that were measured against the Molikpaq caisson over the course of the 1989/90 drilling operation were small in comparison to some of the global ice loading design estimates that were made. The presence of a grounded rubble formation tended to protect the structure from higher ice load levels although it should be recognized that the forces exerted by ice action at the boundary of the rubble were transmitted to the foundation through grounded ice features within the rubble.

The global ice loads that were measured over the winter period are shown in Figure 5.18. The load levels are very low and can be summarized as follows:

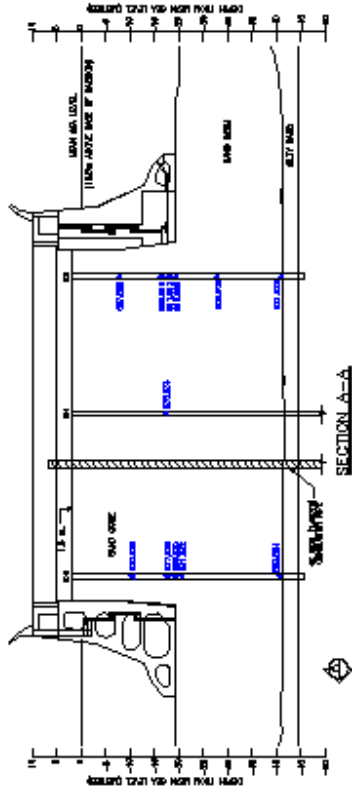
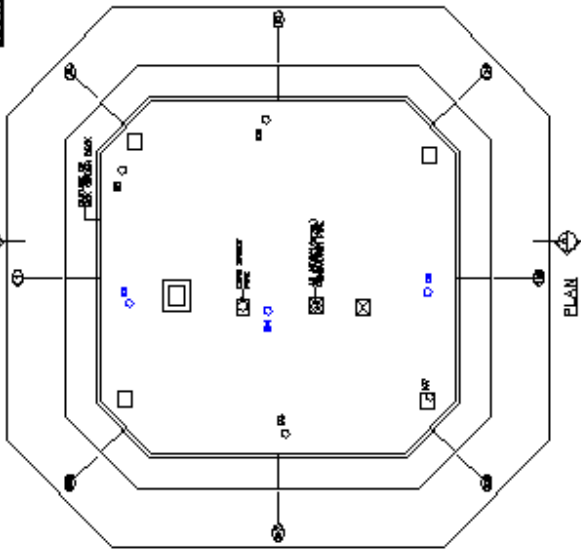
# INCLINOMETERS

INSTALL INCLINOMETERS INSTALLED IN CASING 101, 104 AND 106 ONLY.

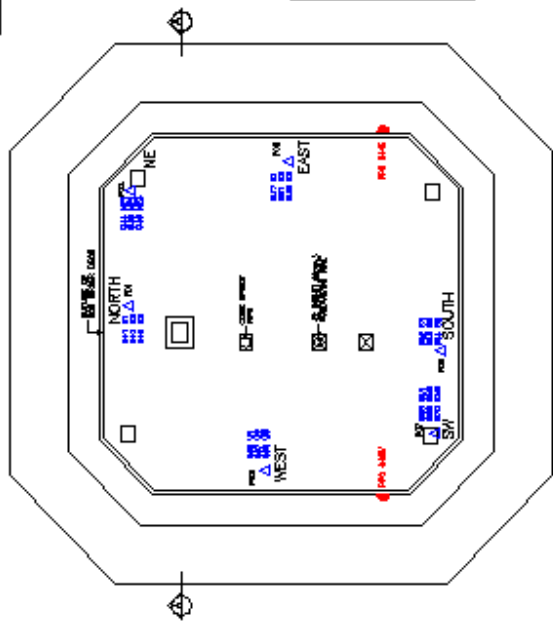
# PIEZOMETERS

SECTION A-A

NOTE: QUASAR PIEZOMETERS ARE LOCATED 16.0m BELOW NSL.
