A major energy conservation retrofit of a bungalow Orr, H. W.; Dumont, R. S.

Internal Report (National Research Council of Canada. Institute for Research in Construction), 1987-05-01

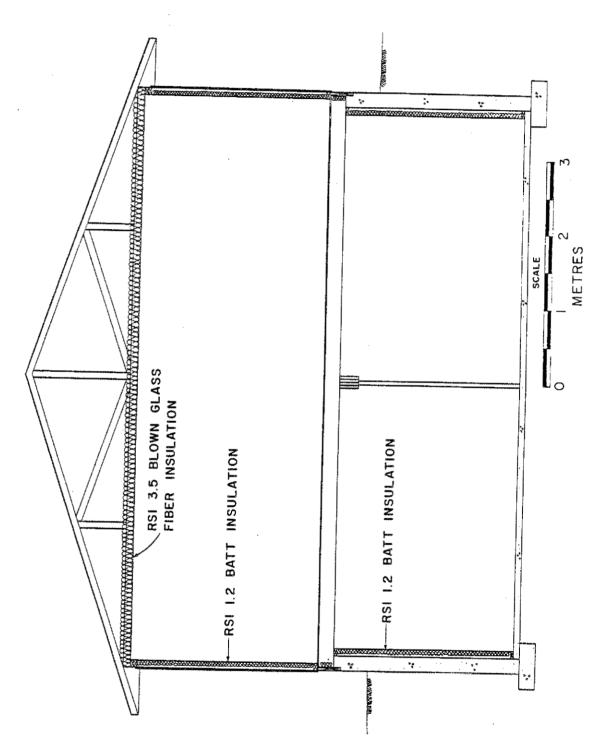
Figure 4. Section view of house--pre-retrofit

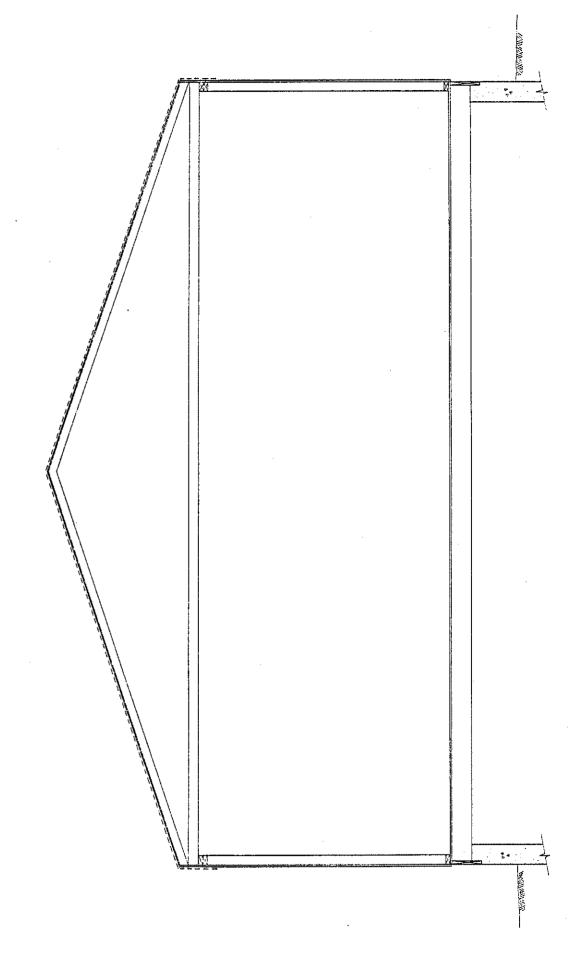
Section view of house after removal of eases Figure 5.

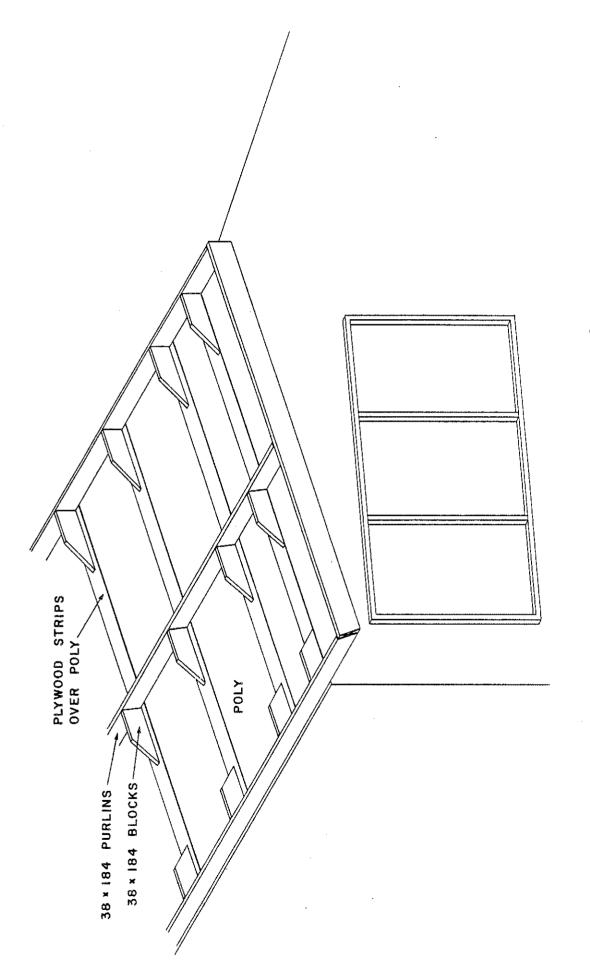
Figure 6. Placement of purlins on the roof

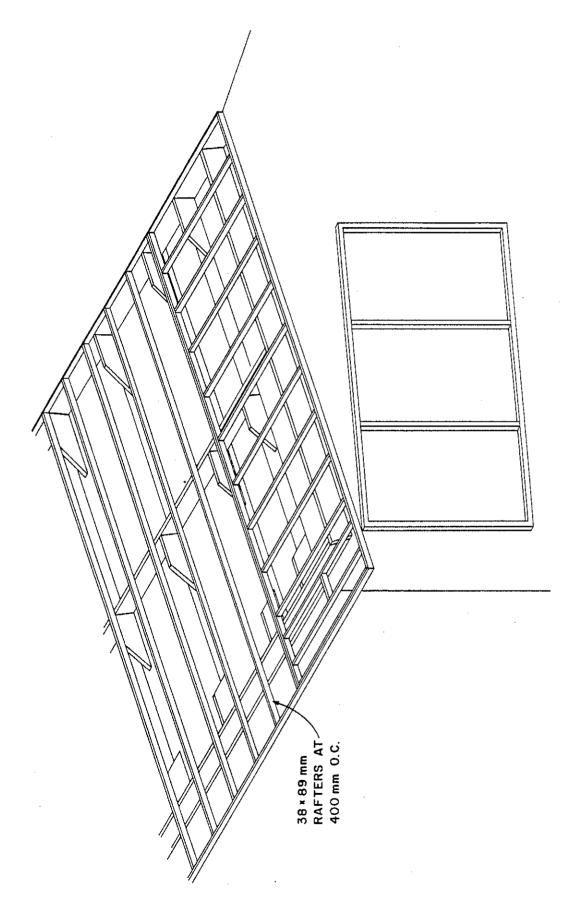
Figure 7. Placement of rafters on top of the purlins

- h. The ladders of 38  $\times$  89 mm material for the overhangs at each end of the roof were then placed.
- i. The 38  $\times$  89 mm rafters were then placed at 400 mm (16 in.) on center on top of the purlins as shown in figure 7. The spacing of the rafters was dictated by the span between the purlins. A 38  $\times$  140 mm eave board was then nailed to the end of the new rafters.

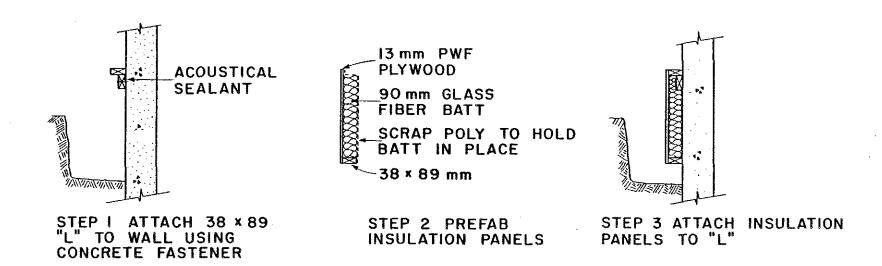
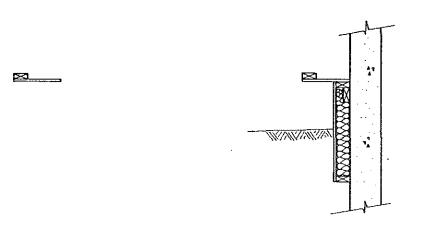
STEP 4 PREFAB PLYWOOD AND BOTTOM PLATE

STEP 5 NAIL BOTTOM PLATE PLYWOOD ASSEMBLY TO INSULATION PANEL

Figure 8. Pressure treated skirt assembly at ground level

wood were nailed together to form an "L". This "L" was attached to the concrete foundation walls in an inverted position using concrete nails inserted with a gun. Thirteen mm thick pressure treated plywood was cut into strips 600 mm wide and a 38 x 89 mm pressure treated piece was nailed to the lower edge of the plywood. Glass fiber insulation batts were fitted to each 2400 mm long panel and fastened to the foundation as shown in figure 8.

- c. 300 mm wide strips of 13 mm plywood were nailed to 38 x 89 mm pieces. The 38 x 89 mm piece was aligned and the plywood was nailed to the top of the "L" mentioned above and shown in figure 8, step 5. These horizontal pieces were blocked temporarily until the wall strapping was nailed to it.

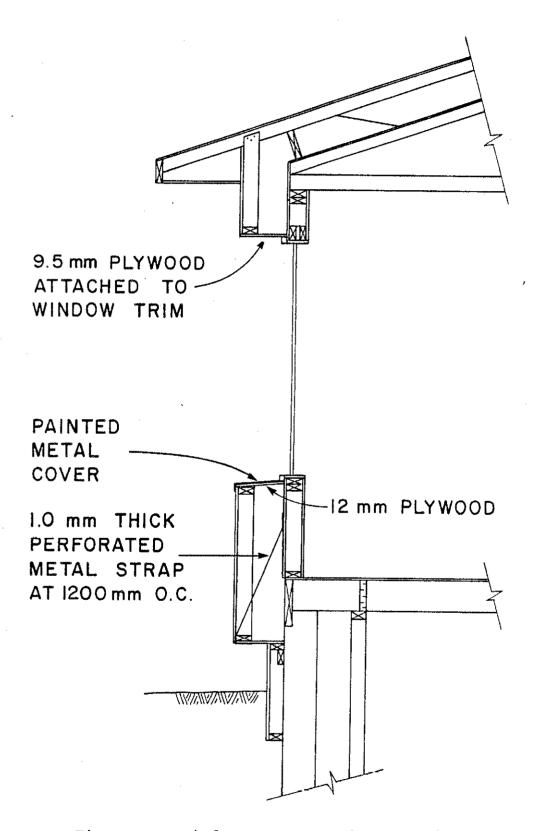
Figure 9. Window treatment for exterior wall

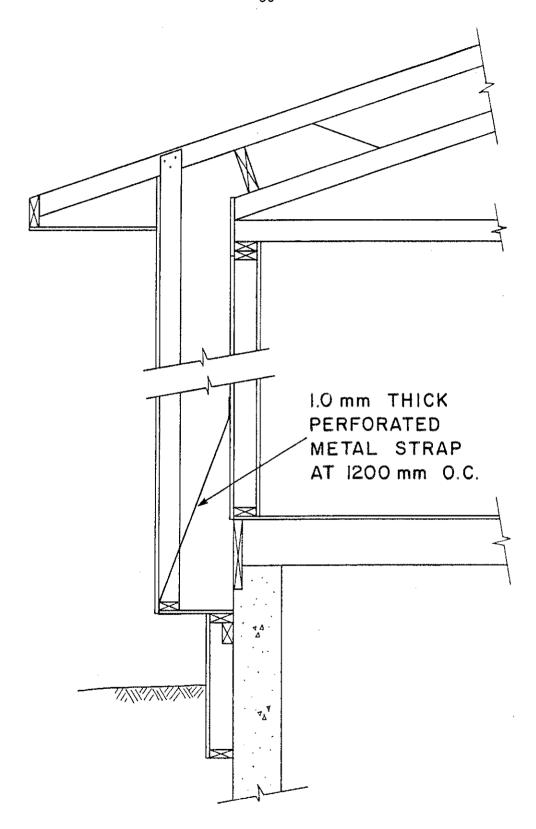
Figure 10. Attachment of second wall members to the house

- d. The wall strapping was then attached. As shown in figure 10, the 38 x 89's were stood on the 38 x 89 mm plate and were nailed into the sides of the rafters with 90 mm nails. A chalk line was snapped to the underside of the rafters to mark the correct position. The strapping was then plumbed and toenailed into the 38 x 89 mm plate. Strapping was installed along the walls until the window and door openings were reached. To provide additional support for the new outer wall, a 1.0 mm thick, 22 mm wide perforated metal strap (commonly used in plumbing applications to support piping) was then attached at 1200 mm on center as shown in figure 10. The strap was screwed first into the 38 x 89 mm bottom plate and then into the wall stud on the inner wall. The strap was then

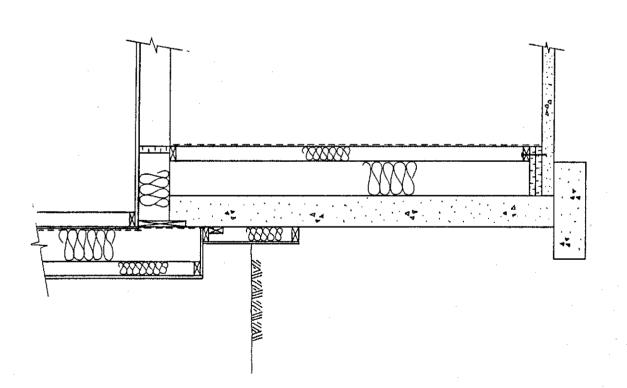
rigure 11. Basement wall interior retrofit section

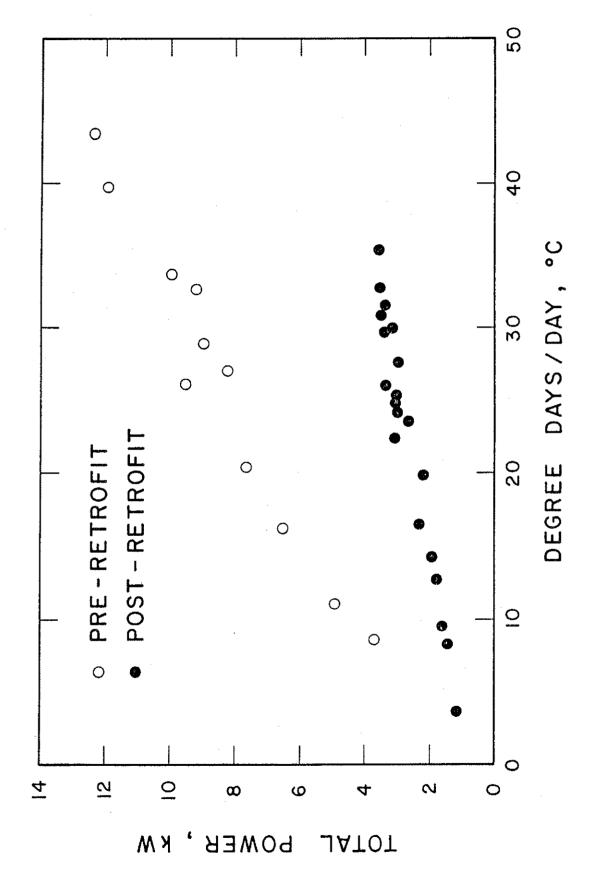
Energy consumption rate as a function of degree-days per day for pre- and post-retrofit states Figure 14.

In the pre-retrofit condition, energy consumption records of the space heating were taken over the period from January to April, 1982. A plot of the total energy consumption of the house as a function of the degree day/day values is presented in figure 14 for this period. A least squares curve fit yielded a slope of 233 W/°C and a Y-intercept of 2370 W. The heating system was a 32.2 kW input (110,000 Btu/h) natural gas atmospheric vent forced air furnace. A steady-state furnace efficiency of 78% was calculated using measurements of the furnace gas CO<sub>2</sub> and the stack temperature.

Following the retrofit, the natural gas furnace was disconnected and electric heaters used. The existing furnace fan and ductwork were kept, and continuous fan circulation used to distribute heat from the space heaters. A 2000 W space heater was placed downstairs and two-1500 W heaters upstairs. A plot of the energy consumption of the house in the post retrofit condition is shown in figure 14. The slope of the energy consumption curve is  $83.2/\text{W}^{\circ}\text{C}$ , and the Y-intercept is 869 W. At a design temperature of  $-34^{\circ}\text{C}$ , the steady-state power consumption of the house was reduced to 5.45 kW, as compared with the value of 13.1 kW for the pre-retrofit condition (assuming an efficiency of 70% for the natural gas furnace).

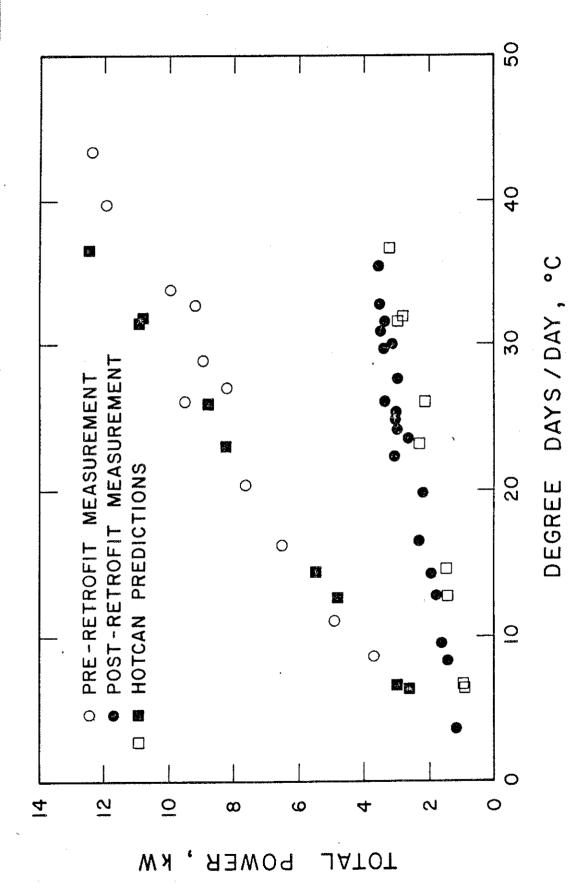
Comparison of actual and predicted energy consumption rate values for house in pre- and post-retrofit states Figure 15.

Figure 15 presents the HOTCAN predictions for the pre- and postretrofit states of the house. For the pre-retrofit comparison, a constant furnace efficiency of 70% was chosen. This efficiency of 70% is somewhat higher than the values of 55 to 65% that are often quoted as a total system efficiency for atmospheric vented natural gas furnaces. In the HOTCAN program, the house air exhausted through the chimney is treated as an explicit heat loss for the house.
