Fire safety summary: Fire research conducted for the project on midrise wood construction: report to Research Consortium for Wood and Wood-Hybrid Mid-Rise Buildings

Su, J. Z.; Lougheed, G. D.

Client Report (National Research Council of Canada. Construction), 2014-12

REPORT TO RESEARCH CONSORTIUM FOR WOOD AND WOOD-HYBRID **MID-RISE BUILDINGS**

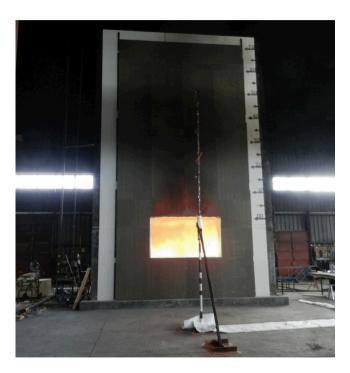
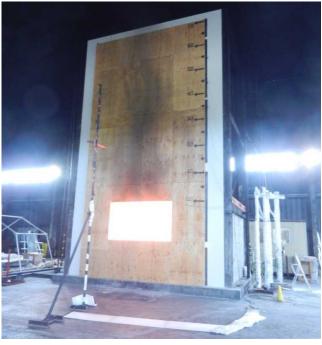
Figure 6. Tests of Exterior Wall Assemblies.

Each wall assembly was three-storey high (5.0 m width and 9.9 m height) with simulated floors between storeys. The base storey wall section included an opening (2.5 m wide and 1.45 m high) to the burn room of the test facility. The wall assembly extended 7.0 m above the opening.

The test with the rain screen assembly showed no fire spread in the rain screen cavities between the OSB sheathing and generic fibre-cement based cladding attached with plywood strapping, indicating a low fire spread potential in the rain screen cavities for assemblies with a 12.7 mm gap between the sheathing and the non-combustible cladding. The results of this test should not be used for rain screen assemblies with larger gaps between the combustible sheathing and noncombustible cladding.

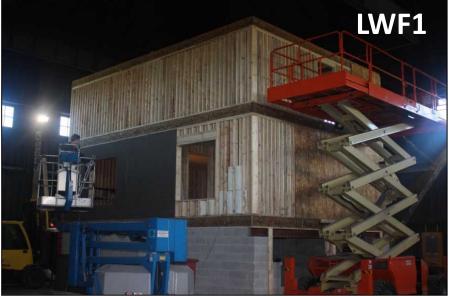
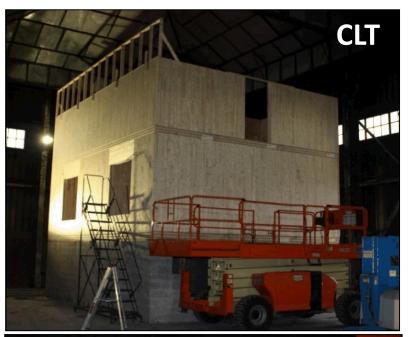
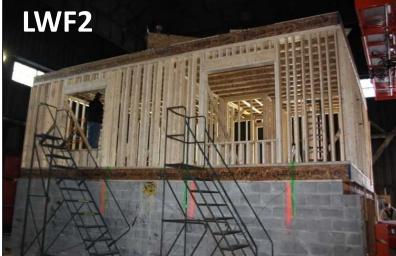
Figure 29. Large-scale apartment test structures under construction.

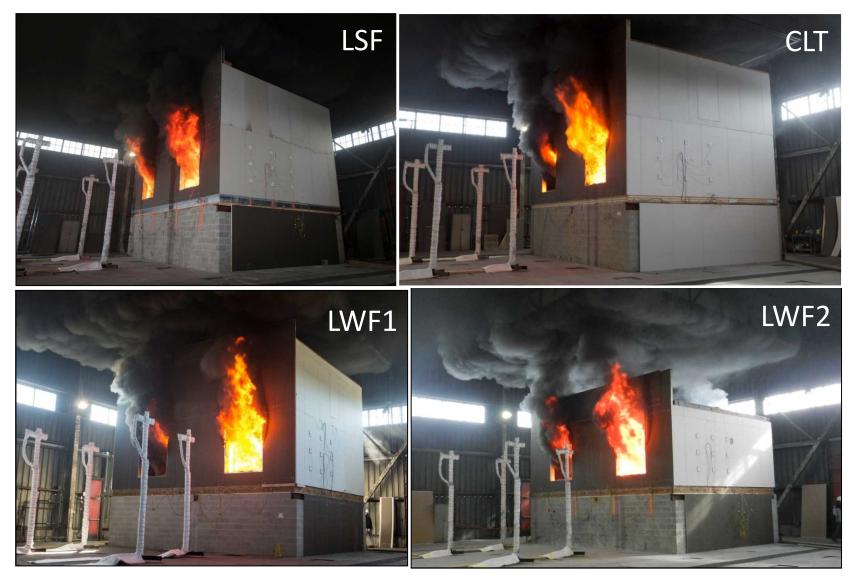
Figure 31. Flashover in both the bedroom and living room areas during large-scale apartment fire tests.

The furniture and contents as well as the hardwood flooring, the kitchen cabinets and counter tops in the fully furnished apartment produced high-intensity fast growing fires with similar initial fire development in all experiments. A smoke alarm was activated in less than 20 s. Flashover occurred in the bedroom at approximately 3 min and the door between the bedroom and the living room was fully breached at 5 min or earlier. Then the fire quickly developed in the living room area and subsequently progressed to the kitchen and entrance area. Localized flashover occurred in the living room/kitchen spaces – typically around 6 min in the living room area, and subsequently progressed to the kitchen area by 10 min and to the entry area by 19 min. Photographs taken after flashover in both the bedroom and living room area are shown in Figure 31.

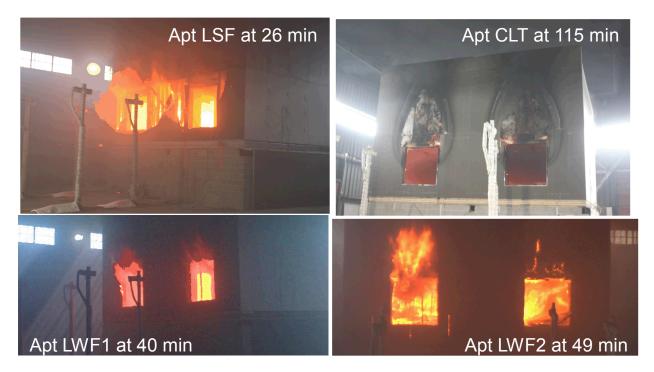
Figure 34. Ventilation conditions through the exterior openings during the large-scale apartment fire tests.
