Fire Resistance of Floor Assemblies in Multi-Family Dwellings

by *M.A. Sultan*

This Update discusses how various factors affect the fire resistance of floors in multi-family dwellings. The information is based on results from a major industry/government research project carried out by the National Research Council's Institute for Research in Construction (IRC).*

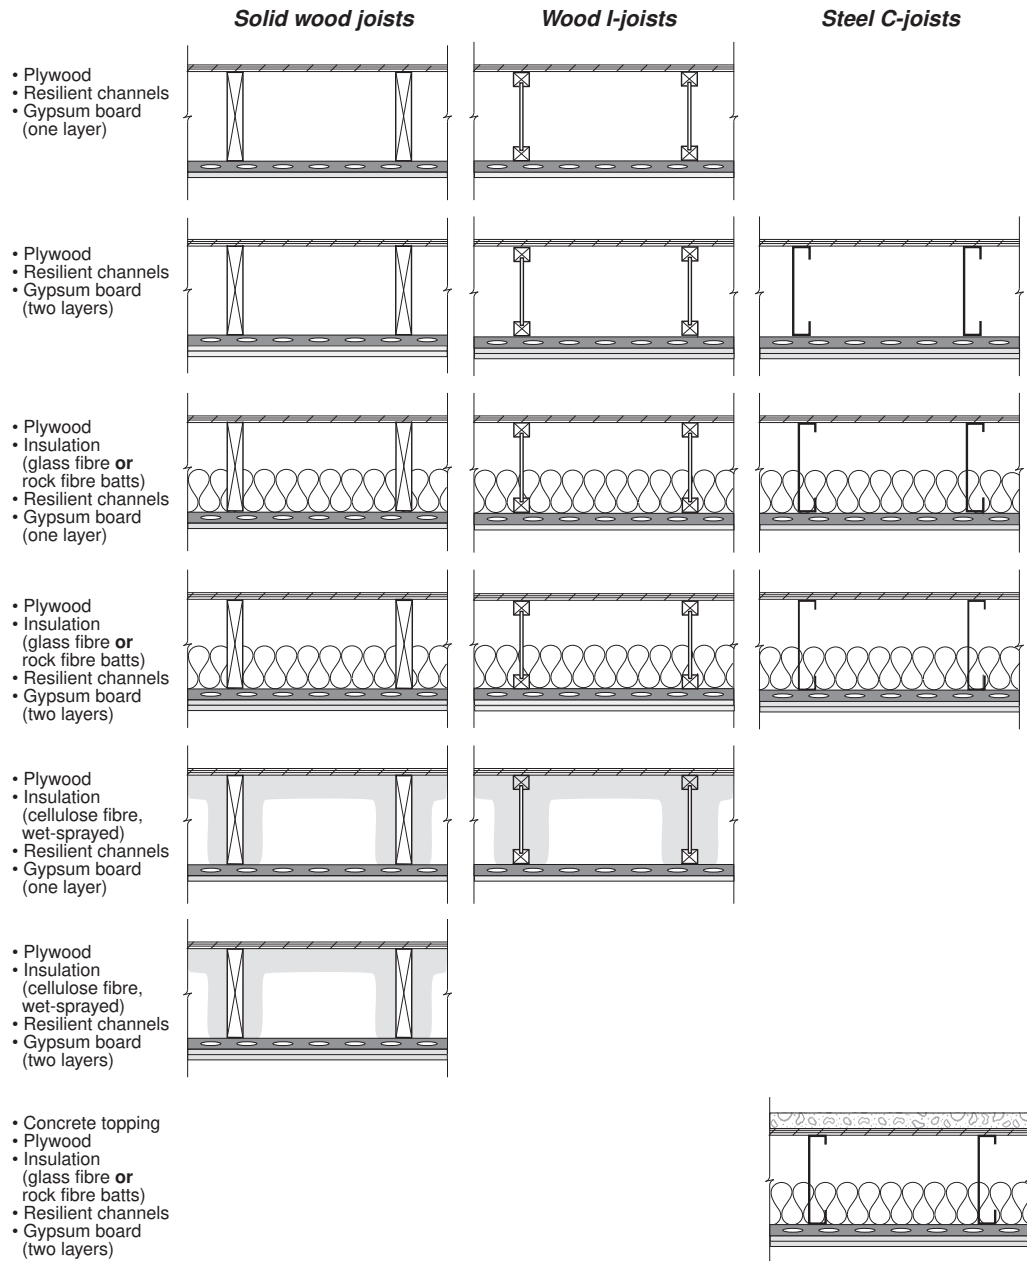
Assemblies with a double layer of gypsum board. Insulation reduced the fire resistance by 7% in the assembly with glass fibre and increased the fire resistance by 7% in the assembly with rock fibre compared to an assembly with no insulation. The glass fibre

had a negative effect on fire resistance (as was the case with the solid wood joist assembly mentioned above). The rock fibre, however, had a positive effect on fire resistance, contrary to its effect in the assembly with solid wood joists, where it had a negative effect. This difference is due to the difference in failure mechanisms: the solid wood joist assembly failed as a result of flame penetration through the subfloor while the wood I-joist assembly failed structurally as the joists, attacked by fire, were unable to carry the load. Nevertheless, assemblies with wood I-joists, a double layer of gypsum board ceiling finish and glass, rock or cellulose fibre insulation were able to provide a one-hour FRR.
