Ensuring good seismic performance with platform-frame wood housing

By J.H. Rainer and E. Karacabeyli

This Update reviews the generally good performance of platform-frame wood housing in earthquakes, presents solutions to some problems that occur in practice, and outlines new developments in technology, standards and codes.

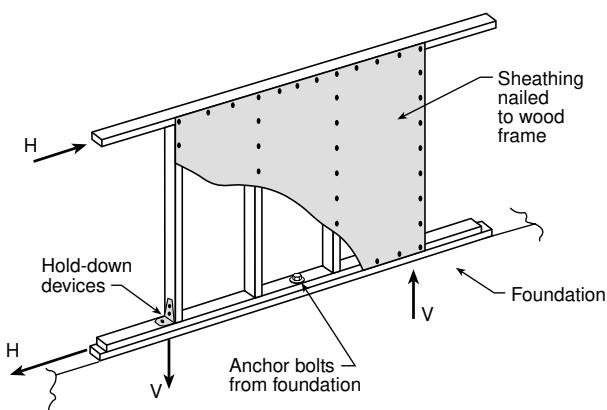
Figure 1. Simplified diagram of main seismic forces acting on a shear wall

From a seismic perspective, the key elements in this type of building are the shear walls. A shear wall is formed by the combination of the vertical studs and the top and bottom plates, with bracing on one or both sides provided by attached sheets of plywood, oriented strand board (OSB) or gypsum board. Depending on the seismic loading requirements, hold-down devices may need to be employed to prevent the wall from lifting at corners or at wall openings (see Figure 1).

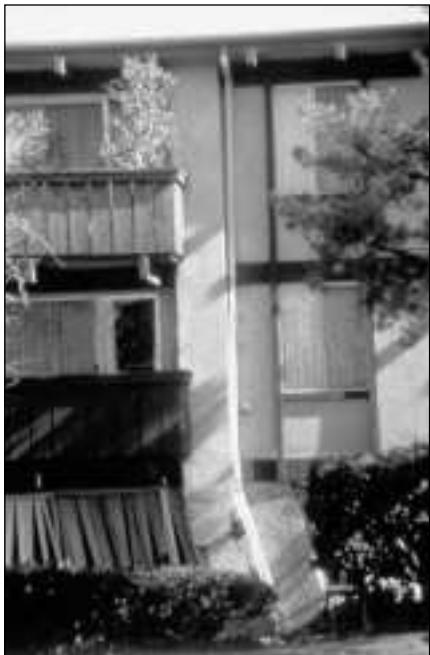
Figure 2. Excessive deformation of a weak first storey in an apartment building, Northridge earthquake 1994. In another part of the building the ground floor collapsed completely.

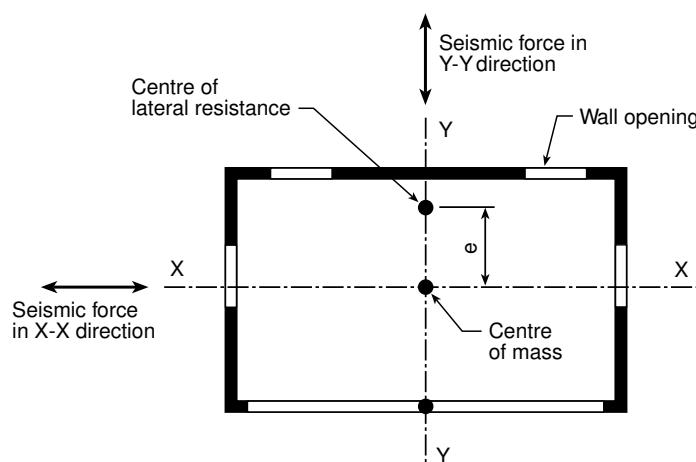
Figure 3. Schematic of an unsymmetrical building layout. Seismic forces in X-X direction cause twisting action in horizontal plane due to eccentricity “e,” the distance between the centre of storey mass and the centre of storey shear wall resistance.

Large openings in the shear walls — such as windows, doors and garage doors — can leave too little wall area. Because the shear wall is so important in resisting seismic shaking, this lack of wall resistance capacity leads to large distortions and eventual collapse, particularly serious in multi-storey buildings (see Figure 2). Large wall openings can also result in an unsymmetrical building layout, which induces additional seismic torsional or twisting forces in the building, aggravating the weak-storey effect (see Figure 3). To compensate for large openings, additional structural resistance may be needed.
