Performance of Protected Ceiling/Floor Assemblies and Impact on Tenability with a Basement Fire Scenario

Research Report (National Research Council Canada. Institute for Research in Construction); no. RR-307, 2011-05-13

IRC-RR-307

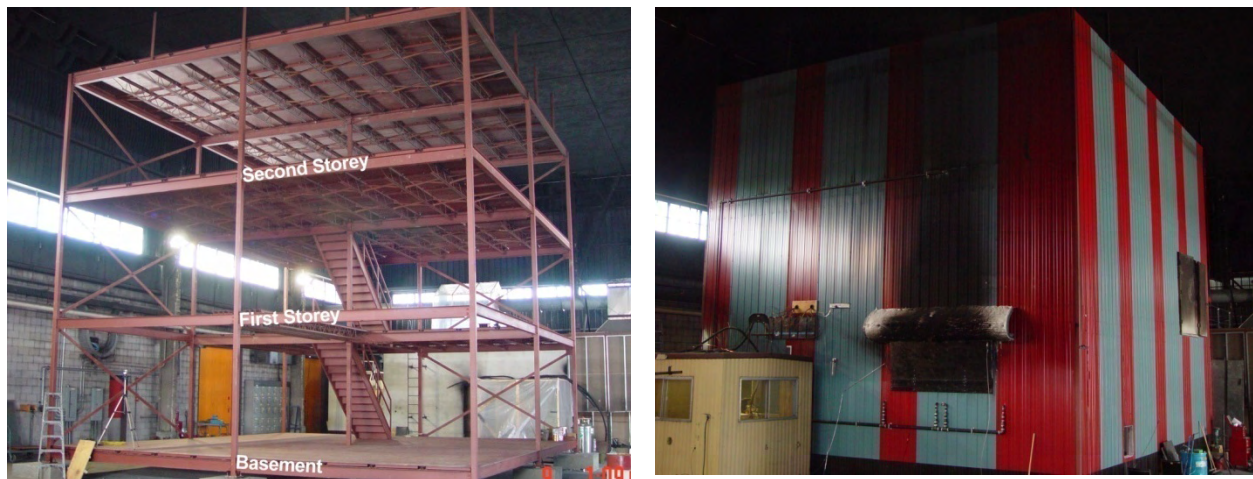
Figure 1. The test facility

The experimental facility used represented a typical two-storey detached single-family house with a basement. Figure 1 and Figure 2 show an elevation view and a plan view, respectively, of the facility with basement, first storey and second storey. Each storey had a floor area of

95 m² and a ceiling height of 2.4 m. There was no heating, ventilating and air-conditioning or plumbing system installed in the test house, i.e., no associated mechanical openings.

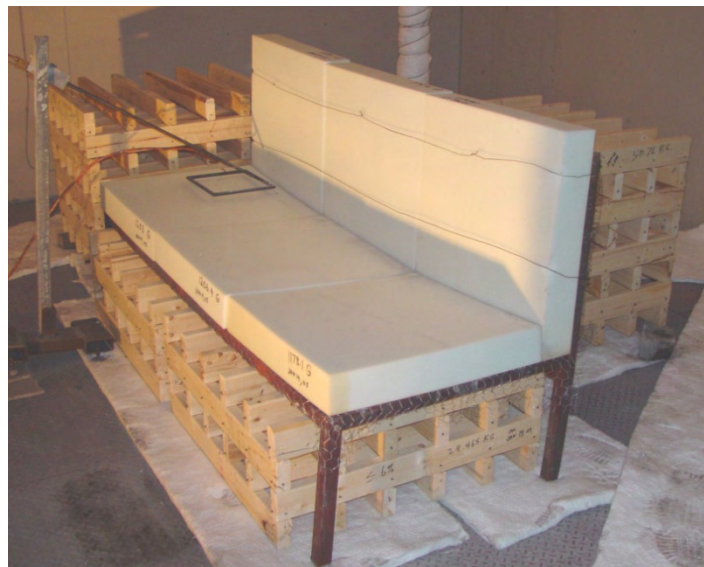
Figure 3. Fuel package

A simple and repeatable fuel package, which had been developed for Phase 1 of the FPH research [10, 11], was used in the full-scale experiments. This fuel package consisted of a mock-up sofa constructed with 9 kg of exposed polyurethane foam (PUF), the dominant combustible constituent of upholstered furniture, and 190 kg of wood cribs beside and underneath the mock-up sofa. A photograph of the fuel package is shown in Figure 3.

The mock-up sofa was constructed with 6 blocks of flexible polyurethane foam (with a density of 32.8 kg/m^3) placed on a metal frame. Each block was 610 mm long x 610 mm wide and 100 mm or 150 mm thick. The 150-mm-thick foam blocks were used for the backrest and the 100-mm-thick foam blocks for the seat cushion. The PUF was used without any upholstery fabric that is used in typical upholstered furniture.

The wood cribs were made with spruce lumber pieces, each piece measuring 38 mm x 89 mm x 800 mm. For the small cribs located under the mock-up sofa, four layers with six pieces per layer were used. The other two cribs used eight layers.

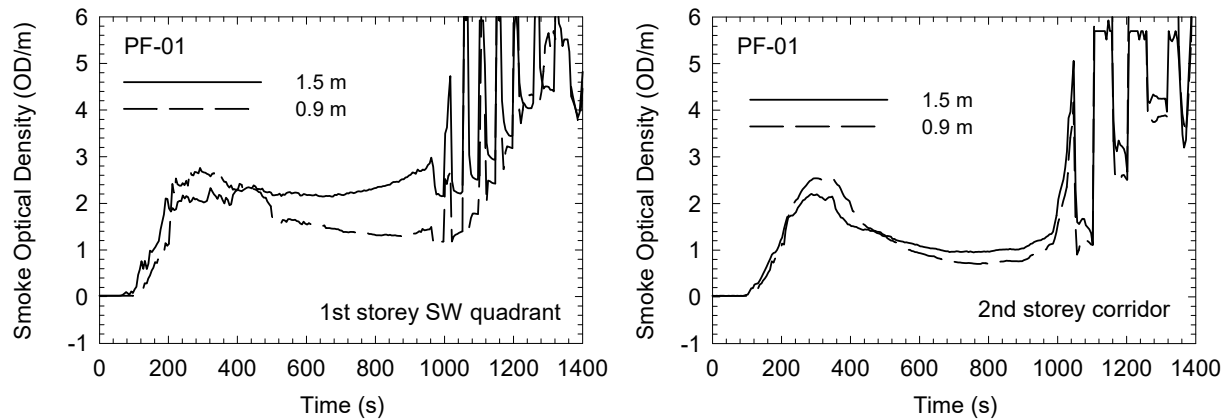
Figure 15. Smoke optical density measurements in Test PF-01

The optical density was measured at 0.9 and 1.5 m heights (simulating the height of the nose/mouth of an average height individual crawling and standing, respectively) above the floor on the first and second storeys. Table 4 shows the times to reach $OD = 2 \text{ m}^{-1}$. Figure 15 shows the optical density-time profiles. It must be pointed out that the video records show no signs of decrease in the optical density after the first peak, indicating that the smoke density meters started the self purging cycle. The smoke density meter has an operation temperature limit of 80°C in its gas chamber; when this temperature is reached, the flow is reversed to cool the chamber to protect the electronic components. The smoke meter resumes operation once the gas chamber is cooled down below 80°C . In this experiment, only the initial part of the curves (up to the first peaks) represents valid measurements.

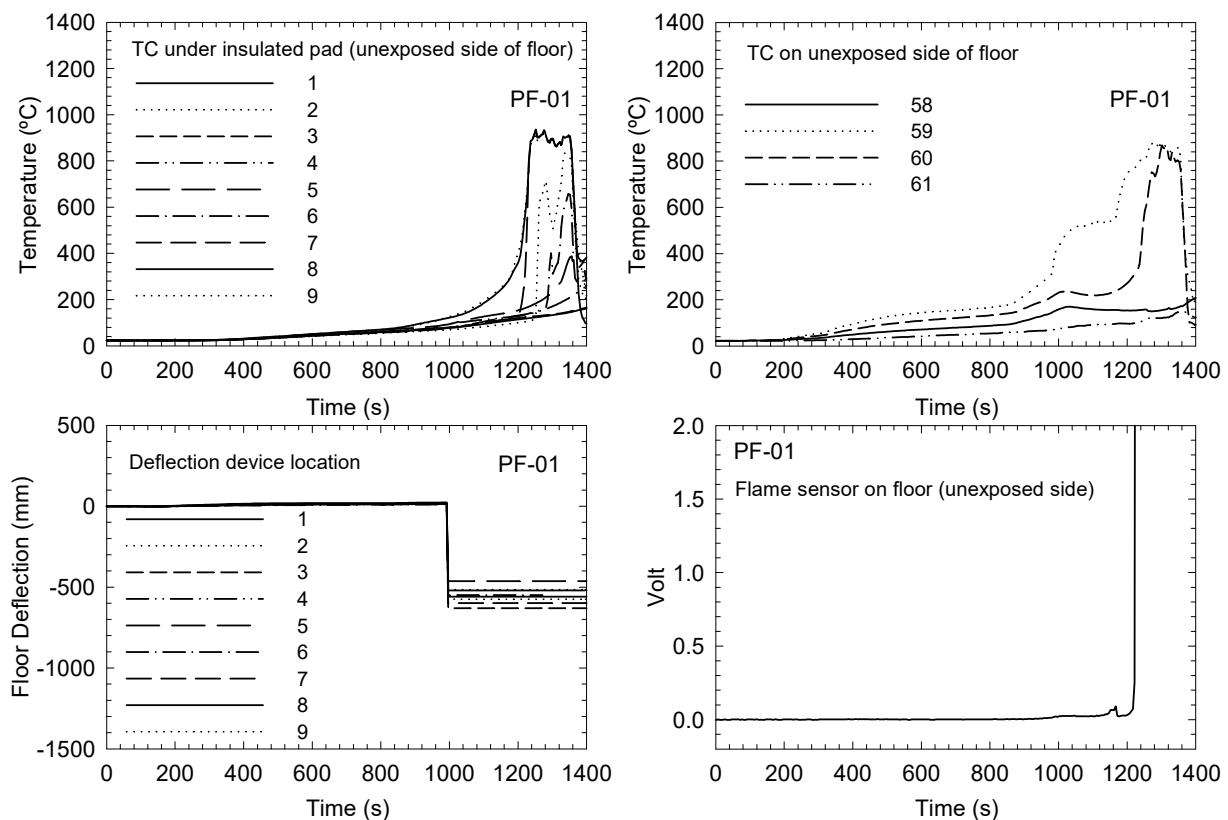
Figure 20. Temperatures, deflections and flame sensor on the unexposed side of the assembly on the first storey in Test PF-01

Figure 20 shows results of the measurements using thermocouples, flame-sensing devices and deflection devices on the unexposed side the test assembly on the first storey.

The flame-sensing device [19] at the central tongue-and-groove joint on the unexposed side of the OSB subfloor provided detection of flame penetration through the test assembly. Figure 20 shows a noticeable voltage signal after 1000 s and a large voltage spike after 1230 s, indicating that the device was detecting flames that had penetrated the test assembly. Flame penetration of the test assembly is also a failure criterion in standard fire-resistance testing [29].

Although the failure time of the test assembly could be slightly different using other criterion, visual observation through the window opening of the fire room confirmed that structural failure occurred at 1320 s. After this time, the test assembly lost function as an egress route. The fire consumed the OSB subfloor in many areas, particularly in areas directly above the fuel package. Several concrete blocks, which were used to apply loading to the test assembly, fell through the subfloor. There was a partial collapse of the test assembly with one floor joist consumed by the fire. Most other solid-sawn wood joists although significantly charred, deflected but did not collapse.

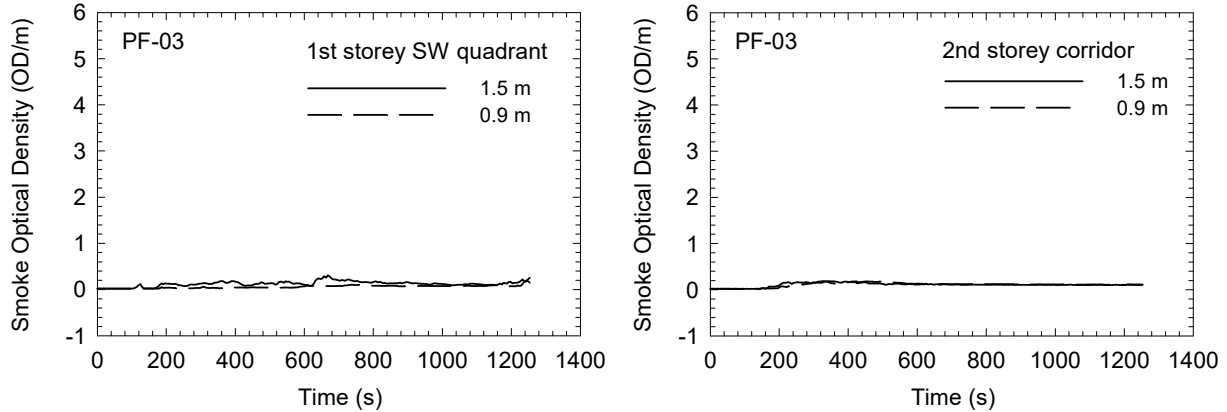
Figure 66. Smoke optical density measurements in Test PF-03

The optical density was measured at 0.9 and 1.5 m heights (simulating the height of the nose/mouth of an average height individual crawling and standing, respectively) above the floor on the first and second storeys. Figure 66 shows the optical density-time profiles; OD remained under 0.2 m^{-1} throughout the upper storeys during the experiment. At this smoke level, a normal person should still be able to see the surroundings.

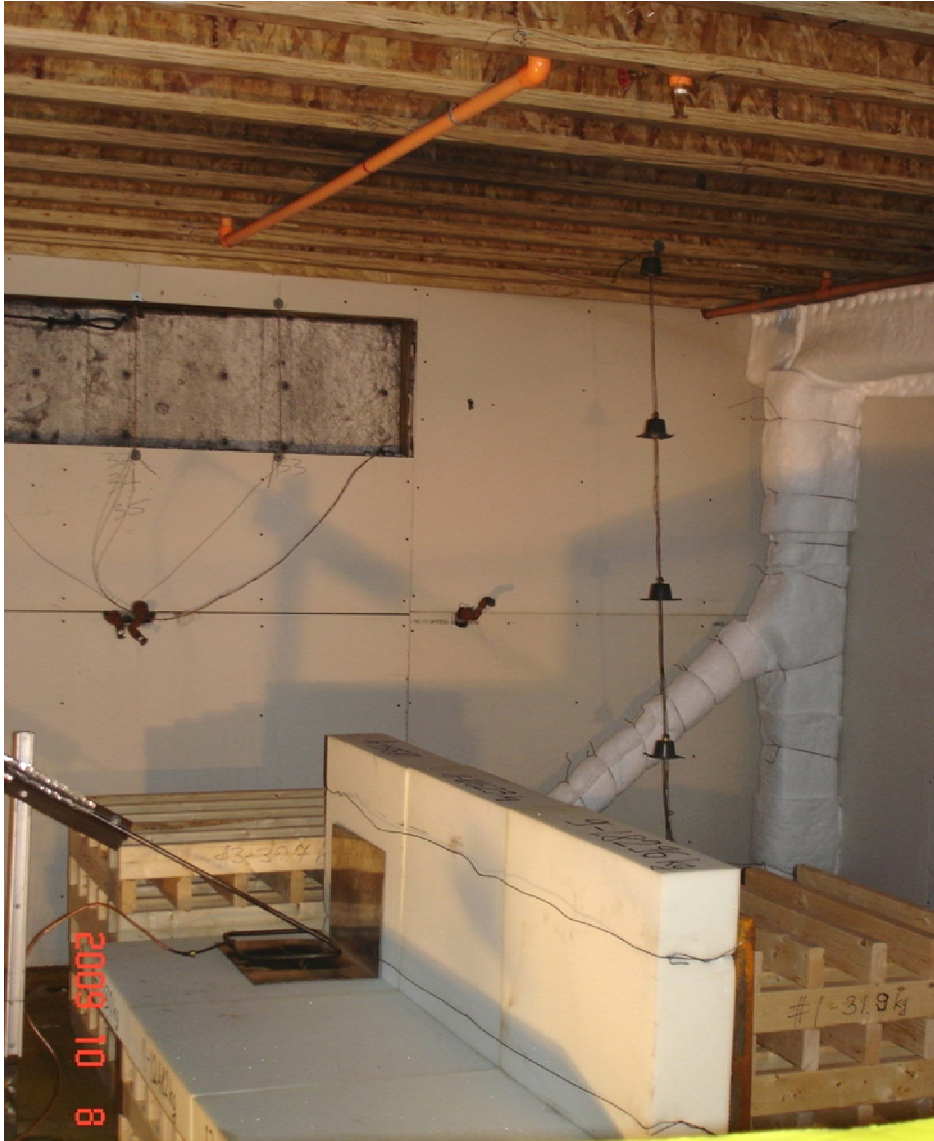
Figure 73. Sprinkler and CPVC piping relative to exposed wood I-joists and fuel (Test PF-03B)

A Reliable F1 Residential 49[†] pendent sprinkler, which had a K factor of 4.9 and a temperature rating of 68°C (155°F), was located 3.05 m (10 ft) from both the south and east walls of the fire room. Figure 72 and Figure 73 show the sprinkler location relative to the wood I-joists and fuel package in the experiment. The deflector of the sprinkler was approximately 25.4 mm (1”) below the bottom of the wood I-joists and 330 mm (13”) below the subfloor. The sprinkler and CPVC plastic piping (25.4 mm in diameter) were installed per NFPA 13D and APA Technical Note J745 [31, 32]. It should be noted that a portion of the CPVC piping ran right above the fuel package.

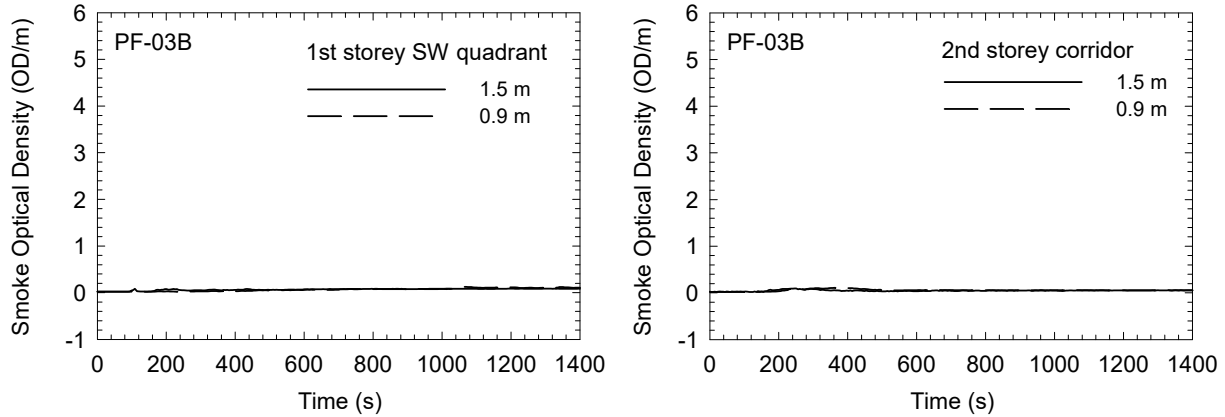
Figure 76. Smoke optical density measurements in Test PF-03B

The optical density was measured at 0.9 and 1.5 m heights (simulating the height of the nose/mouth of an average height individual crawling and standing, respectively) above the floor on the first and second storeys. Figure 76 shows the optical density-time profiles; OD remained under 0.15 m^{-1} throughout the upper storeys during the experiment. At this smoke level, a normal person should still be able to see the surroundings.

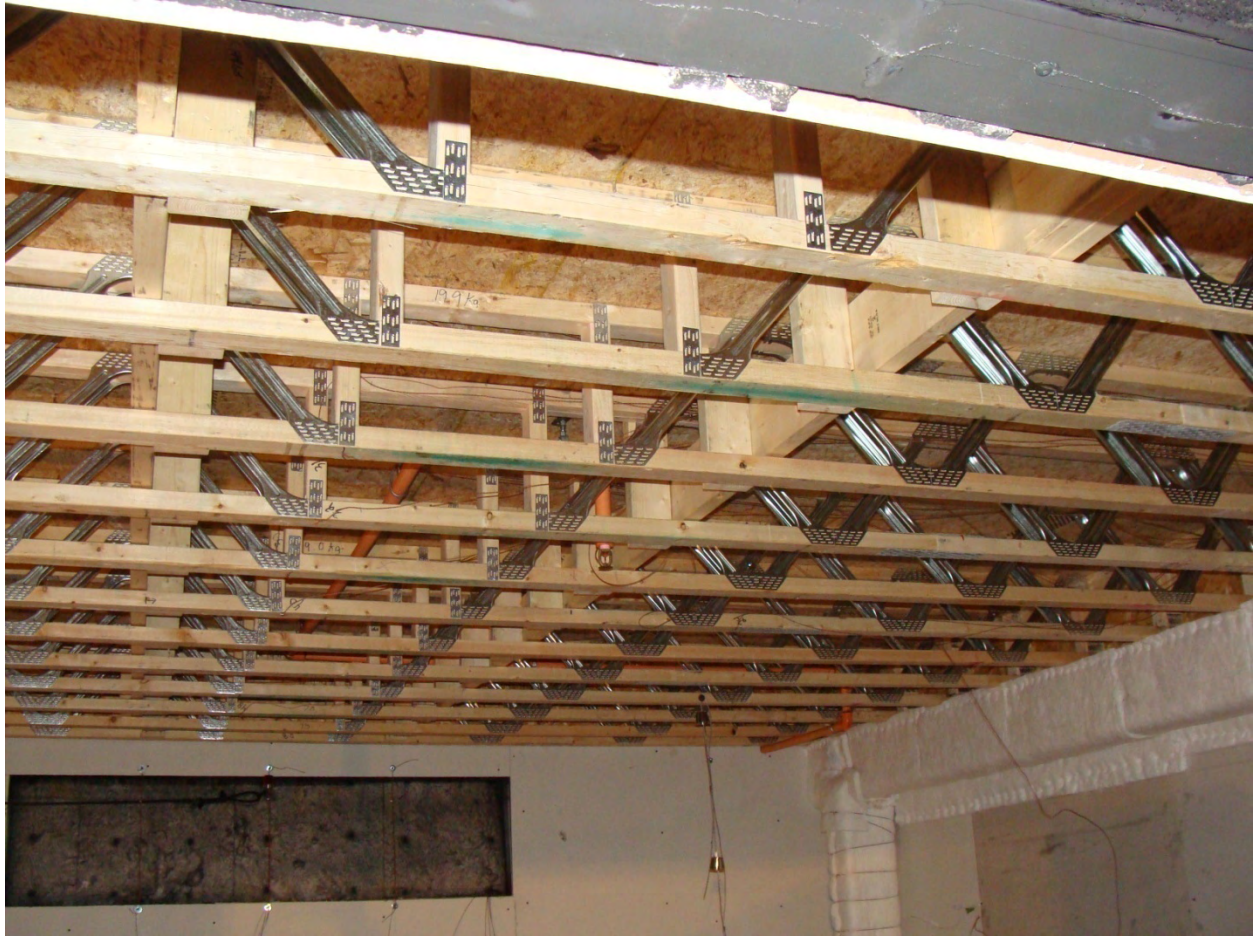
Figure 83. Metal-web wood truss assembly and sprinkler in Test PF-06

The overall dimensions of the metal-web wood truss assembly were 5079 mm x 5150 mm. The assembly had no finished ceiling in the basement – the trusses were exposed in the fire room. Figure 82 and Figure 83 show the test assembly, along with sprinkler and fuel package. The metal-web wood trusses were 302 mm deep, with top and bottom chords of dimensions of 38 mm x 64 mm. The metal webs (20 gauge) had teeth 9.5 mm long and had 0.0171 teeth per square millimeter. The trusses were spaced at 400 mm on centre. The bottom chords of the trusses were reinforced with two strongbacks 38 mm x 140 mm located toward the centre of the span. Based on calculations of maximum strength and deflection, the truss span length chosen was 4.813 m. This span allowed the metal-web wood trusses to extend across the entire length of the fire room (with no need for an intermediate support). Rim boards (headers) 9.5 mm thick x 302 mm deep, were placed around the assembly. In addition, a solid wood 38 mm x 89 mm x 5150 mm member as part of the header was added at the top ends of the trusses to provide lateral support.
