Performance of Protected Ceiling/Floor Assemblies and Impact on Tenability with a Basement Fire Scenario

IRC-RR-307

May 2011

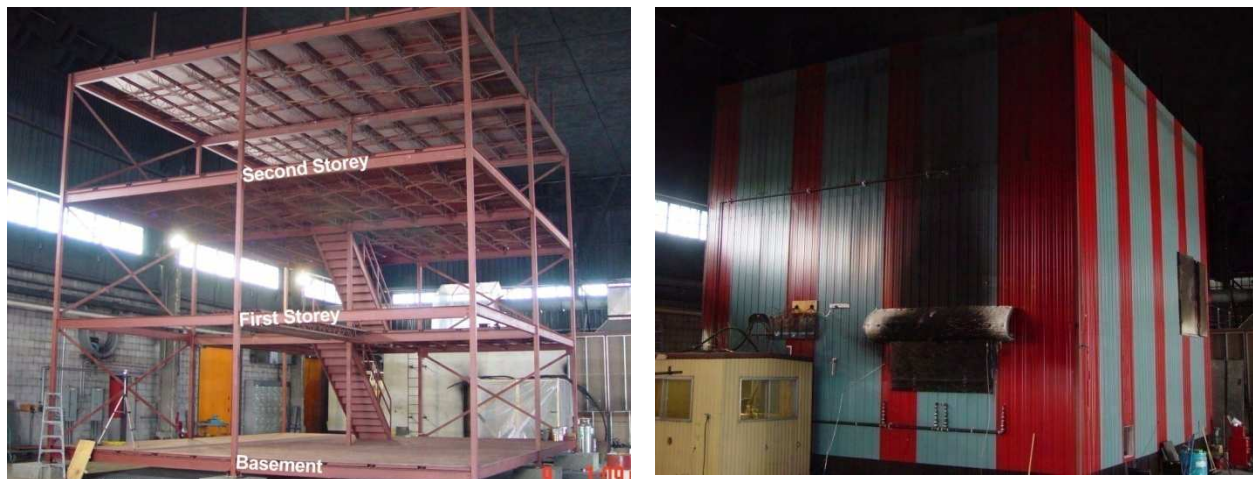
Figure 1. The test facility

The experimental facility used represented a typical two-storey detached single-family house with a basement. Figure 1 and Figure 2 show an elevation view and a plan view, respectively, of the facility with basement, first storey and second storey. Each storey had a floor area of

95 m² and a ceiling height of 2.4 m. There was no heating, ventilating and air-conditioning or plumbing system installed in the test house, i.e., no associated mechanical openings.

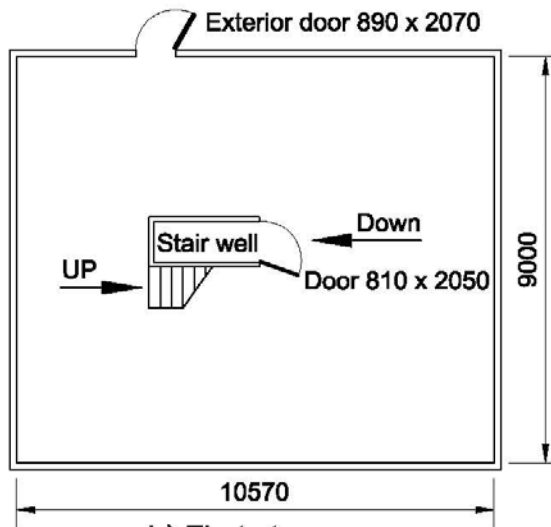
Figure 2. Facility plan view (all dimensions in mm)

A 0.91-m-wide x 2.05-m-high doorway opening located on the north wall of the fire room led into an empty stairwell enclosure (without a staircase). At the top of this stairwell, a 0.81-m-wide x 2.05-m-high doorway led into the first storey. This doorway leading to the first storey either had a door in the closed position (closed basement doorway) or had no door (open basement doorway), depending on the scenario being studied. There is no requirement for a basement door in the National Building Code of Canada (NBCC) [9].

The first storey had an open-plan layout. A test ceiling/floor assembly was constructed directly above the fire room for each experiment (more details are provided in Sections 4.2 - 4.9). The remainder of the floor on the first storey was constructed out of noncombustible materials. A 0.89-m-wide x 2.07-m-high doorway led to the exterior. The staircase to the second storey was not enclosed. There were no window openings on the first storey.

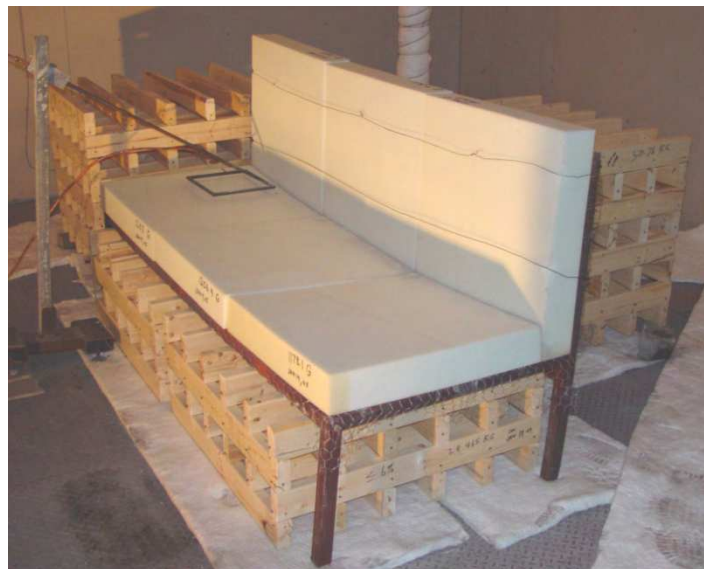
Figure 3. Fuel package

A simple and repeatable fuel package, which had been developed for Phase 1 of the FPH research [10, 11], was used in the full-scale experiments. This fuel package consisted of a mock-up sofa constructed with 9 kg of exposed polyurethane foam (PUF), the dominant combustible constituent of upholstered furniture, and 190 kg of wood cribs beside and underneath the mock-up sofa. A photograph of the fuel package is shown in Figure 3.

The mock-up sofa was constructed with 6 blocks of flexible polyurethane foam (with a density of 32.8 kg/m^3) placed on a metal frame. Each block was 610 mm long x 610 mm wide and 100 mm or 150 mm thick. The 150-mm-thick foam blocks were used for the backrest and the 100-mm-thick foam blocks for the seat cushion. The PUF was used without any upholstery fabric that is used in typical upholstered furniture.

The wood cribs were made with spruce lumber pieces, each piece measuring 38 mm x 89 mm x 800 mm. For the small cribs located under the mock-up sofa, four layers with six pieces per layer were used. The other two cribs used eight layers.

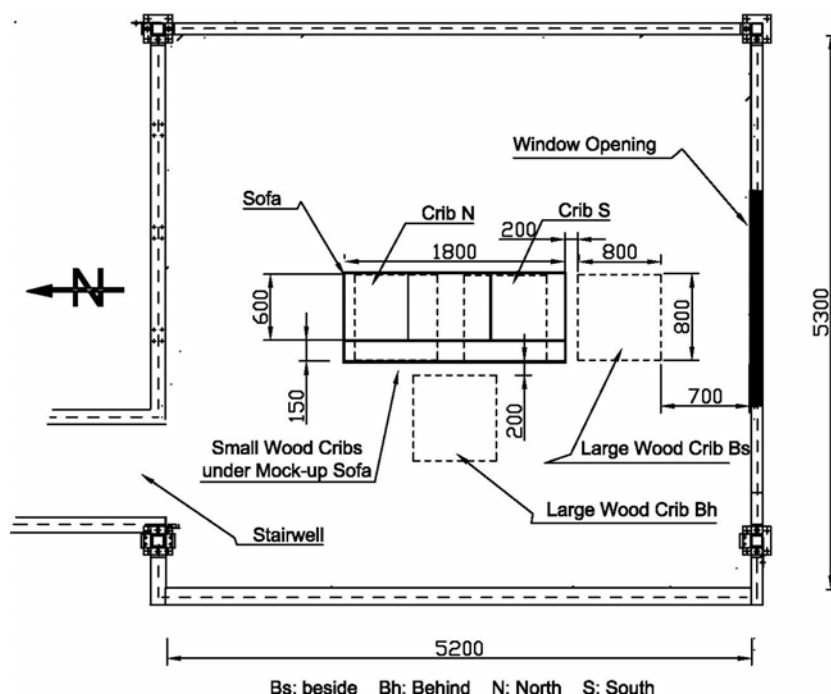
Figure 4. Layout of the fuel package (all dimensions in mm)

The placement of the fuel package in the basement fire room is illustrated in Figure 4. The fuel quantity used in each experiment is listed in Table 1. The mock-up sofa was located at the center of the floor area. The mock-up sofa was ignited in accordance with the ASTM 1537 test protocol [12] and the wood cribs provided the remaining fire load to sustain the fire for the desired period of time. This fuel package provided a relatively-severe, fast-growing basement fire with a very reproducible fire exposure [10, 11, 13].

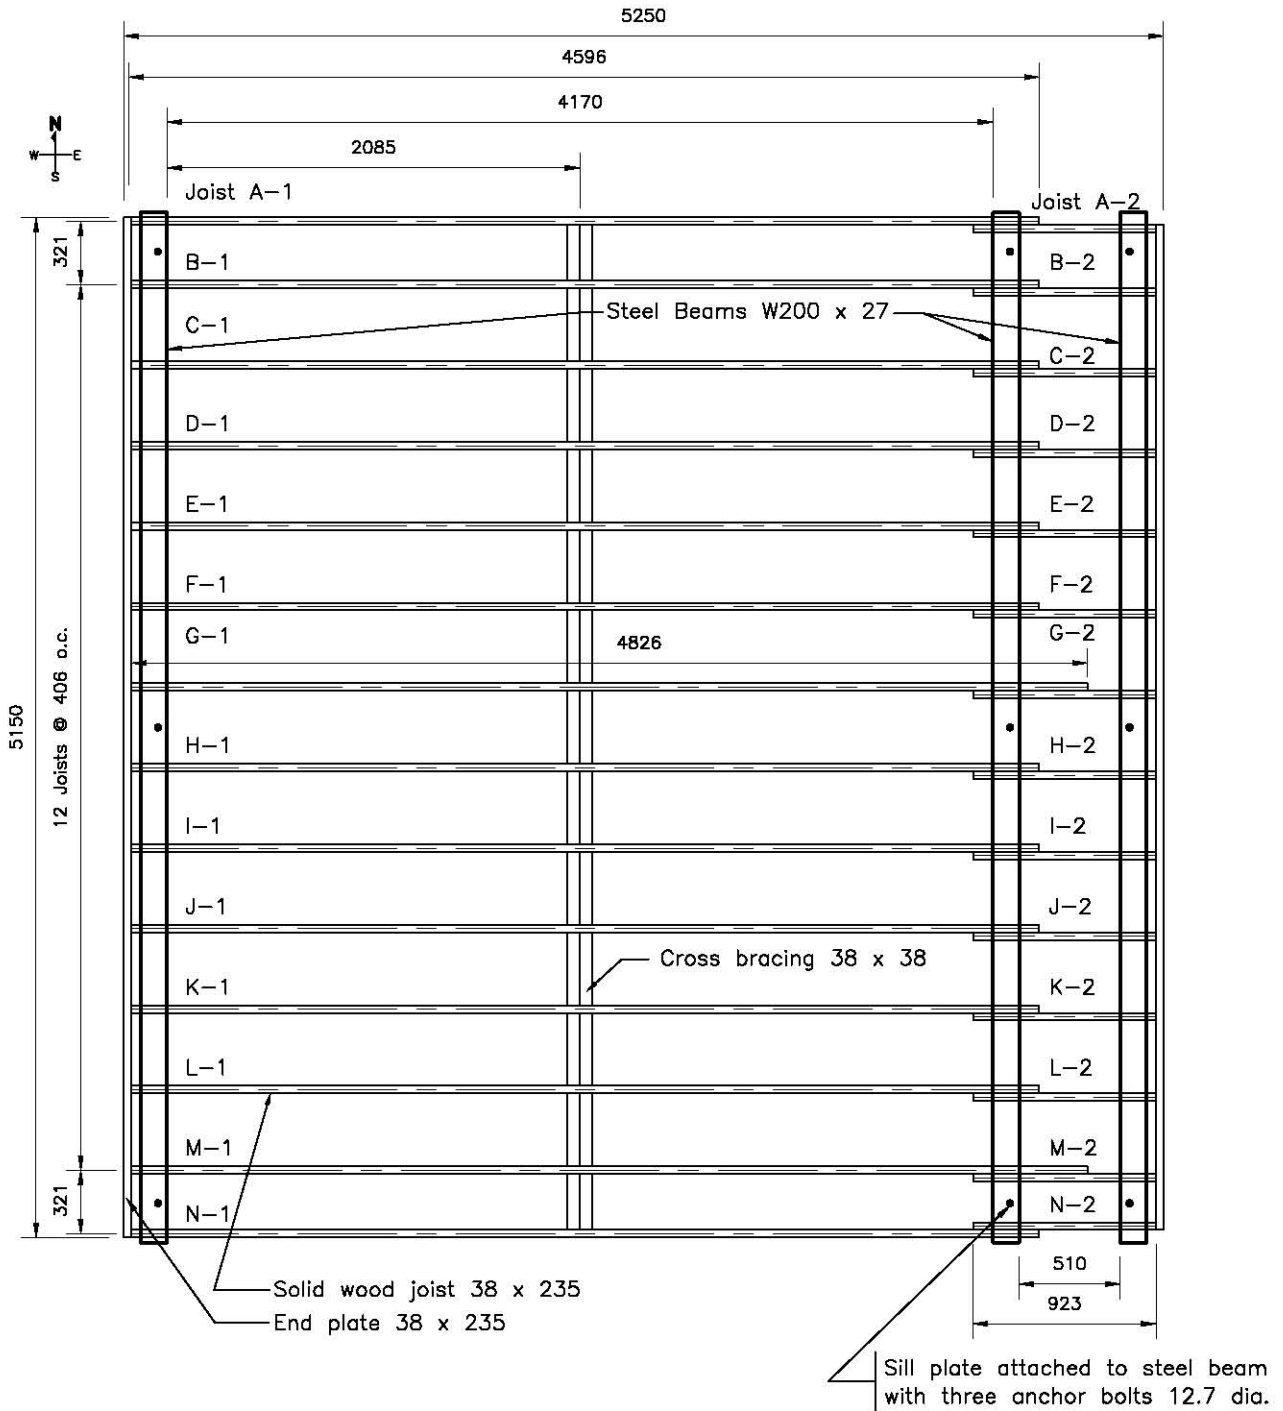
Figure 5. Solid-sawn wood joist layout details (PF-01) (all dimensions in mm)

The overall dimensions of the solid-sawn wood joist assembly were 5250 mm x 5150 mm. Specific dimensions of the components of the assembly are provided in Figure 5 to Figure 10.

The solid-sawn wood joists were manufactured using spruce-pine-fir (SPF) lumber bearing a grade-stamp 'No.2 and better'. The structural members were 235 mm deep x 38 mm wide (nominal 2" x 10"), and were spaced at 400 mm on centre (Figure 5). The joist span length was 4.17 m (Figure 5) based on the span tables of the NBCC [9]. This corresponds to the maximum span allowed for wood floor joists of SPF lumber graded as 'No.2 and better', and constructed with cross-bridging mid-span and the joists spaced at 400 mm o.c. Since the maximum span allowed for the solid-sawn wood joists was shorter than the length of the fire room, a beam was used as an intermediate support at the end of the 4.17-m span and a set of shorter joists were used to increase the span of the floor to extend to the end of the fire room.

Rim boards (headers) made of solid lumber that were 38 mm thick x 235 mm deep, were placed at the east and west sides of the test assemblies as shown in Figure 5. One row of diagonal wood cross-bracing, 38 mm thick x 38 mm wide, was placed at the centre of the longer span of the assembly between the joists. Details of the cross-bracing and its location within the joist layout for the above-mentioned assembly are shown in Figure 5 and Figure 6.

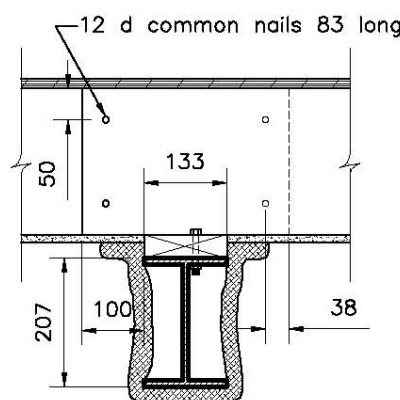
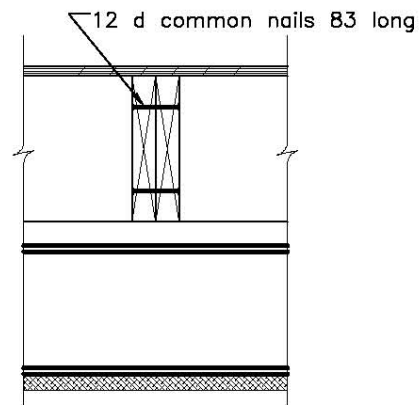
Figure 6. Details of end connection, supports, cross-bracing and joist overlap (PF-01) (all dimensions in mm)

Figure 6 shows the details of the joint overlap and the supporting steel beams, as well as the end connection. Ceramic fibre blankets were used to fill any gaps between the assembly and the end walls. Ceramic fibre blankets were also used to protect the steel beams and columns so that they were not subjected to fire and would not fail during the test.

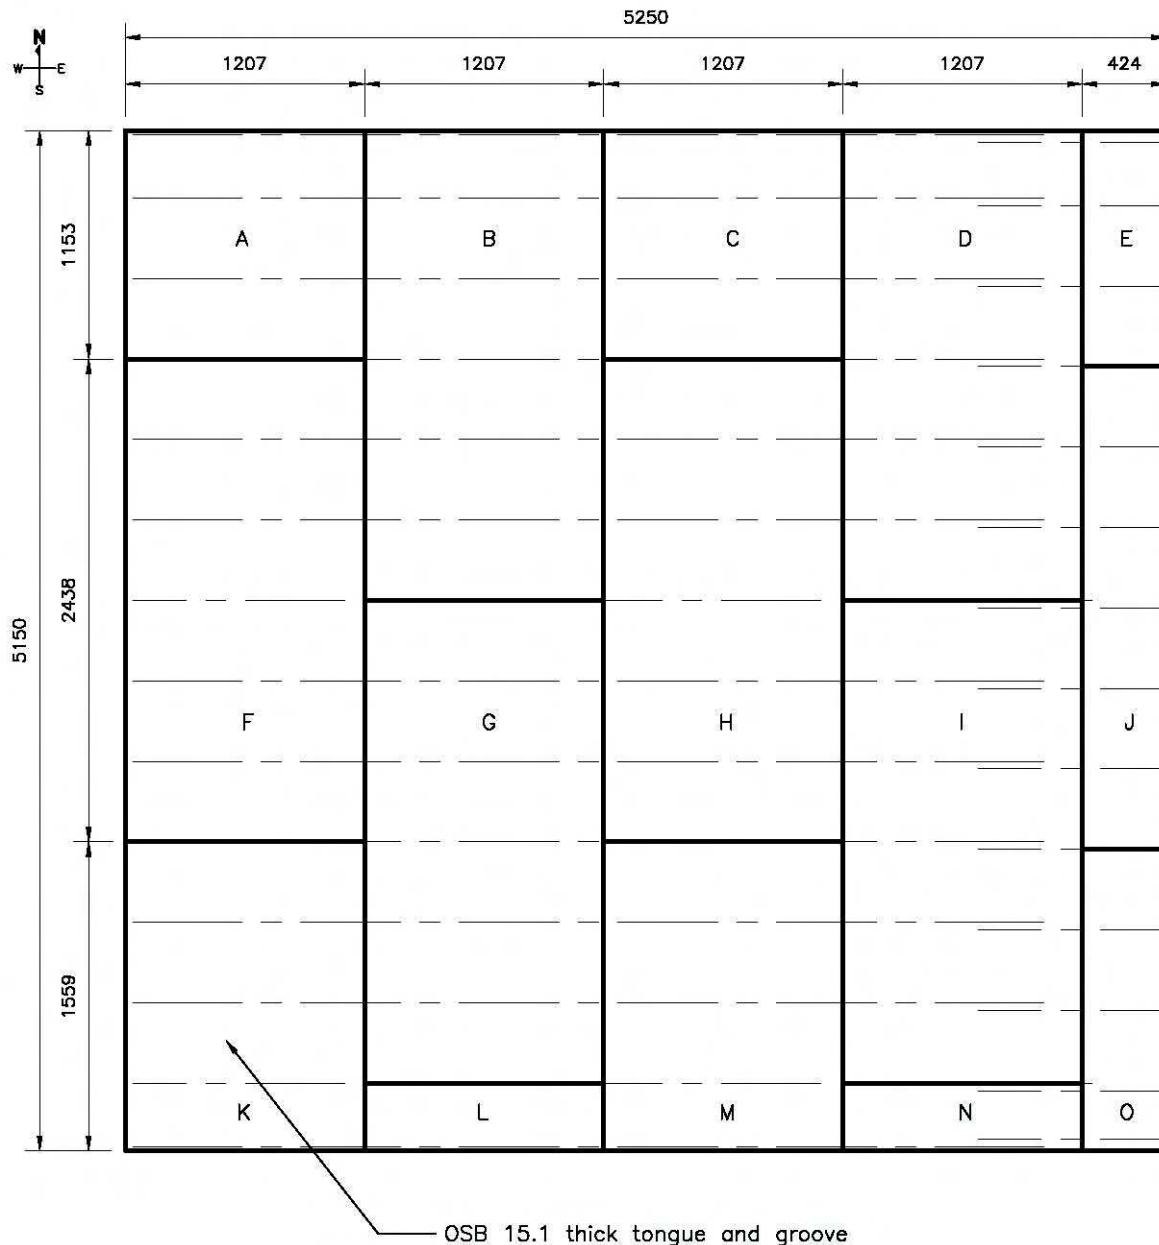
Figure 7. OSB subfloor layout (PF-01, PF-03, PF-03B, PF-04 and PF-05) (all dimensions in mm)

OSB was used as the subfloor material in the test assembly. The specific OSB material used was selected based on a separate study documented in reference [28]. The subfloor panels were 15.1 mm thick, with a full panel size of 1.2 x 2.4 m. The longer panel edges had a tongue-and-groove profile while the short panel edges were square butt ends. Figure 7 shows the layout of the subfloor. The nailing pattern and description of nails used to attach the OSB panels to the solid-sawn wood joists and rim board (header) are shown in Figure 8.

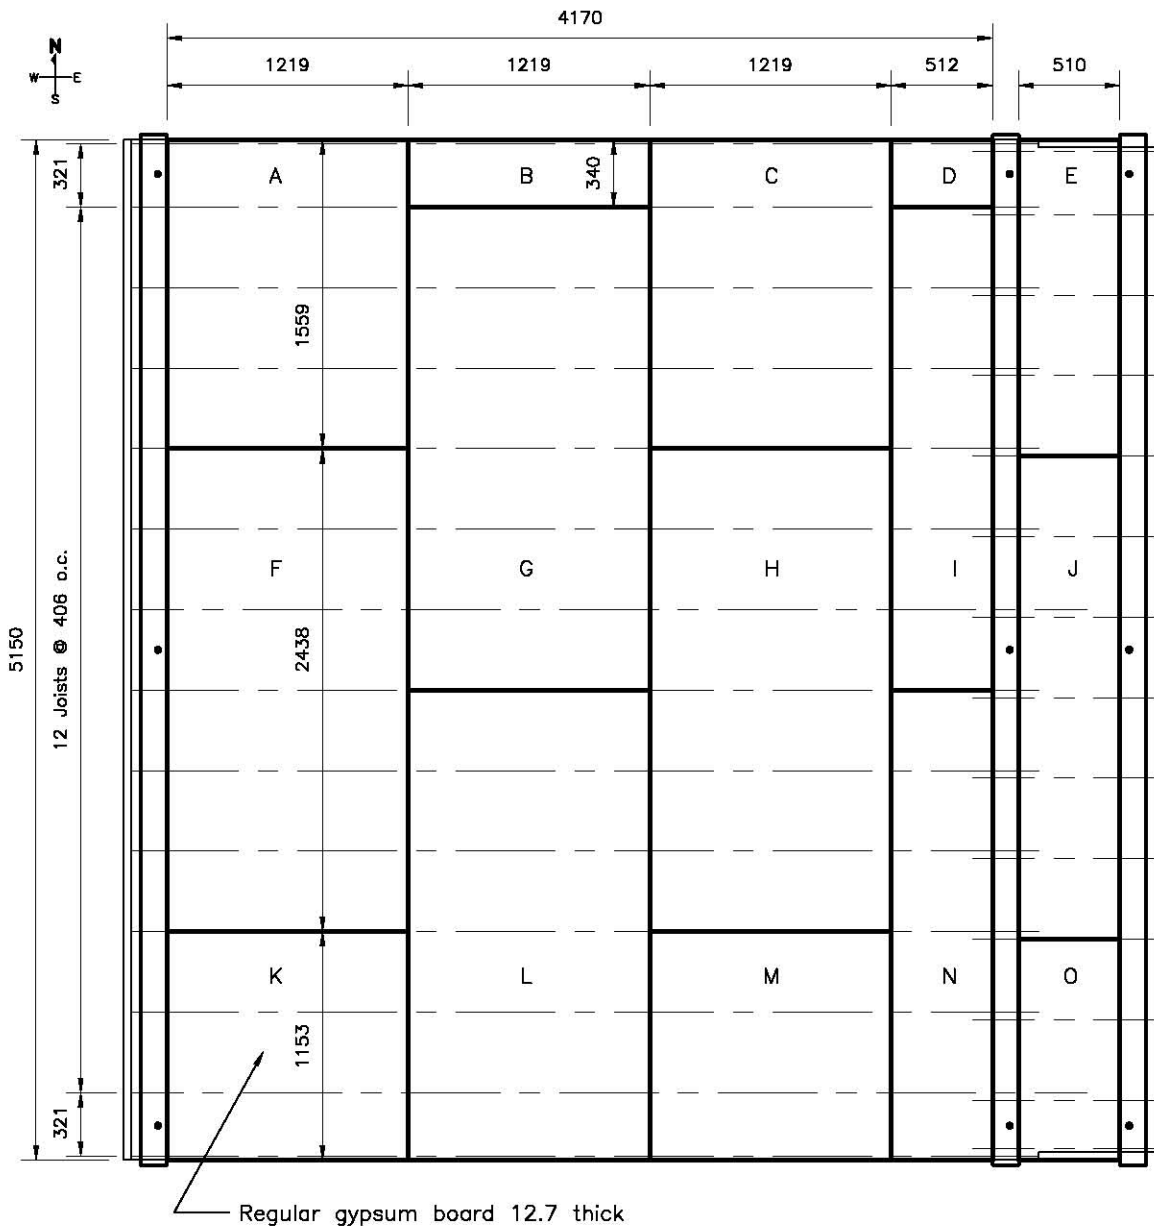
Figure 9. Gypsum board layout on the assembly as the basement ceiling (PF-01) (all dimensions in mm)

Regular gypsum board was installed on the basement side of the ceiling/floor assembly by being fastened directly to the bottom of the joists. The gypsum board was 12.7 mm thick, with a full sheet size of 1.2 x 2.4 m. Figure 9 shows the layout of the gypsum board on the assembly. The joints of the gypsum board were finished with joint compound and tape. The screw pattern and description of screws used to fasten the gypsum board to the solid-sawn wood joists and rim board (header) are shown in Figure 10.

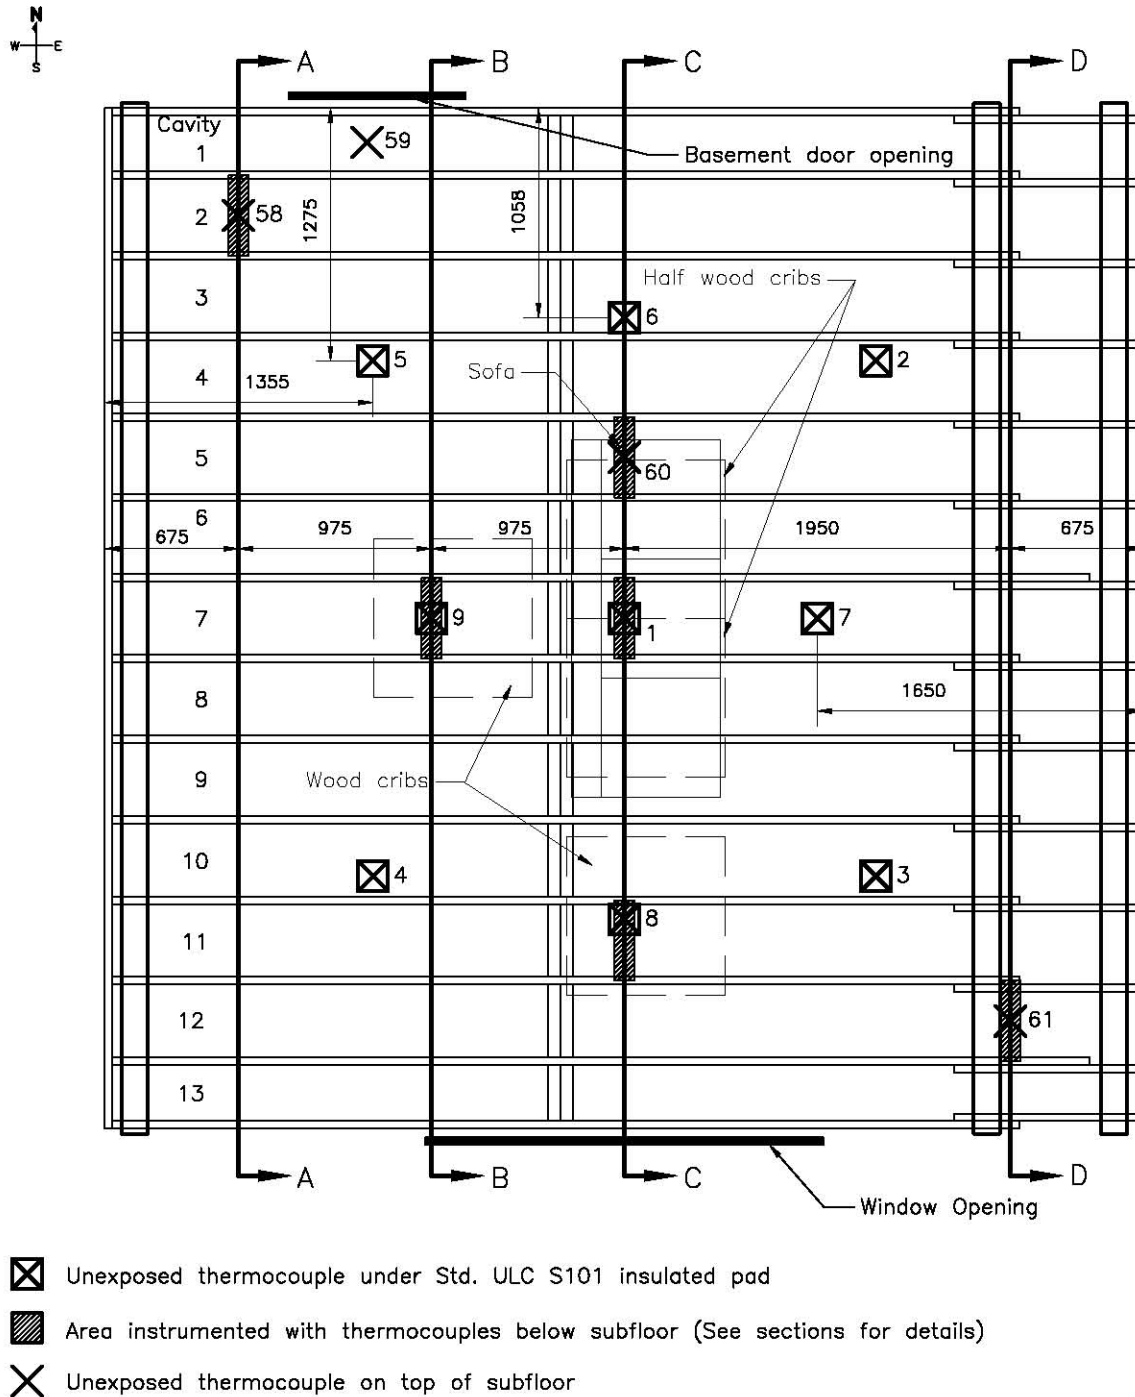
Figure 11. Thermocouples locations in PF-01 assembly (all dimensions in mm)

Sixty-one Type K (20 gauge) chromel-alumel thermocouples, with a thickness of 0.91 mm, were used for measuring temperatures at a number of locations throughout the assembly. The thermocouples were located on the unexposed side and in the cavities of the assembly as shown in Figure 11 and Figure 12. These locations were chosen to monitor the conditions of the assembly at critical locations during the fire tests.

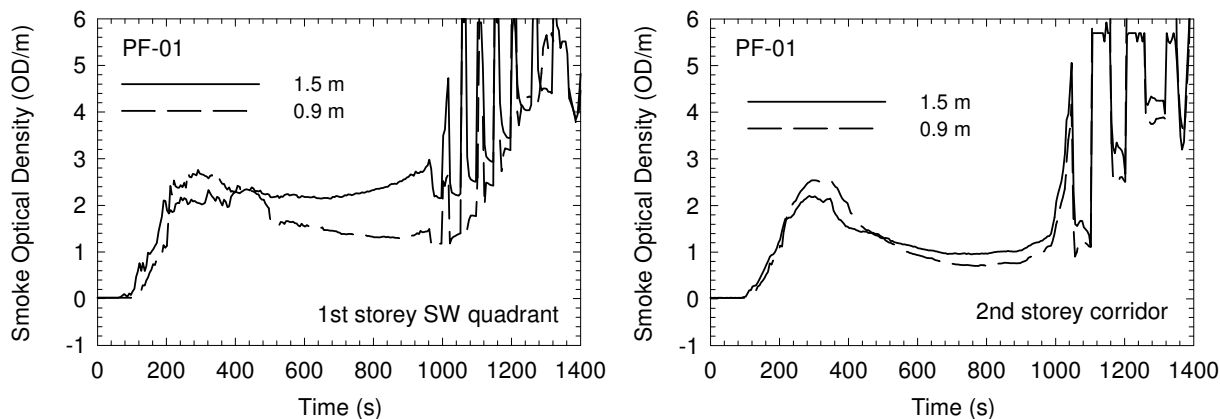
Figure 15. Smoke optical density measurements in Test PF-01

The optical density was measured at 0.9 and 1.5 m heights (simulating the height of the nose/mouth of an average height individual crawling and standing, respectively) above the floor on the first and second storeys. Table 4 shows the times to reach $OD = 2 \text{ m}^{-1}$. Figure 15 shows the optical density-time profiles. It must be pointed out that the video records show no signs of decrease in the optical density after the first peak, indicating that the smoke density meters started the self purging cycle. The smoke density meter has an operation temperature limit of 80°C in its gas chamber; when this temperature is reached, the flow is reversed to cool the chamber to protect the electronic components. The smoke meter resumes operation once the gas chamber is cooled down below 80°C . In this experiment, only the initial part of the curves (up to the first peaks) represents valid measurements.

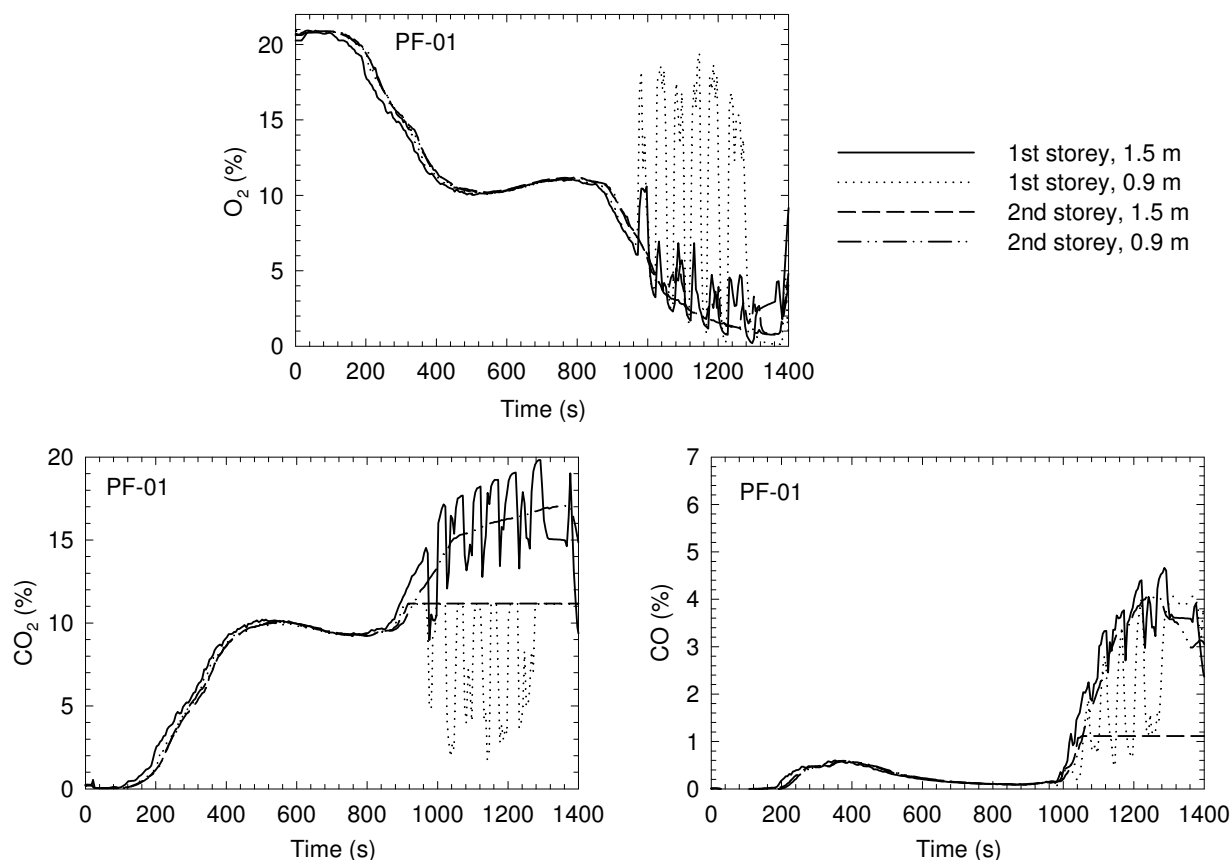
Figure 16. CO, CO₂ and O₂ concentrations in Test PF-01

Figure 16 shows the CO , CO_2 and O_2 concentration-time profiles measured at the southwest quarter point on the first storey and at the centre of the corridor on the second storey during the experiment. Within approximately 400 s, oxygen was diminished to below 10% and CO_2 increased to above 10%, which could cause incapacitation and lead to rapid loss of consciousness due to lack of oxygen alone or due to the CO_2 asphyxiant effect alone [22]. The concentrations were below 5% O_2 and above 16% CO_2 near the end of the experiment. Note that two gas analyzers used had an upper limit of 10% for CO_2 measurements and one gas analyzer used had an upper measurement limit of 1% CO . All other gas analyzers had higher measurement limits.

The tenability analysis indicated that the toxic effect of CO would be capable of causing incapacitation at an earlier time than the effect of O₂ vitiation and the asphyxiant effect of CO₂. The times to reach the specified FED for exposure to O₂ vitiation, CO₂ and CO are shown in Table 5.

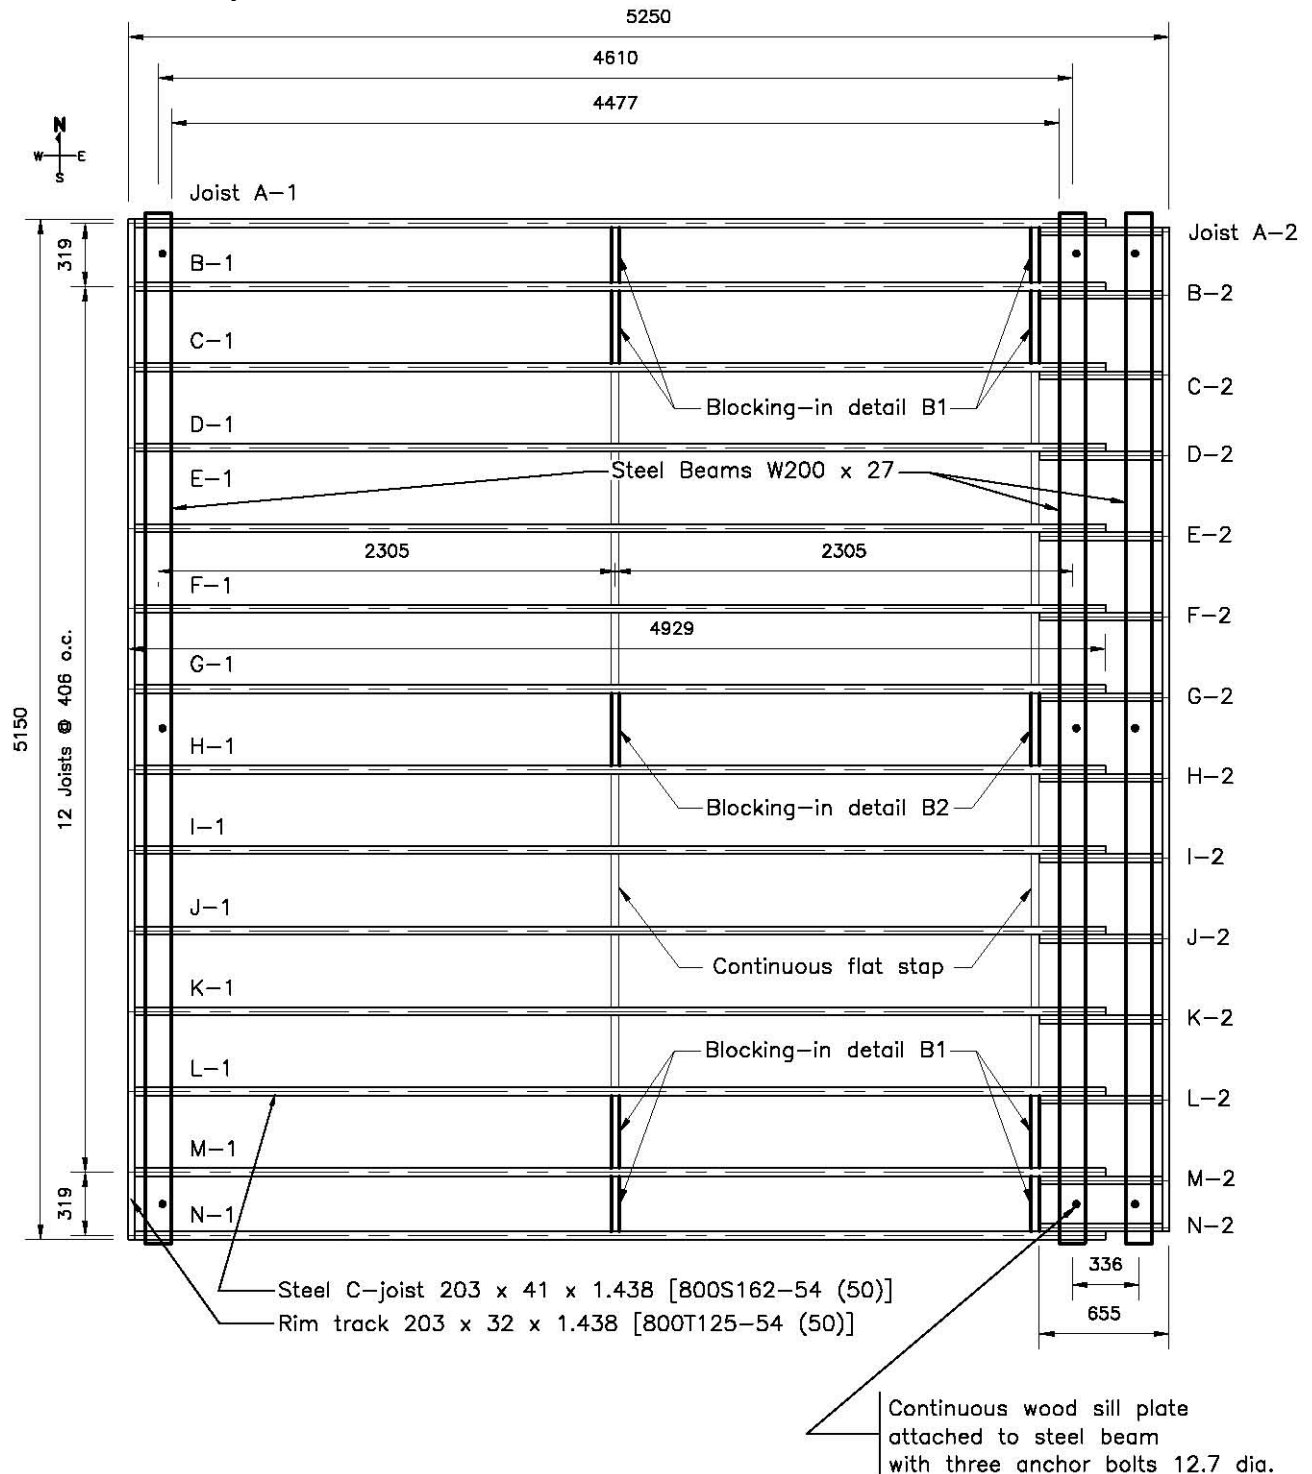
The overall dimensions of the steel C-joist assembly were 5250 mm x 5150 mm. Specific dimensions of the various components of the assembly are provided in Figure 21 to Figure 27. The light-gauge steel C-joists were 203 mm x 41 mm, 1.438 mm (gauge 17), and were spaced at 400 mm on centre (see Figure 21). Based on calculations of maximum strength and deflection, the C-joist span length chosen was 4.477 m [9]. Since the maximum span allowed for the steel C-joists does not extend across the entire length of the fire room, a steel beam was used as an intermediate support at the end of the 4.477-m span and a set of shorter C-joists were used to increase the span of the test assembly to the end of the room. Figure 21, Figure 22 and Figure 23 show the details of the joist overlaps and the supporting steel beams. This

Rim tracks (headers) made of steel 203 mm x 32 mm and 1.438 mm thick, were placed at the east and west sides of the test assemblies as shown in Figure 21. Blocking-in, stiffeners and a continuous strap were used. Details are shown in Figure 21 to Figure 23.

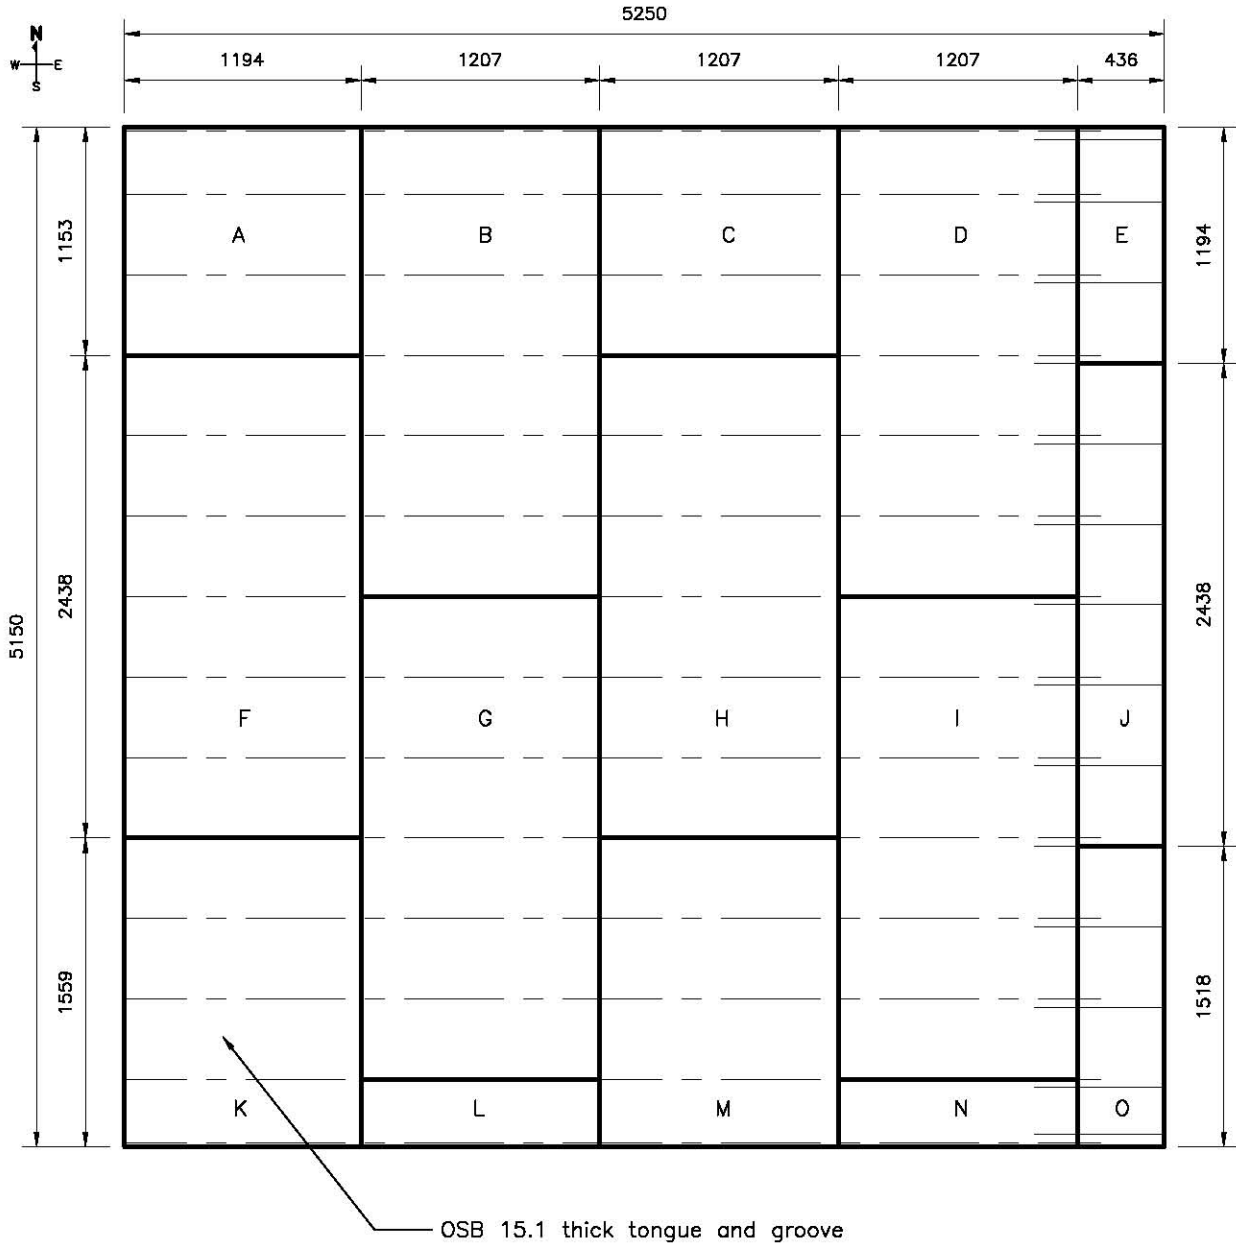
Figure 24. Subfloor layout (PF-02) (all dimensions in mm)

OSB was used as the subfloor material in the test assembly. The specific OSB material used was selected based on a separate study documented in reference [28]. The subfloor panels were 15.1 mm thick in the assembly, with a full panel size of 1.2 x 2.4 m. The longer panel edges had a tongue-and-groove profile while the short panel edges were square butt ends. Figure 24 shows the layout of the subfloor. The screw pattern and description of screws used to attach the OSB panels to the steel C-joists and rim track are shown in Figure 25.

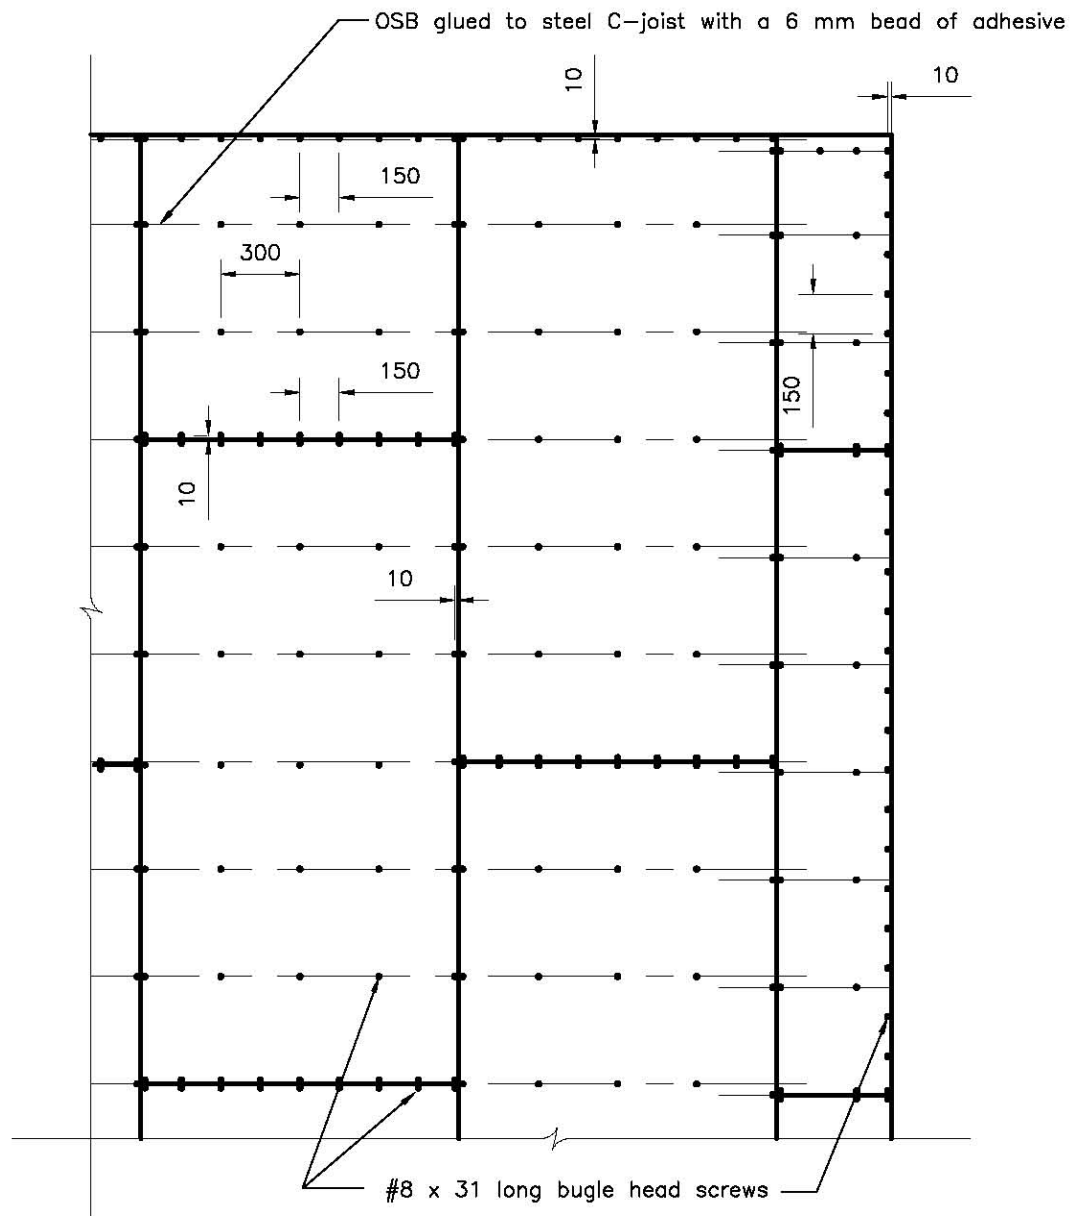
Figure 25. Subfloor screw pattern and screw description (PF-02) (all dimensions in mm)

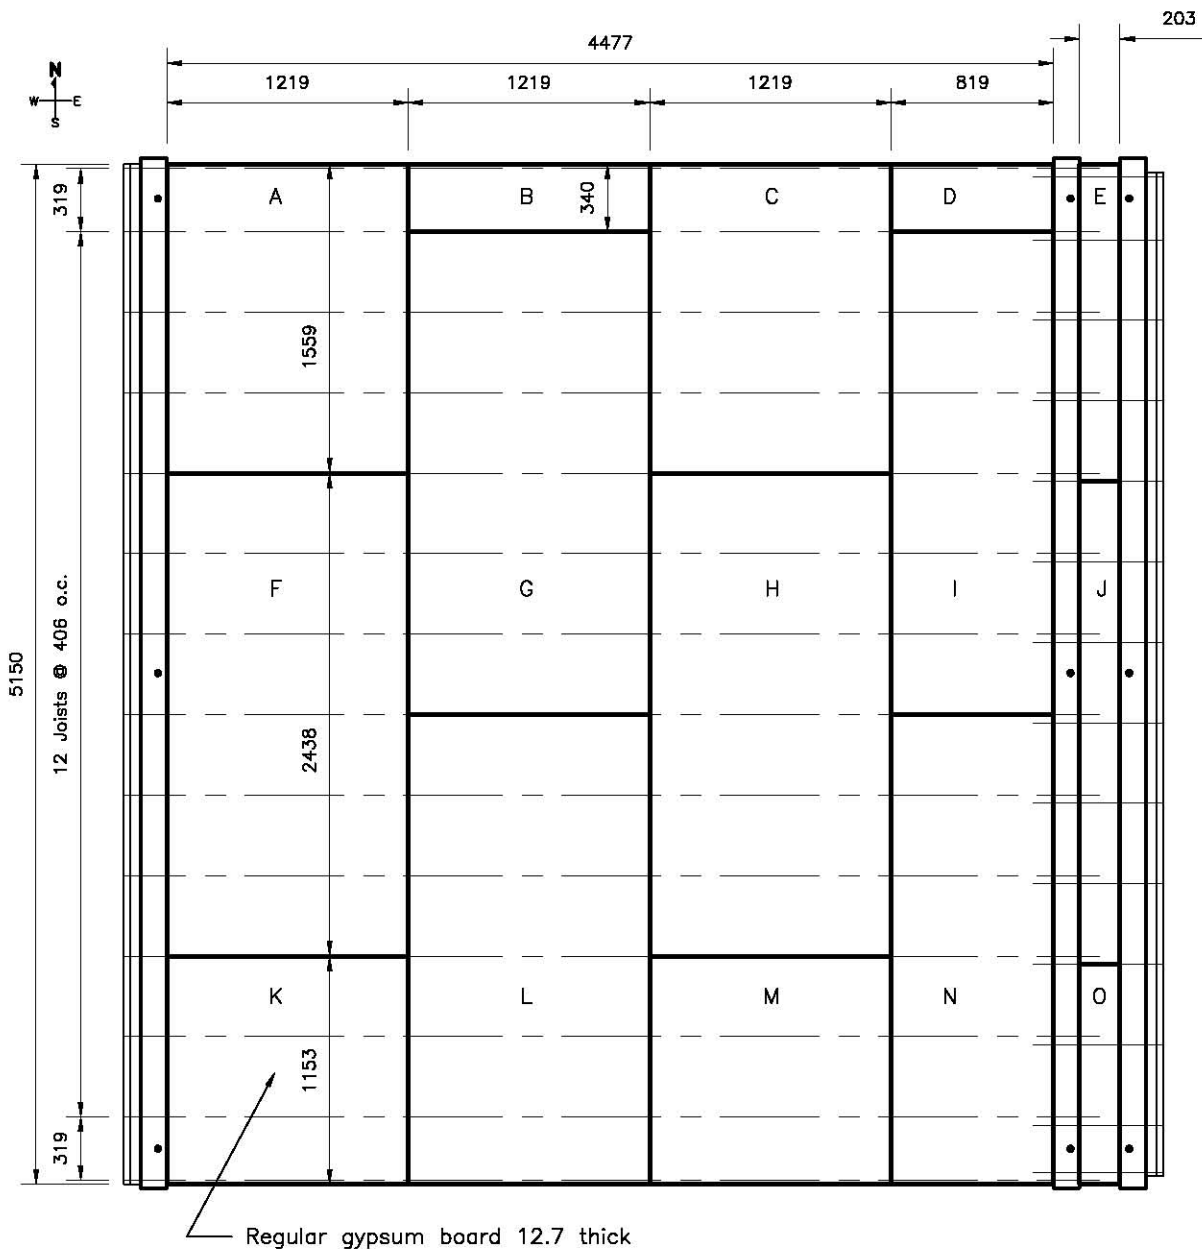
Figure 26. Gypsum board layout on the assembly as the basement ceiling (PF-02) (all dimensions in mm)

Regular gypsum board was installed on the basement side of the test assembly by being fastened directly to the bottom of the steel C-joists. The gypsum board was 12.7 mm thick, with a full sheet size of 1.2 x 2.4 m. Figure 26 shows the layout of the gypsum board on the assembly. The joints of the gypsum board were finished with joint compound and tape. The screw pattern and description of screws used to fasten the gypsum board to the steel C-joists and rim track are shown in Figure 27.

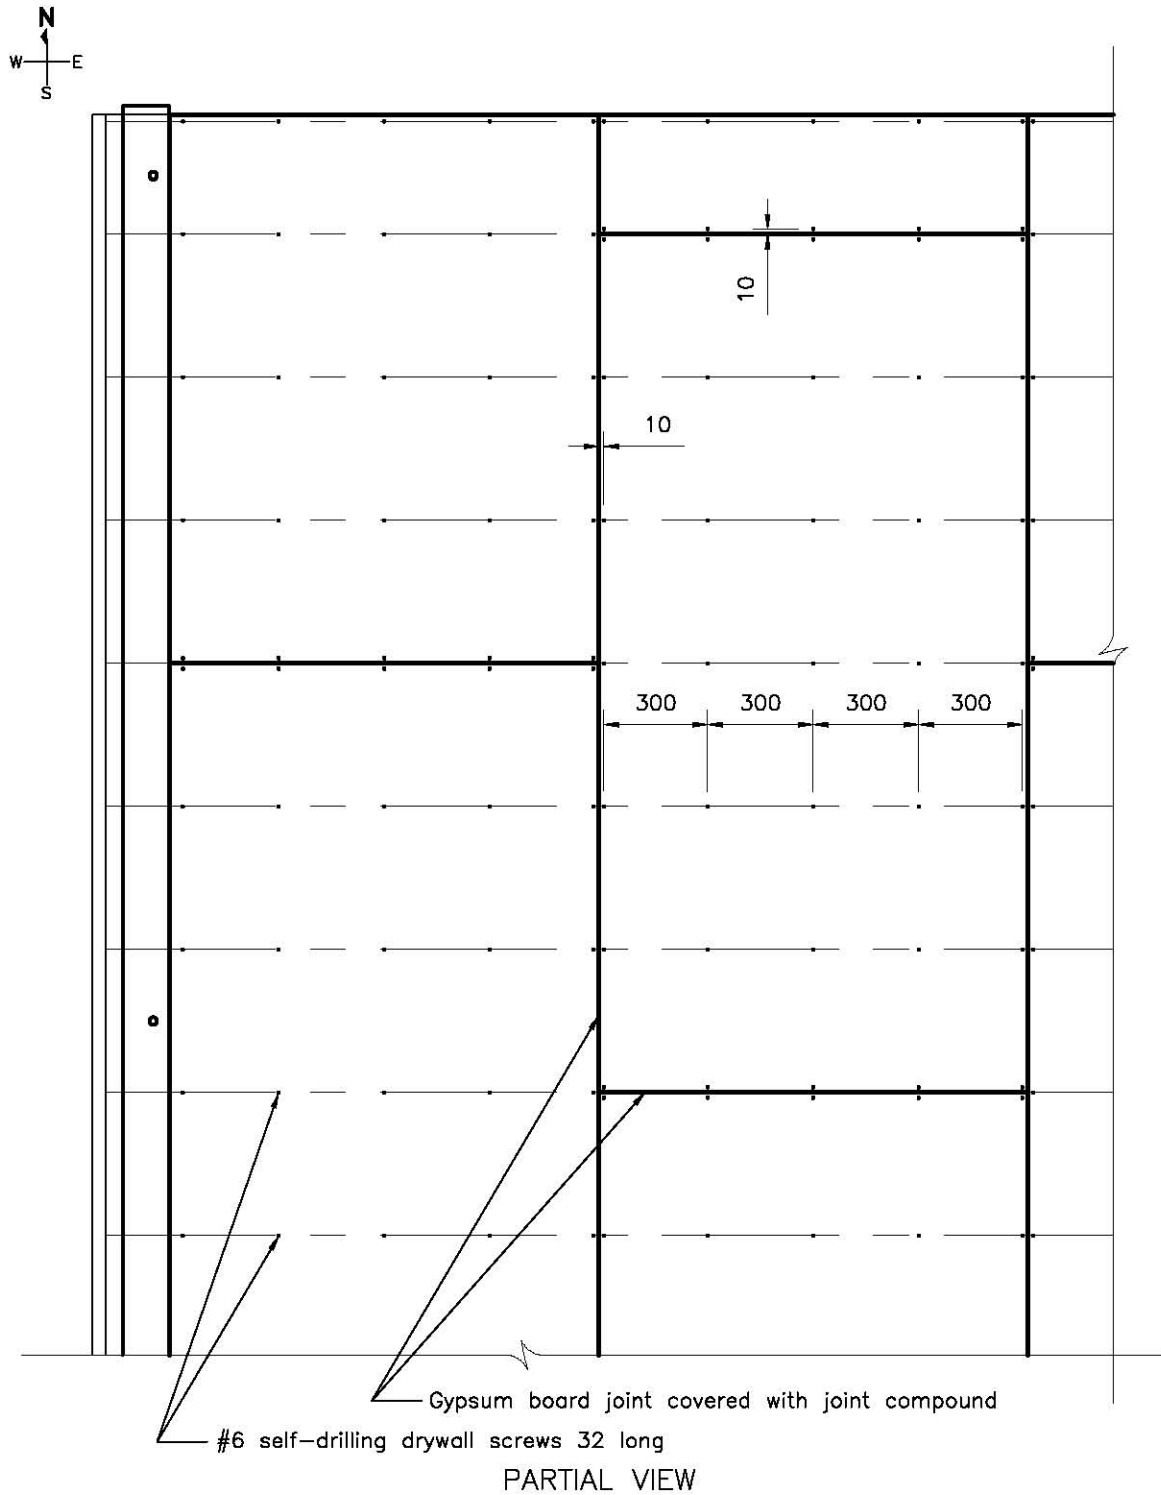
Figure 27. Gypsum board screw layout for steel C-joint assembly (PF-02) (all dimensions in mm)

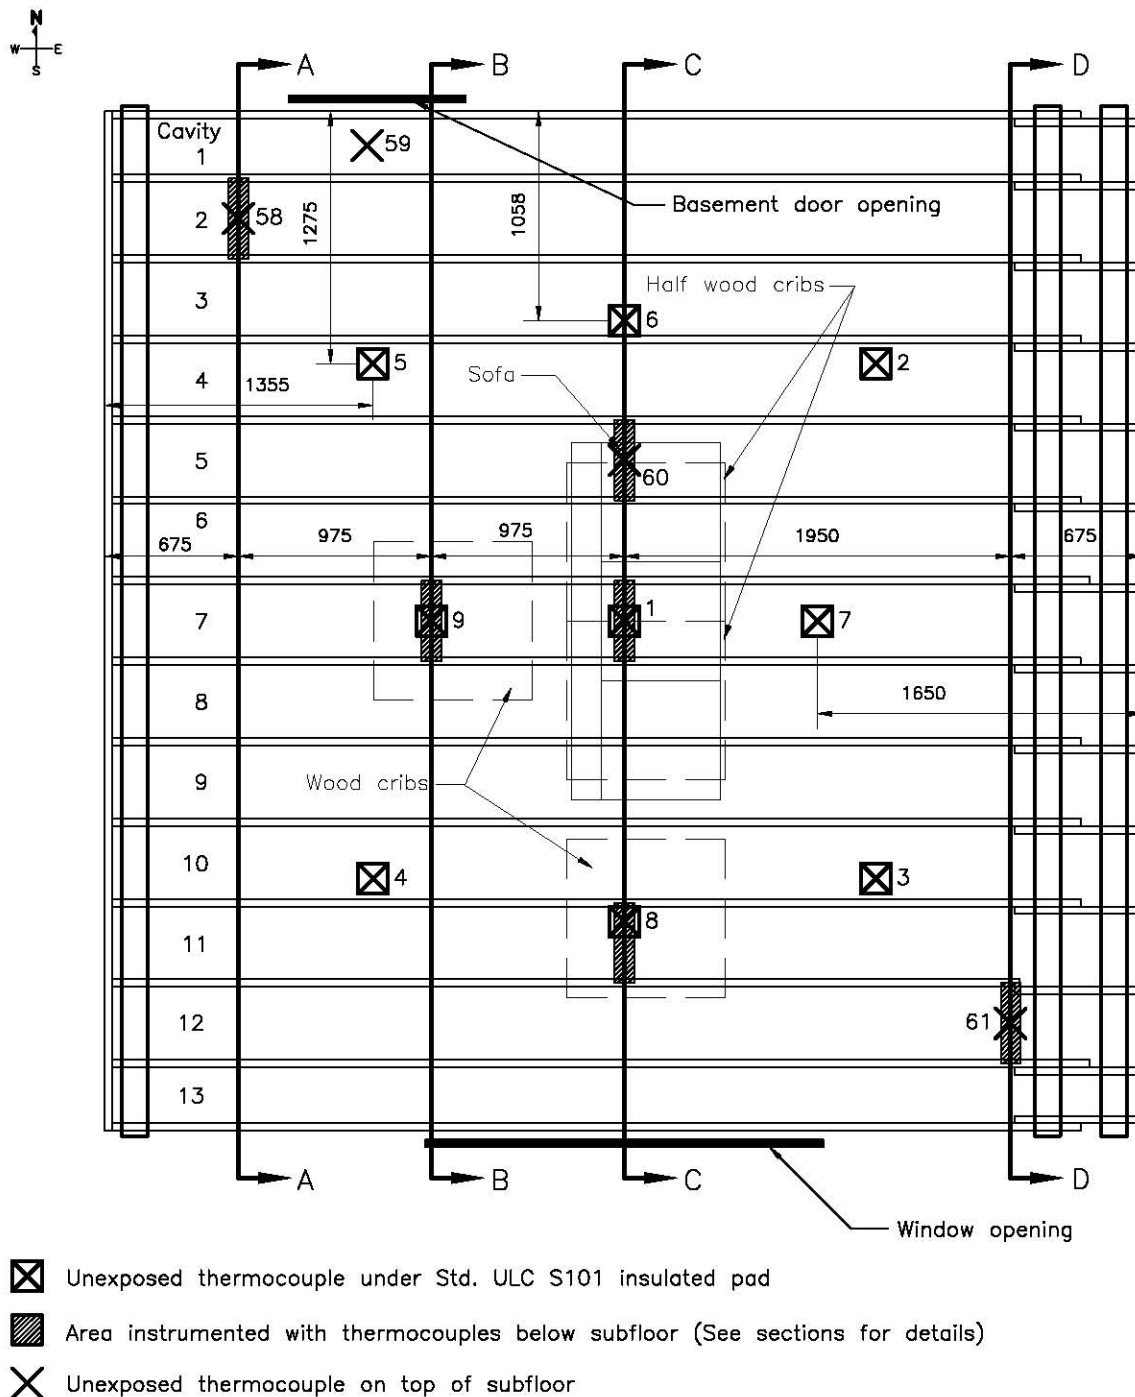
Sixty-one Type K (20 gauge) chromel-alumel thermocouples, with a thickness of 0.91 mm, were used for measuring temperatures at a number of locations throughout the assembly. The thermocouples were located on the unexposed side and in the cavities of the assembly as shown in Figure 28 and Figure 29. These locations were chosen to monitor the conditions of the assembly at critical locations during the fire tests. The floor deflection was measured at 9 points on the unexposed surface of the test assembly at the locations as shown in Figure 13.

Figure 28. Thermocouples locations in PF-02 assembly (all dimensions in mm)
