Performance of Protected Ceiling/Floor Assemblies and Impact on Tenability with a Basement Fire Scenario

IRC-RR-307

May 2011

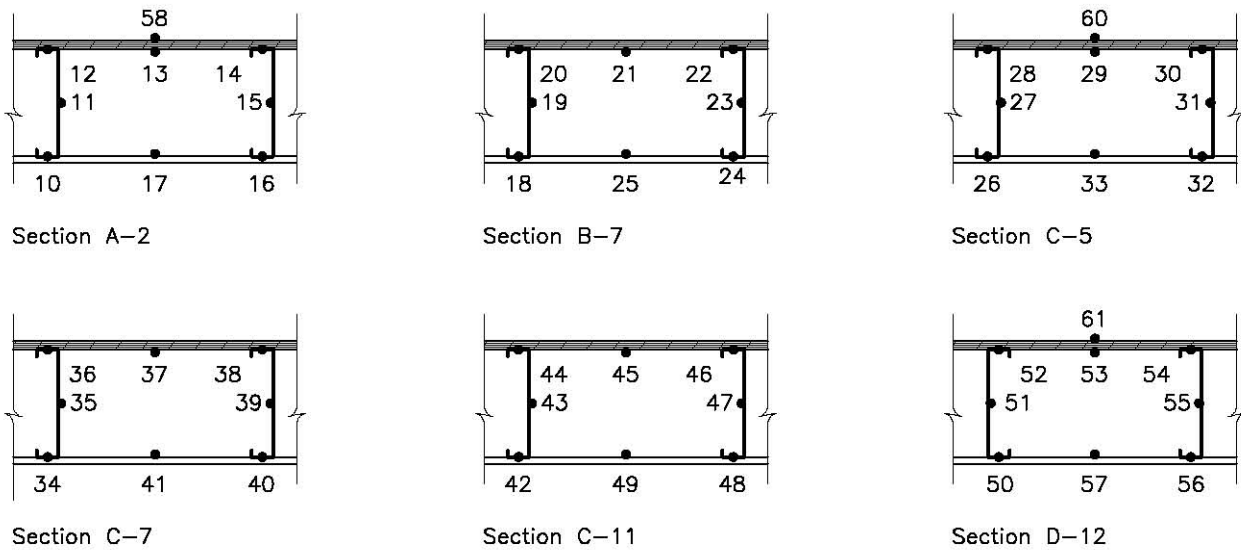
Figure 29. Thermocouples locations in the different sections shown in Figure 28 (PF-02)

Sixty-one Type K (20 gauge) chromel-alumel thermocouples, with a thickness of 0.91 mm, were used for measuring temperatures at a number of locations throughout the assembly. The thermocouples were located on the unexposed side and in the cavities of the assembly as shown in Figure 28 and Figure 29. These locations were chosen to monitor the conditions of the assembly at critical locations during the fire tests. The floor deflection was measured at 9 points on the unexposed surface of the test assembly at the locations as shown in Figure 13.

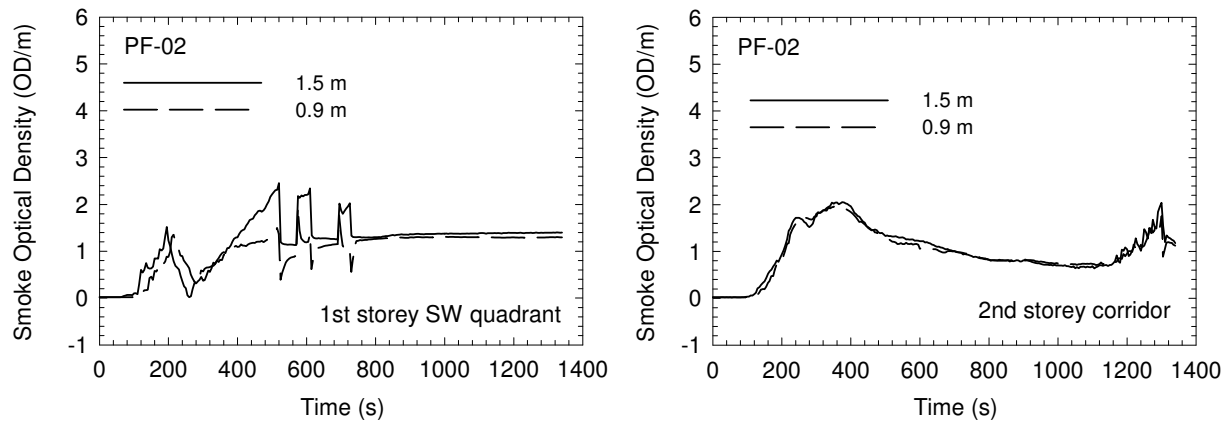
The optical density was measured at 0.9 and 1.5 m heights (simulating the height of the nose/mouth of an average height individual crawling and standing, respectively) above the floor on the first and second storeys. Figure 31 shows the optical density-time profiles. The second storey reached $OD = 2 \text{ m}^{-1}$ after 220 s. It must be pointed out that the video records show complete darkness in the test house on both storeys after 200 s. The smoke density meter has an operation temperature limit of 80°C in its gas chamber; when this temperature is reached,

the flow is reversed to cool the chamber to protect the electronic components. The smoke meter resumes operation once the gas chamber is cooled down below 80°C. In this experiment, only the initial part of the curves (up to 200 s) represents valid measurements.

Figure 31. Smoke optical density measurements in Test PF-02

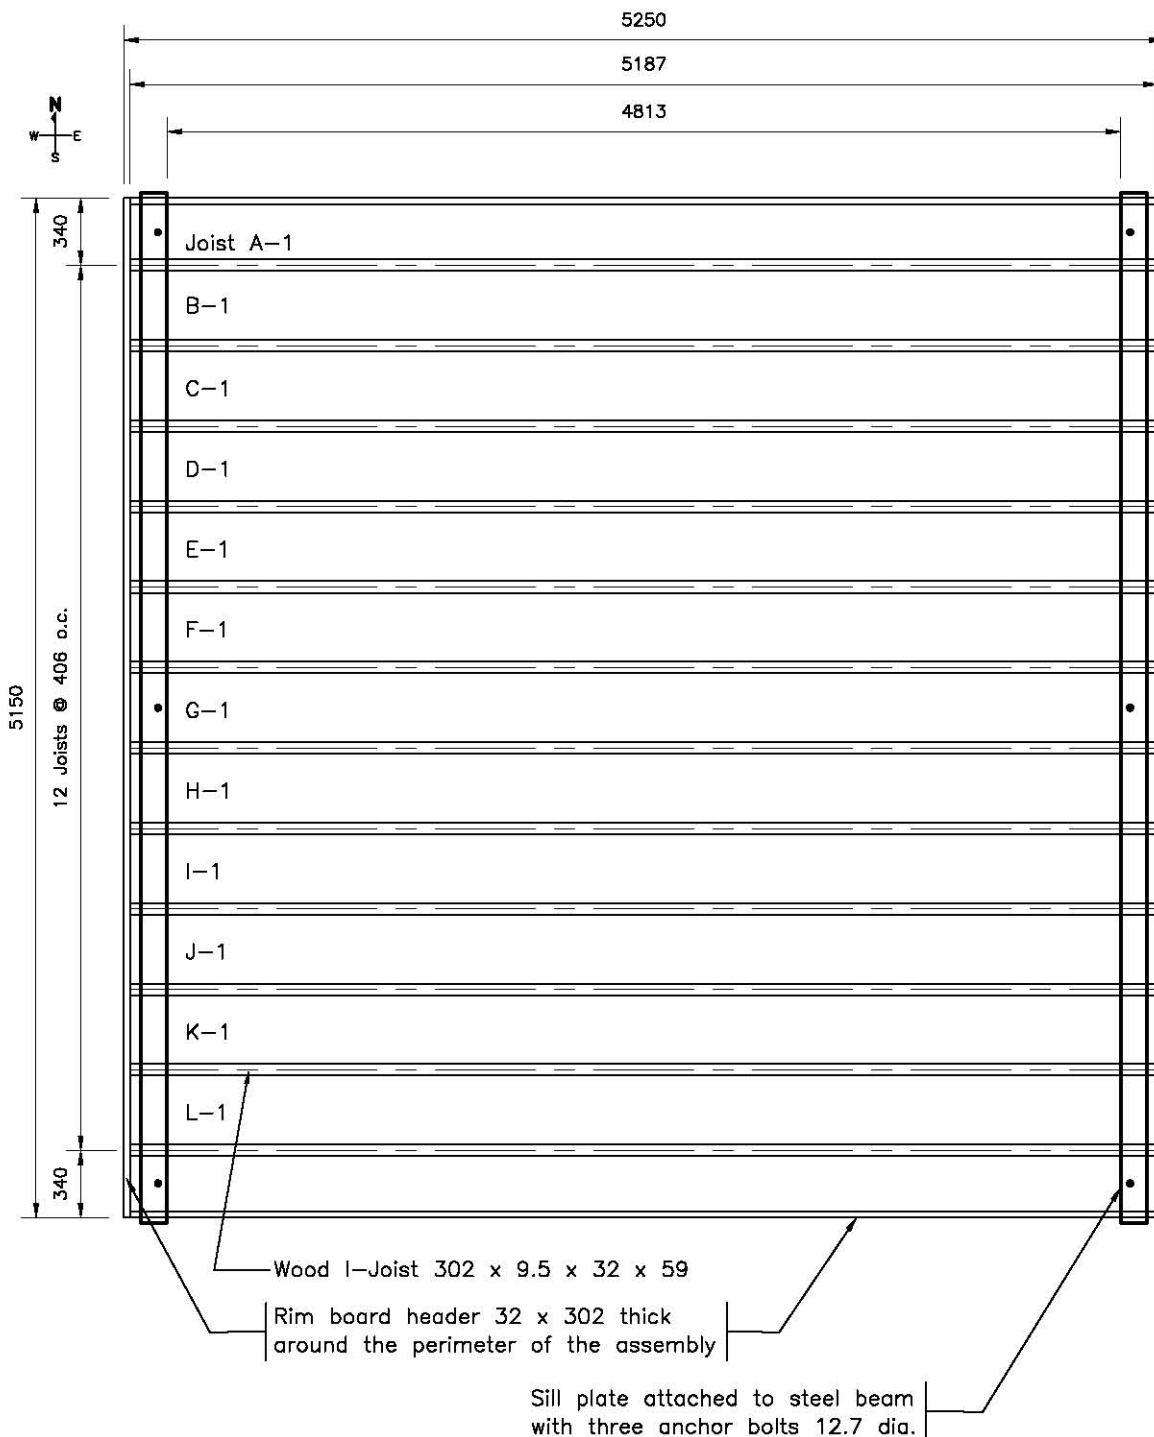
The overall dimensions of the wood I-joist assemblies were 5250 mm x 5150 mm. Specific dimensions of the various components of the assemblies are provided in Figure 37 to Figure 40. The wood I-joists were 302 mm deep, with an OSB web of 9.5 mm thick and the flanges were laminated veneer lumber (32 mm x 59 mm). The I-joists were spaced at 400 mm on centre. Based on calculations of maximum strength and deflection, the I-joist span length chosen was 4.813 m. This span allowed the wood I-joists to extend across the entire length of the fire room (with no need for an intermediate support). Laminated strand lumber (LSL) rim boards

(headers) 32 mm thick x 302 mm deep (grade 1.3E), were placed around the perimeter of the assemblies as shown in Figure 37. It should be noted that, compared to the wood I-joists A used in Phase 1 of the FPH research, the wood I-joists used for current experiments were slightly modified by the manufacturer – the depth of the top and bottom flanges of the wood I-joist were changed from 35 mm to 32 mm. This change did not result in any change to the structural design values assigned to the wood I-joist members.

Figure 37. Wood I-joist layout details for Tests PF-03, PF-03B, PF-04 and PF-05 (all dimensions in mm)

The test assembly used in Test PF-05 was identical to those used in Tests PF-03, PF-03B and PF-04 conducted using wood I-joists (see Figure 37 and Figure 40) except that the basement side had different protection measures. In Test PF-05, a suspended ceiling with the mineral fibre panels on metal track was installed below the test assembly in the basement fire room. The installation of the suspended ceiling followed the recommendations of the manufacturer. The mineral fibre panels were 12.7 mm thick, with a full-panel size of 0.6 x 1.2 m. Figure 51 and Figure 52 show details of the suspended ceiling layout, end connection and the supporting beams.

Except that the exposed side (basement side) had no finished ceiling, the wood I-joist assembly used in Test PF-03 was identical to those used in Tests PF-04 and PF-05 (see Figure 37, Figure 38, Figure 40 and Figure 41). The wood I-joists were exposed in the basement fire room. The thermocouples for measuring temperatures throughout the assembly were located on the unexposed side and in the exposed cavities of the test assembly as shown in Figure 41 and Figure 61.

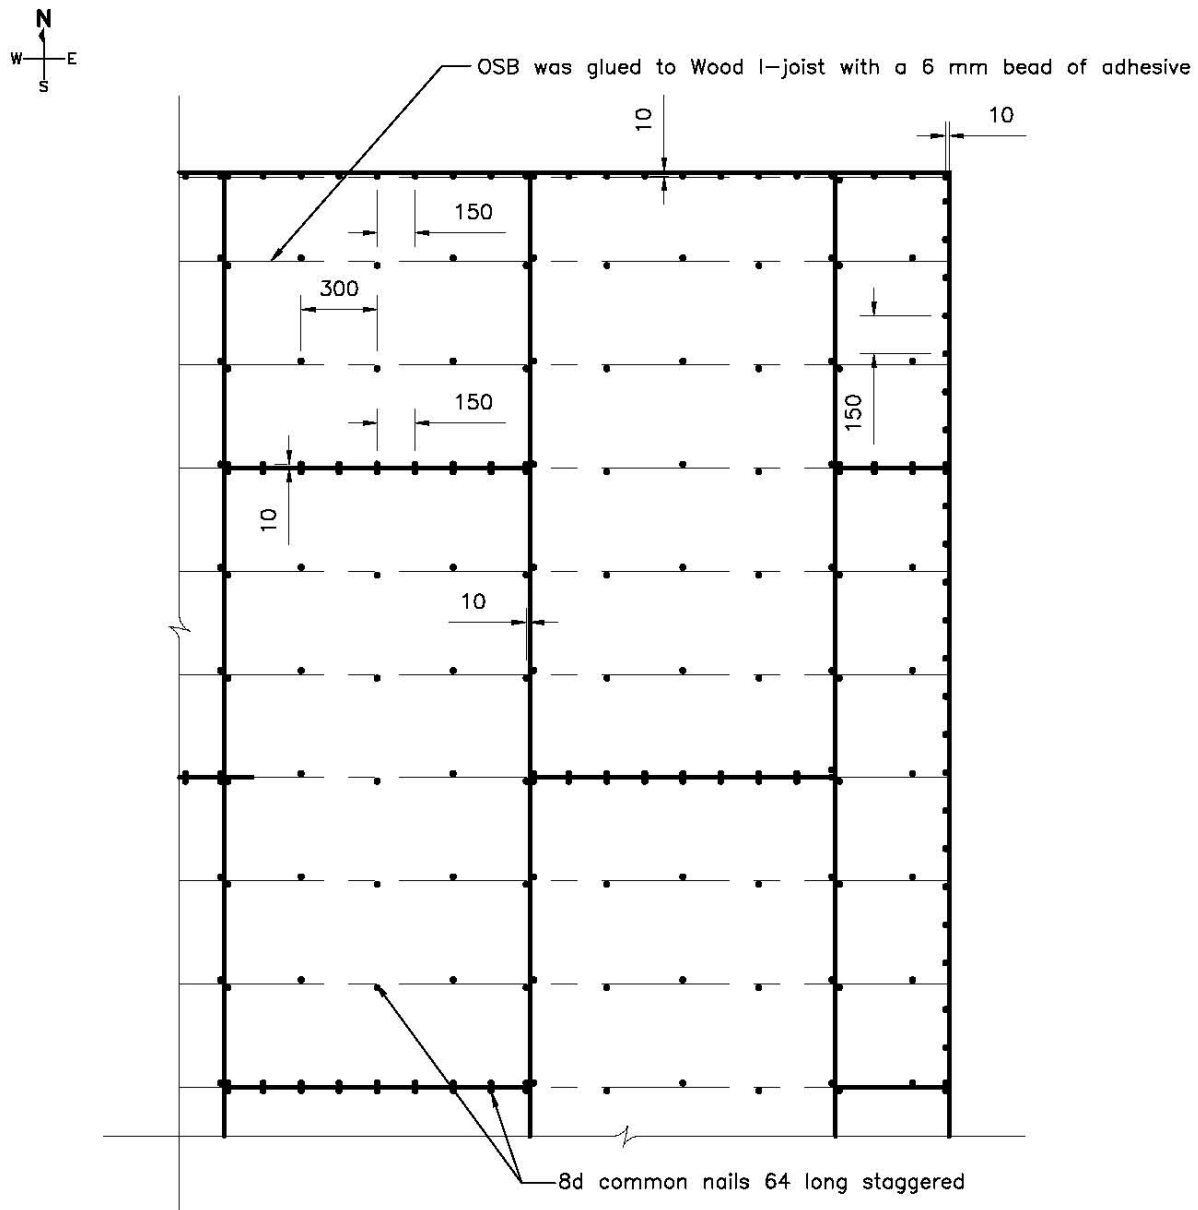
OSB was used as the subfloor material in the test assemblies. The specific OSB material used was selected based on a separate study documented in reference [28]. The subfloor panels were 15.1 mm thick, with a full panel size of 1.2 x 2.4 m. The longer panel edges had a tongue-and-groove profile while the short panel edges were square butt ends. Figure 7 shows the layout of the subfloor. The nailing pattern and description of nails used to attach the OSB panels to the wood I-joists and rim board (header) are shown in Figure 40.

Figure 40. Subfloor nail pattern (Tests PF-03, PF-03B, PF-04 and PF-05) (all dimensions in mm)

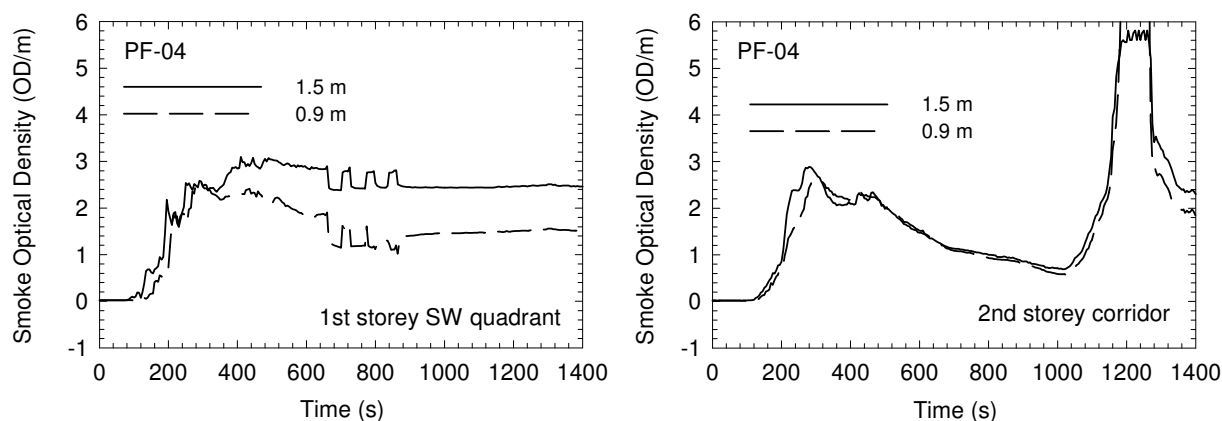
The optical density was measured at 0.9 and 1.5 m heights (simulating the height of the nose/mouth of an average height individual crawling and standing, respectively) above the floor on the first and second storeys. Table 13 shows the times to reach $OD = 2 \text{ m}^{-1}$. Figure 44 shows the optical density-time profiles. It must be pointed out that the video records show no signs of decrease in the optical density after the first peak, indicating that the smoke density meters started the self purging cycle after that time. The smoke density meter has an operation temperature limit of 80°C in its gas chamber; when this temperature is reached, the flow is reversed to cool the chamber to protect the electronic components. The smoke meter resumes

Figure 44. Smoke optical density measurements in Test PF-04

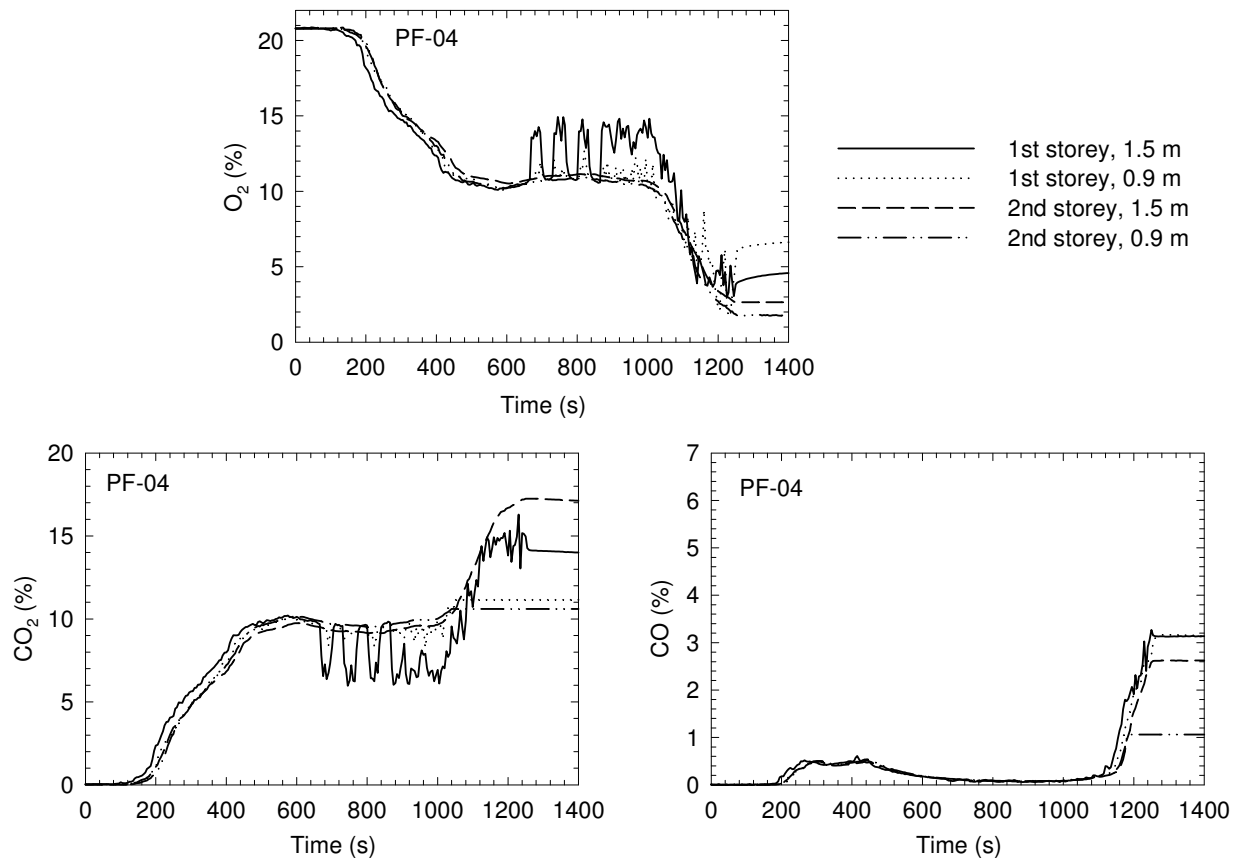
Figure 45 shows the CO, CO₂ and O₂ concentration-time profiles measured at the southwest quarter point on the first storey and at the centre of the corridor on the second storey during the experiment. Within approximately 400 s, oxygen was diminished to 11% and CO₂ increased to close to 10%, which could cause incapacitation and lead to loss of consciousness rapidly due to lack of oxygen alone or due to the CO₂ asphyxiant effect alone [22]. The concentrations were below 5% O₂ and above 15% CO₂ near the end of the experiment. The tenability analysis indicated that the toxic effect of CO would be capable of causing incapacitation at an earlier time than the effect of O₂ vitiation and the asphyxiant effect of CO₂. The times to reach the specified FED for exposure to O₂ vitiation, CO₂ and CO are shown in Table 14.

Figure 45. CO, CO₂ and O₂ concentrations in Test PF-04

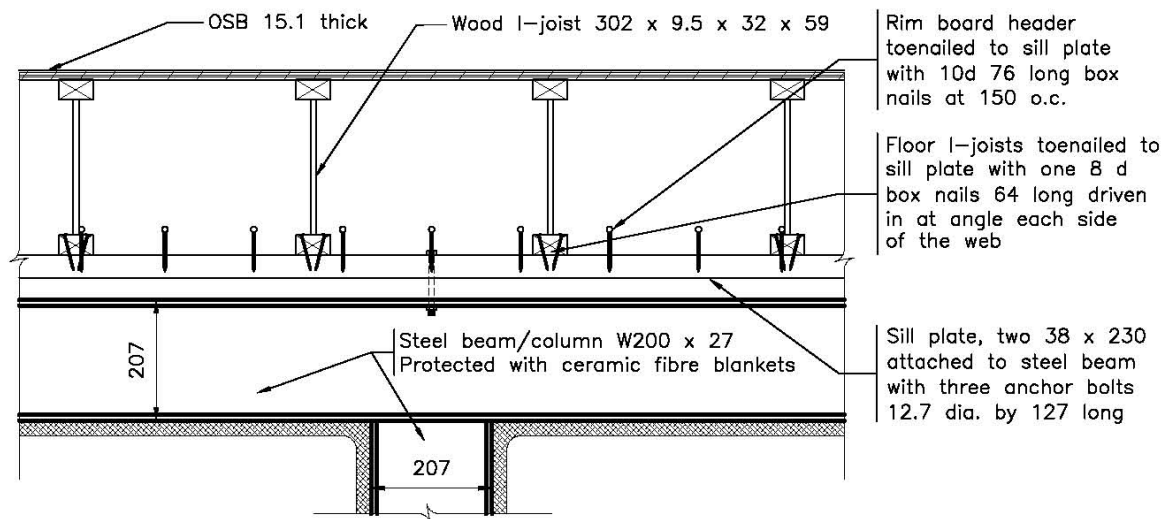
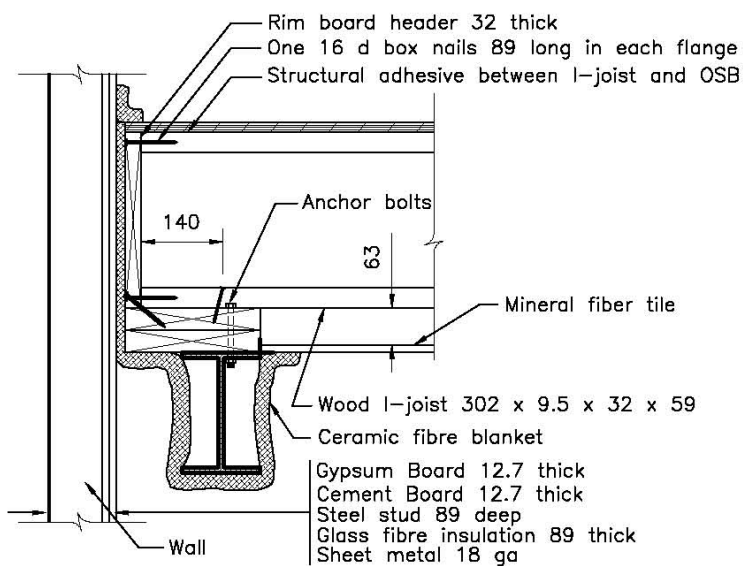
Figure 51. Details of end connection and supports for Test PF-05 (suspended ceiling) (all dimensions in mm)

End connection details (East view)

End connection details (North view)

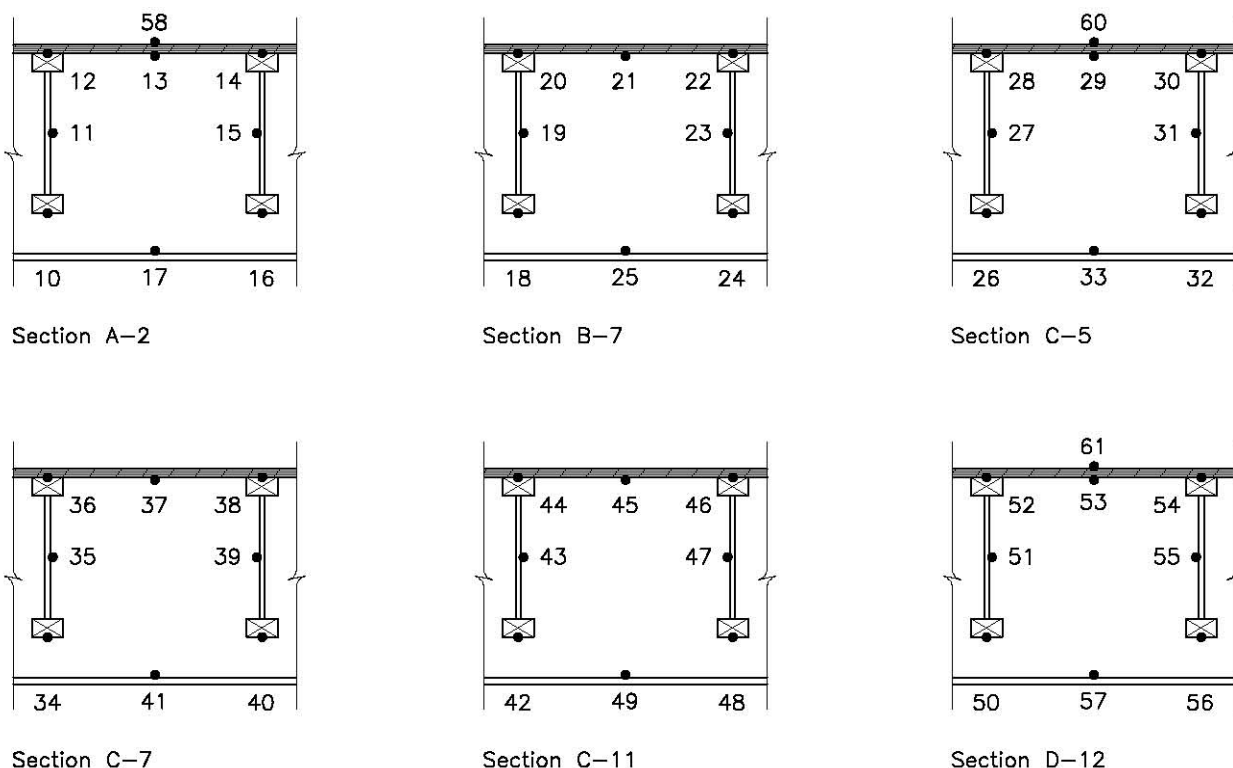
Figure 53. Thermocouples installed in the sections shown in Figure 41 (Test PF-05)

The thermocouples for measuring temperatures throughout the assembly were located on the unexposed side and in the cavities of the assembly as shown in Figure 41 and Figure 53.

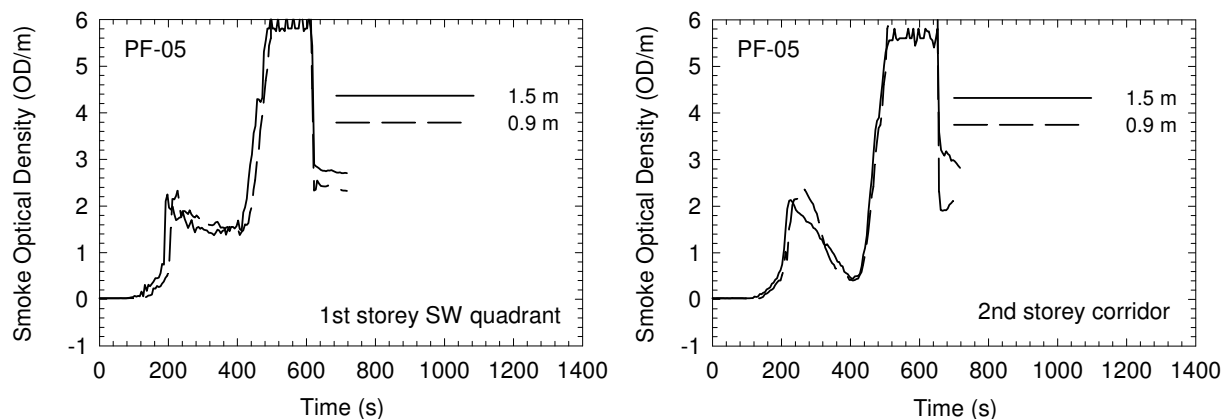
Figure 55. Smoke optical density measurements in Test PF-05

The optical density was measured at 0.9 and 1.5 m heights (simulating the height of the nose/mouth of an average height individual crawling and standing, respectively) above the floor on the first and second storeys. Table 19 shows the times to reach $OD = 2 \text{ m}^{-1}$. Figure 55 shows the optical density-time profiles. It must be pointed out that the video records show no signs of decrease in the optical density after the first peak, indicating that the smoke density meters started the self-purging cycle. The smoke density meter has an operation temperature limit of 80°C in its gas chamber; when this temperature is reached, the flow is reversed to cool

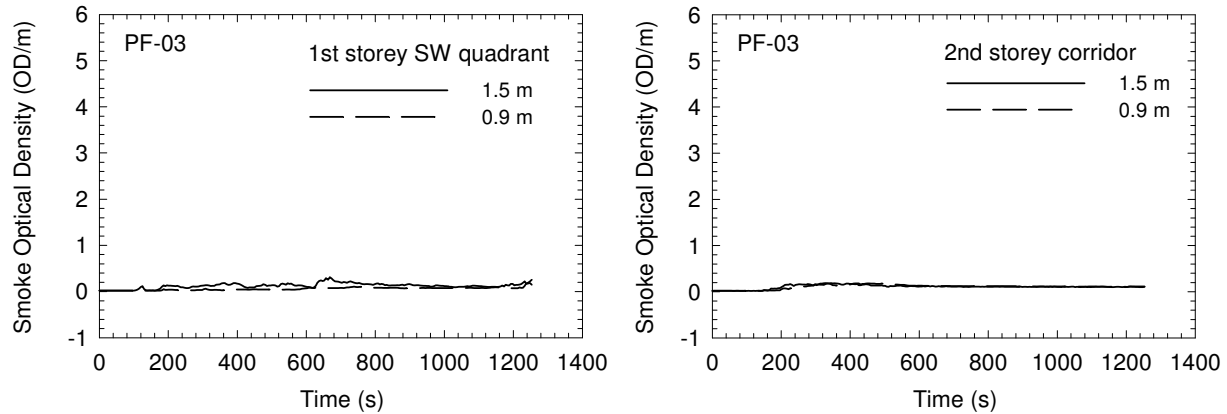
Figure 66. Smoke optical density measurements in Test PF-03

The optical density was measured at 0.9 and 1.5 m heights (simulating the height of the nose/mouth of an average height individual crawling and standing, respectively) above the floor on the first and second storeys. Figure 66 shows the optical density-time profiles; OD remained under 0.2 m^{-1} throughout the upper storeys during the experiment. At this smoke level, a normal person should still be able to see the surroundings.

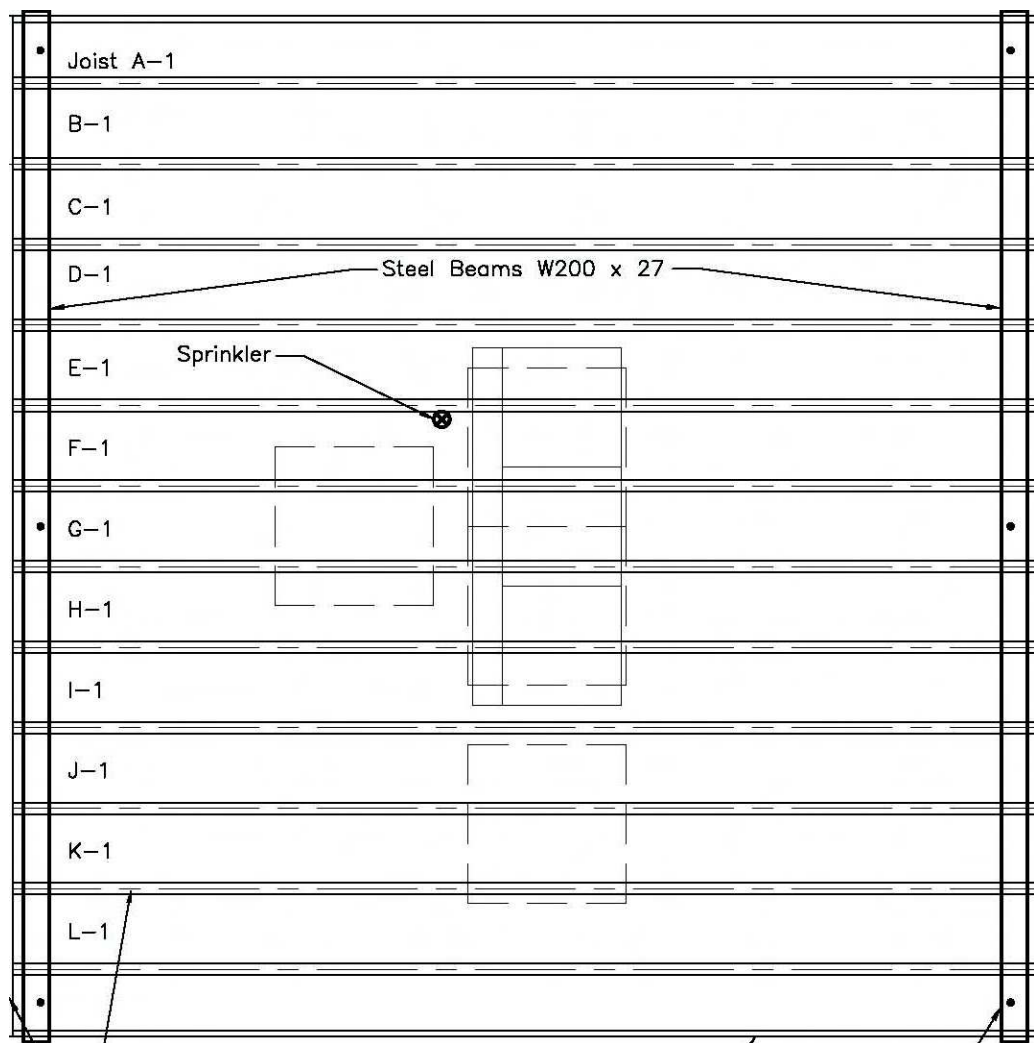
Figure 72. Sprinkler location related to wood I-joists and fuel in Test PF-03B (all dimensions in mm)

A Reliable F1 Residential 49[†] pendent sprinkler, which had a K factor of 4.9 and a temperature rating of 68°C (155°F), was located 3.05 m (10 ft) from both the south and east walls of the fire room. Figure 72 and Figure 73 show the sprinkler location relative to the wood I-joists and fuel package in the experiment. The deflector of the sprinkler was approximately 25.4 mm (1”) below the bottom of the wood I-joists and 330 mm (13”) below the subfloor. The sprinkler and CPVC plastic piping (25.4 mm in diameter) were installed per NFPA 13D and APA Technical Note J745 [31, 32]. It should be noted that a portion of the CPVC piping ran right above the fuel package.

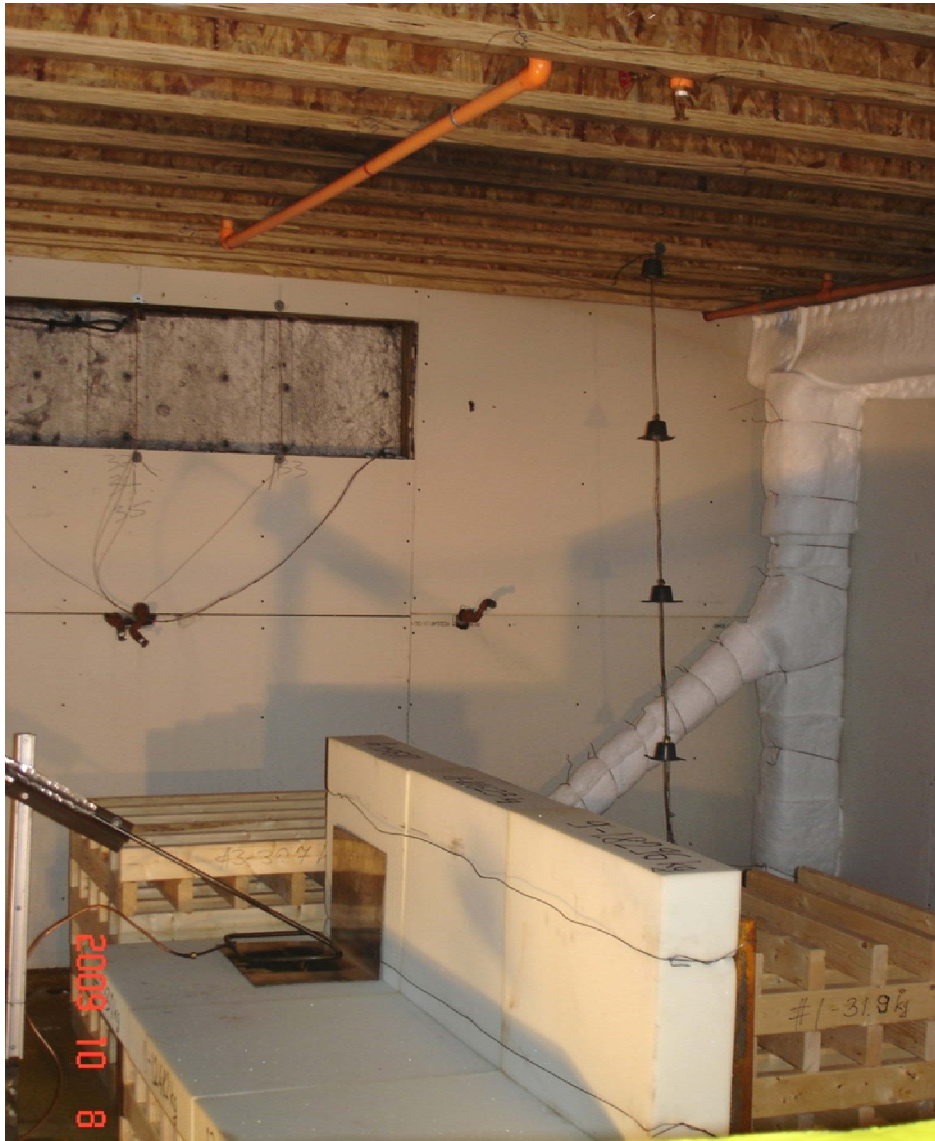
Figure 73. Sprinkler and CPVC piping relative to exposed wood I-joists and fuel (Test PF-03B)

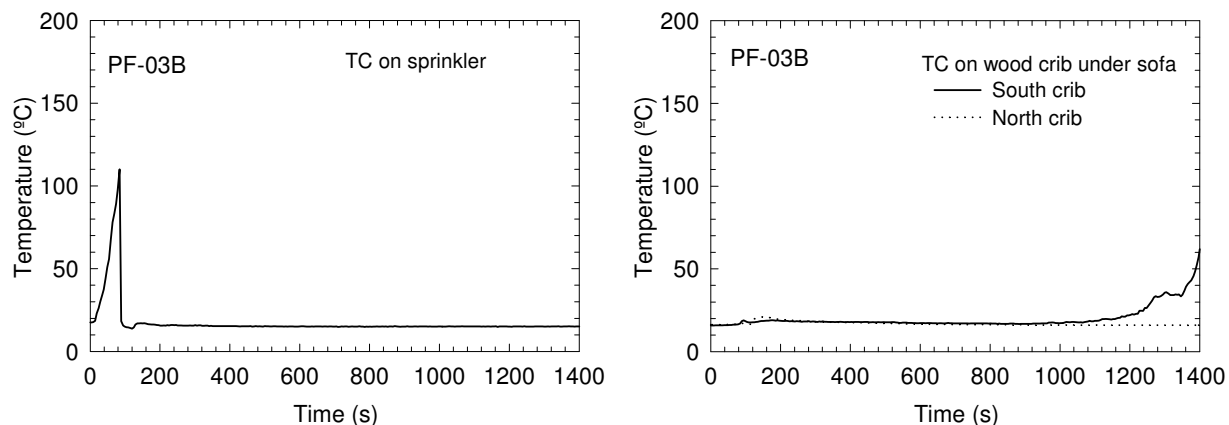
Figure 74. Temperatures at sprinkler and wood cribs in the fire room in Test PF-03B

The polyurethane foam used for the mock-up sofa was ignited and dominated the initial fire growth. Figure 74 shows the temperature measured beside the sprinkler and on the wood cribs underneath the mock-up sofa in the basement fire room. The sprinkler activated at 87 s and quickly suppressed the fire. Based on observation and video records, visible flame disappeared in the fire room at 135 s. There was small flame re-appearing from 200 to 640 s then subsiding. The sprinkler discharge continued for 1800 s (30 min).

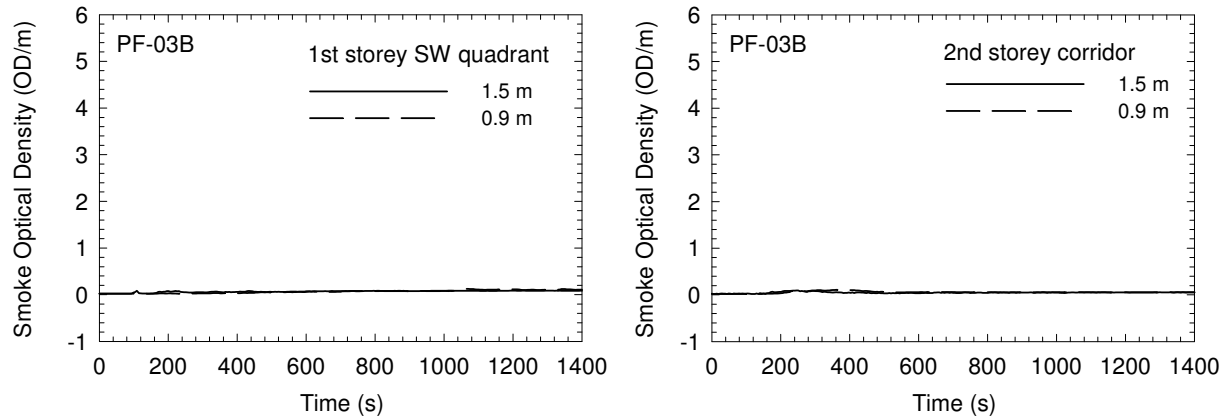
Figure 76. Smoke optical density measurements in Test PF-03B

The optical density was measured at 0.9 and 1.5 m heights (simulating the height of the nose/mouth of an average height individual crawling and standing, respectively) above the floor on the first and second storeys. Figure 76 shows the optical density-time profiles; OD remained under 0.15 m^{-1} throughout the upper storeys during the experiment. At this smoke level, a normal person should still be able to see the surroundings.

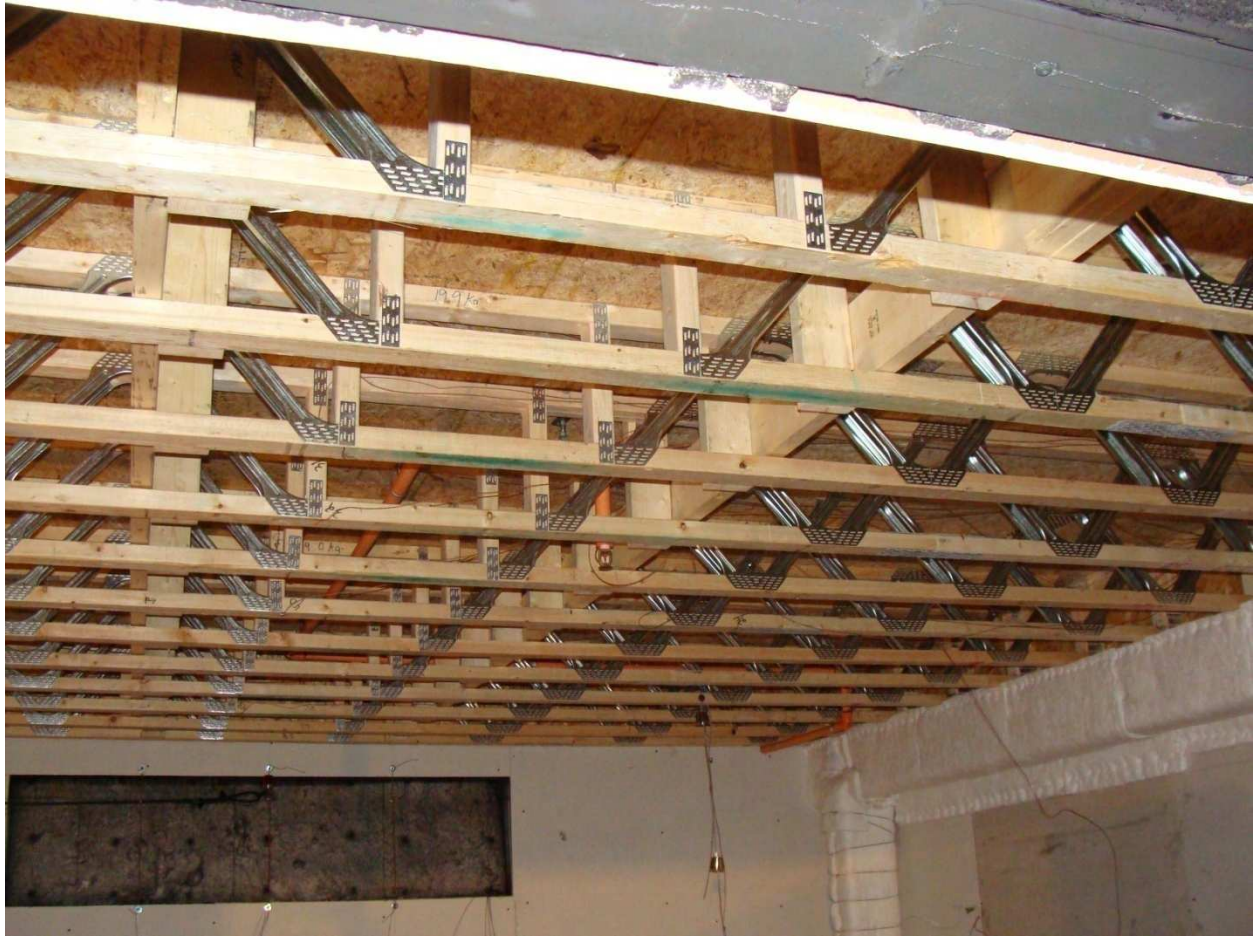
Figure 83. Metal-web wood truss assembly and sprinkler in Test PF-06

The overall dimensions of the metal-web wood truss assembly were 5079 mm x 5150 mm. The assembly had no finished ceiling in the basement – the trusses were exposed in the fire room. Figure 82 and Figure 83 show the test assembly, along with sprinkler and fuel package. The metal-web wood trusses were 302 mm deep, with top and bottom chords of dimensions of 38 mm x 64 mm. The metal webs (20 gauge) had teeth 9.5 mm long and had 0.0171 teeth per square millimeter. The trusses were spaced at 400 mm on centre. The bottom chords of the trusses were reinforced with two strongbacks 38 mm x 140 mm located toward the centre of the span. Based on calculations of maximum strength and deflection, the truss span length chosen was 4.813 m. This span allowed the metal-web wood trusses to extend across the entire length of the fire room (with no need for an intermediate support). Rim boards (headers) 9.5 mm thick x 302 mm deep, were placed around the assembly. In addition, a solid wood 38 mm x 89 mm x 5150 mm member as part of the header was added at the top ends of the trusses to provide lateral support.

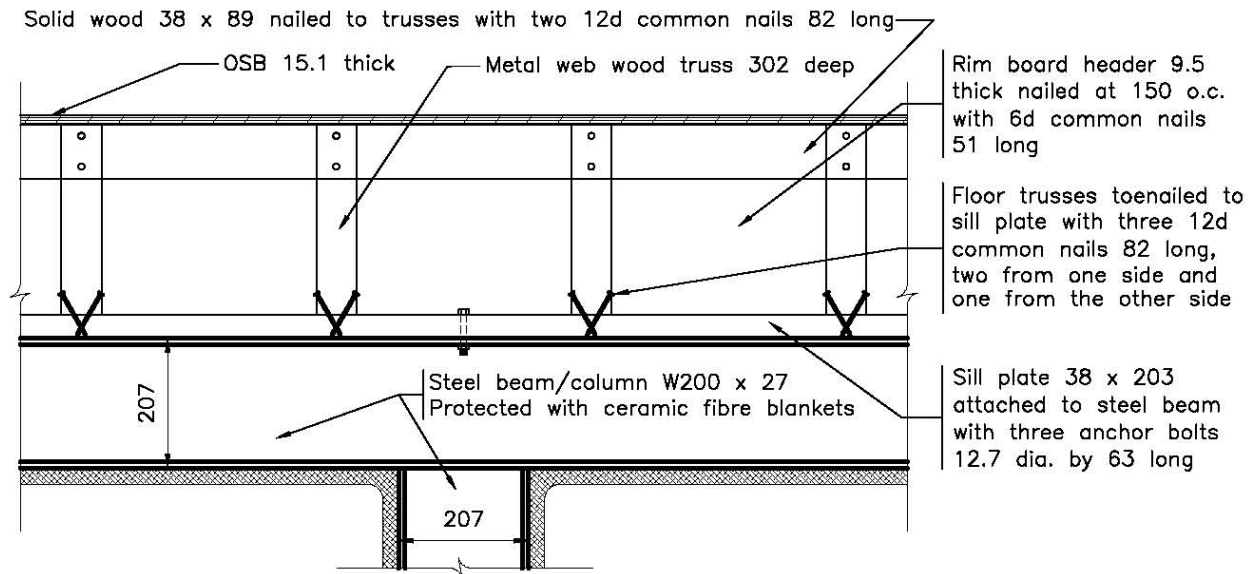
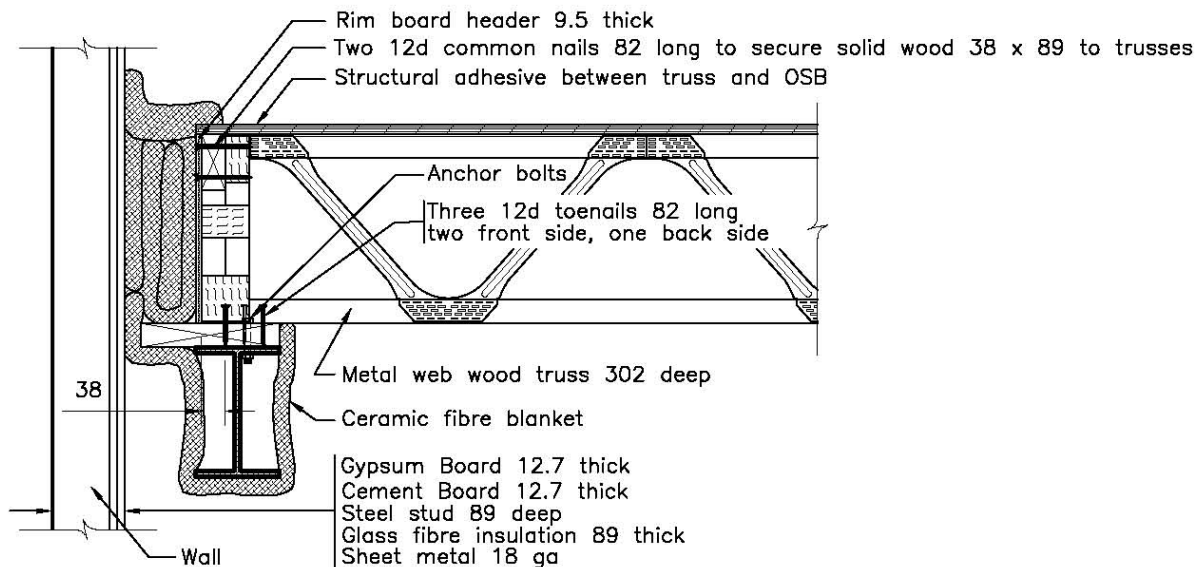
End connection details (East view)

End connection details (North view)

Figure 84. Details of end connection and supports for Test PF-06 (sprinkler protection) (dimensions in mm)

The metal-web wood truss assembly was supported by two horizontal steel beams, each of which was supported by two steel columns (a total of four columns for each assembly). The beams were bolted to the columns, which were stiffened by steel bars and rested stably on the floor under the weight of the assembly and beams. Figure 84 shows the details of the end connection and supporting beams. Ceramic fibre blankets were used to fill any gaps between the assembly and the end walls, also to protect the steel beams and columns.

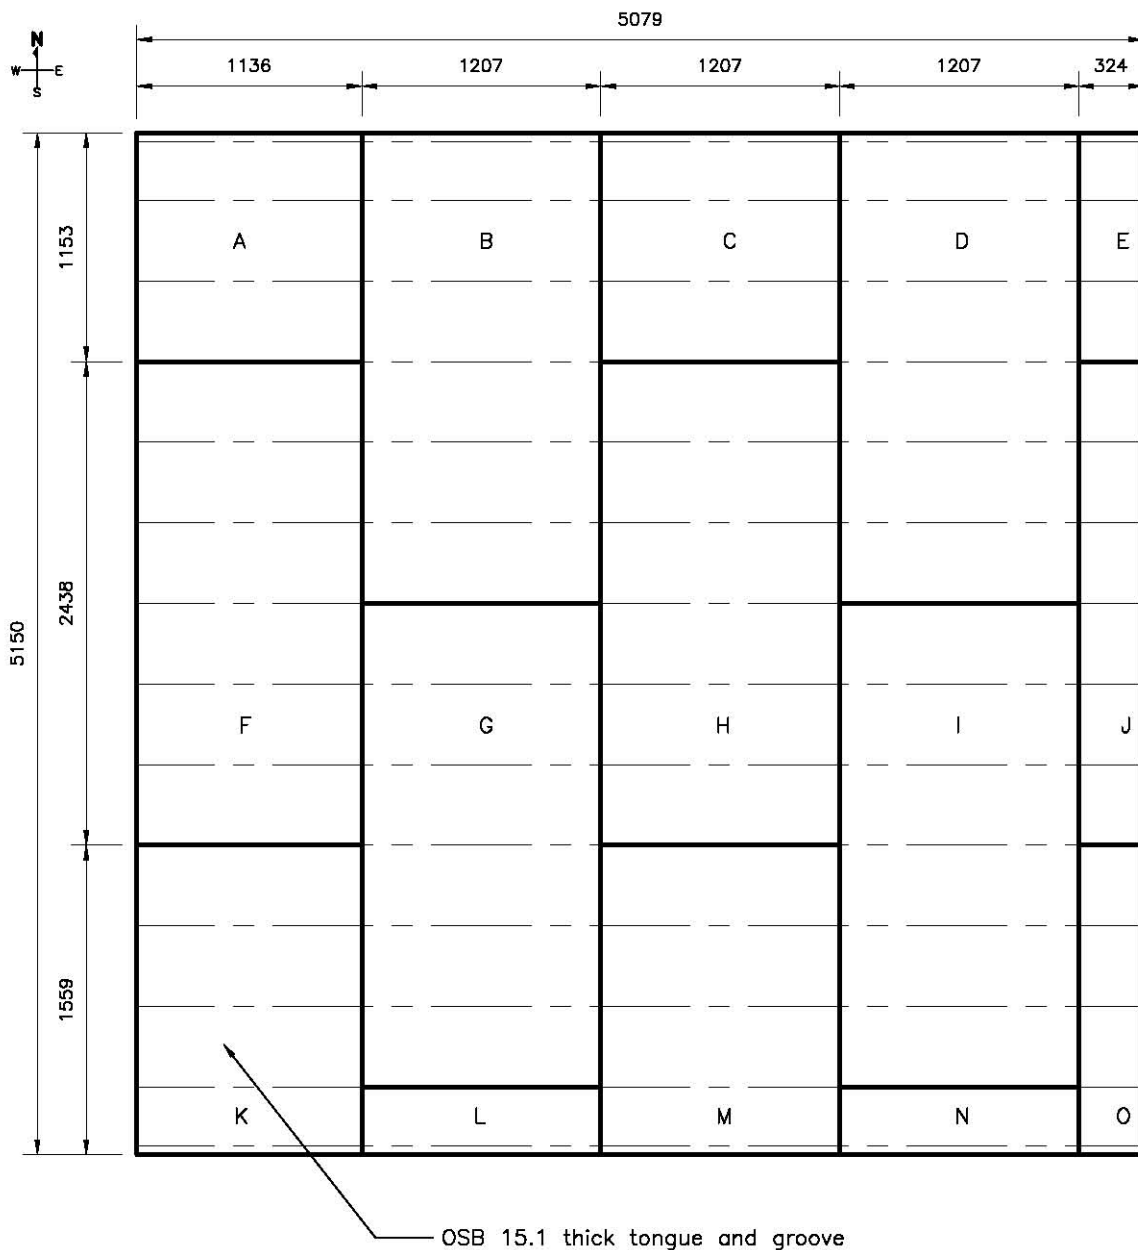
Figure 85. OSB subfloor layout (Tests PF-06 and PF-06C) (all dimensions in mm)

OSB was used as the subfloor material in the test assembly. The specific OSB material used was selected based on a separate study documented in reference [28]. The subfloor panels were 15.1 mm thick, with a full panel size of 1.2 x 2.4 m. The longer panel edges had a tongue-and-groove profile while the short panel edges were square butt ends. Figure 85 shows the layout of the subfloor. The screw pattern and description of screws used to attach the OSB panels to the metal-web wood trusses are shown in Figure 86.

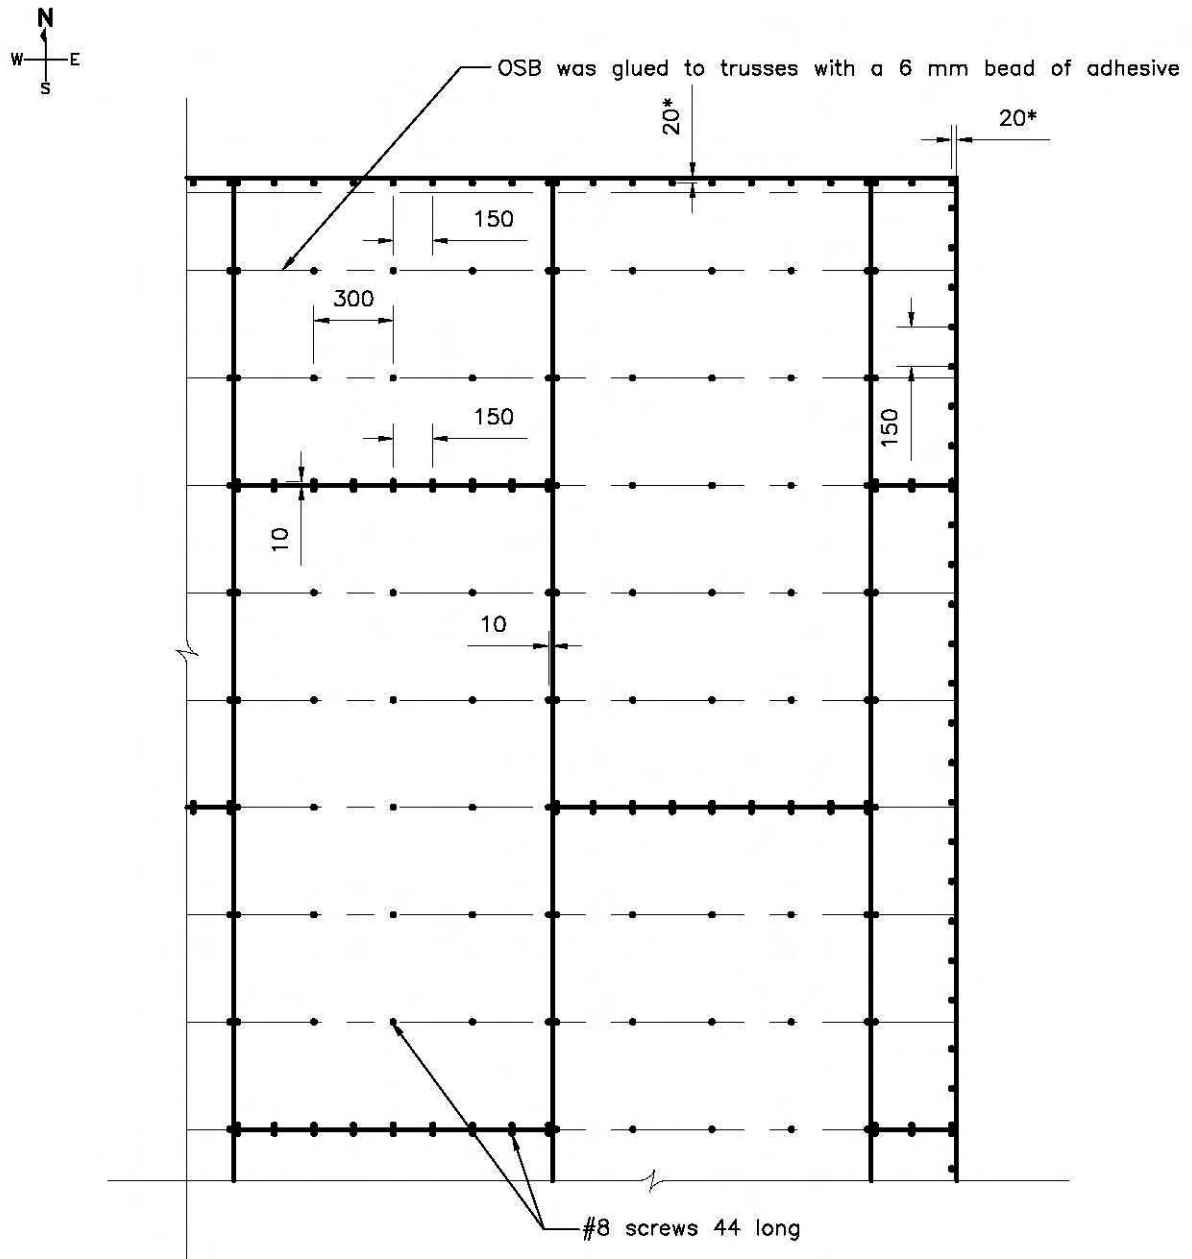
Figure 86. Subfloor screw pattern (Tests PF-06 and PF-06C) (all dimensions in mm)

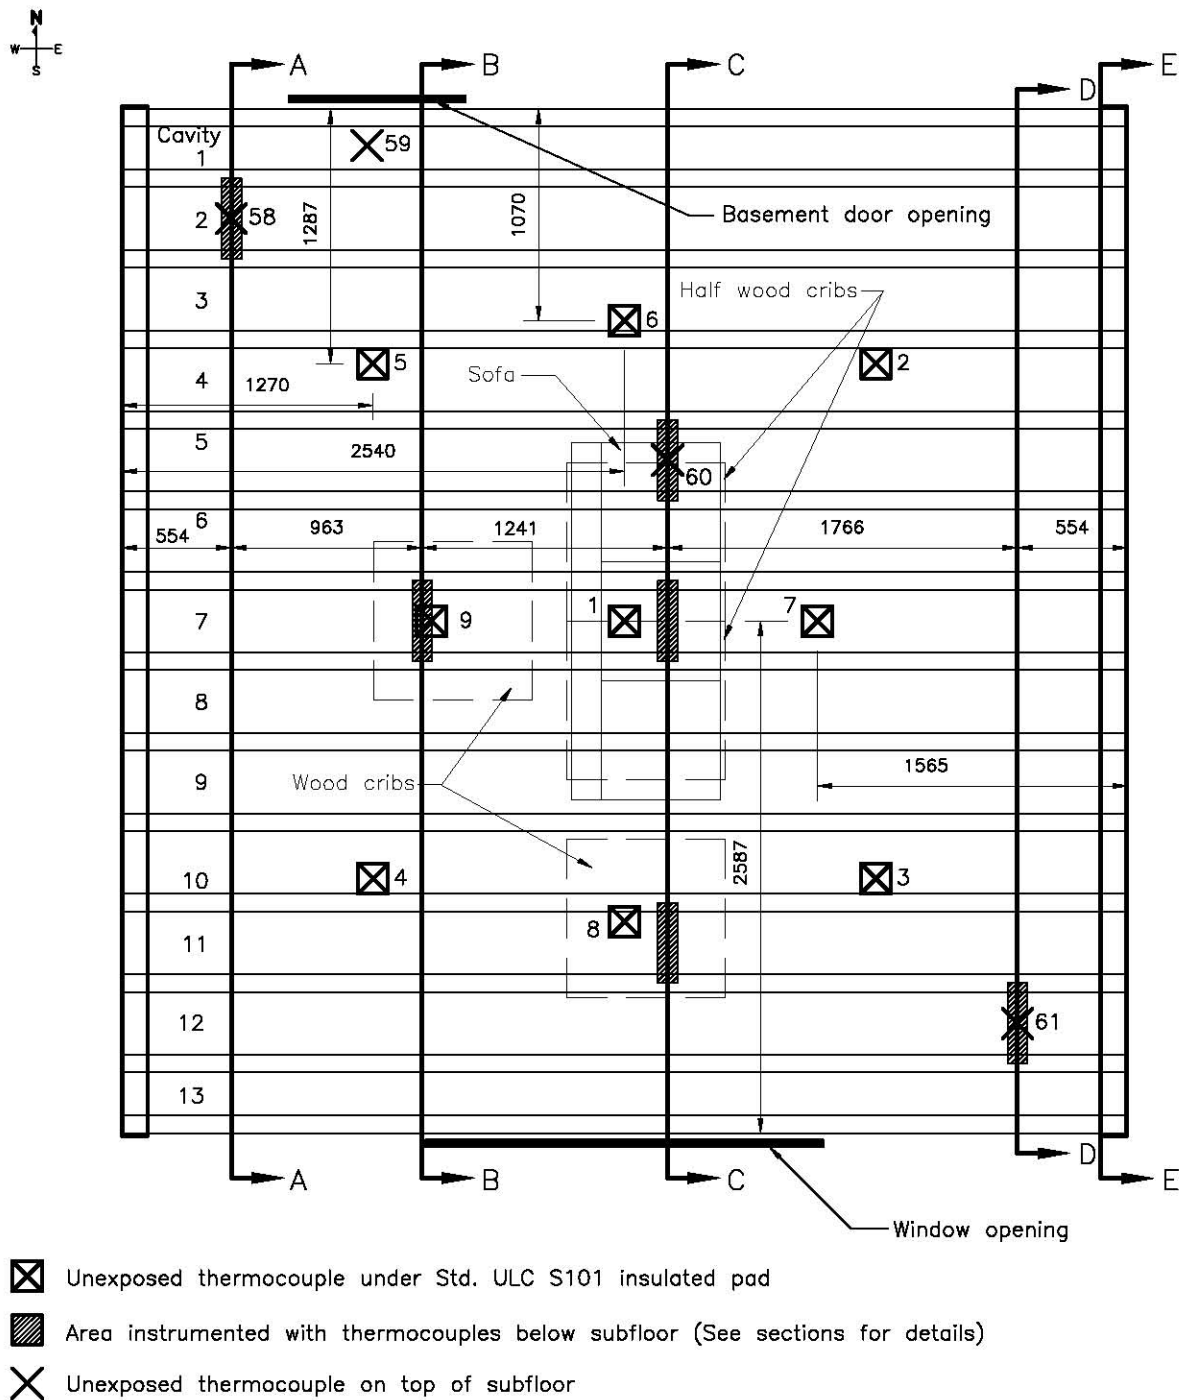
Figure 87. Thermocouples locations (Tests PF-06 and PF-06C) (all dimensions in mm)

Sixty-one Type K (20 gauge) chromel-alumel thermocouples, with a thickness of 0.91 mm, were used for measuring temperatures at a number of locations throughout the assembly. The thermocouples were located on the unexposed side and in the cavities of the assembly as shown in Figure 87 and Figure 88. These locations were chosen to monitor the conditions of the assembly at critical locations during the fire tests. The floor deflection was measured at 9 points on the unexposed surface of the test assembly at the locations shown in Figure 13.

The thermocouples for measuring temperatures throughout the assembly were located on the unexposed side and in the cavities of the assembly as shown in Figure 87 and Figure 99.
