Performance of Protected Ceiling/Floor Assemblies and Impact on Tenability with a Basement Fire Scenario

IRC-RR-307

May 2011

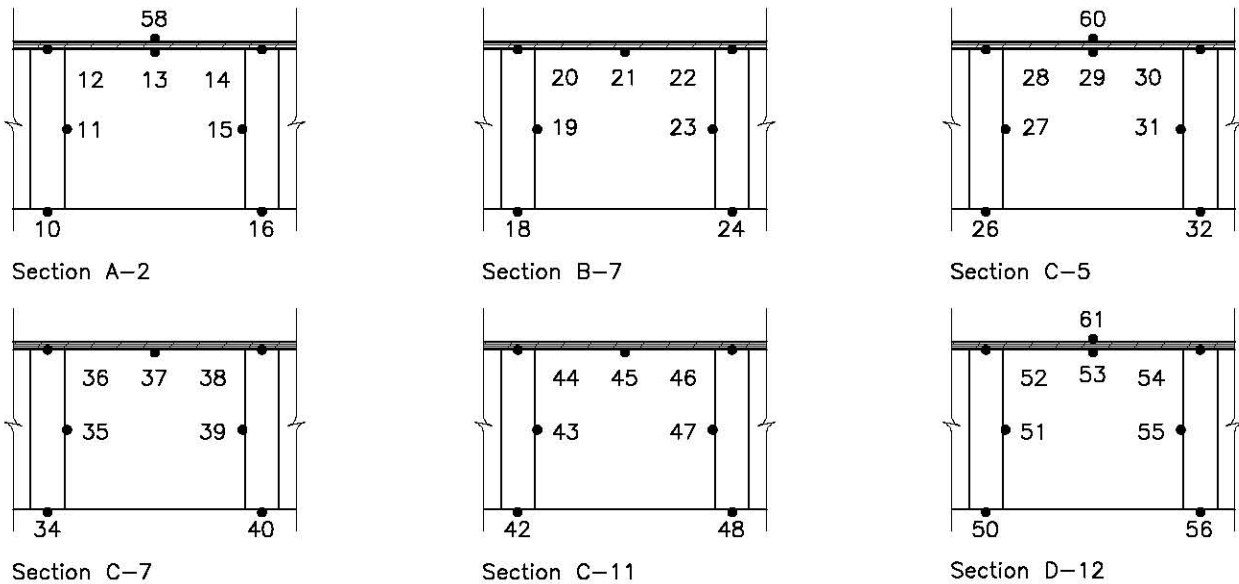
Figure 88. Thermocouples installed in the sections shown in Figure 87 (Test PF-06 only)

Sixty-one Type K (20 gauge) chromel-alumel thermocouples, with a thickness of 0.91 mm, were used for measuring temperatures at a number of locations throughout the assembly. The thermocouples were located on the unexposed side and in the cavities of the assembly as shown in Figure 87 and Figure 88. These locations were chosen to monitor the conditions of the assembly at critical locations during the fire tests. The floor deflection was measured at 9 points on the unexposed surface of the test assembly at the locations shown in Figure 13.

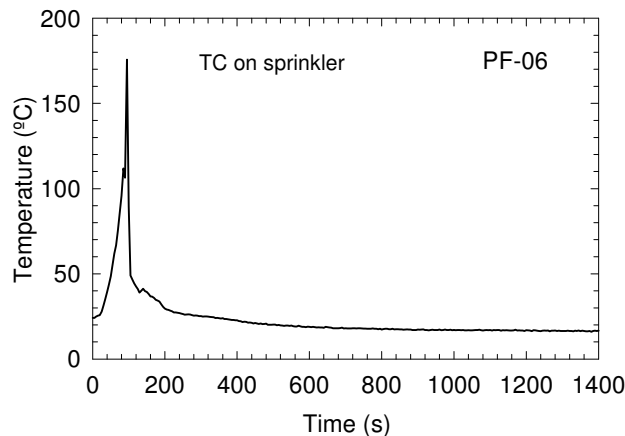
Figure 89. Temperature beside sprinkler in the basement fire room in Test PF-06

The polyurethane foam used for the mock-up sofa was ignited and dominated the initial fire growth. Figure 89 shows the temperature measured beside the sprinkler in the basement fire room. The sprinkler activated at 87 s and quickly suppressed the fire. Based on observation and video records, visible flame disappeared in the fire room at 200 s. There was no more visible flame afterward. The sprinkler discharge continued for 1800 s (30 min).

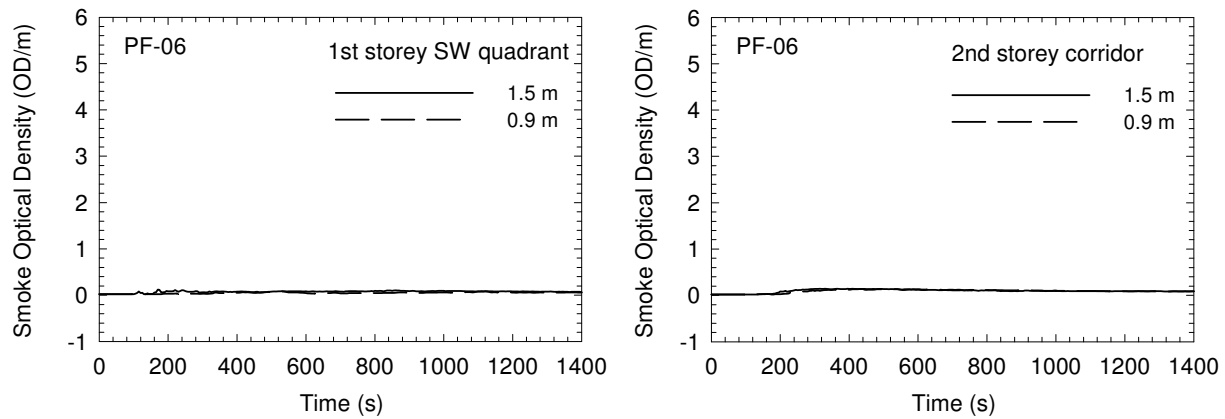
Figure 91. Smoke optical density measurements in Test PF-06

The optical density was measured at 0.9 and 1.5 m heights (simulating the height of the nose/mouth of an average height individual crawling and standing, respectively) above the floor on the first and second storeys. Figure 91 shows the optical density-time profiles; OD remained under 0.15 m^{-1} throughout the upper storeys during the experiment. At this smoke level, a normal person should still be able to see the surroundings.

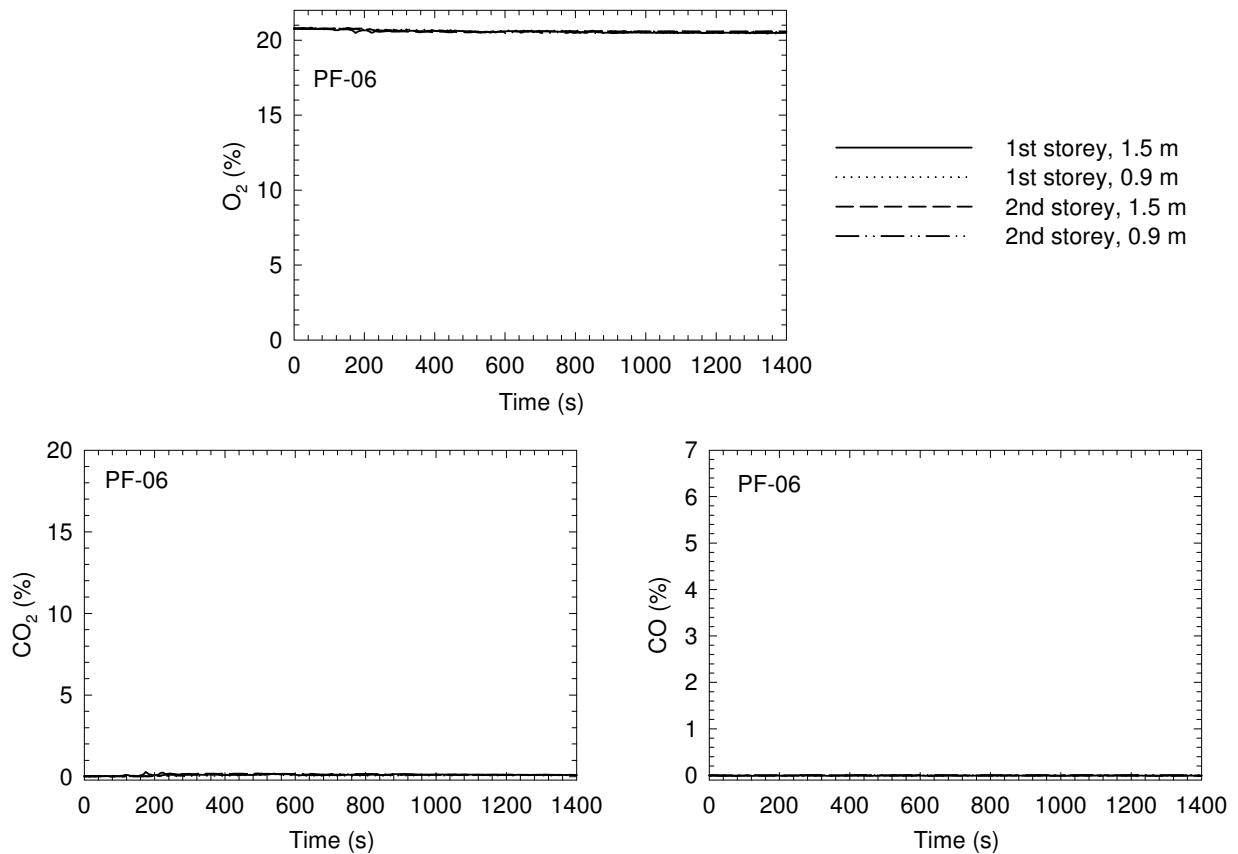
Figure 92. CO, CO₂ and O₂ concentrations in Test PF-06

Figure 92 shows the CO, CO₂ and O₂ concentrations at the southwest quarter point on the first storey and at the centre of the corridor on the second storey during the experiment. The oxygen concentrations were above 20.5%. The CO₂ concentrations were below 0.25%, and CO below 0.01%. These conditions would not cause incapacitation or any reduction in tenable conditions.

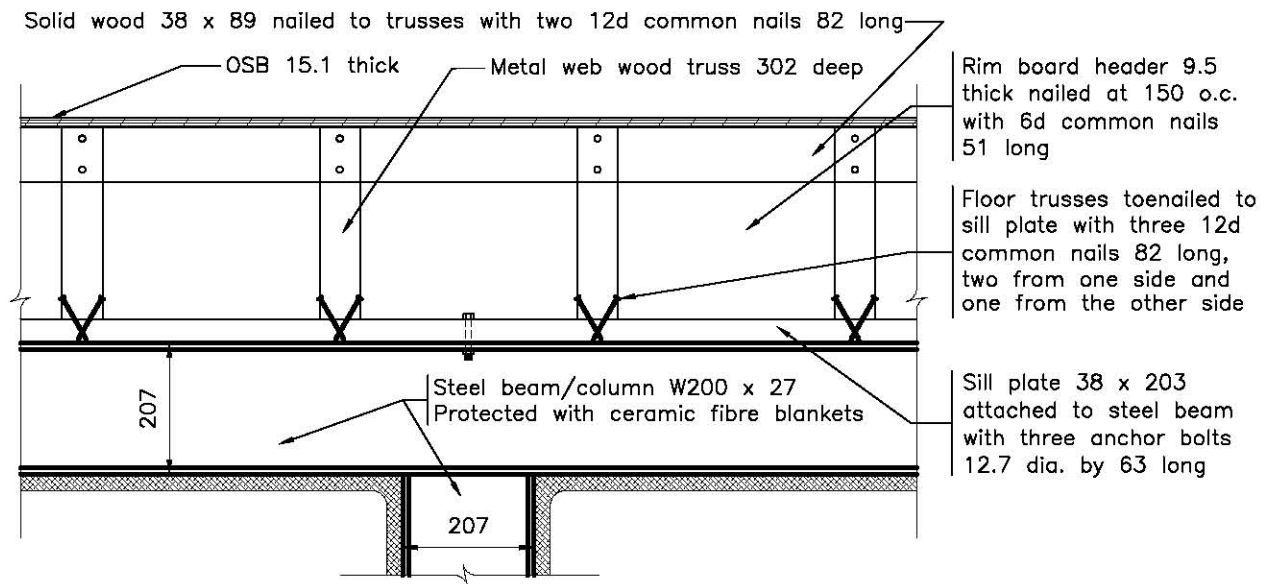
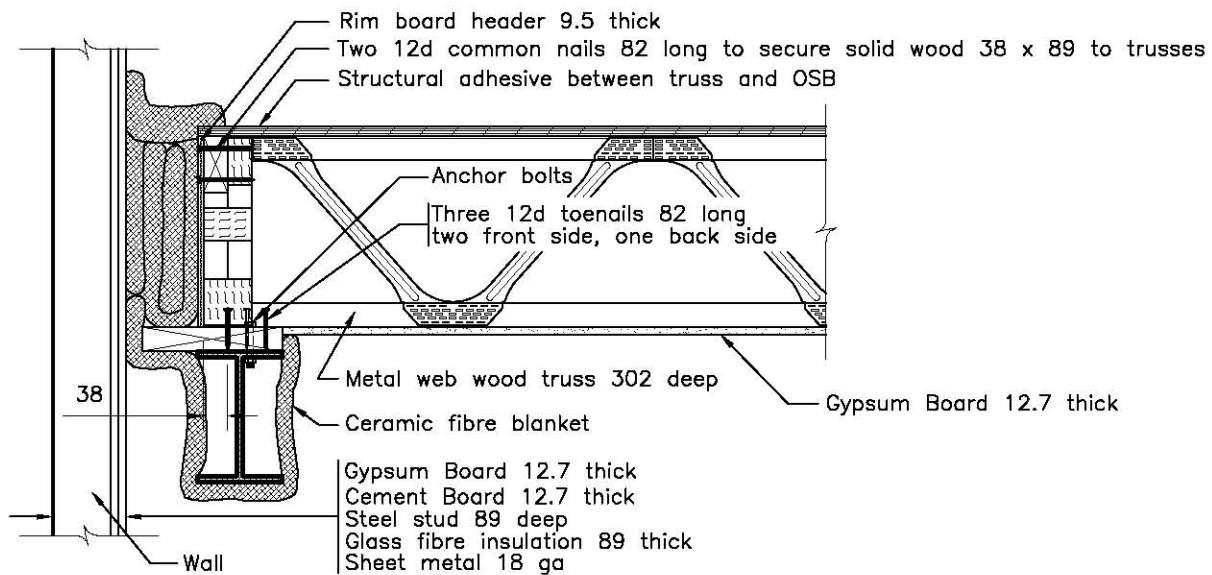
Figure 98. Details of end connection and supports for Test PF-06C (gypsum protection) (all dimensions in mm)

End connection details (East view)

End connection details (North view)

Regular gypsum board was installed on the basement side of the PF-06 assembly by being fastened directly to the bottom chords of the metal-web wood trusses. The gypsum board was 12.7 mm thick, with a full sheet size of 1.2 x 2.4 m. Figure 39 and Figure 98 show details of the gypsum board installation and layout, end connection and the supporting beams. The joints of the gypsum board were finished with joint compound and tape. The screw pattern and description of screws used to fasten the gypsum board to the trusses and rim board (header) are shown in Figure 10.

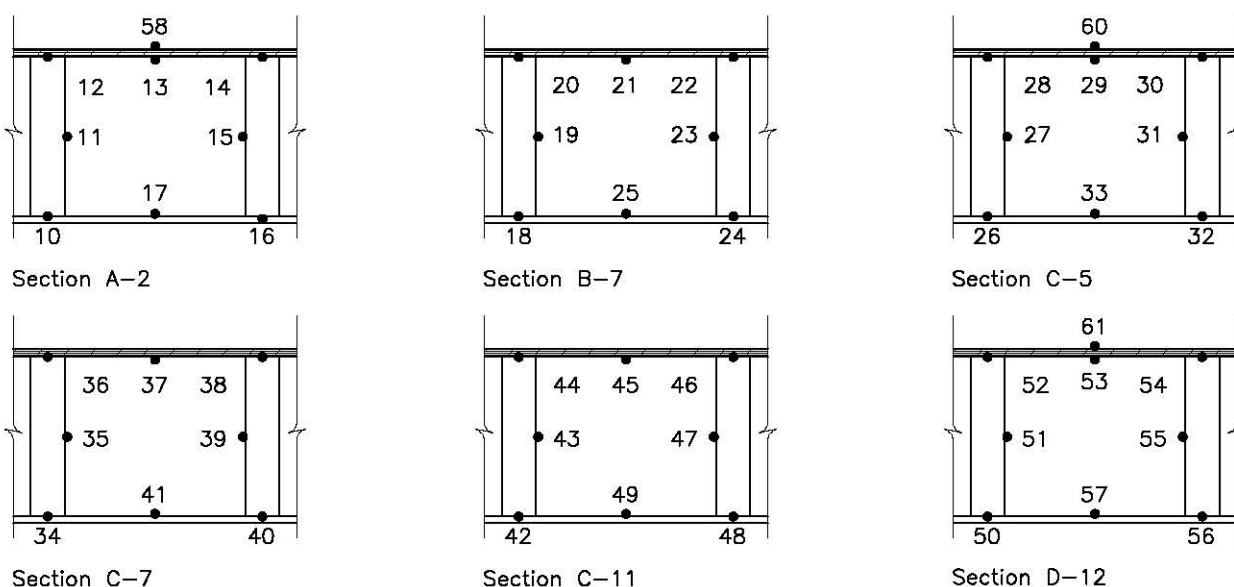
Figure 99. Thermocouples installed in the sections shown in Figure 87 (Test PF-06C only)

The thermocouples for measuring temperatures throughout the assembly were located on the unexposed side and in the cavities of the assembly as shown in Figure 87 and Figure 99.

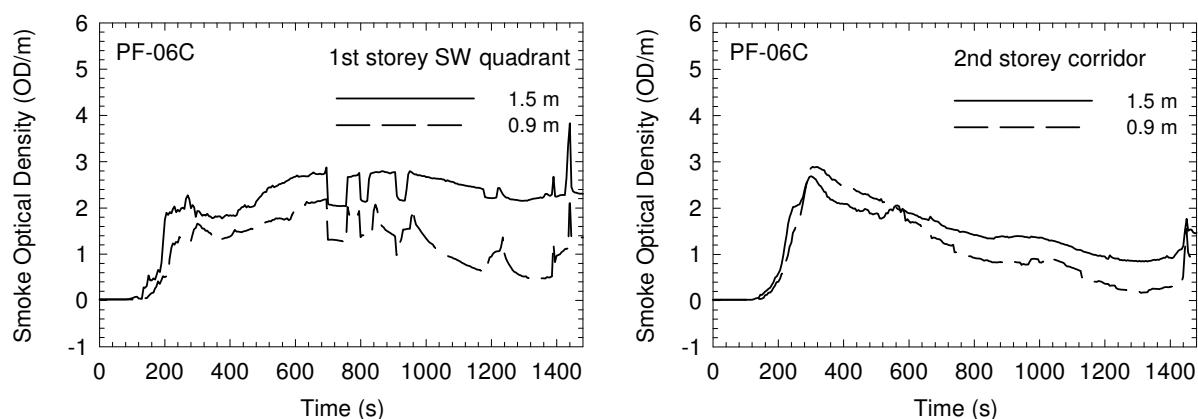
Figure 101. Smoke optical density measurements in Test PF-06C

The optical density was measured at 0.9 and 1.5 m heights (simulating the height of the nose/mouth of an average height individual crawling and standing, respectively) above the floor on the first and second storeys. Table 27 shows the times to reach $OD = 2 \text{ m}^{-1}$. Figure 101 shows the optical density-time profiles. It must be pointed out that the video records show no signs of decrease in the optical density after the first peak, indicating that the smoke density meters started the self-purging cycle after the first peak. The smoke density meter has an operation temperature limit of 80°C in its gas chamber; when this temperature is reached, the
