https://doi.org/10.1061/(ASCE)1076-0342(2007)13:1(1) Journal of Infrastructure Systems, 13, March 1, pp. 1-11, 2007-03-01

QUANTIFYING EFFECTIVENESS OF CATHODIC PROTECTION IN WATER MAINS: CASE STUDIES

Balvant Rajani and Yehuda Kleiner Institute for Research in Construction, National Research Council Canada, Ottawa, Ontario Canada K1A 0R6 Tel: (613)-993-3810, fax: (613)-954-5984 E-mail: <u>Balvant.Rajani@nrc-cnrc.gc.ca</u>

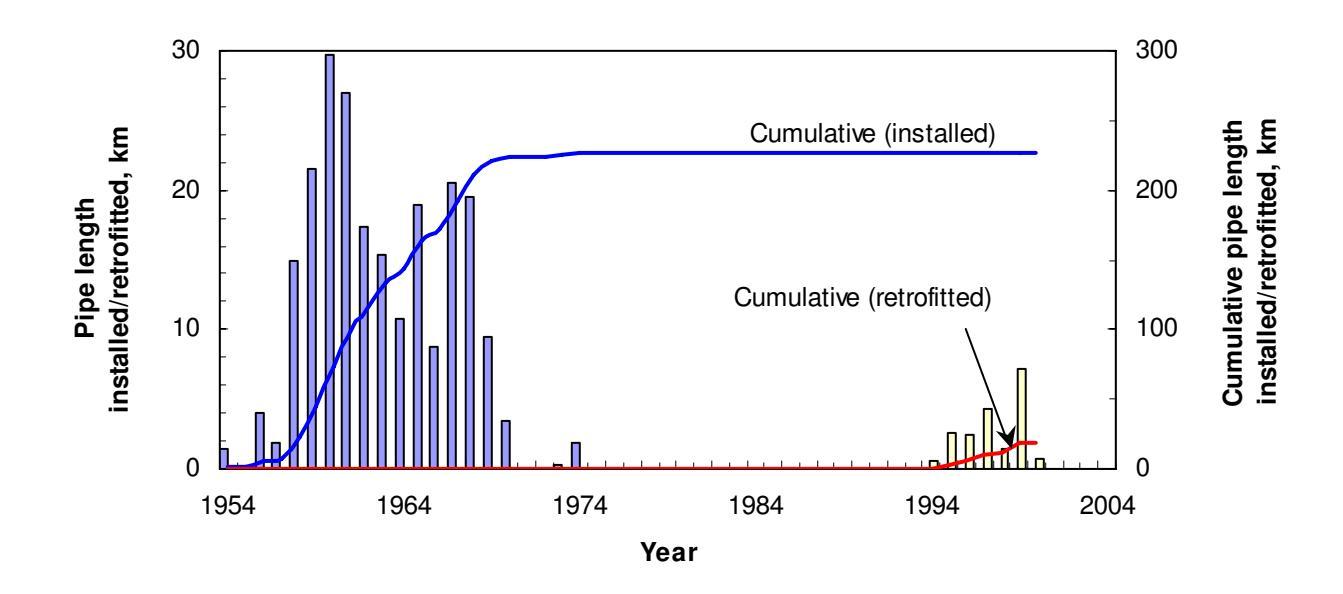
Figure 1. Lengths of 150 mm diameter CI pipes installed (between 1954 and 1974) and retrofitted (between 1994 and 2000) in Ottawa.

Several groups of pipes were established from the Ottawa data but only one, Group OT-1, is discussed here. Group OT-1 consisted of lined cast iron (CI) pipes, 150 mm in diameter, installed between 1954 and 1974. The total length of the water mains in Group OT-1 was 227 km and the total number of breaks recorded was 1,324. In Group OT-1, 19 km of water mains have been CP-retrofitted through the period 1994-2000. These retrofitted mains were denoted Sub-Group OT-1b. The water mains in Group OT-1 that have not been retrofitted (208 km) were denoted Sub-Group OT-1a. Pipes in Group OT-1 have been protected with hot spot CP (HS CP) since 1990. Figure 1 shows the all the CI

pipes in Group OT-1 and the portion of those retrofitted between 1994 and 2000. Table 1 gives key characteristics for pipes within each sub-group of Group OT-1.

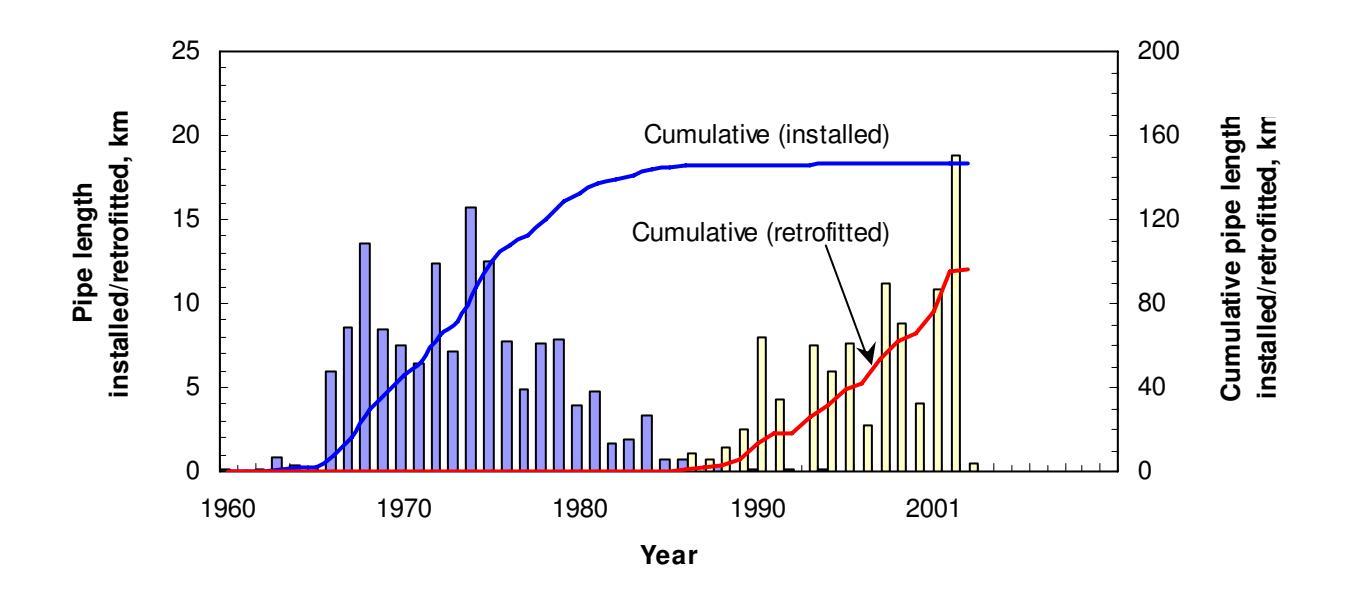
Figure 2. Lengths of 150 mm diameter DI pipes installed (between 1960 and 1994) and retrofitted (between 1994 and 2003) in Scarborough.

Several homogeneous groups of pipes were established from the Scarborough data but only two groups, Groups SC-1 and SC-3, are discussed here. Group SC-1 consisted of 150 mm cast iron mains installed between 1921 and 1940, which corresponded to the period when pit cast iron mains with thick wall thickness were produced. Group SC-3 consisted of 150 mm ductile iron mains installed between 1960 and 1996 as shown in Figure 2 and subsequently retrofitted between 1986 and 2003. Group SC-3 was divided into sub-groups 'a' and 'b' representing pipes without and with retrofit, respectively. Table 1 gives key characteristics for pipes within each sub-group of Group SC-3.

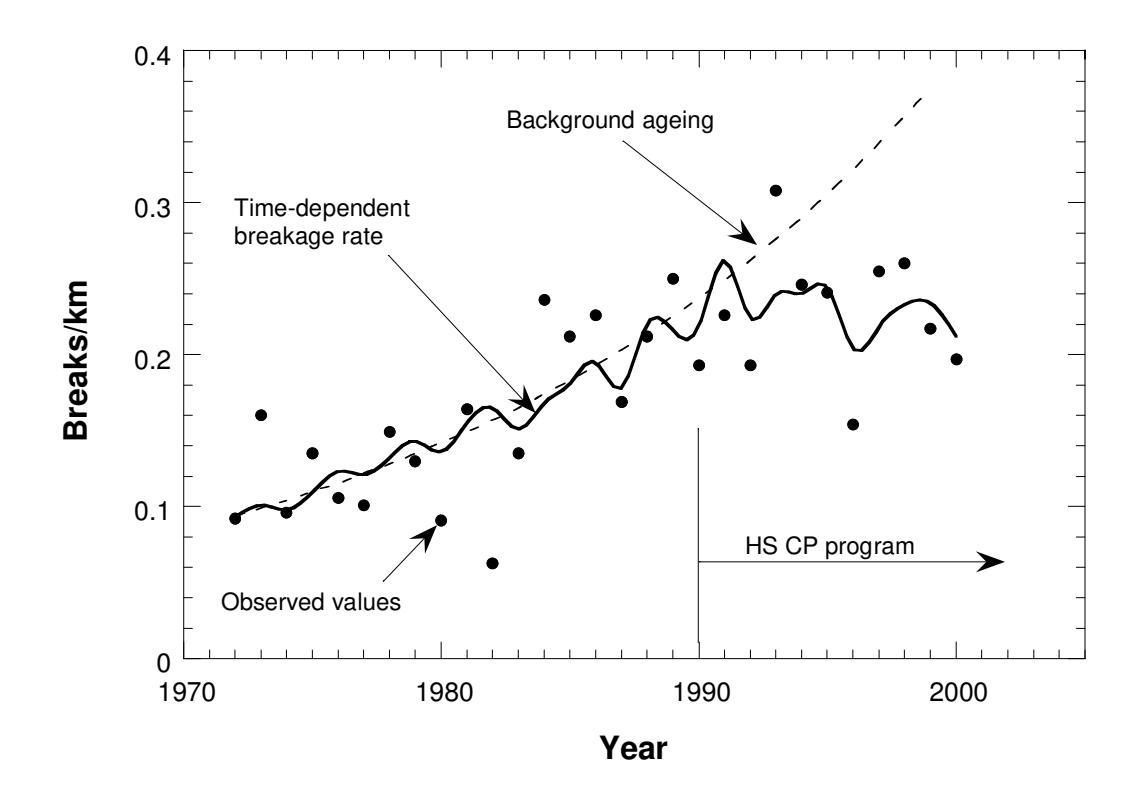
Figure 3. Breakage analysis for pipe sub-group OT-1a.

Figure 3 illustrates the breakage rate pattern between 1970 and 2001 identified for the sub-group OT-1a with a hot spot cathodic protection (HS CP) program that started in 1990. The covariates used for the regression included the (mandatory) background ageing as well as freezing index (*FI*), rain deficit (*RD*) (both cumulative and snapshot), and (HS CP). For the HS anodes, the life expectancy and time lag were assumed $t_{LF} = 15$ years, $t_{LG} = 1$ year, respectively (life expectancy is defined as the duration through which the anode functions effectively in the ground, time lag is defined as the average time between anode installation and full cathodic protection – see Kleiner and Rajani, 2004).

The coefficients (Table 2) corresponding to each of the covariates applied in this analysis indicate the influence of each covariate on the historical breakage pattern. The ageing rate of 0.053 of sub-group OT-1a indicates that the breakage rate (breaks/km) increased about 5.3% annually. This 'background ageing' is depicted by the dashed curve in Figure 3. The quality of the model 'fit' in the break history analysis of sub-group OT-1a (adjusted coefficient of determination $r^2 = 0.558$) could be considered as quite high for this type of analysis.

The freezing index (*FI*) at a value of -0.058 had a rather small influence on the breakage pattern. The rainfall deficit (*RD*) coefficients with values as small as 0.016 and 0.04, seemed to play an insignificant role. A plausible reason for *FI* having such a minor influence on the breakage rate in Ottawa is that the typical depth of water mains is 2.4 m (8 feet), which is below much of the frost penetration depth. Further, Ottawa receives a high precipitation rate throughout the year and therefore the soil moisture is rarely depleted, which might explain why *RD* had no influence on the breakage pattern of subgroup OT-1a. The hot spot CP had a notable influence in decreasing break rates (coefficient value of -0.135), as is evident from the downturn of the breakage rate starting in the early 1990s.

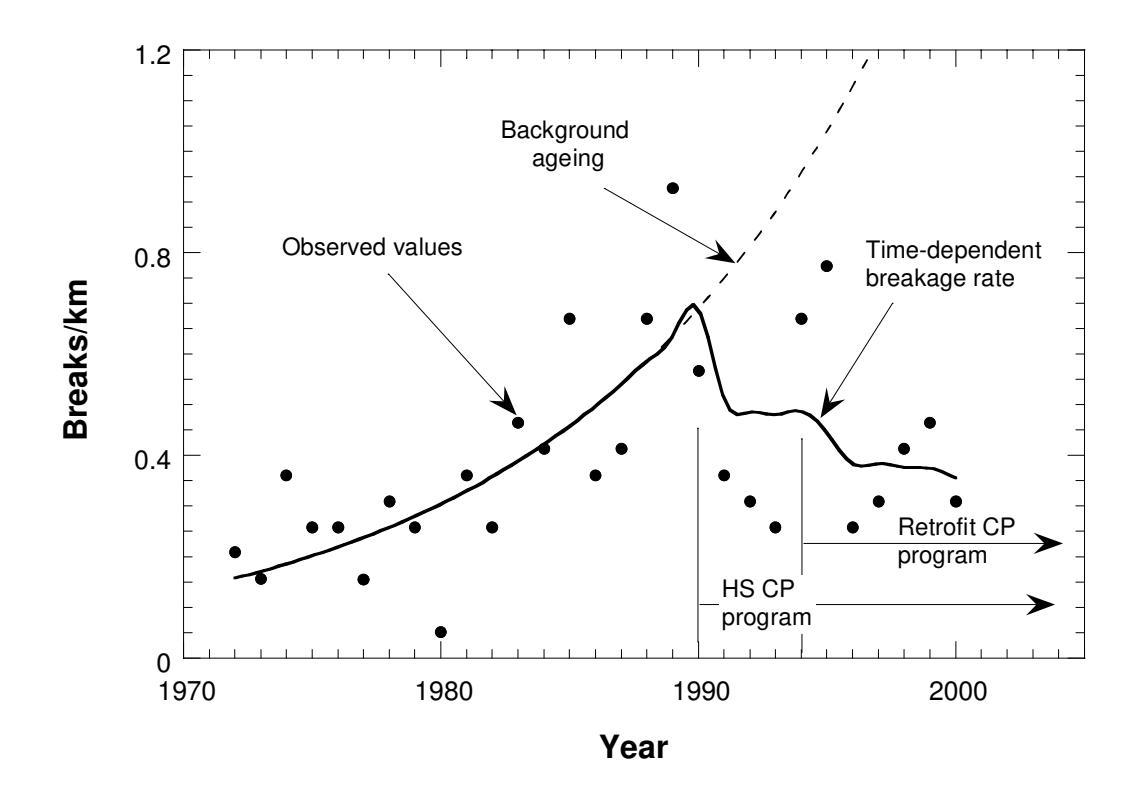
Figure 4. Breakage analysis for pipe group OT-1b.

Figure 4 illustrates the historical breakage pattern established for the sub-group OT-1b, with 19 km of CI pipes that have been 'hot spotted' since 1990 and gradually retrofitted with CP since 1994. Similar to sub-group OT-1a (and arguably for the same reasons described earlier), the climate covariates did not have a significant influence on the quality of the model 'fit'. In fact, omitting the *FI* and *RD* covariates from the analysis increased the value of the adjusted coefficient of variation (r^2) because of the 'gain' of three degrees of freedom in the regression. The ageing rate, however, was almost 50% greater than that of OT-1a, at 0.082, which probably explains why this group of pipes was first selected for retrofit.

Figure 4 clearly shows the sharp downturn in the breakage rate in the early 1990s following the start of the HS CP program. There seemed to be a continuing decline in the breakage rate from the mid 1990s, when the retrofit program started. It should be noted that the mathematical model assumes that once a pipe is retrofitted, the HS CP effect is completely overwhelmed by the retrofit effect because of the sheer density of the retrofit anodes and because it is assumed that retrofit CP is renewed in perpetuity. Consequently, the model attributes the decline in breakage rate after 1994 to the retrofit program; however, it is plausible that the breakage rate in this group might have continued to decline with the HS CP only, even without the retrofit CP program.

The relatively low adjusted coefficient of determination ($r^2 = 0.316$) indicates a moderately poor fit of the model to the data. This could be partially explained by the

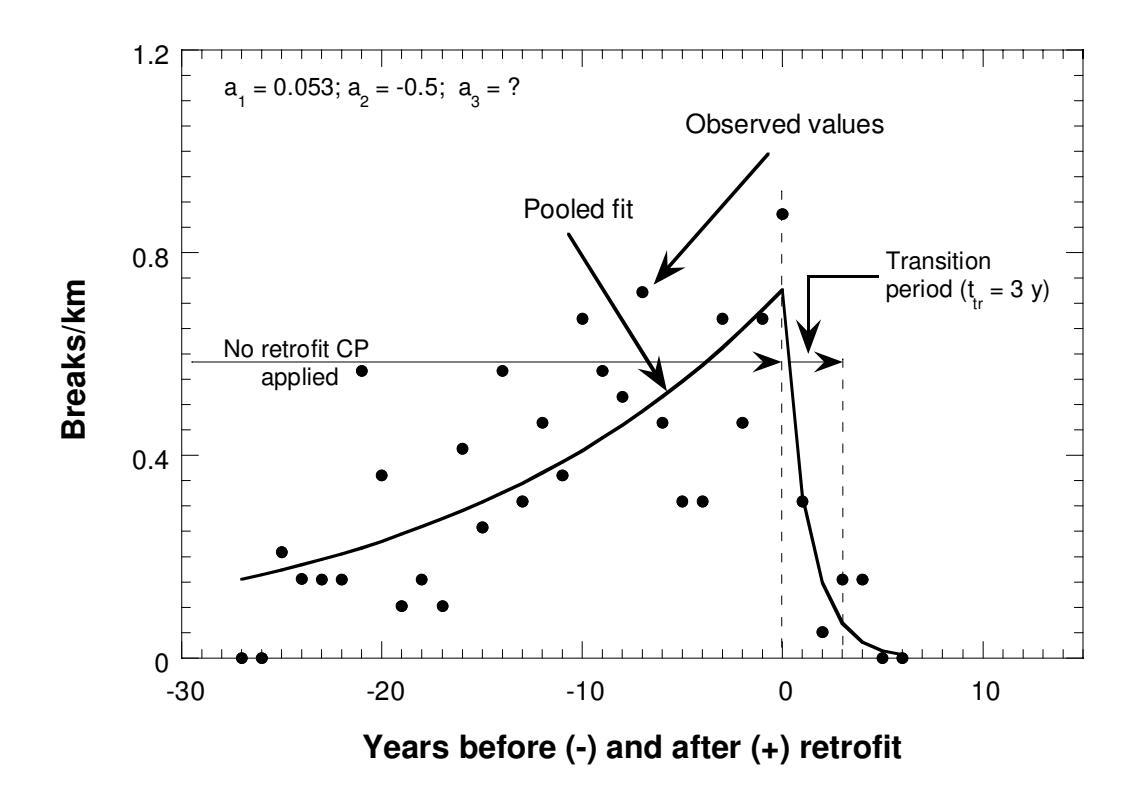
Figure 5. Breakage analysis for pooled data of pipe group OT-1b.

For situations where few data exist on breakage rates before and after retrofit CP, Kleiner and Rajani (2004) proposed an alternative method to establish model coefficients, where the breakage data are pooled so as to reflect breakage rates at years relative to the year of retrofit, rather than along an actual time line. Figure 5 shows the breakage pattern before and after retrofit CP for sub-group OT-1b. Two of the three phases of the retrofit model, pre-retrofit breakage increase and post-retrofit transition period are clearly shown. There were insufficient post-retrofit breakage data to establish the post-retrofit (third phase) breakage pattern.

The ageing rate prior to retrofit CP (phase 1) is $a_1 = 0.053$, which is smaller than 0.082 obtained through the true 'time-line' break history analysis. This apparent incongruity could be explained by the fact that in the last 5 years prior to the beginning of the retrofit program the pipes had been protected by HS CP, which reduced the observed pre-retrofit breakage rate. The transition period (t_{tr}) was found to be 3 years with a breakage rate reduction coefficient $a_2 = -0.5$. The adjusted coefficient of determination was a relatively high 0.605. The pooled analysis shows that corrosion is essentially arrested within a period of 3 years after anode installation. The post retrofit ageing parameter, a_3 , could not be reliably established because of insufficient post retrofit data.

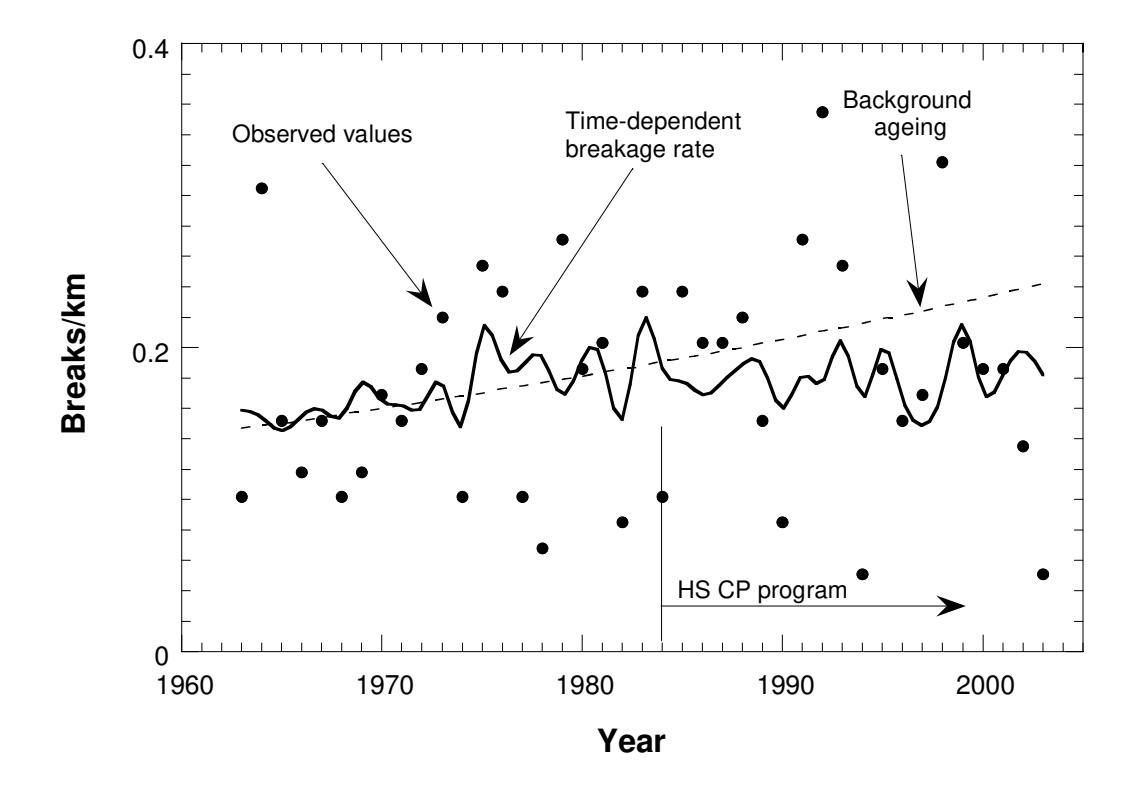
Figure 6. Breakage analysis for Group SC-1.

Figure 6 illustrates the pattern of the historical breakage rates established for Group SC-1, with a hot spot CP program that commenced in 1984. The adjusted coefficient of determination ($r^2 = -0.099$) is very low, indicating a poor 'fit' of the model to observed data. The ageing rate is estimated at 0.012 (breaks/km). The hot spot CP program did not seem to have had minor (if any) influence on the observed break rates.

A coherent ageing pattern was not detected and the climatic as well as the CP covariates did not seem to contribute much to the model's 'explanatory' ability. A possible

explanation for this phenomenon could be that the pipes within this group belonged to a class of pipes that were manufactured prior to 1957 and had a wall thickness of 10.9 mm (0.43 in), which is high in comparison with pipes that were manufactured and installed in later years. It is possible that the high wall thickness for this vintage of pipes was responsible for the lack of visible ageing. This phenomenon may correspond to the bathtub theory (Kleiner and Rajani 2001), where this group could be in the 'in-usage' phase (where breaks are random and breakage rate is constant before visible ageing starts). It should however be noted that the exponential models used in the current analysis cannot mathematically accommodate the bathtub theory. It might therefore be beneficial to dedicate future research to developing an alternative model that could address pipe groups whose breakage pattern resembles the 'in-usage phase'.

It can be seen that in this group, this 'constant' breakage rate (0.1 - 0.3 breaks/km/yr) is relatively low compared to the other groups, which is another indicator that Group SC-1 is in the 'in-usage' phase of a typical bathtub curve of the life cycle of a buried pipe. It should be noted that this specific group was selected as a case history to illustrate that it is not always possible to identify ageing (deterioration) where observed data indicate that it does not exist.

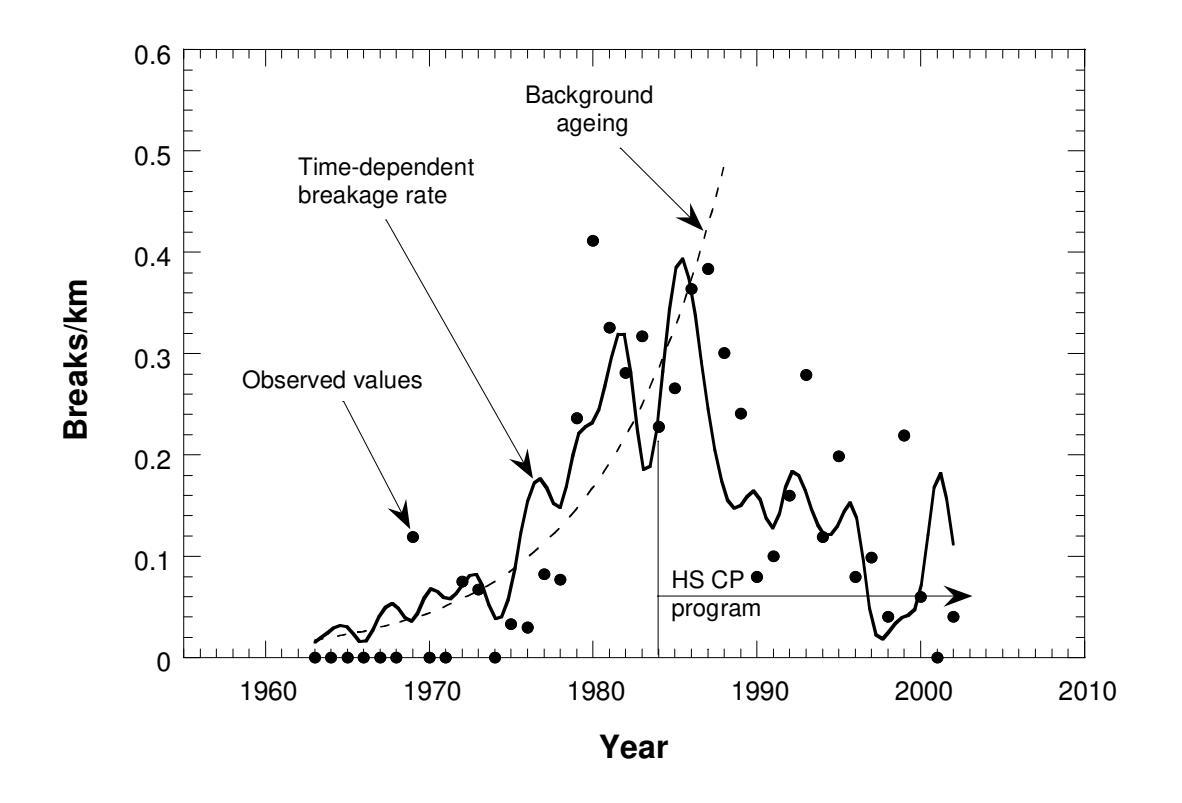
Figure 7. Breakage analysis for sub-group SC-3a

The break history analysis for sub-group SC-3a is shown in Figure 7 and the values for the corresponding coefficients are in Table 2. Sub-group SC-3a consisted of ductile iron (DI) pipes with hot spot CP anodes installed since 1984. The quality of the model "fit" in the break history analysis of sub-group SC-3a (adjusted coefficient of determination $r^2 = 0.524$) is moderately high. It appears that the hot spot CP program has had a dramatic influence (coefficient value of -0.503) in reducing the breakage rate of these ductile iron pipes for the past 20 years. The background ageing rate of 0.133 indicated an annual breakage rate increase (breaks/km) of about 13.3%, which is extremely high compared to the groups of mains discussed earlier.

All climatic covariates except freezing index (*FI*) turned out to have a significant effect on the breakage pattern of sub-group SC-3a. It should be noted, however, that the influence of snapshot rainfall deficit is significant and the value for the cumulative rainfall deficit is contrary to expectation according to the rationale provided by Kleiner and Rajani (2004). This contradiction could not be explained at the time of analysis. Further research is certainly warranted on possible pipe failure mechanisms that could explain this observation, or alternatively, improve the underlying model.

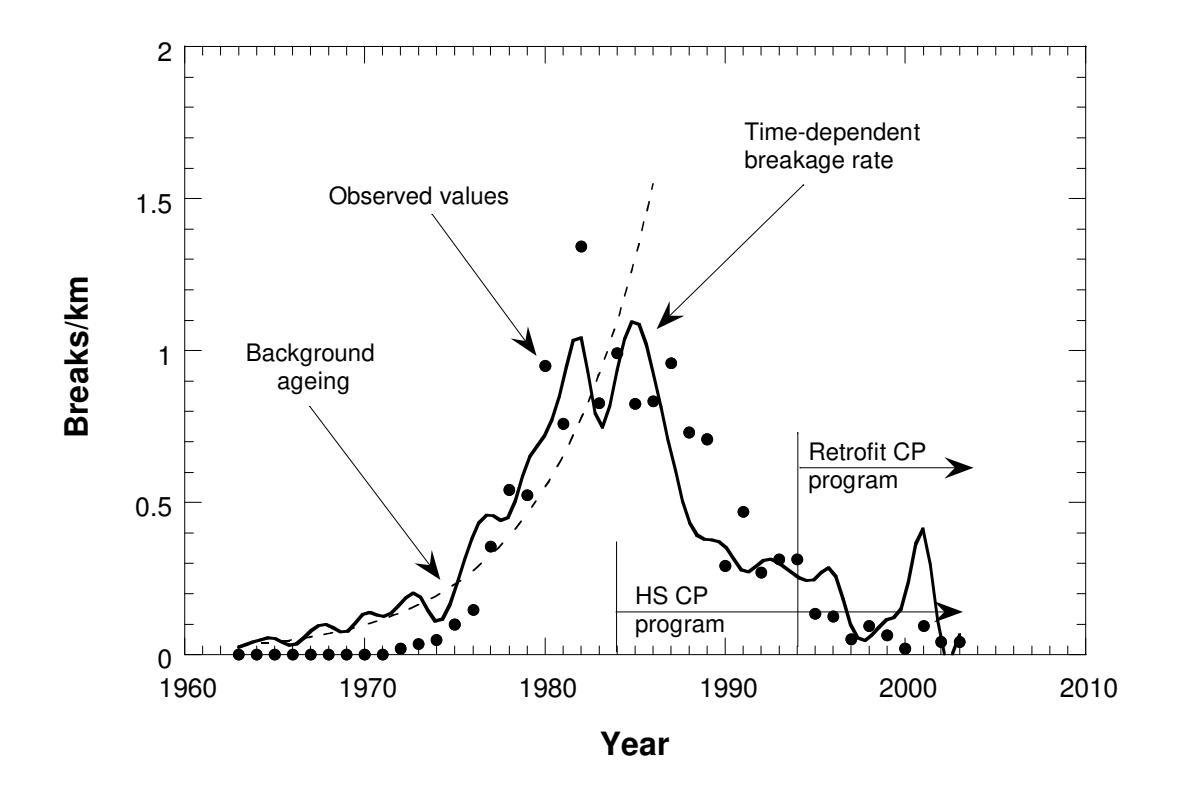
Figure 8. Breakage analysis for Group SC-3b

The break history analysis for sub-group SC-3b is shown in Figure 8. Sub-group SC-3b consisted of DI pipes that had been gradually retrofitted with anodes since and had, as well, CP hot spot anodes installed since 1984. The combined effect of retrofit and hot spot strategies for the past 18 years has had a dramatic influence to arrest water main breaks to insignificant levels. The background ageing rate of 0.172 indicated an annual breakage rate increase of about 17.2%, which is about 25% higher (Table 2) that for the ductile iron mains in sub-group SC-3a. The overall breakage rate of sub-group SC-3b was an order of magnitude higher than that of Group SC-3. This difference probably explains why this particular group was targeted by the utility for the retrofit cathodic protection.

Two concurrent CP programs between 1994 and 2003 protected sub-group SC-3b. The hot spot CP had a notable influence in reducing break rates although the corresponding coefficient (value of -0.24) seemed low relative to sub-group SC-3a. The reason for this low coefficient value is that the HS CP covariate expresses the density of effective anodes along the pipe. In fact the factor that actually influences the model is the product of this density and the corresponding coefficient. Since the average number of breaks/km in sub-group SC-3b was much higher than that in sub-group SC-3a, the corresponding HS CP coefficient was much lower (the respective products are similar) resulting in a similar influence of HS CP on the breakage rates of the two sub-groups. This suggests that one should be judicious when attempting to apply HS CP coefficients across sub-groups.

Nearly 66% of the 96 km of DI pipes in sub-group SC-3b were retrofitted between 1995 and 2003 (the last 8 years of the analysis period), which indicates that the hot spot program initiated in 1984 was significantly responsible for the decrease in breakage rates. It is therefore possible that the hot spot retrofit program alone might have been sufficient to affect most of the observed decline in breakage rate of sub-group SC-3b. Both rainfall deficit covariates, *RD* snapshot and *RD* cumulative, turned out to have a significant effect on the breakage pattern of Group SC-3b. Omitting the freezing index (*FI*) from the analysis increased the adjusted coefficient of determination, r^2 , from 0.763 to 0.78 because of a gain of one degree of freedom. Once again the coefficients of the *RD* covariates were negative, which is contrary to expectation.

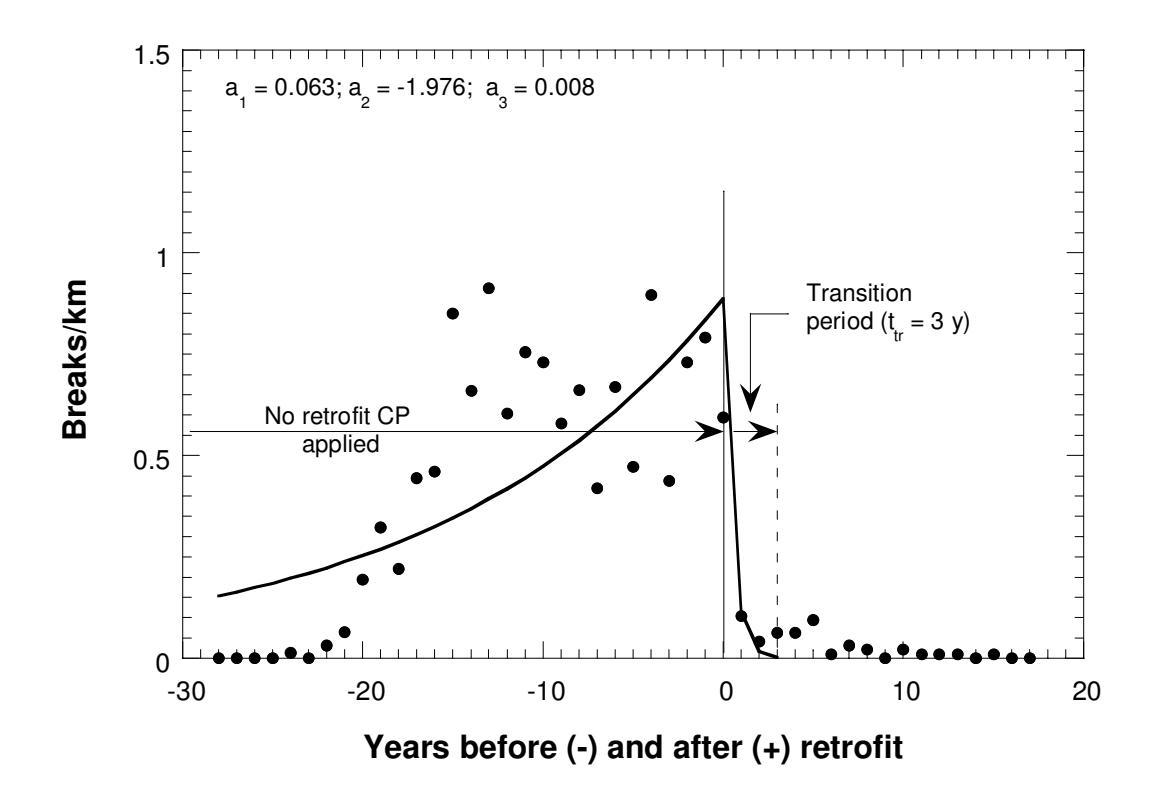
Figure 9. Pooled break analysis for retrofitted pipes in Group SC-3b

Figure 9 illustrates the results of the alternative method of analyzing breakage data for retrofitted pipes by pooling the breakage data so as to reflect breakage rates in years relative to the year of retrofit, rather than along a time line. Three phases, including a pre-retrofit breakage increase, post-retrofit transition period and post retrofit breakage increase are clearly identified. The ageing rate obtained (0.172) through 'conventional' break history analysis was significantly higher than that estimated (0.063) from pooled analysis. This apparent incongruity in estimates of ageing rates prior to the application of CP has been explained earlier for sub-group OT-1b, except that the difference here is much higher, probably because the HS CP covariate coefficient in sub-group SC-3b is much higher than that of sub-group OT-1b.

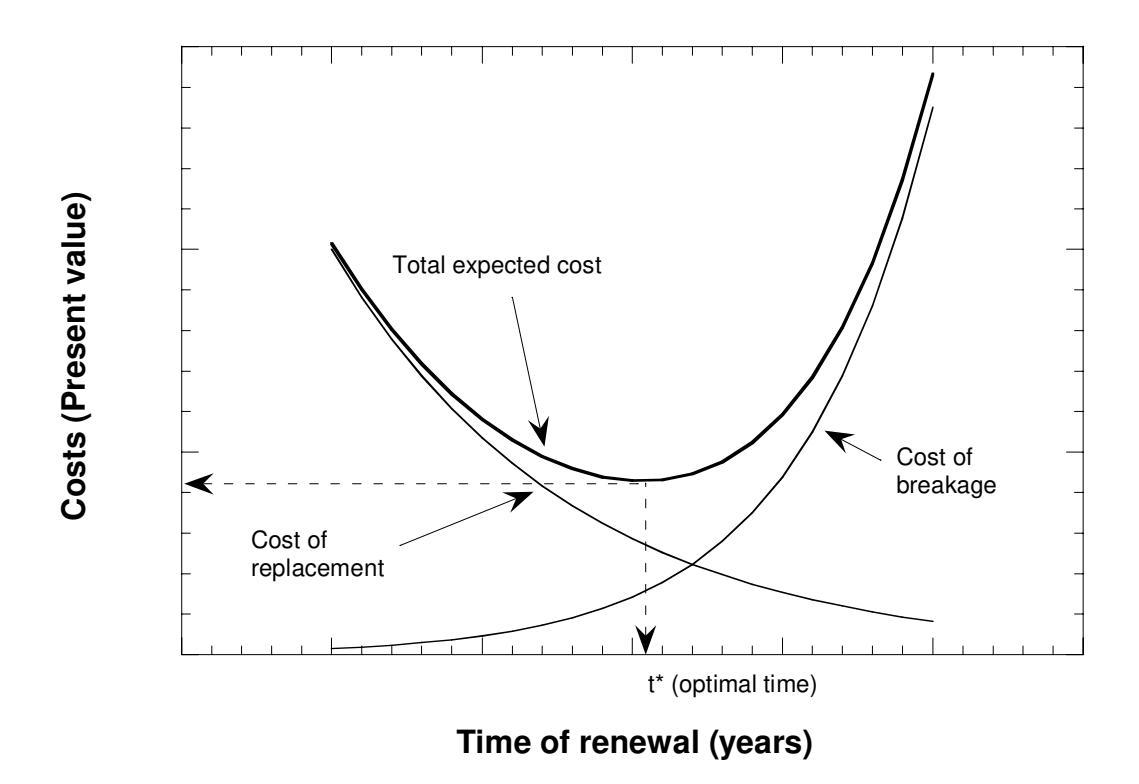
Figure 10. Life cycle cost curve

Generally, the explicit minimization of life cycle costs requires the comparison of the present value of all the costs that are associated with a decision strategy. As pipes age, their breakage rates increase and therefore the present value of breakage repair costs increase as well. At the same time, as one defers pipe replacement, the present value of replacement costs is reduced due to discounting. The sum of all these costs typically form a convex cost curve, whose minimum point is the optimal time for replacement, as is illustrated in Figure 10. Kleiner and Rajani (2004) showed how the costs of hot spot and retrofit cathodic protection could be considered in the life cycle cost analysis for water mains. They demonstrated that an effective cathodic protection program could shift this total cost curve so as to delay the optimal time of replacement as well as reduce the total cost.

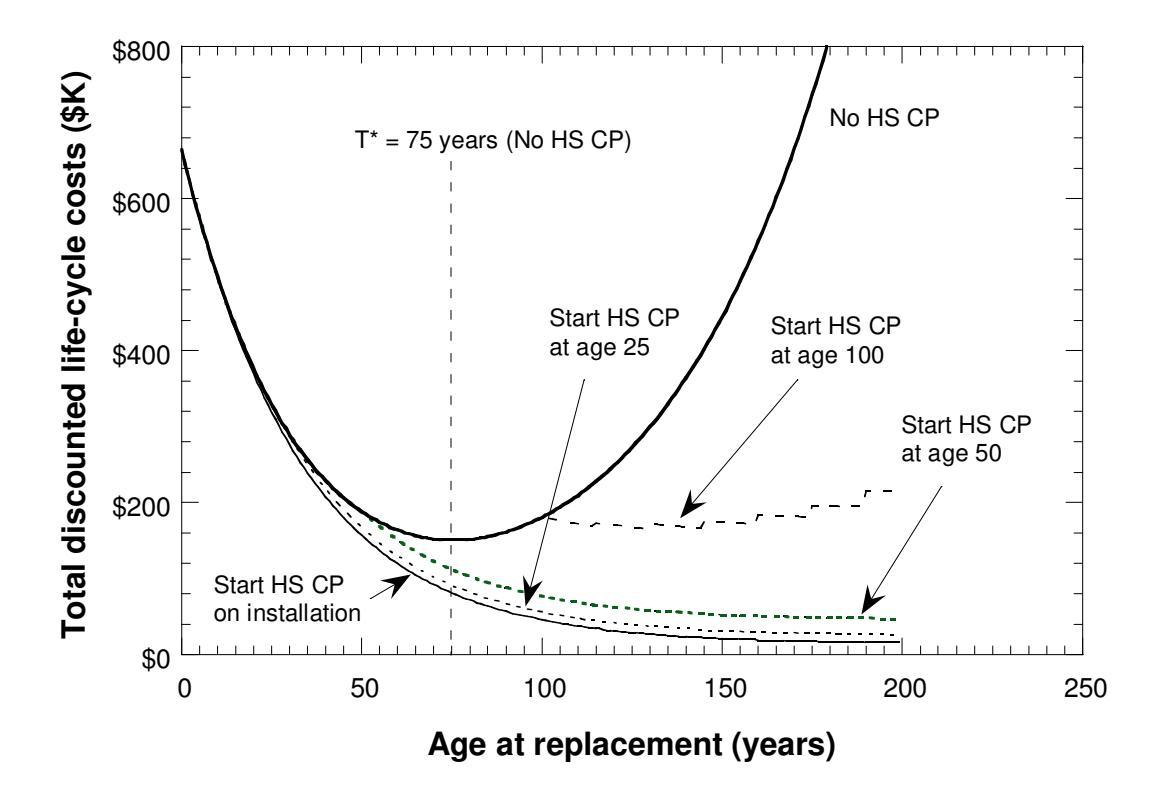
Figure 11. Life cycle cost for hot spot cathodic protection of pipes in Group OT-1a.

Figures 11 and 12 show the life cycle costs of Ottawa's CI pipe sub-group OT-1a with HS CP or with retrofit CP, respectively. The convex curve depicting the total cost is clearly visible. The figures show also how this convex curve varies depending on the time at which the cathodic protection program commences. The cost curves comprise the total life cycle (excluding pipe installation), including breakage repair and breakage-related costs, cathodic protection measures, pipe replacement as well as breakage costs that are associated with replacement (new) pipe when deterioration advances.

Figure 11 shows that for sub-group OT-1a, hot spot CP has a significant impact on the life cycle cost of the water mains, as it can shift the bottom of the total cost curve down and right (reducing total cost as well as deferring the optimal time of replacement or thus in fact extending the economic life of the pipe). Without cathodic protection, the economic life of the pipes in this group is about 75 years, with a life cycle cost of about \$151,000/km. The HS CP implementation can extend the life to beyond 200 years and reduce the life cycle cost significantly, depending on when the HS CP program

commences. Figure 11 further shows that for sub-group OT-1a there is little cost saving when HS CP is implemented very early in the life of a pipe, compared to a later time. This is expected because at an early deterioration stage the number of breaks is relatively small and the number of HS anodes will thus be small, resulting in a very small difference in breakage rates with or without HS CP. As the pipe ages and deteriorates further, the cost savings in implementing HS CP become increasingly more significant. Consequently, the total discounted life cycle costs are not much different whether HS CP commences at a pipe age of 0, 25 or 50 years. Having said that, it appears that early implementation of HS CP is prudent because cost is minimal. At the same time, late implementation can also be quite beneficial. Ottawa had initiated the hot spot CP program in 1990 (the group vintage is 1954 to 1974), which appeared to be a robust strategy for sub-group OT-1a.

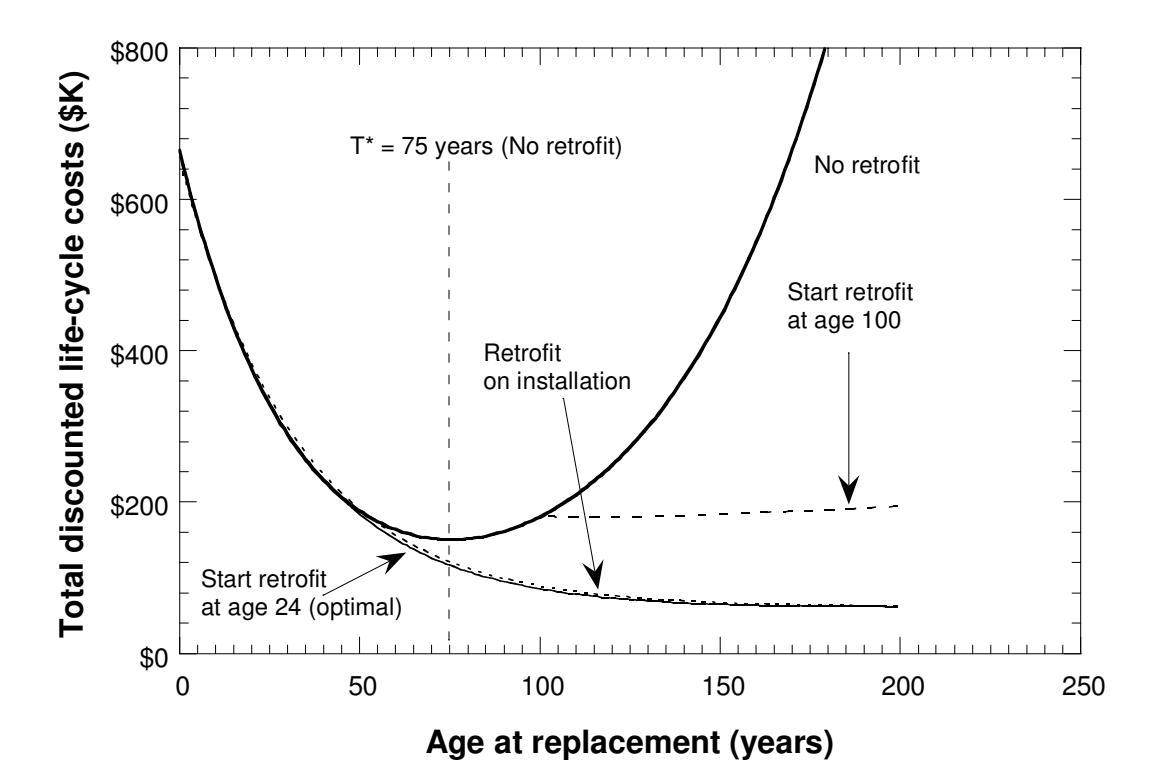
Figure 12. Life cycle cost for retrofit cathodic protection of pipes in Group OT-1b.

Figure 12 shows the life cycle costs of the pipes in the same sub-group OT-1a, assuming they would be retrofitted rather than hot spotted. Retrofit CP appears to have a substantial impact on the life cycle cost. The optimal time of commencing a retrofit program is at age 24, however, even if the pipes were retrofitted as late as age 80, the optimal time for replacement would still be deferred to beyond 200 years of age and the total discounted life cycle cost would be reduced to about \$60,000/km. Figure 12 also shows that retrofit CP would be beneficial (deferring replacement and reducing life cycle costs) even if implemented at a pipe age as late as 100 years. Figures 11 and 12 show that the life cycle costs of HS CP is somewhat lower than that of retrofit. This is attributed to the relatively early and large cash outlay that the retrofit strategy entails. Ottawa had initiated its retrofit CP program in 1994 (the group vintage is 1954 to 1974), which appeared to be a good strategy for Group OT-1b. It should be remembered, however, that this life cycle cost analysis treats each strategy (hot spot or retrofit) as if it was the only one implemented. In sub-group OT-1b, if both strategies were used simultaneously, one must apply engineering judgment to choose the more appropriate cost curve.

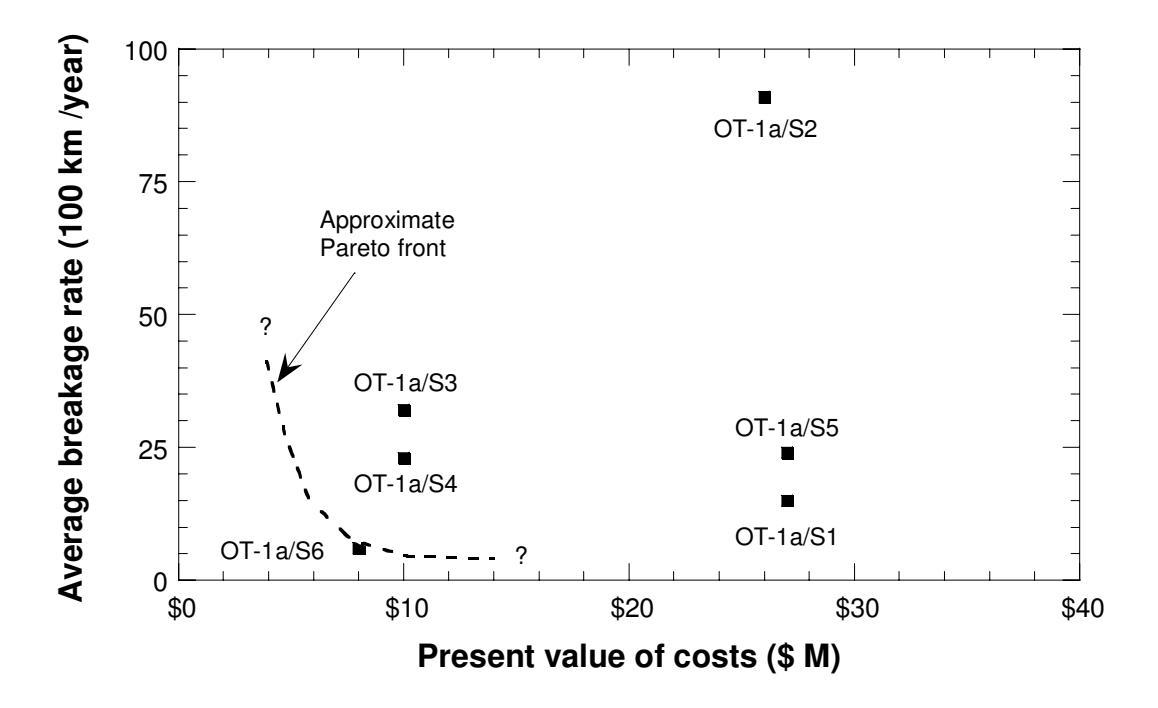
Figure 13. Pareto graph for planning scenarios for pipe group OT-1a from Ottawa.

A common approach to identify the best strategy among a set of competing strategies with multiple objectives is to plot the outcome for each strategy in the form of a scatter plot, e.g., present value of costs vs. expected average breakage rate. This approach simplifies the consideration of a large number of possible strategies. This form of the scatter plot is also known as Pareto optimality, which measures efficiency in multicriteria and multi-party situations and is found to have wide applicability in economics, game theory, multi-criteria decision-making, and the social sciences. In the current example, the two conflicting objectives are costs and breakage rate. If strategy A is both more expensive and results in a higher breakage rate than strategy B, it is said that strategy A is inferior. A collection of all non-inferior strategies forms a 'Pareto optimality front'. The results of the six scenarios were plotted on a chart to define an approximate Pareto optimality front, as illustrated in Figure 13. It can clearly be seen that scenarios OT-1a/S1, OT-1a/S2, OT-1a/S3, OT-1a/S4, and OT-1a/S5 were inferior and scenario OT-1a/S6 was non-inferior. Scenario OT-1a/S6 can be considered to be on the optimality front, in view of the precision levels involved in these analyses. A rigorous analysis might include more scenarios to define a more robust Pareto efficiency front. The decision maker could then select the preferred scenario along this front. This preference would reflect the implicit monetary value that the decision maker placed on the average breakage rate as a surrogate for customer service level.

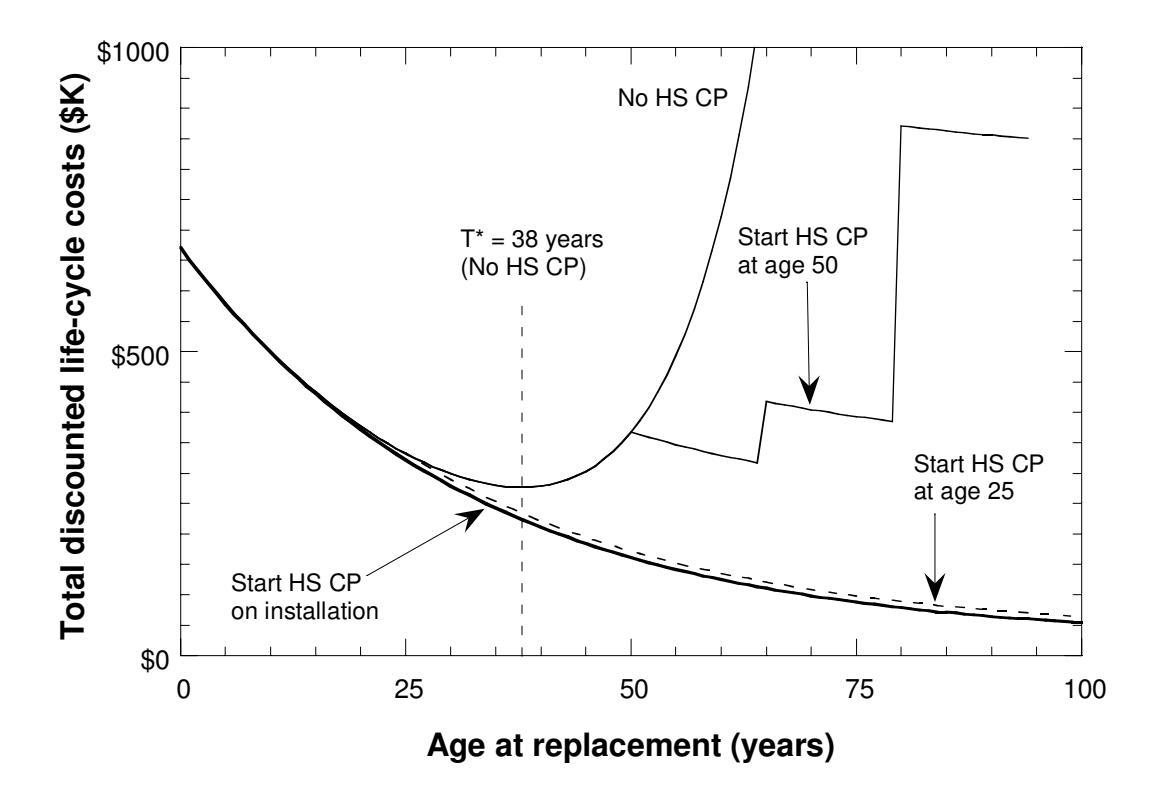
Figure 14. Life cycle cost for hot spot cathodic protection of pipes in Group SC-3a.

The discounted life cycle cost analyses for Group SC-3a are illustrated in Figure 14 and Figure 15. Unit cost data for the life cycle analysis are shown in Table 3. Figure 14 and Figure 15 show that without CP the optimal time for replacing the pipes was estimated at the age of 38, and their total discounted life cycle cost if replaced at that age was approximately \$277,000/km, which was the result of a very high ageing rate.

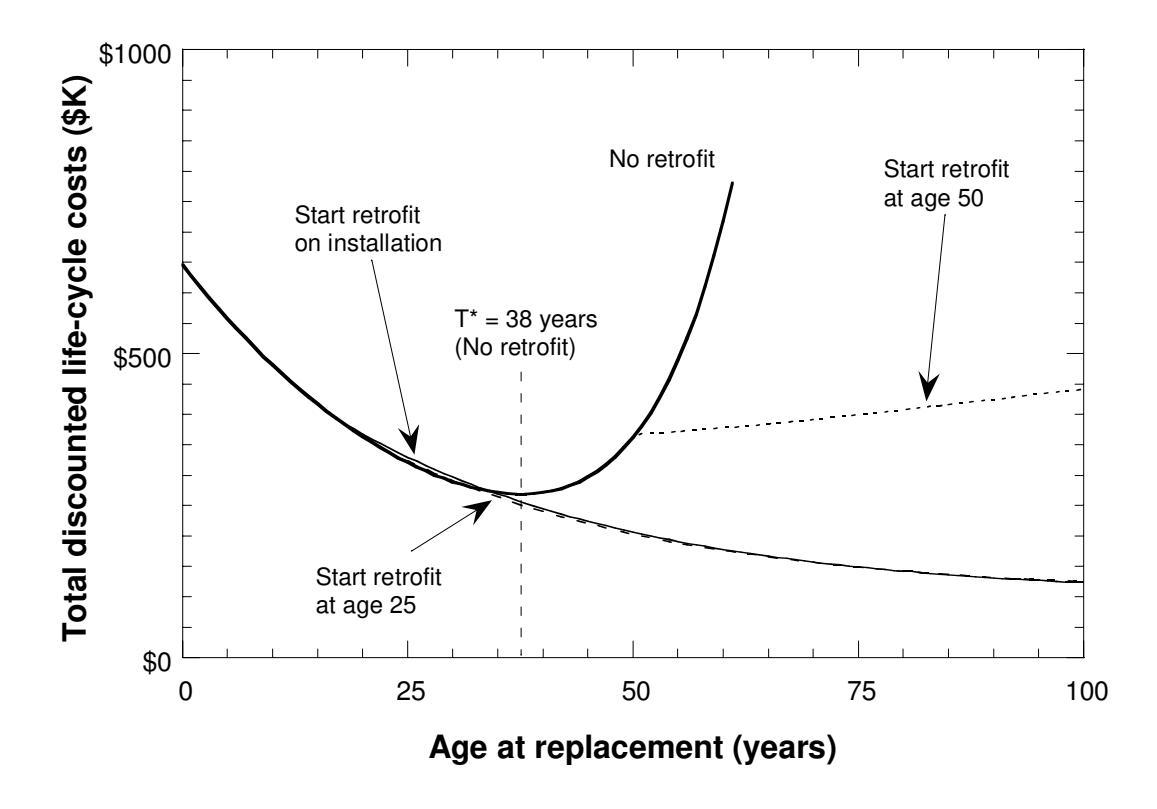
Figure 15. Life cycle cost for retrofit cathodic protection of pipes in Group SC-3a.

Figure 15 shows if the pipe were retrofitted with CP upon installation (no hot spot protection), the optimal time for replacement would be deferred to beyond the age of 100 years and its total discounted life cycle cost would be reduced to below \$113,000/km. Figure 15 also shows that retrofit CP could be beneficial (deferring replacement and reducing life cycle costs) even if implemented at a pipe age as late as 25 years. The retrofit program that effectively began in 1990 for Group SC-3b has resulted in a significant reduction in breakage and replacement costs. It is to be noted that doubling of the ageing rate between Groups OT-1a and SC-3a, i.e., 0.053 to 0.133, had the dramatic effect of reducing the optimal renewal time from 75 to 38 years. Therefore, control of the ageing rate through the mitigative application of cathodic protection on cast and ductile iron mains has important economic (life cycle costs) implications.

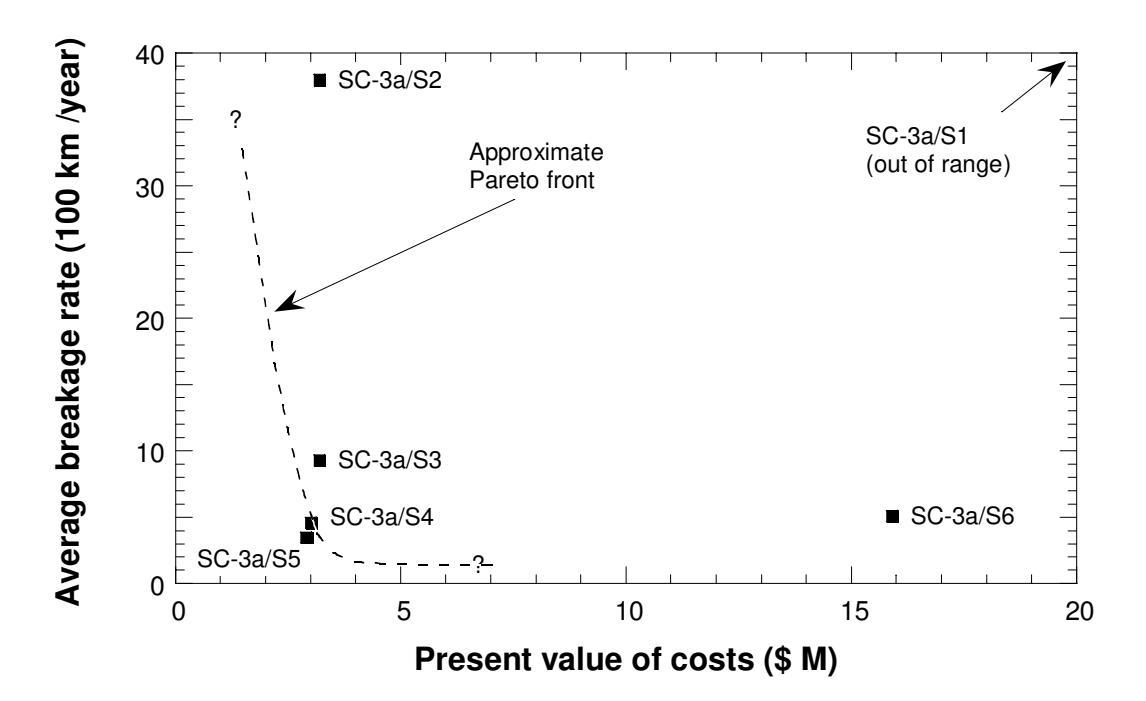
Figure 16. Pareto graph for planning scenarios for pipe group SC-3a from Scarborough.
