Fatigue 2010

Fatigue Analysis for CF-18 Component: Wing Fold Shear-Tie Lug

Min Liao^a*, Guillaume Renaud ^b

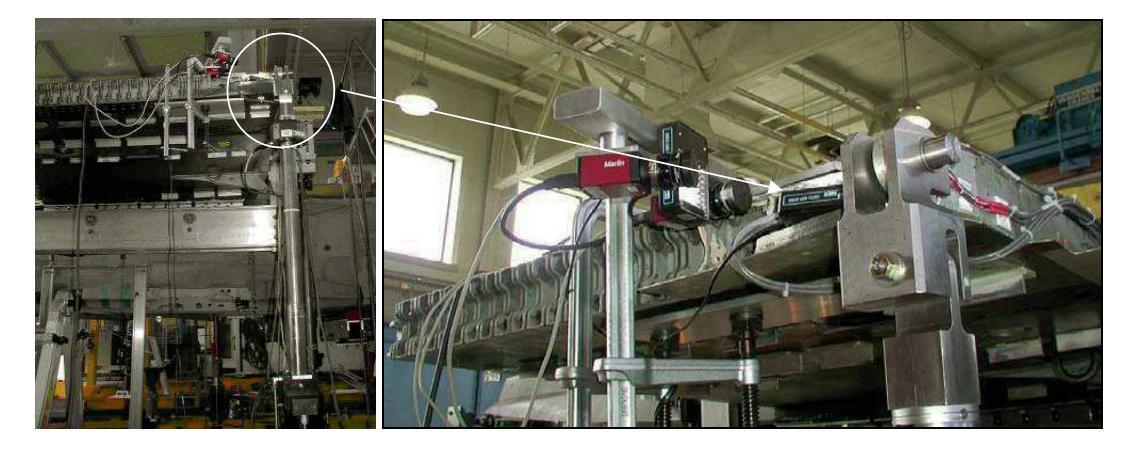
Figure 1 FT312 test set-up, (a) actuator load cell installation; (b) loading lug and digital image correlation camera [1].

The test specimen for FT312 was retained from the original IFOSTP (International Follow-on Structural Test Project) FT245 wing test. This wing component was retired after having accumulated about 60% of one RLLs (repeated load lifetimes). *Note* the wing fold shear-tie area of this wing had not been loaded during FT245 testing. The test article shear-tie lug was installed in its original position on the left side of the fuselage, along with a reaction system consisting of a contour board with solid struts, as illustrated in Figure 1 (a). Although a single actuator was used to apply loads directly to the shear-tie lug (Figure 1 (b)), the entire test setup was close to the actual situation with all the supporting wing and fuselage structures.

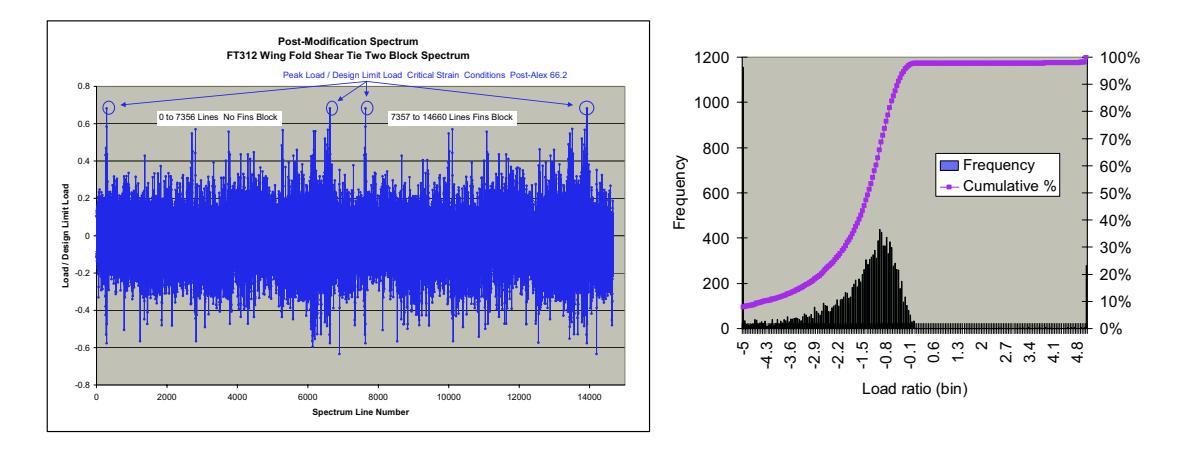
Figure 2 (a) Post-modification spectrum sequence plot [1]; (b) Statistical plots of spectrum load ratio.

Figure 2 (b) shows that the most frequent load ratios were around R=-0.8, and there were no high R-ratio (R=Pmin/Pmax) loads such as R=0.7 to 1.3. The number of cycles of small loads, i.e., below 5% of the maximum or minimum loads (absolute values), represented about 3% of the total load end levels in the test spectrum. Therefore, the test spectrum did not have too much high R-ratio and small loads.

by approximately 8% and the number of cycles was shortened. The post-modification spectrum had 14,656 end levels for the fin-on and fins-off sequence, as illustrated in Figure 2 (a).

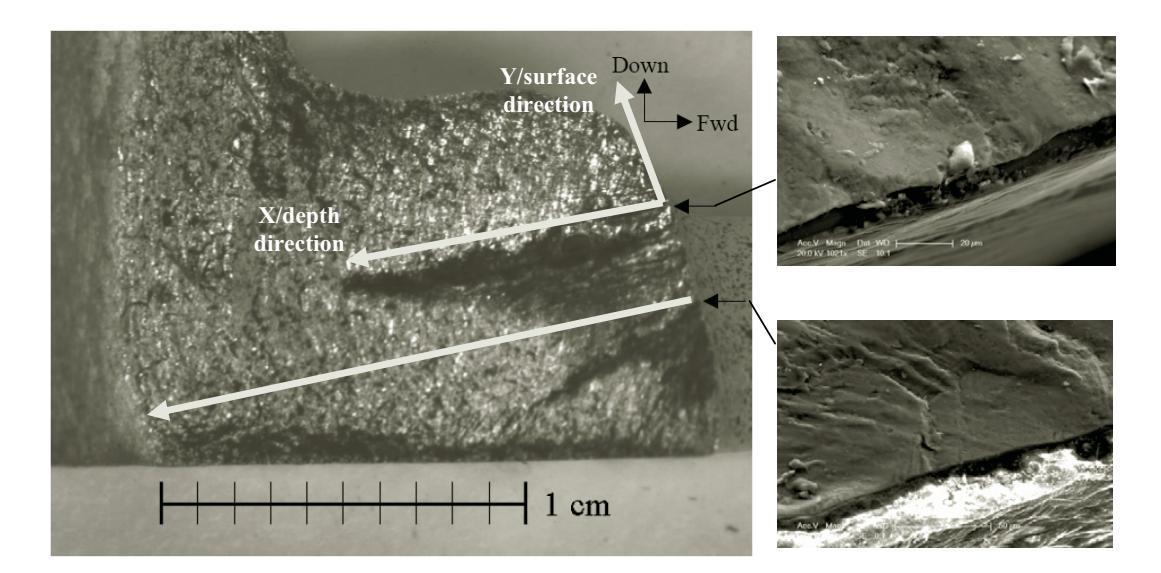
The QF work was carried out at Quality Engineering Test Establishment (QETE) [5] and the Royal Military College (RMC) using SEM (scanning electronic microscopy) [6] for both pre- and post-modification lug fracture surfaces. For the pre-modification lug, multiple cracks were found to nucleate from IVD (ion vapour deposit) pits whose depths were between 5 to 10 µm. Fatigue striations were clearly visible right after the IVD pits, although the first repeatable crack patterns started from 231µm. For the post-modification lug, multiple cracks also nucleated in the same location; two main cracks grew and coalesced, as shown in Figure 3. The upper crack nucleation feature was found to be a constituent particle, but the lower cracking feature was not clear, and no clear fatigue striations were observed near the crack nucleation region.

Figure 3 (a) Fracture surface and two main cracks; (b) upper crack nucleation feature: particle; c) lower crack nucleation feature: unclear.

The Center Semi-elliptical Edge Surface Crack model of AFGROW (4.11.15.0) was used to analyze the crack growth of the shear-tie lug. The thickness of the model was measured to be 10.0 mm (0.3937") from the fracture surface (Figure 3), and the width of the model was assumed to be 203 mm (4"), over 10 times the thickness of the fracture surface. This assumption is based on the fact that, the lug flange is actually turning into a corner and connects to the lug main body. Therefore, the crack growth would slow down when approaching the corner (see Figure 6). The assumed width would reduce the finite width effect on the crack growth, as observed in the fractography study (Figure 3).

First, fatigue analysis was carried out for the long crack growth from 1.053 mm (0.04146") to 14.75 mm (0.58") as measured from the QF. The two main cracks on the fracture surface (Figure 3) were gapped by a 3.0 mm (0.118") distance. Thus the initial single surface crack was 1.053 mm (0.04146") deep and 5.10 mm (i.e., 0.118"+2x0.04146"=0.201") wide. Without using any retardation model, the AFGROW produced the crack growth curve as shown in Figure 11 (a). It is shown that the analytical curve is very close to the test till the crack depth reached about 3.0 mm, and then diverted away from the test. Overall the analytical life is about ~55% shorter than the test life. The AFGROW Willenborg Retardation model was tried, which could shift the analytical curve closer to the test in the end point, but the shape of the curve is still very different from the test. Considering that the majority of load ratios in the spectrum were around -0.8, the retardation model was not further investigated in this work.

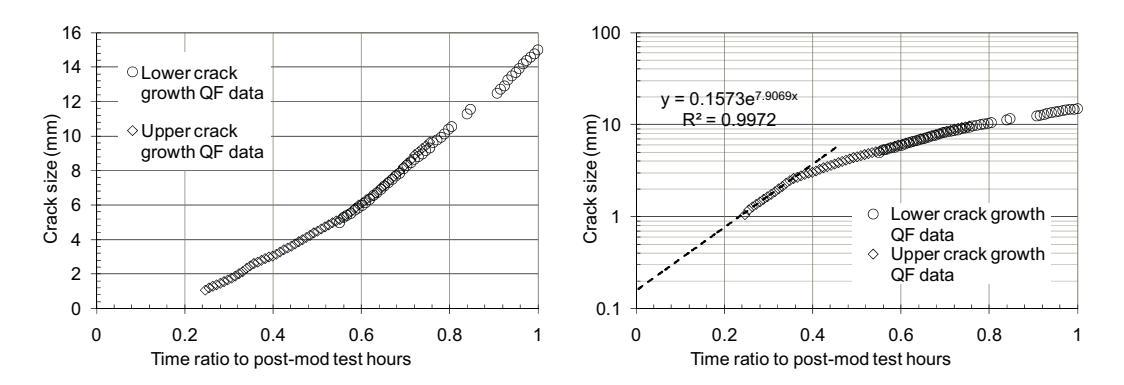
The QF crack growth data are presented, in both linear-linear and log-linear scales, in Figure 4 for the postmodification lug. The first repeatable crack pattern was found starting from 1.053 mm for the upper crack, and 4.979 mm for the lower crack. The two cracks merged at about 9.62 mm and grew to 14.75 mm, where the fatigue test stopped. It is shown that the crack growth curves are like two log-linear curves (Figure 4 (b)), with a knee (changing of slope) at about 3.0 mm. An exponential equation was used to back extrapolate the first linear portion of the data, which led to an initial crack size of 0.157 mm in depth (Figure 4 (b)).

Figure 4 (a) QF crack growth data for the post-mod test, linear scale for crack size; (b) Logarithmic scale for crack size.

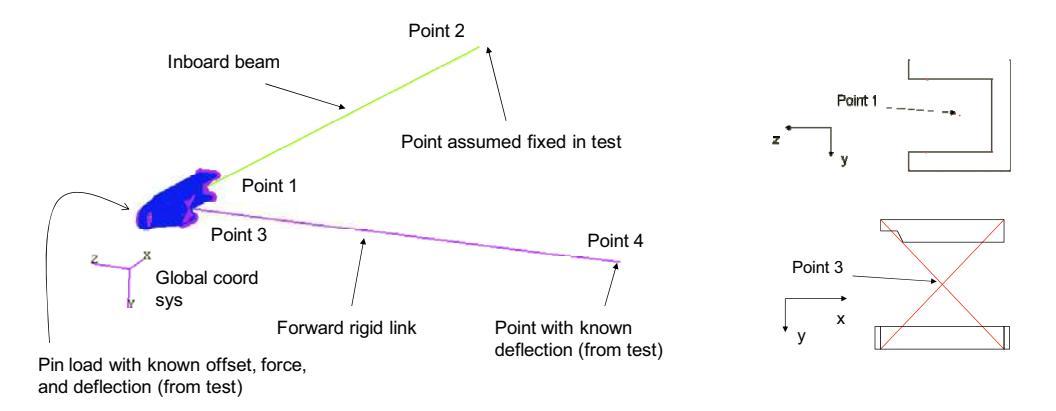
For fatigue analysis purpose, a simple but efficient FE model was developed. To simplify the model, the adjacent structures were not modelled; instead, artificial structural elements were used in the model to attach to the lug to apply the proper boundary conditions that could match the test displacement and strain measurements. These elements, shown in Figure 5, were connected to the lug using multi-point constraints at the points illustrated in Figure 5.

Figure 5 Shear-tie lug FE model, and the inboard beam and forward rigid link attachment points

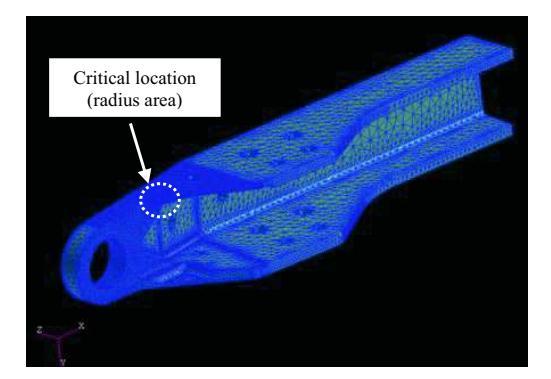
A detailed parasolid model of the shear-tie lug was obtained using CATIA and the DIC (Digital Image Correlation) data on the cracking location. The shear-tie lug was meshed using linear tetrahedral elements, using higher element densities around the pin hole, the strain gauge locations, and the critical radius area. The meshing strategy was implemented in PCL (Patran Command Language) so that several local mesh parameters were allowed to change in order to calibrate the simplified FE model. A meshed lug and the real part are shown in Figure 6.

Figure 6 NRC shear-tie lug FE mesh and the real part

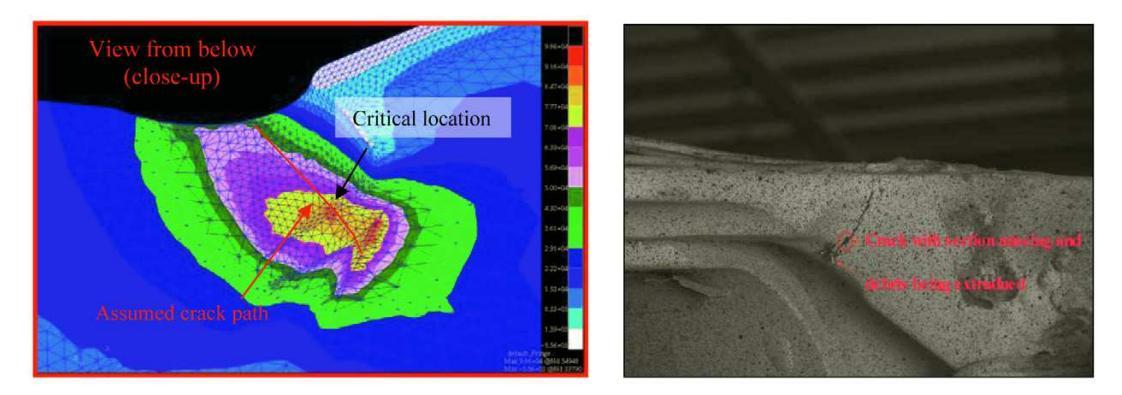
FT312 test. For the post-modification shear lug which had the cracking area repaired (blend-out), both NRC, MRO FE analyses, and DIC measurements gave a maximum principal stress of approximately 15 ksi for a 1000 lbs downward load, at the cracking area (Figure 7 (a)). It should be noted that a sharp edge (high stress) area was discarded because it was caused by part of improper DIC data imported in CATIA, while the actual blend-out was smooth. A comparison of NRC FE high stress area and test crack area (DIC coated) is presented in Figure 7 (b).

Figure 7 (a) Maximum principal stress distribution (post-mod, linear analysis, max. down load); (b) Visible crack on DIC coated lug, no load [1].

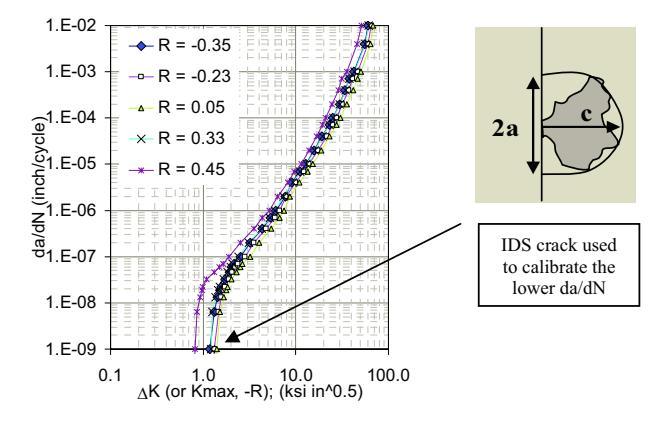
To generate microstructural level short/small crack data, fatigue tests were carried out at NRC using 32 SENT (single edge notched tension) coupons made of 7050-T7452 hand forging (core material) [7]. The marker band technique was used to reproduce the naturally nucleated short crack growth (da/dN) data, which are usually as low as 10^{-8} inch/cycle (2.54x10⁻⁷ mm/cycle). Most importantly, the lower da/dN (<10⁻⁸ inch/cycle) curves were generated in association with the crack nucleating IDS (initial discontinuity states)/particles/pores measured from the fracture surfaces. For example, for each R ratio, the curve was extended to a smaller da/dN region based on the ΔK for the IDS crack (with an average aspect ratio of 1.0) and a best fitted slope (da/dN)/ ΔK , which resulted in the mean life matched with the test. The IDS based short-long crack growth curves are shown in Figure 8, which is actually imported into AFGROW in Tabular Look-up format. These curves were demonstrated to result in better fatigue life estimations than other 7050 material models, when a short/small crack growth is involved [7].

Figure 8 Crack growth rate da/dN- IK curves for 7050-T7452 hand forging.

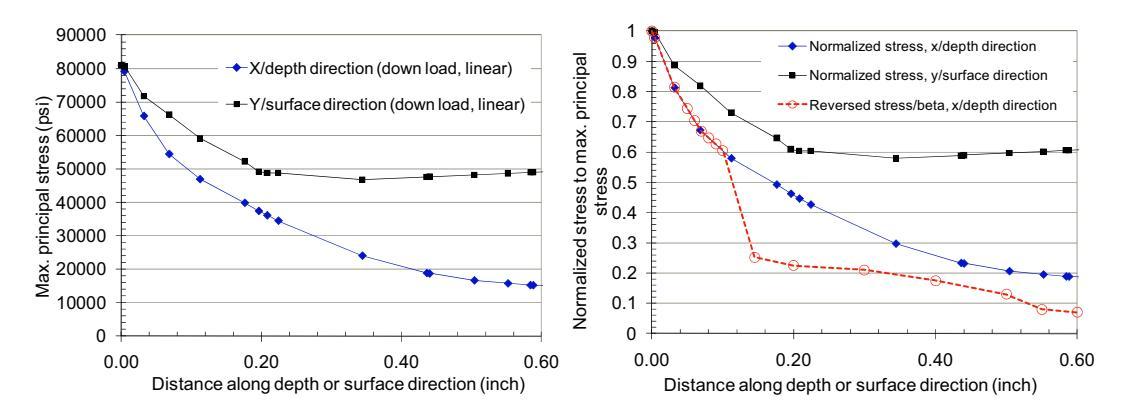
In this paper, the post-modification lug was used for fatigue analysis. From the fractography of the shear-tie lug, it was found that the crack had mainly grown in a mode I pattern. The maximum principal stress distributions along the two directions of the crack plane were taken from the FE analysis, as presented in Figure 10 (a). This figure indicates that the stress quickly decreased in the depth direction (into the material).

As the shear-tie lug was under a complex loading condition, and the AFGROW model was limited to uniform remote loading. The 3D FE based maximum principal stress distributions for the uncracked structure, shown in Figure 10 (a), was converted into normalized stress, in Figure 10 (b), based on the maximum stress point, in order to allow AFGROW to approximately simulate the crack growth in the shear-tie lug.

Figure 10 (a) Max. principal stress distributions (post-mod), x, y direction shown in Figure 3; (b) Normalized stress distribution from 3D FE and from reversed engineering.

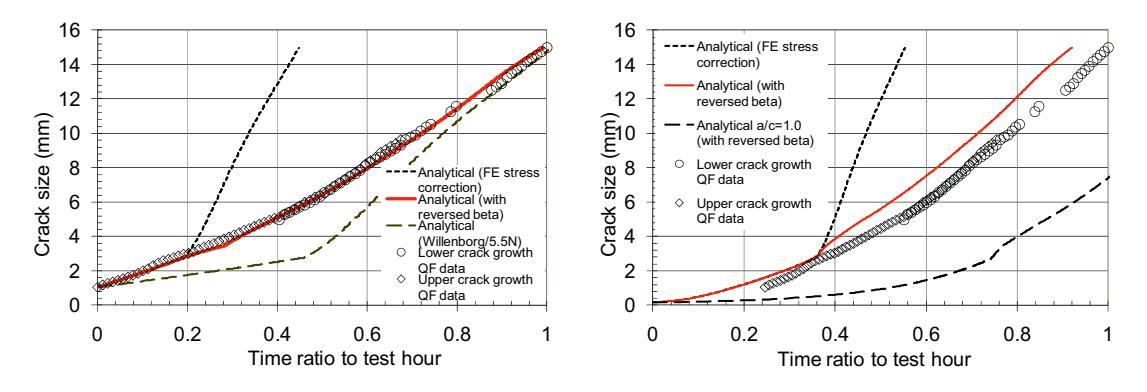
Figure 11 (a) Fatigue long crack growth analysis; (b) fatigue total life analysis.

The reasons for the shorter analytical life were: 1) the FE stress distribution, based on the uncracked structure, would be changed after a certain crack size, which was also not adequately accounted by the classic AFGROW model; 2) possible residual stress present in the die forged shear-tie lug, which could reach two digits in ksi from a XRD (X-ray Diffraction) measurement on a spare shear-tie lug. Theoretically, a FE code capable of analyzing a crack, like StressCheck, is needed to accurately determine the stress distribution and stress intensity factor along with crack growth path, with residual stress information, if available, from inside material. A preliminary study on the StressCheck FE modelling, on the shear-tie lug proved to be very challenging due to the complex geometry (multi-holes, multi-curvature) and loading conditions. In this paper, an engineering approach was proposed for the fatigue analysis. The approach was based on the reversed beta correction, which was obtained by altering the normalized stress distribution in AFGROW in order to match the test data. This procedure only altered the normalized stress distribution was presented in Figure 10, together with the original FE stress distribution. Using this reversed beta/stress distribution, the analytical crack growth curve was obtained and shown in Figure 11 (a).

The analytical crack growth curves are presented in Figure 11 b), along with the QF crack data. The comparison indicates that,

- Using the FE based stress correction, the analytical total life is about 45% shorter than the test. The first part of the life, to the crack depth of ~3.0mm, is very close to the test, after that the life curve is very different from the test.
- Using the same reversed beta/stress distribution determined in *Section 5.3*, the analytical total life and the crack growth curve shape are close to the test results.

In addition, if multiple cracks were not considered and only one crack with $a_0=c_0=0.157$ mm was used, the analytical total life was about 32% longer than the test Figure 11 (b).
