Measurements of hydrophobicity for silicone rubber coating on outdoor insulators

Measurements of Hydrophobicity for Silicone Rubber Coating on Outdoor Insulators

Measurement Science and Standards, National Research Council Canada
1200 Montreal Rd.

Authors: Refat Atef Ghunem and Li-Lin Tay

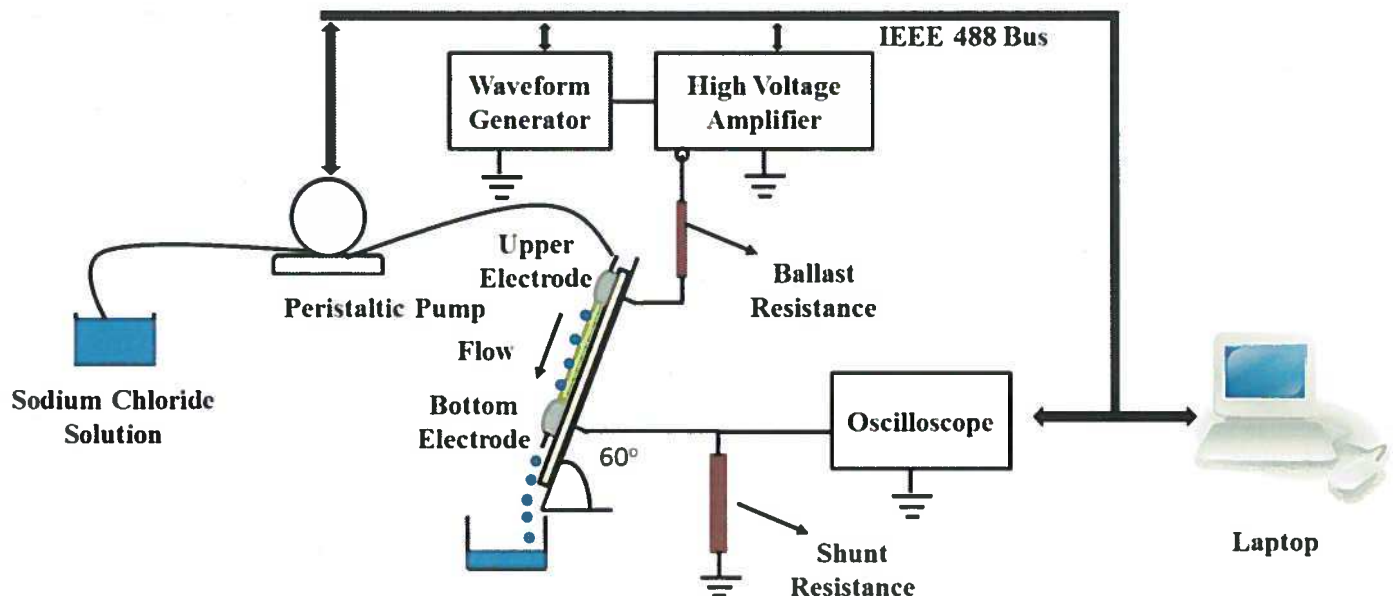
Figure 2. Schematic circuit of the DDT

Figure 2 shows the basic circuit diagram of the DDT that can be used to evaluate the hydrophobicity retention of silicone rubber. Silicone rubber coating sample is continuously wetted under voltage, utilizing a liquid contaminant. The liquid contaminant constitutes of aqueous solution of sodium chloride with a conductivity of 1.5 mS/cm, and applied at a flow rate of 1mL/min by a peristaltic pump. The sample possesses a dimension of 120 mm×50 mm with a thickness of 6 mm, and mounted on an insulating support using stainless steel electrodes. With a standard 5 cm distance between the electrodes, the hydrophobic surface eventually becomes hydrophilic in a measured amount of time [5]. The relative time-to-hydrophilicity can be accordingly utilized to rank different coating materials or to asses aged samples with respect to a reference coating material.

During the test, the liquid contaminant forms in bead-like shape on the hydrophobic surface; whereas, a continuous channel can be observed on the hydrophilic surface. Measuring 2 mA (rms) leakage current (LC) is the stopping criterion for the DDT as it indicates a hydrophilic surface [5]. The applied rms voltage is between 3-6 kV at power frequency [5]. The LC is sampled through shunt resistance using an oscilloscope as a digitizer with a minimum sampling rate of 30720 (512×60) sample/second. Each second a one-waveform window is acquired and post processing is applied to calculate the rms value of the LC, fundamental, third and fifth harmonic components.

The low order harmonics are extracted as potential diagnostic indicators for the degree of hydrophobicity during the test. Low order harmonics of LC have been successfully shown to be indicators of silicone rubber aging during standard accelerated aging conditions [6]. Such indicators, although extracted in laboratory conditions, can be of significant potential when successfully correlated with the actual conditions and the existing field experience.

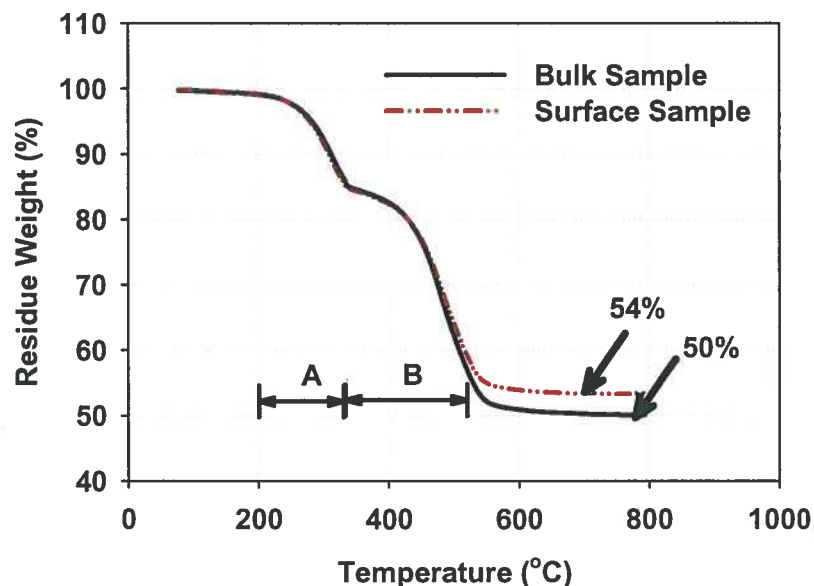
Thermal analysis can be utilized to detect and identify the byproducts of oxidation due to corona, partial discharges and wetting on the surface of the coating material. Figure 3 shows an example of the thermogravimetric analysis (TGA) conducted for a silicone rubber insulating material with a surface that has been subject to aging in a 400 kV power transmission system. The TGA was conducted in nitrogen for surface and bulk samples under temperature range between 80 and 800 °C with a 10 °C/min heating rate. The samples weighted around 3 mg and the TGA balance has a sensitivity of 0.1µg. Utilization of a bulk material that has not been subject to the outdoor aging conditions is important in order to develop a reference for the analysis of the surface.

Two decomposition stages can be identified for silicone rubber insulating materials in the TGA, A and B as shown in Figure 3. Stage A starts as approaching 200 °C, the dehydration temperature of the ATH filler, and stage B is initiated as approaching 400 °C, the decomposition temperature of silicone rubber [7]. The remnant residue obtained by the end of stage B mainly constitutes of alumina and silica char due to the dehydration of ATH and decomposition of silicone rubber, respectively.

Figure 3. TGA of surface and bulk samples of silicone rubber insulating material taken from a 400 kV power system.

Although aging of the surface was evident with visual observations, no evidence of erosion was observed. Erosion initiates as hotspots with temperatures exceeding 200 °C develop on the surface under the effect of dry-band arcing, leading to the dehydration of ATH and thus formation of alumina char on the eroded surface. With no evidence of erosion reported for the analyzed samples, obtaining an increase in the residue for the surface as compared to the bulk can be reported as evidence of increase in the silica residue (surface oxygen content) and thus aging [8], (Figure 3). Similarly a comparison can be made between an aged sample in the field and a reference (standard) sample for condition assessment of silicone rubber coating materials of high voltage insulators.
