Construction Technology Update; no. 31, 1999-12-01

Fire Performance of High-Strength Concrete Structural Members

by **V.K.R. Kodur**

The increased use of high-strength concrete in buildings and structures has led to concerns about its fire performance, especially the problem of spalling. This Update presents research results comparing the fire resistance of high-strength and normal-strength concrete columns and offers guidelines for improving the fire resistance of high-strength concrete structural members.

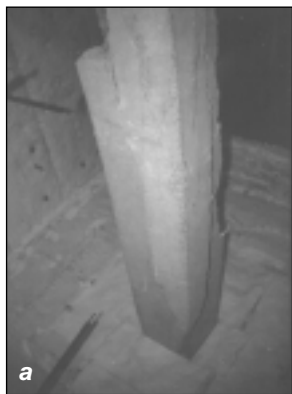
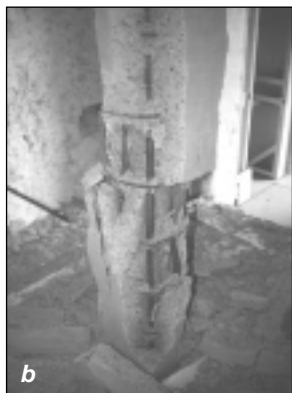
Figure 1. View of (a) normal-strength concrete column and (b) high-strength concrete column after fire-resistance tests

An important finding in the research was that while there was no spalling in the NSC column, there was significant spalling at the corners of the HSC column just before failure. There was also some spalling in the HSC column in the initial stages of fire exposure. Figure 1 shows the condition of the two types of columns after the fire resistance tests. In the HSC column, the reinforcement (both longitudinal and transverse) is completely exposed and there is significant spalling.

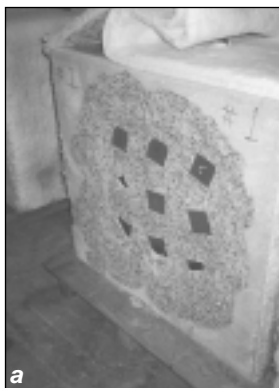
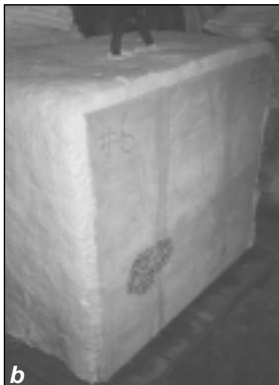
Figure 5. View of high-strength concrete blocks after two-hour hydrocarbon fire test: (a) block without polypropylene fibres; (b) block with polypropylene fibres

The addition of polypropylene fibres minimizes spalling in HSC members under fire conditions.¹ One of the most accepted theories on this is that by melting at a relatively low temperature of 170°C, the polypropylene fibres create “channels” for the steam pressure in concrete to escape, thus preventing the small “explosions” that cause spalling. The study showed that the amount of polypropylene fibres needed to minimize spalling is about 0.1 to 0.25% (by volume). Further research is being carried out to determine the optimum fibre content for different types of concrete. The effect of polypropylene fibres on spalling is illustrated in Figure 5, which shows HSC concrete blocks after two hours of fire exposure.⁵
