## **Preventing rebar corrosion in concrete structures**

**NRCC-47625**

## **PREVENTING REBAR CORROSION IN CONCRETE STRUCTURES**

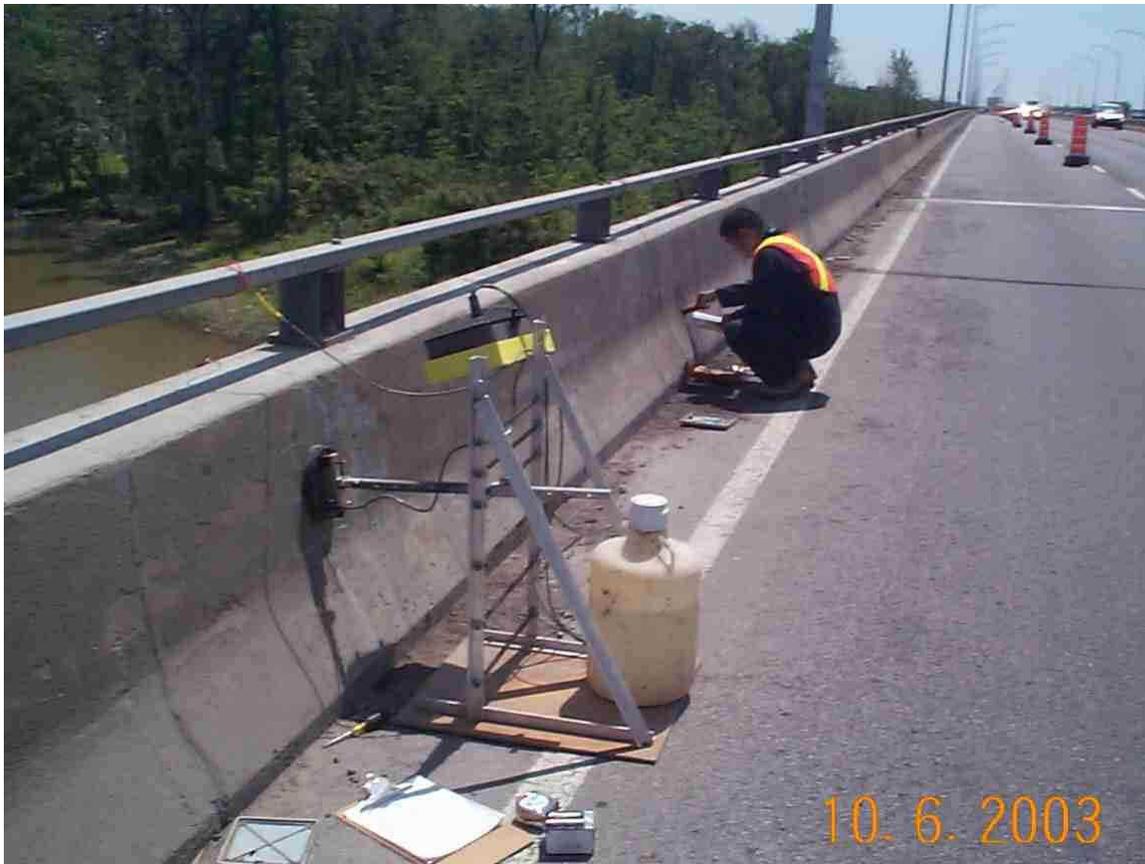
**A researcher measures the rebar corrosion rate on a rebuilt barrier wall on the Vachon bridge.**

1. Corroded concrete column on a highway overpass in Ottawa.
2. A severely damaged parapet on the Vachon bridge in Laval, Quebec, before demolition.
3. A concrete slab on the Vachon bridge after demolition.
4. A researcher measures the rebar corrosion rate on a rebuilt barrier wall on the Vachon bridge. A corrosion inhibitor was added to the concrete used in the reconstruction.
