Canadian Acoustics, 52, 3, 2024-09-08

The Transmission Loss of Double Stud Walls with Layers of Gypsum Board Installed inside the Wall Cavity

Jeffrey Mahn[†], Sabrina Skoda¹, Iara B. Cunha¹

¹National Research Council Canada

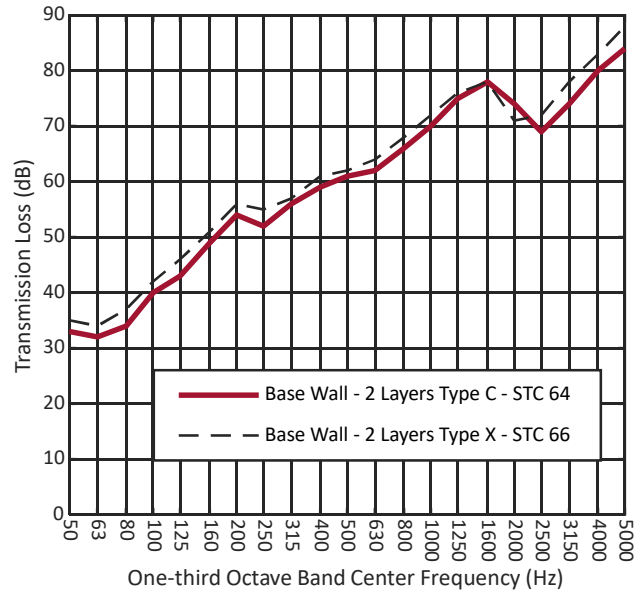
Figure 3: Transmission loss of the base wall assembly with two layers of 15.8 mm normal weight Type X gypsum board installed on both sides of the wall (STC 66) and two layers of 12.7 mm Type C gypsum board installed on both sides of the wall (STC 64).

The base wall assembly was evaluated with two layers of 15.8 mm (5/8”) normal weight Type X gypsum board (10.80 kg/m²) installed on both sides of the wall and again with two layers of 12.7 mm (1/2”) Type C gypsum board (9.80 kg/m²) directly attached to both sides of the wall. The resulting transmission loss curves measured in full accordance with the standard, ASTM E90 [5] are compared in Figure 3. The wall assembly with the heavier, Type X gypsum board resulted in a higher transmission loss over much of the frequency range and an STC rating of 66 as opposed to 64 for the wall assembly with the Type C gypsum board.

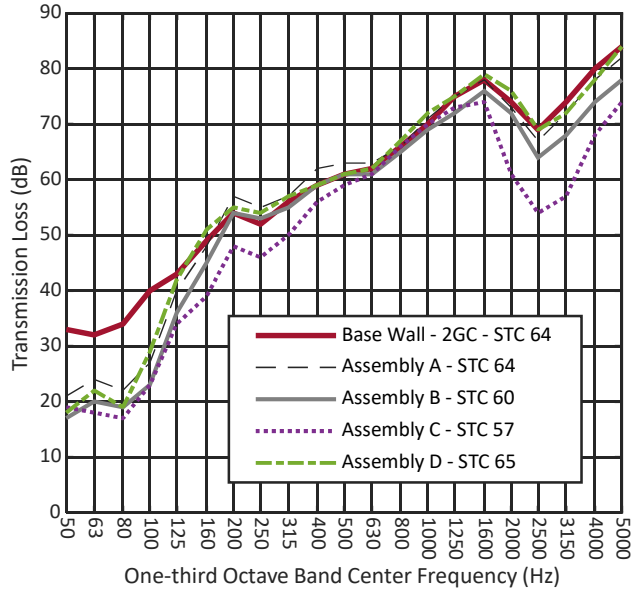
Figure 4: Comparison between the transmission loss values of the base wall assembly with two layers of Type C gypsum board installed on both sides of the wall and the transmission loss values of the wall assemblies listed in Table 1.

Next, the transmission loss curves of the four wall assemblies shown in Table 1 were evaluated. Each wall had one or more layers of 12.7 mm Type C gypsum board directly attached on each side of the wall and one or more layers of 12.7 mm Type C gypsum board attached inside the wall cavity between the rows of studs. A distance of 25.4 mm between the gypsum board in the wall cavity and the adjacent row of studs was maintained for each of the wall assemblies. Wall Assembly C included thermal insulation installed in the inter-stud cavities of only one side of the wall. The transmission loss curves for the wall assemblies are compared in Figure 4 to the transmission loss of the base wall assembly with the Type C gypsum board. The differences between the transmission loss curves are shown in Figure 5.

The transmission loss curve of Wall Assembly C shows a deep dip around the coincidence frequency in the 3150 Hz one-third octave band as well as a lower transmission loss in the mid frequencies compared to the curves of the other wall assemblies. The results are a reminder of the importance of including thermal insulation in the inter-stud cavities on both sides of double stud walls. The transmission loss curve of Wall Assembly B also shows a deeper coincidence dip than the base wall assembly, indicating the importance of including dissimilar layers of gypsum board to improve the

transmission loss of a wall. But the most striking feature of the curves in the figures is the sharp decrease in the transmission loss below 200 Hz for all of the walls with gypsum board inside the wall cavity. For walls B and C, the decrease was on the order of 17 dB. Uris, et al. [6] found a similar difference when comparing the transmission loss of triple leaf steel stud walls to that of a double leaf wall. This same effect has been seen when adding gypsum board linings to each side of concrete block masonry walls, creating a triple leaf wall [7]. However, despite the size of the dips, the STC ratings of Wall Assembly A and D were equal to or higher than the STC rating of the base wall assembly, giving no indication of the poor performance of the wall assemblies at the lower frequencies.

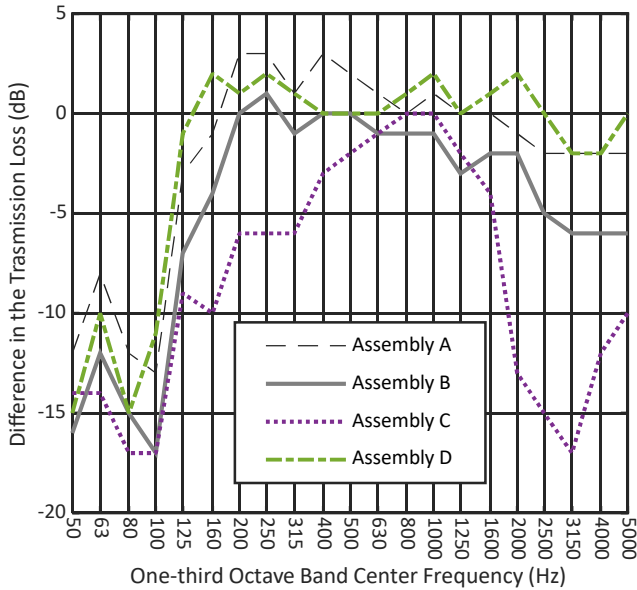
Figure 5: Difference in the measured transmission loss of the wall assemblies compared to the transmission loss of the base wall assembly with Type C gypsum board.

The cause for the dip in the transmission loss curves around the 80 Hz one-third octave band is the division of the wall cavity into two smaller cavities separated by the gypsum board installed between the rows of studs. Ballagh [8] notes that for a triple leaf system, the resonance frequencies are not simply the resonant frequencies of each cavity of the assembly, but rather the interactions of all of the components in the system must be taken into account.

While the one mass-air-mass resonance of the base wall assembly occurred in the 40 Hz one-third octave band, all of the other wall assemblies had two resonances which fell into the 63 Hz, 80 Hz or 100 Hz one-third octave bands. The resulting decrease in the transmission loss due to the mass-air-mass resonances of the triple leaf walls was on the order of 14 to 17 dB for the wall assemblies included in the evaluation. The depth of the dips in the transmission loss curves around 80 Hz shows the negative effect of installing the gypsum board inside the wall cavity and why the practice should be avoided.

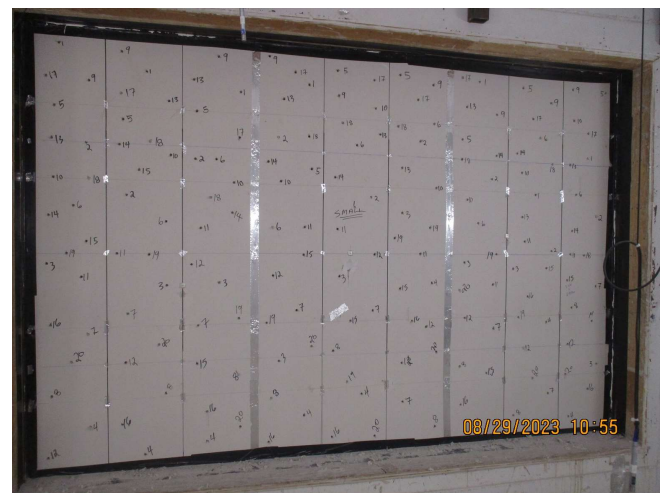
Figure 7: Image of the wall with twenty holes per bay (Case 12), resulting in one hundred and twenty holes in the wall.

The holes in the gypsum board were made using either a 6.4 mm (1/4”) drill bit or a 12.5 mm (1/2”) drill bit. The holes were randomly located along the height of the cavity between the studs. A list of the tests including the number of holes per bay and the total number of holes per side of the wall are listed in Table 3. An image of the wall with twenty holes drilled per cavity (Case 12 from Table 3) is shown in Figure 7.

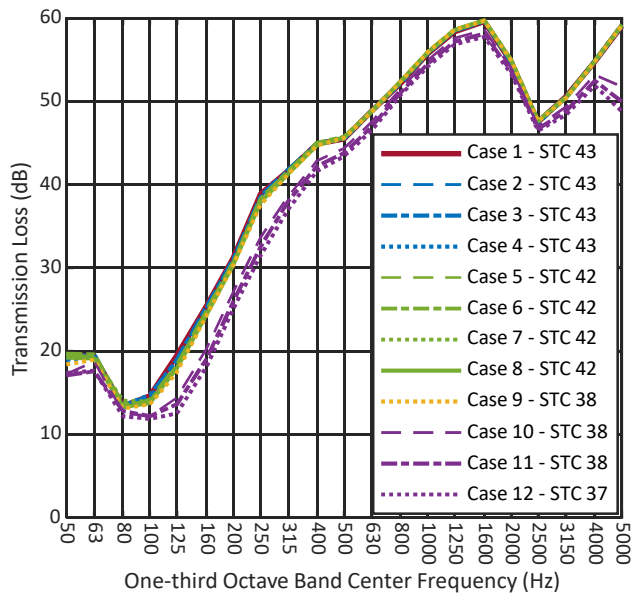
Figure 8: Comparison between the transmission loss values of a single stud wall as an increasing number of holes were drilled into the gypsum board on each side of the wall. The list of cases is shown in Table 3.

The transmission loss curves of the twelve cases are compared in Figure 8. The differences between the transmission loss curves for the wall assembly with the holes and the wall with no holes are compared in Figure 9. The figure shows that the 6.4 mm diameter holes drilled in the gypsum board had little effect on the transmission loss of the wall assembly until there were forty-eight 6.4 mm diameter holes drilled into the gypsum board on each side of the wall. Even then, the difference was only 1 dB in the 125 Hz and 160 Hz one-third octave bands. It wasn’t until ninety-six 6.4 mm diameter holes were drilled into the gypsum board on each side of the wall that the STC rating dropped further due to the changes between the 100 Hz and 250 Hz one-third octave bands. Drilling larger, 12.5 mm diameter holes in the gypsum board further decreased the transmission loss between the 100 Hz and 250 Hz one-third octave bands as well as at 5000 Hz.

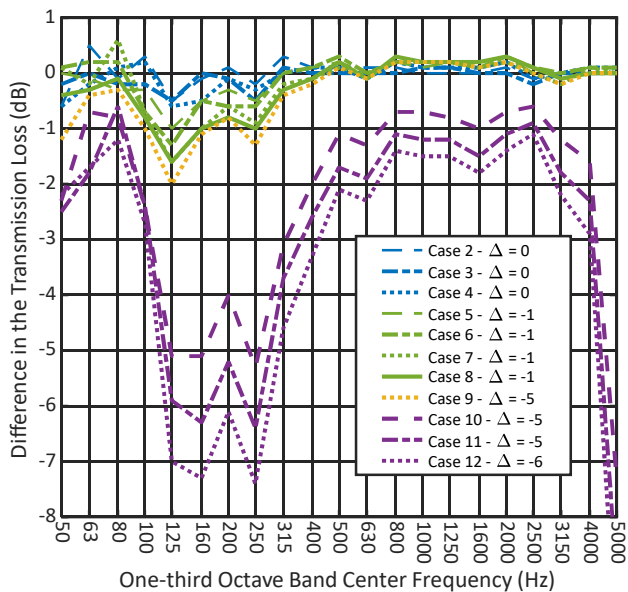
Figure 9: Change in the transmission loss of a single stud wall as an increasing number of holes were drilled into the gypsum board on each side of the wall.

A significant number of holes, well beyond what could be referred to as normal use for a wall were required before the transmission loss of the single stud wall was negatively affected. It is expected that the double stud wall designs with layers of thermal insulation in the wall cavities will show less effect due to holes in the gypsum board caused by normal use.
