A New Test Method for Quantifying Air Leakage of a Mechanically-Attached Roofing Assembly

Suda Molleti, Ph.D.,¹ Bas A. Baskaran Ph.D., P.Eng.,^{2c}

Abstract

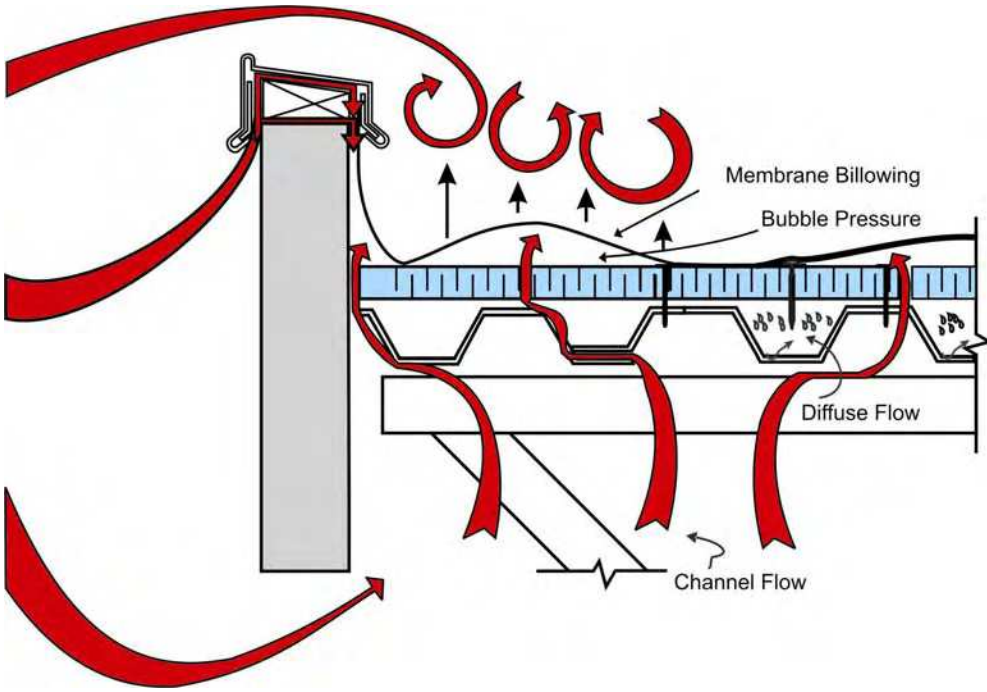
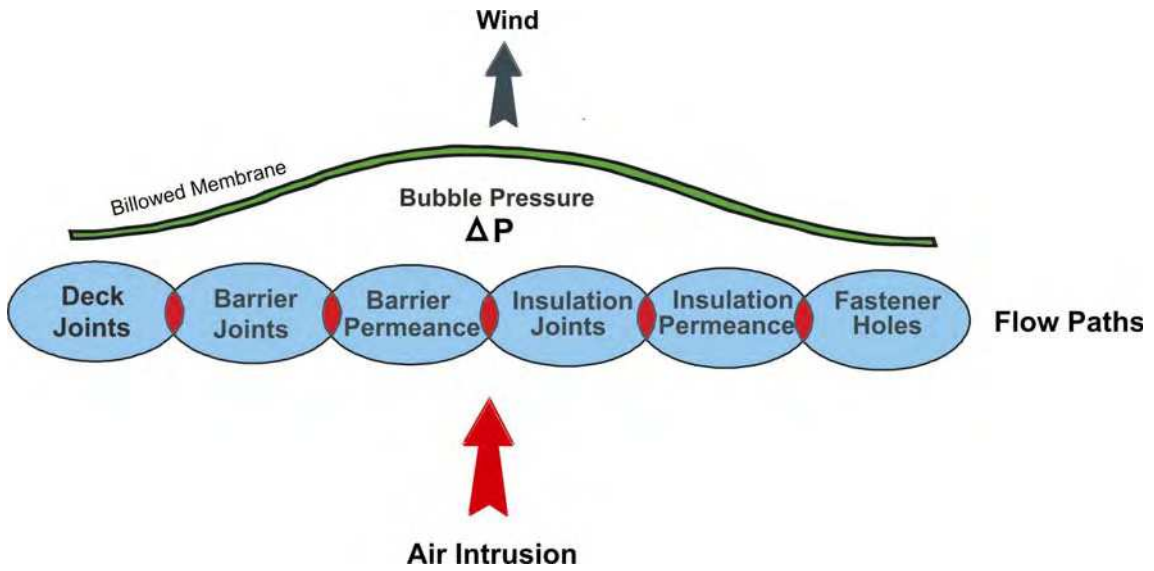
Figure 1: Air leakage mechanism of MAA during wind uplift

MAA meet these two prerequisites during wind uplift conditions. Figure 1 illustrates the airflow mechanism through MAA. The waterproof membrane, which acts as an air barrier/retarder, is placed on top of the insulation and attached to the structural steel deck using mechanical fasteners. The attachment locations are then overlapped and seamed. Wind induced suction lifts the membrane and causes membrane elongation and billowing between the attachments. The magnitude of the wind induced suction; the membrane's elastic properties and the fastening

pattern determine the deflection of the membrane billowing. The momentary displacement or billowing of the membrane creates a relative negative pressure below the lifted membrane and this draws indoor air into the roof, thereby satisfying the first prerequisite. The second prerequisite is met by the lack of airflow control at the deck level. Flow paths are created by the component's air permeability and joints/junctions/ penetrations in the roofing assembly.

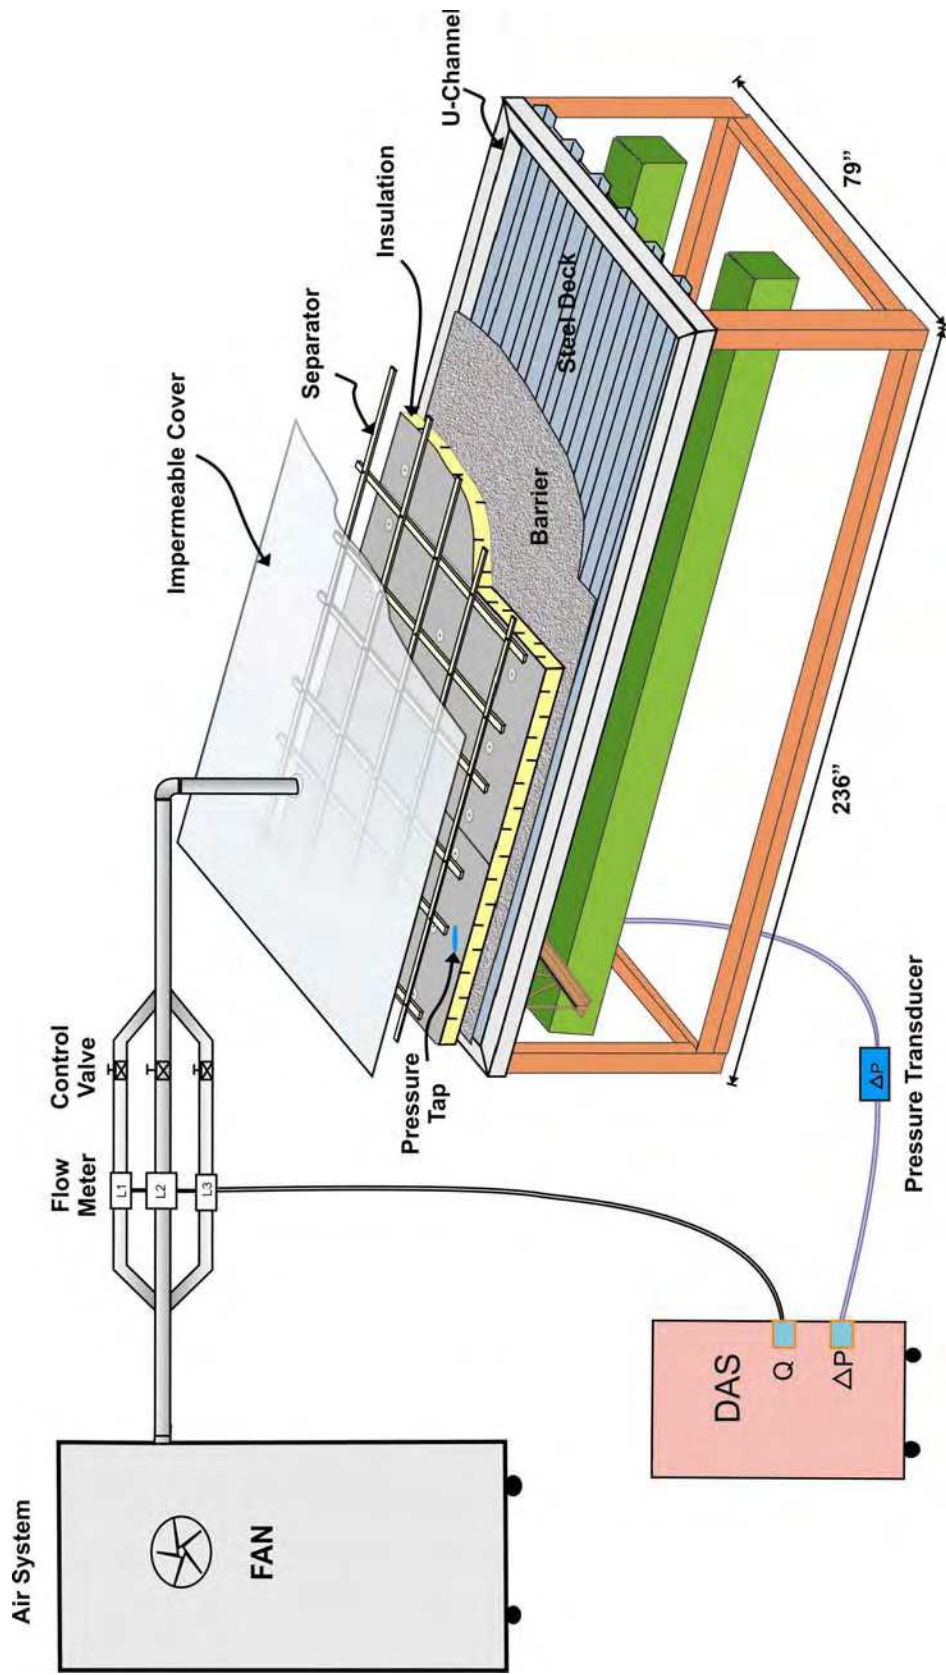
Figure 2: Experimental set-up for determination of air flow resistance of roofs

Recently, Molleti and Baskaran (2006) reported the details of the newly developed air leakage test method for roofing assemblies. Figure 2 illustrates the experimental setup developed for the air leakage quantification. As shown in Figure 2, the test frame has a dimension of 2 m x 6 m x 0.8 m (79" x 236" x 32"). The test specimen/roof assembly is installed in the frame, which is supported on a lifting mechanism with adjustable jacks. This feature allows for investigating different roofing assembly thicknesses accommodating different roofing components.

Following the above experimental setup (Figure 2) the present study quantified air leakage rate of five roofing assembly configurations. The five roofing assemblies are:

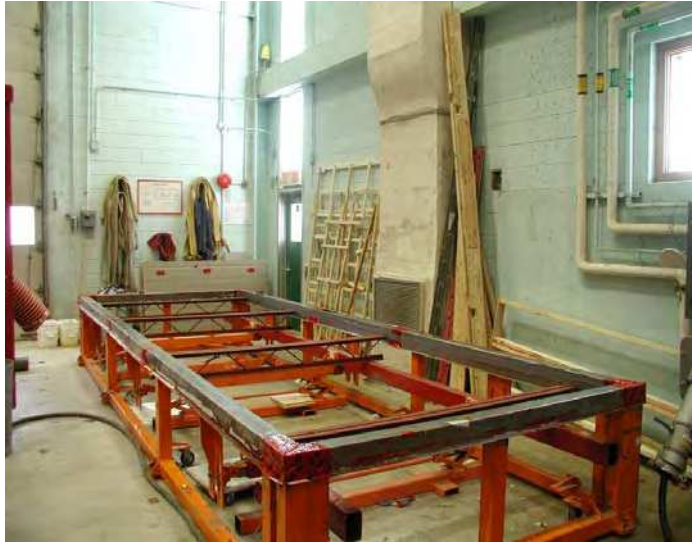
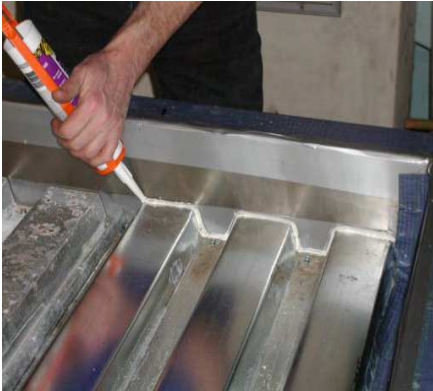
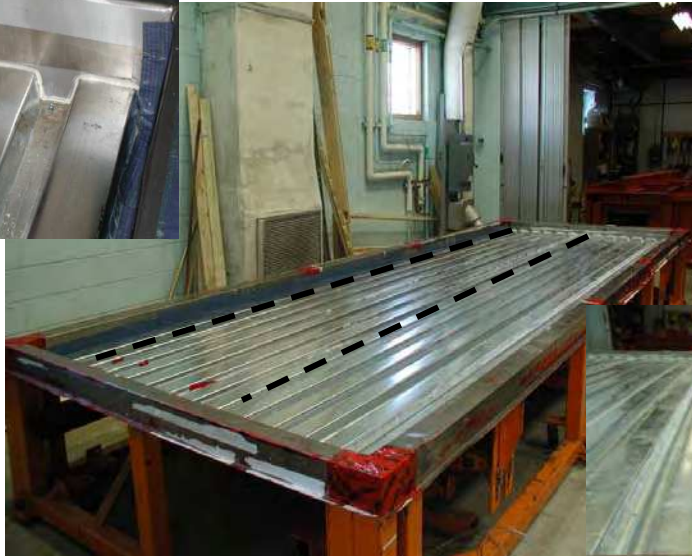
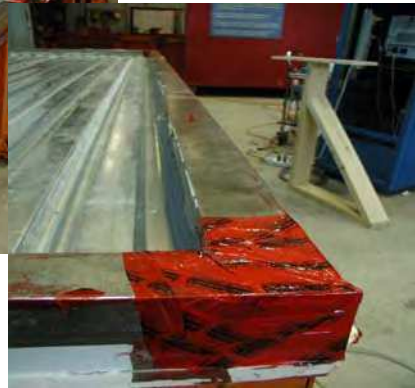
Figure 3: Deck Installation and edge treatment

This experimental set up is intended to measure the wind uplift resistance associated with the field zone of the roof. In order to achieve this, the edge treatment of the test assembly was handled by installing steel U-channels along the perimeter of the test frame as shown in Figure 3. As the width of table was 2006 mm (79”), one full sheet of 914 mm (36”) wide and two cut pieces of 610 mm (24”) and 483 mm (19”) wide steel decks were installed along the

table length as shown in Figure 5. The steel deck was 0.76 mm (22-Ga) thick with a profile height of 38 mm (1.5") and a flute width of 150 mm (5.9"). The black dotted lines indicate the deck overlaps. To eliminate the air leakage along the edges of the deck, the steel deck edges are butted to the U-channel, and the gap between them was sealed using sealant and adhesive membrane as shown in Figure 3. Thus, the field zone of the roof is simulated, assuring that the airflow occurs along the steel deck seams and not the deck edges.

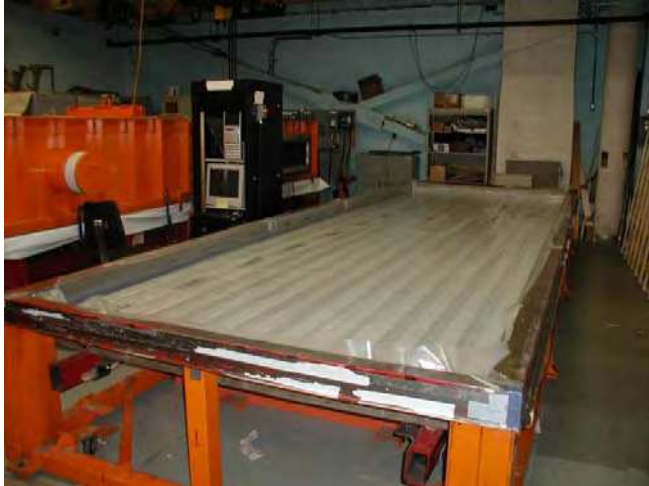
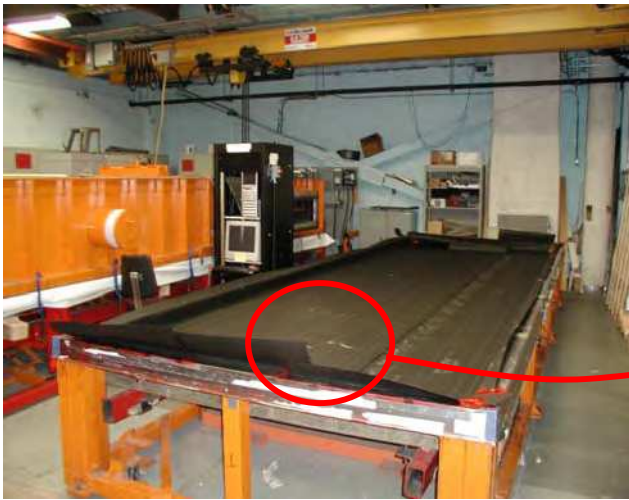
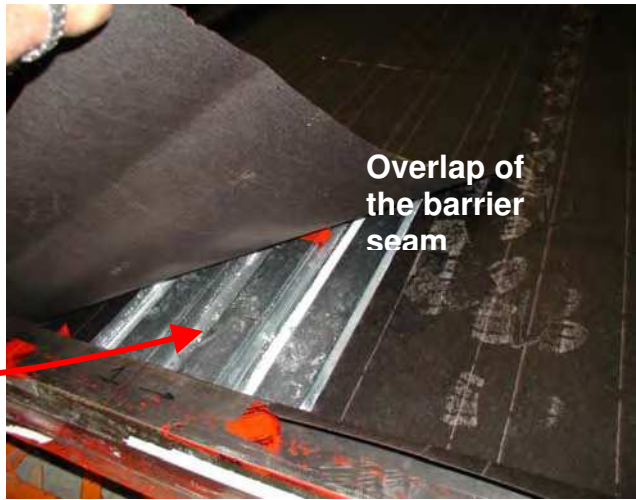
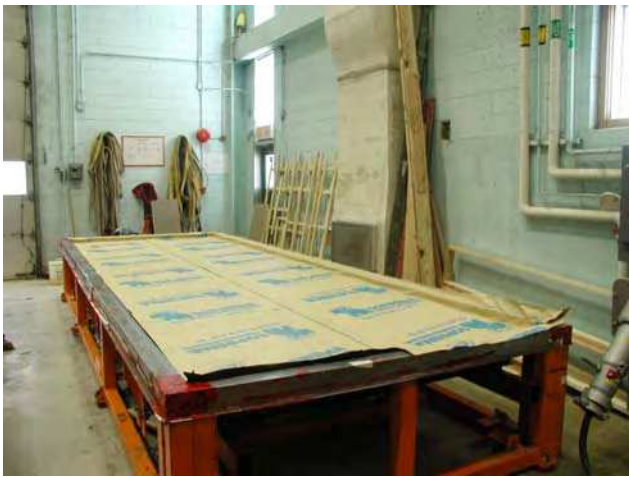
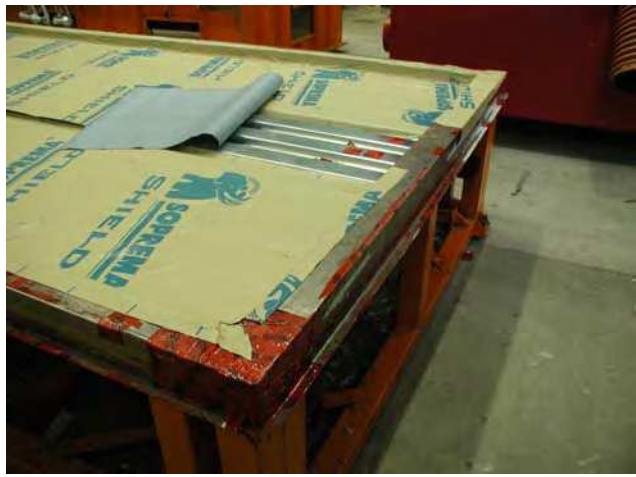
Figure 4: Barrier Installation

Figure 4 shows the installation of the three barriers/retarders. **A3** had building paper as the barrier/retarder and since the building paper comes in width of 914 mm (36") two full sheets of 914 mm (36") and one cut sheet of 457 mm (18") were laid on the steel deck. The sheets had an overlap of 152 mm (6") and by using adhesive (vapour-bloc glue) the overlaps were joined. The edges of the building paper were pulled and bent at 90° over the U channel and sealed to the U channel as shown in the Figure 4, and at the corners the building paper was cut at 45° and folded over the U-channel. **A4** had self adhered membrane sheet (SAM) as barrier/retarder and as SAM also comes in sheet widths of 914 mm (36") the installation procedure is similar to the building paper except this is a self-adhered film, which adheres directly to the top flange of the steel deck. For **A5**, a continuous sheet of polyethylene was

installed on the steel deck. The edges of the polyethylene sheet were pulled and bent at 90° over the U channel as shown in the Figure 4. The edge treatment of the polyethylene sheet was similar to the building paper in **A3**.

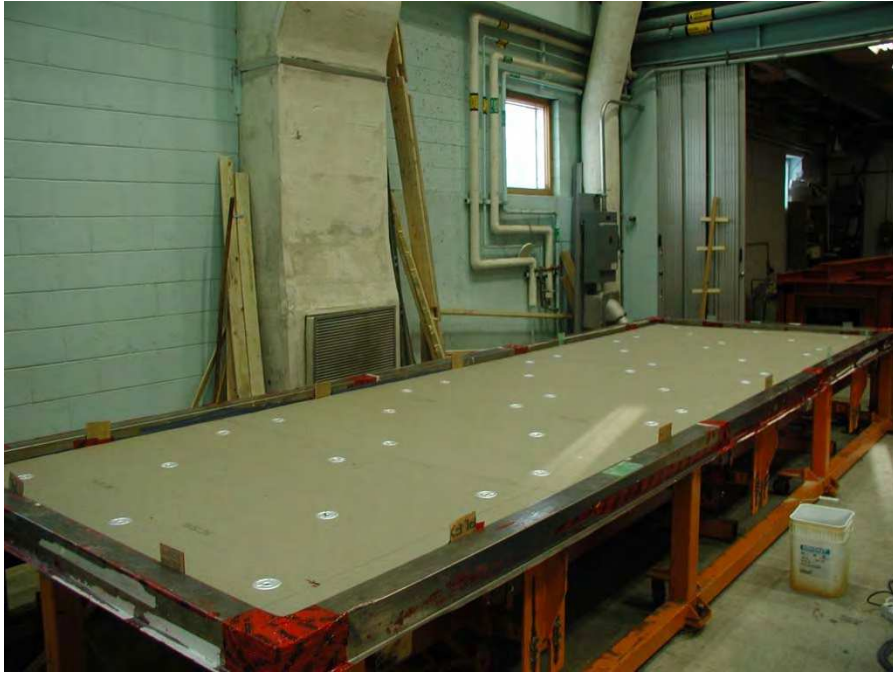
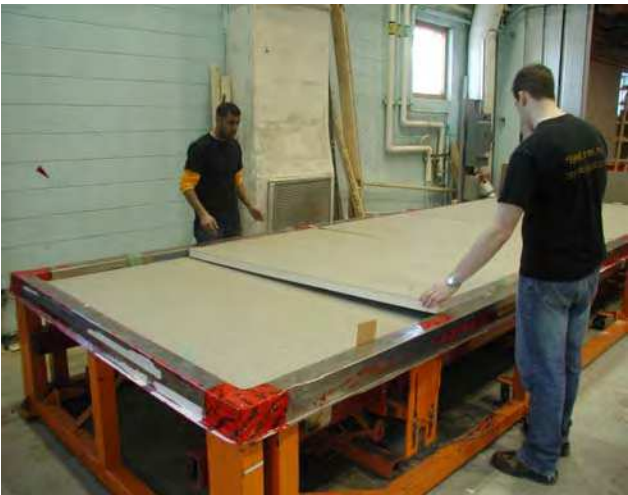
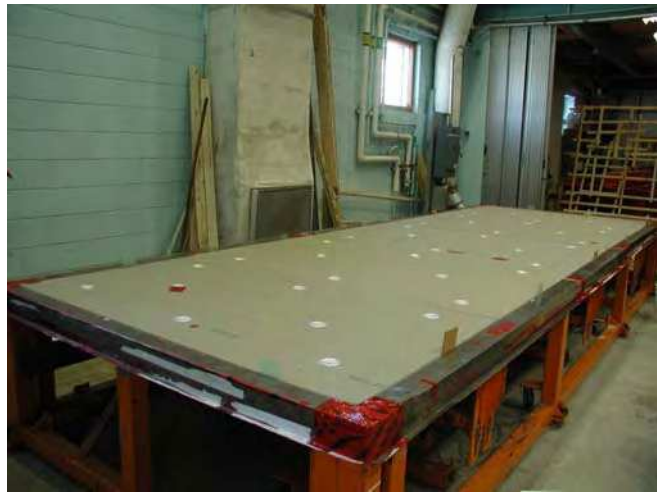
(a) One Layer Insulation

(b) Two layer staggered insulation

Figure 5: Insulation installation

Figure 5 illustrates the cross section view of the two-insulation layouts and Figure 6 shows the typical layout of insulation attachment. For all the five tested assemblies, 51 mm (2") thick polyisocyanurate boards with a compressive strength of 170 Kpa (25 psi) were used as the insulation. In **A1**, **A3**, **A4** and **A5** insulation configuration comprised of a layer of insulation with four full boards of 1219 mm x 2006 mm (48" x 79") and one partial board of 1118 mm x 2006 mm (44" x 79") installed with the long edges perpendicular to the deck flutes. In **A2**, the insulation layout is similar to the former assemblies except that it comprises of two layers of insulation in staggered arrangement. The insulation boards were mechanically fastened to the steel deck with 76 mm (3") diameter circular plastic plates and 127 mm (5") long fasteners. Each insulation board was attached with 8 fasteners, which has a fastener density of one fastener per 0.3 m² (3.3 ft²)

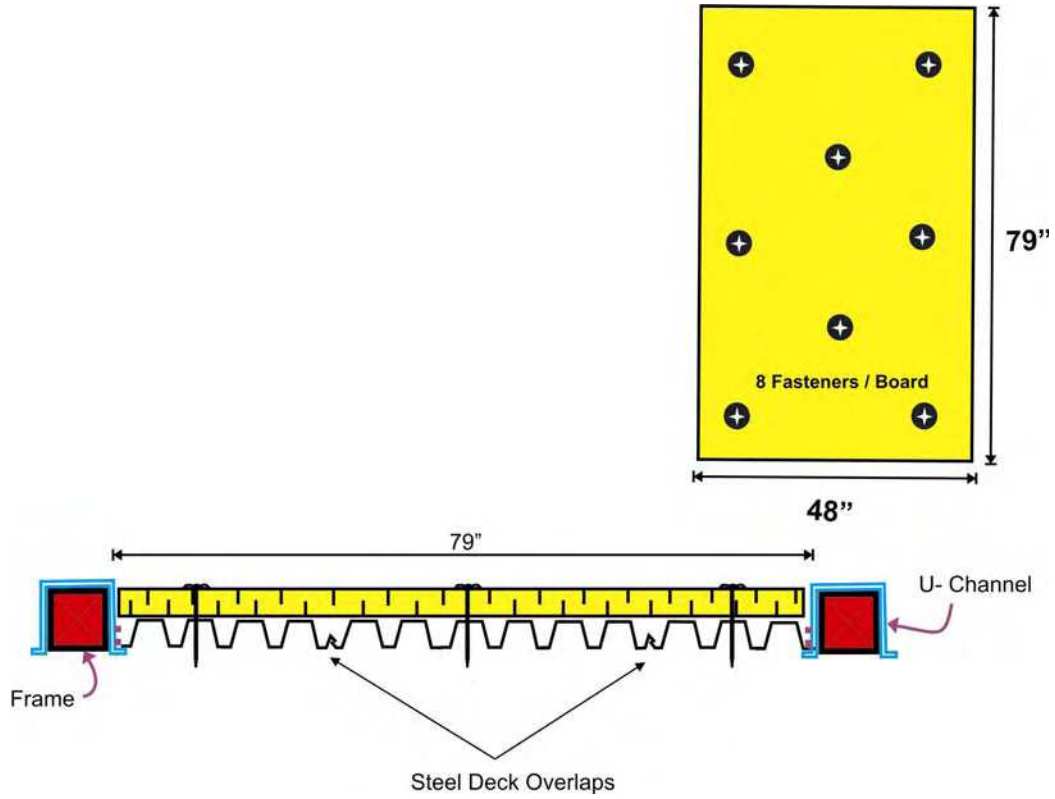
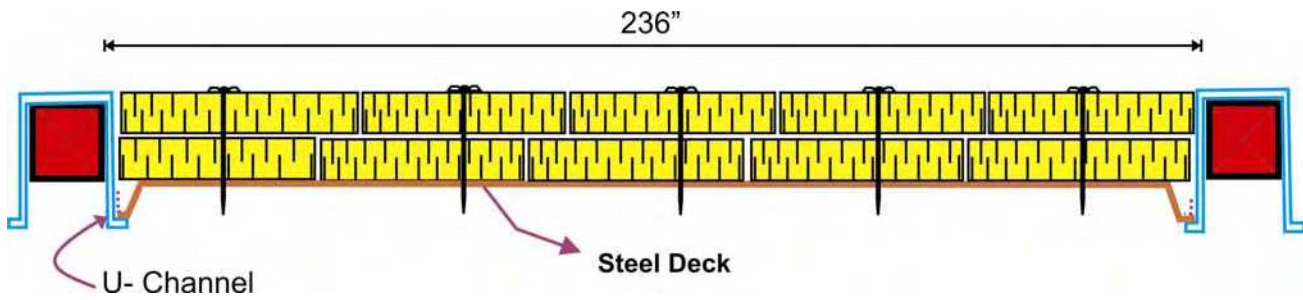
(a) One layer insulation layout (Front view along the table width)

(a) Two layer staggered insulation layout (Side view along the table length)

Figure 6: Cross-sectional layout of the insulation installation

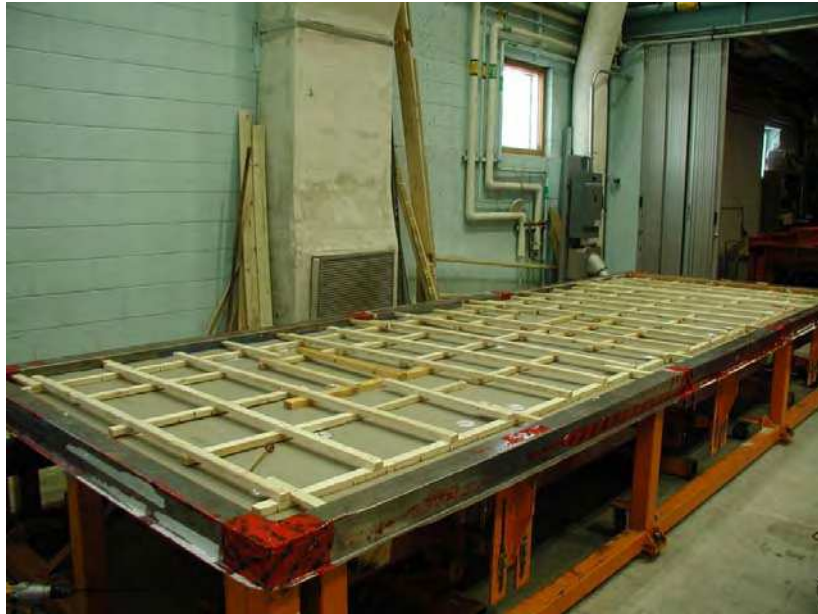
Figure 7: Installation of the separator

With the insulation in position and fastened to the deck, a square meshed wooden separator was installed on top of the insulation as shown in Figure 7. The role of the separator is to provide the gap or space between the test specimen and the impermeable cover for creating uniform differential pressure across the specimen and for allowing the airflow without any obstruction. A minimum gap of 50mm (2") was maintained for this purpose. After the completion of the separator installation, two pressure taps are installed on either ends of the test specimen. These pressure taps measure the differential pressure across the test specimen.

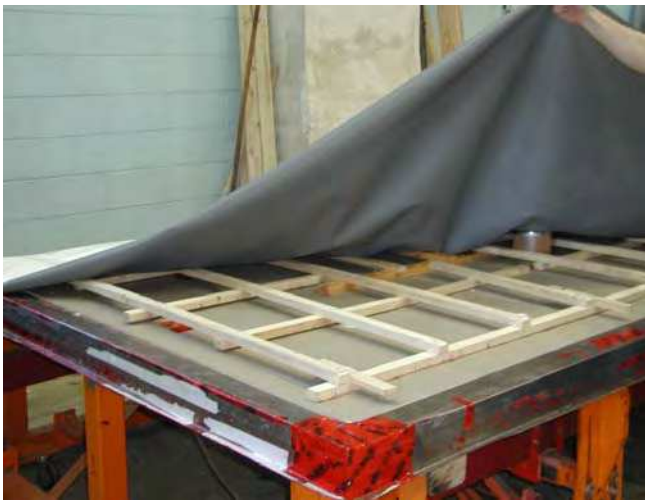
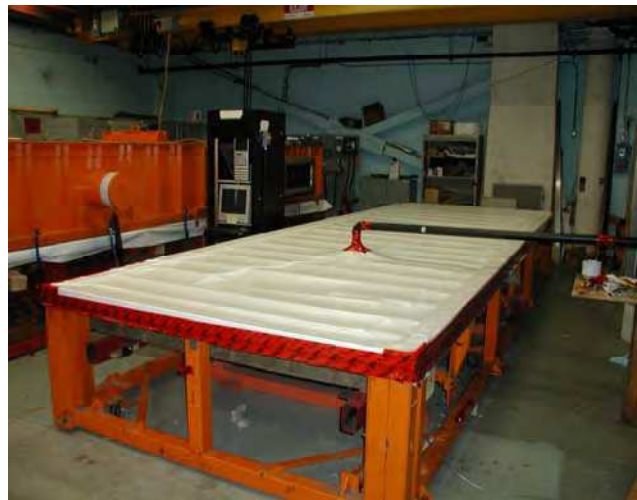
Figure 8: Installation of the impermeable cover

A continuous sheet of impermeable cover as shown in Figure 8, was laid on top of the

separator. The overhang edges of the impermeable cover were adhered to the frame edges, thus eliminating any extraneous airflow into the test specimen. Provisions were made to install the flow measurement setup by making a 50 mm (2") diameter opening on top of the impermeable cover. One end of the flow measurement setup has an air filter, which was inserted into the test specimen, and the other end was connected to the air system. In between them, the flow-measuring device and the adjustable control valve were installed. The former measures the airflow rate and the latter controls the applied pressure.

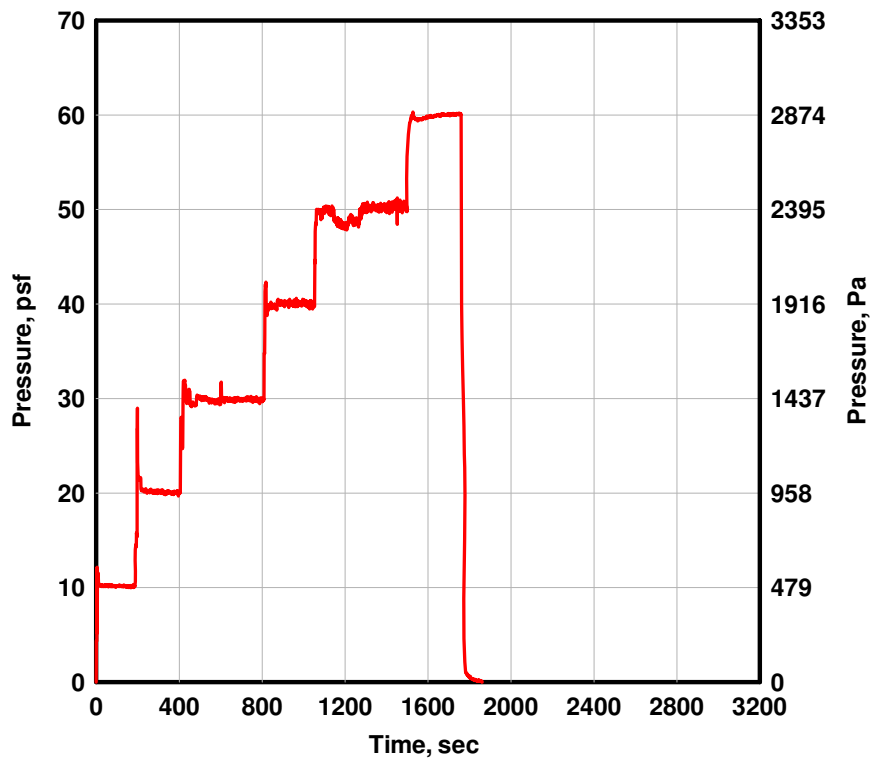
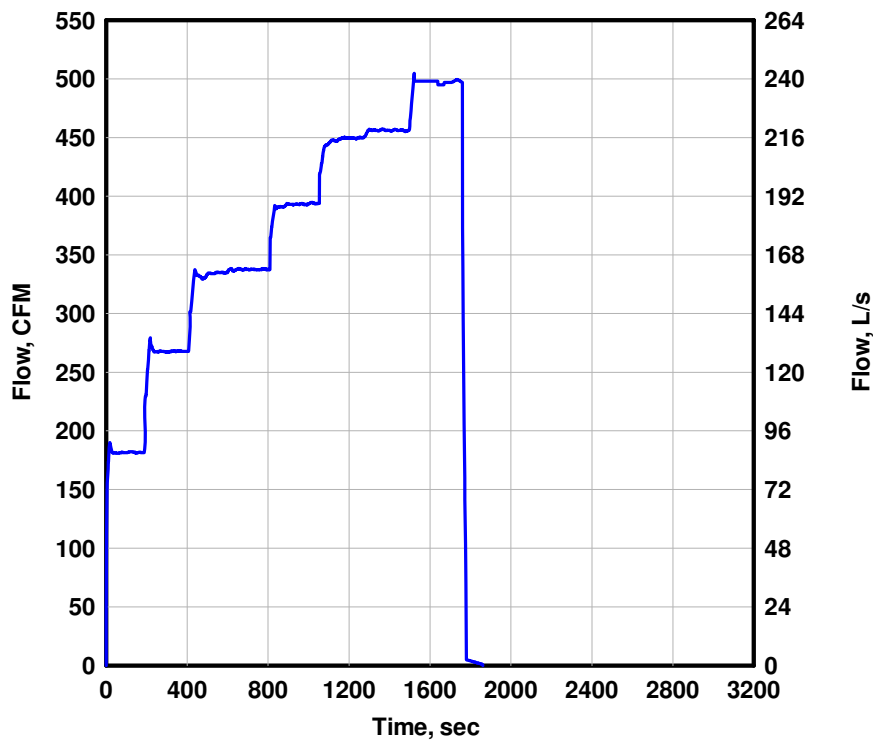
Figure 9: Measured pressure and flow time histories of A1

Figures 9 and 10 shows a typical measured pressure and flow time histories of two assemblies, one without barrier/retarder (**A1**) and other with barrier/retarder (**A5**) respectively. The pressure

time history is a measure to verify whether the applied pressure equals the target pressure of the test protocol. The applied pressure at each pressure level comprises of three parts: 1) Pressure Build-up 2) Pressure Stabilization 3) Pressure Measured (Molleti and Baskaran, 2006). As per the test procedure, the pressure is measured for a minimum duration of 60 secs after it stabilizes. The pressure stabilization varies from assembly to assembly and is dependent on the air tightness of the tested assemblies, which leads to varying testing time as shown on the X-axis of the Figures 9 and 10. Error analysis was performed between the target pressures and the measured pressure for all the assemblies. Data indicates that the measured pressure showed an error of 0.2% deviation from the target. As shown in Figure 10, the peaks in the pressure measurement for both the assemblies can be attributed to the manual operation of the control valve.

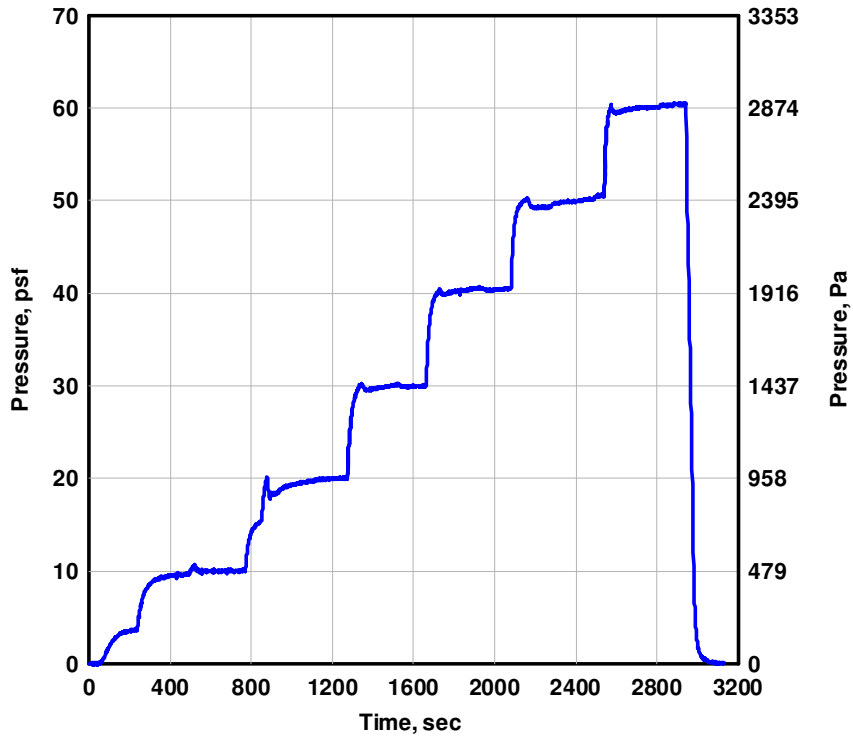
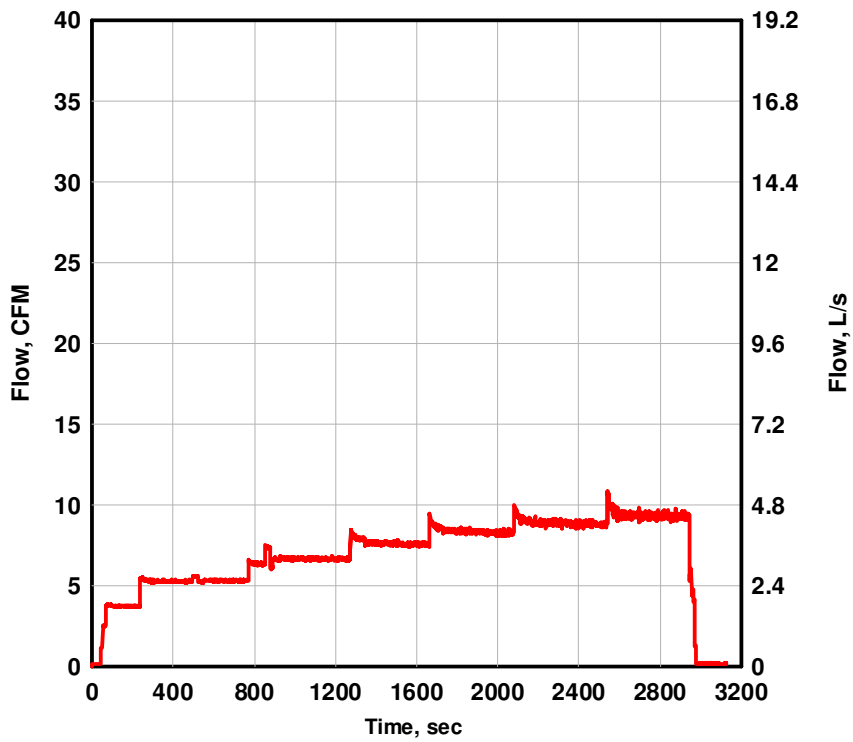
Figure 10: Measured pressure and flow time histories of A3

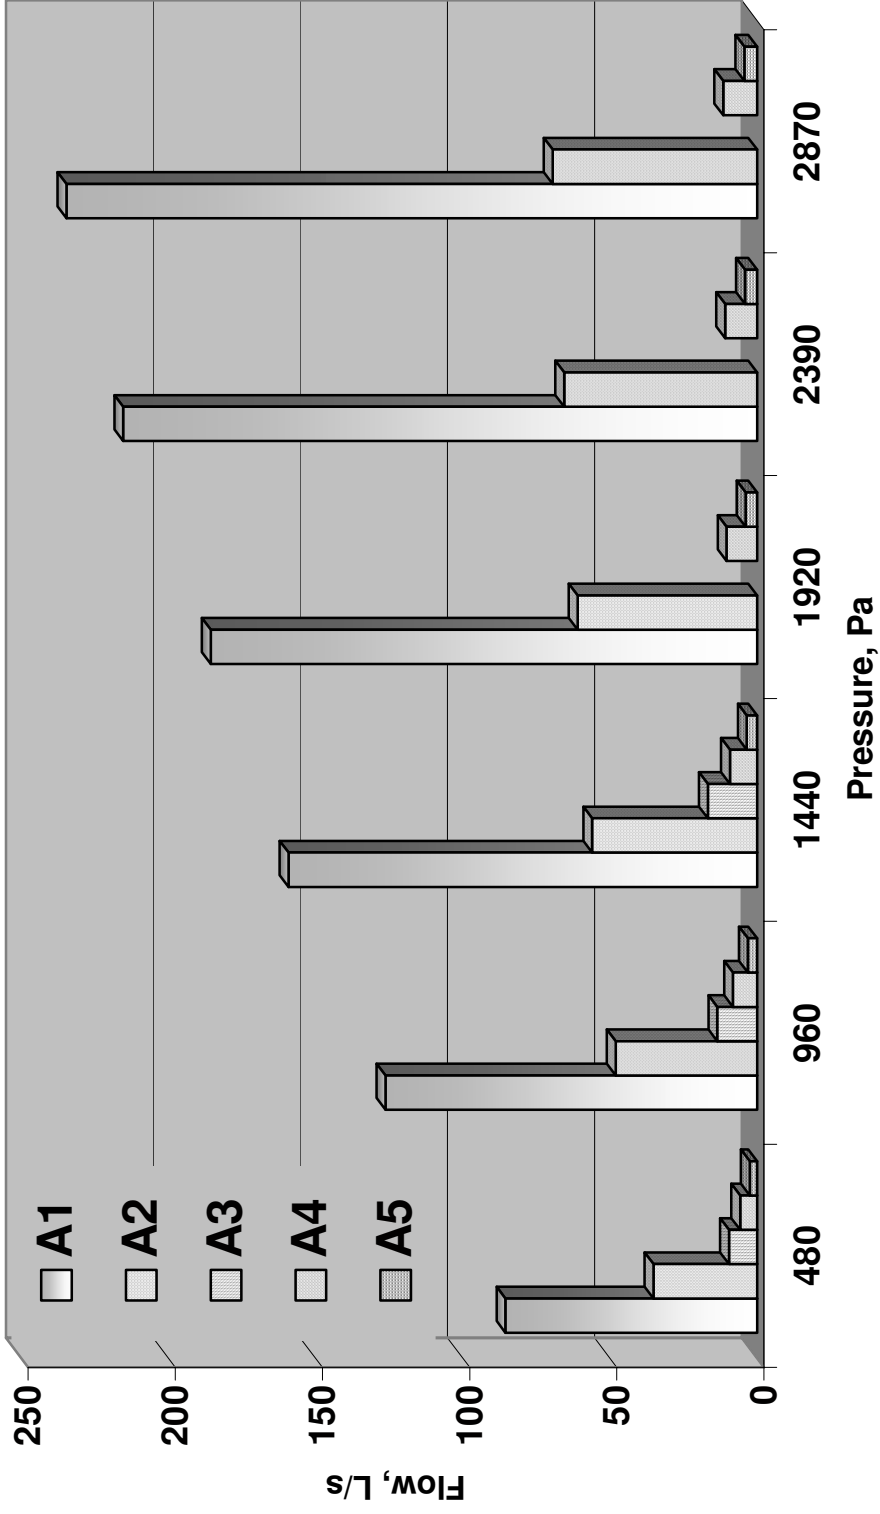
Figure 11: Air leakage rate of the five tested assemblies

Figure 11 presents the measured air leakage rate of the five assemblies. Data clearly indicates that **A1** and **A2** without barrier/retarder had a greater leakage rate when compared to the assemblies with barrier/retarder namely **A3**, **A4** and **A5**. The present study also attempts to answer whether the staggered arrangement of insulation boards as in **A2** can be as effective as that of having a barrier/retarder in an assembly. The comparison of the data from Figure 11 points out that the staggered arrangement of insulation in **A2** certainly provided the air retarding effect in comparison to **A1**, however it proved to be not as effective as the assemblies with

barrier/retarder (**A3, A4, & A5**). It is also to be noted that in Figure 11, no air leakage data is presented for **A3** (*with building paper*) beyond 1440 Pa (30 psf). The reason was, during the air leakage testing of **A3**, at one corner a 45° cut made in the building paper opened up or enlarged. This led to a drastic increase in the airflow rate and as a result the test was stopped. Irrespective of this drawback **A3** provided a good air retarding effect up to 1440 Pa (30 psf).

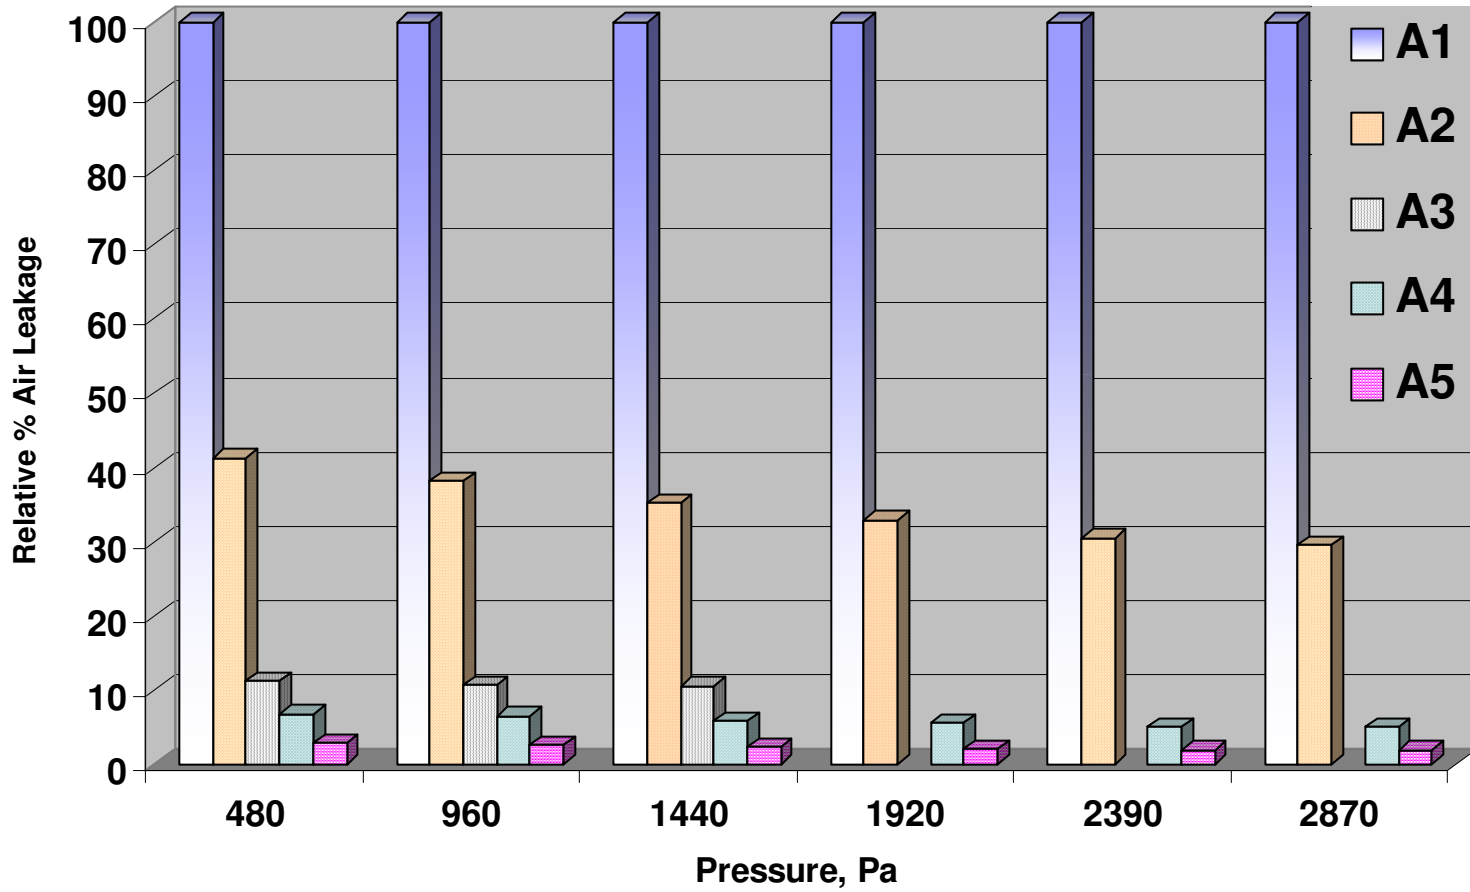
Figure 12: Relative comparison of the air leakage resistance of the tested assemblies with respect to A1

To further illustrate the relative performance of the air retarding effect of the different assemblies, Figure 12 presents the percentage air leakage of the assemblies relative to **A1**. To get a better understanding, a typical pressure of 1440 Pa (30 psf) was selected for the following discussion. If it is assumed that **A1** without any barrier/retarder had 100% air leakage, then relative to the air leakage of **A1**, observations can be summarized as follows:

- **A2** with staggered insulation has 35% of air leakage of **A1** or air leakage reduced by 65%
- **A3** with building paper has 10% of air leakage of **A1** or air leakage reduced by 90%
- **A4** with self-adhered film 6% of air leakage of **A1** or air leakage reduced by 94%,
- **A5** with polyethylene sheet has 2% of air leakage of **A1** or air leakage reduced by 98%

High leakage rate of **A1** can be attributed to the channel flow occurring at the deck and insulation joints. With the inclusion of another layer of insulation, **A2**, did provide good air leakage resistance by reducing 65% of air intrusion, however it could not be as effective as assemblies with a barrier/retarder. The channel flow between the joints in the insulation boards was providing the necessary flow path for air movement into the assembly. **A4** and **A5** with self-adhered film and polyethylene sheet as barriers/retarders, showed good air leakage resistance. The reduced air leakage resistance of **A3** could be mainly attributed to the seam joints and corner edge treatments of the building paper. It should be noted that the building paper being a soft material, if not properly installed has a tendency to tear. Within the assemblies with barrier/retarders, **A5** showed better air leakage resistance by reducing airflow by 75% and 60% compared to **A3** and **A4**. However, it should be noted here that the polyethylene sheet in **A5** was continuous without any seam joints, which represents the best-case scenario.

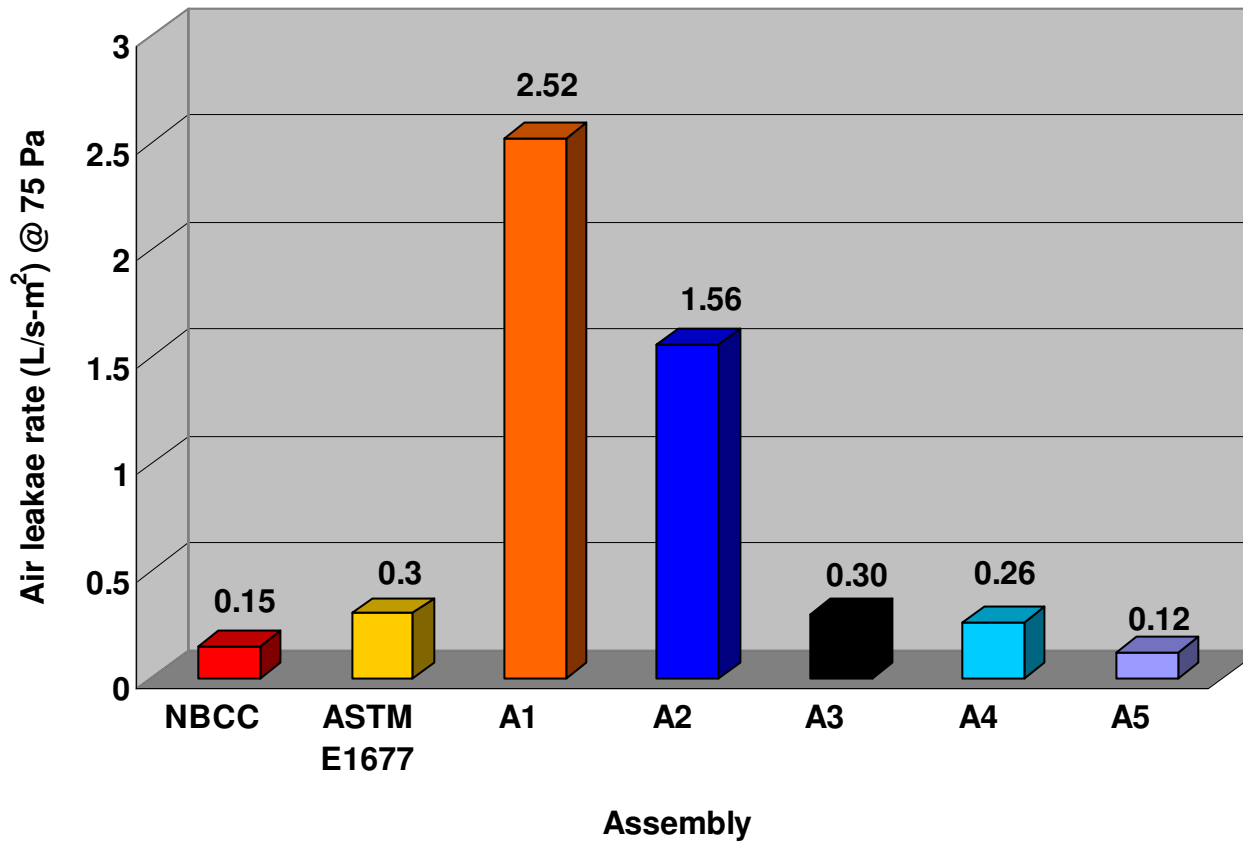
Figure 13: Comparison of measured air leakage with the existing codes of practice and standard

For an air barrier/retarder system in opaque, insulated portions of the building envelope, Part 5 of the NBCC (2005) recommends three permissible air leakage rates corresponding to various indoor humidity levels as shown in Table 1. To verify whether the tested assemblies comply with this code requirement, air leakage rates of the five assemblies were calculated at 75 Pa (1.56 psf) and compared with the NBCC [based on the laboratory testing condition 0.15 L/s.m² (0.03 ft³/min.ft²) was selected] as shown in Figure 13. **A1** had a leakage rate of 2.52 L/s.m² (0.5 ft³/min.ft²), **A2** had 1.56 L/s.m² (0.31 ft³/min.ft²), **A3** had 0.30 L/s.m² (0.06 ft³/min.ft²), **A4** had 0.26 L/s.m² (0.051 ft³/min.ft²) and **A5** had 0.12 L/s.m² (0.023 ft³/min.ft²) respectively. Comparison of these data with the NBCC indicates that none of the assemblies except **A5** comply with the NBCC code requirement. However, once again it should be remembered here that the assembly set-up of **A5** represents the idealistic construction procedure having proper edge treatment and no seam joints, which has achieved its end result demonstrating the significance of air intrusion. Similarly, ASTM E1677-2005, Standard Specification for an Air Barrier (AB) Material or System for Low-Rise Framed Building Walls, calls for an assembly air permeance requirement of 0.30 L/s.m² (0.06 ft³/min.ft²) at 75 Pa (1.5 psf). However, the standard restricts this permissible leakage rate to the opaque walls. Therefore, the comparison presented in Figure 13 relative to ASTM E1677 is not really applicable to roofing assemblies, however, it signifies the necessity of similar air leakage resistance requirement for roofing assemblies.
