Proceedings of Materials Science and Technology, pp. 37-49, 2013-10-31

FIBER LASER DEPOSITION OF INCONEL 718 USING POWDERS

^{1,2}Y.N. Zhang, ^{1,2}X. Cao, ¹P. Wanjara and ²M. Medraj

¹National Research Council Canada – Aerospace, Montreal, Quebec, H3T 2B2, Canada

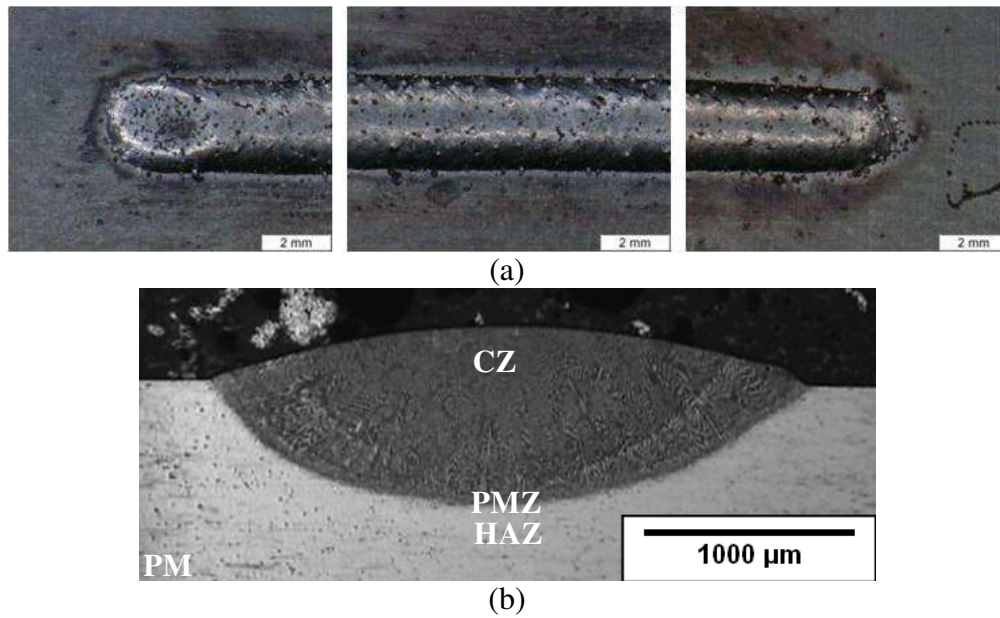
Figure 1. (a) Surface morphology and (b) transverse cross-section of an ADED single bead clad on 3-mm thick IN718 substrate. The cladding direction is from the right to the left in Figure 1a.

Using process parameters that were optimized on a 3-mm thick IN718 substrate in the STed condition, the characteristics of an ADED single bead from the top surface (Figure 1a) reveal a silver-colored crown surface, which indicates adequate shielding protection during laser deposition and cooling. From the transverse cross-section (Figure 1b), the wide and shallow morphology of the single bead is indicative of laser deposition operated in conduction mode. The dilution ratio (i.e. melted area in the substrate/total melted area) is approximately 60%, which suggests a relatively low heat efficiency. As shown in Figure 1b, the clad zone (CZ), the partially melted zone (PMZ), the heat affected zone (HAZ) and the STed IN718 parent material (PM) can be clearly identified. The narrow HAZ is due to the use of a high energy density laser beam with a small spot size and low heat input. No visible pores or cracks were apparent on both the surface and transverse views of the single beads.

Figure 7 shows the microstructures of the IN718 substrate materials. For the 3-mm thick IN718 sheets, used in solution heat treated condition for the deposition of the single beads (Fig. 1), the microstructure mainly consisted of equiaxed austenitic γ grains decorated with some needle-like δ phase, Nb-rich MC type primary carbides and carbonitrides (Figure 7a). Specifically, the continuous matrix of γ grains is an fcc Ni-based austenitic phase with a high percentage of solid-solution elements such as Co, Cr, Fe, Mo, Nb, Al, Si, Ti and Mn. The needle-like $\text{Ni}_3\text{Nb}-\delta$ particles are then mainly precipitated at the grain boundaries of the austenitic γ matrix. The as-serviced IN718 (that was STAed before service) consisted mainly of equiaxed austenitic γ grains, globular $\text{Ni}_3\text{Nb}-\delta$ precipitates at the grain boundaries or the interior of the grains and Nb-rich MC particles, as well as some age-hardening/strengthening γ' and γ'' phases (that are not apparent in the optical image shown in Figure 7b). Compared to the as-serviced IN718, slight coarsening of the austenitic γ grains is observed after PCHT that can be attributed to the additional solution heat treatment applied (Figure 7c). It is noteworthy that the re-aging heat treatment may also cause coarsening or re-precipitation of the strengthening phases such as γ' and γ'' in the grain interior of the γ matrix; due to the γ/γ' eutectic reaction, γ' can also form in the interdendritic or intergranular regions [1].

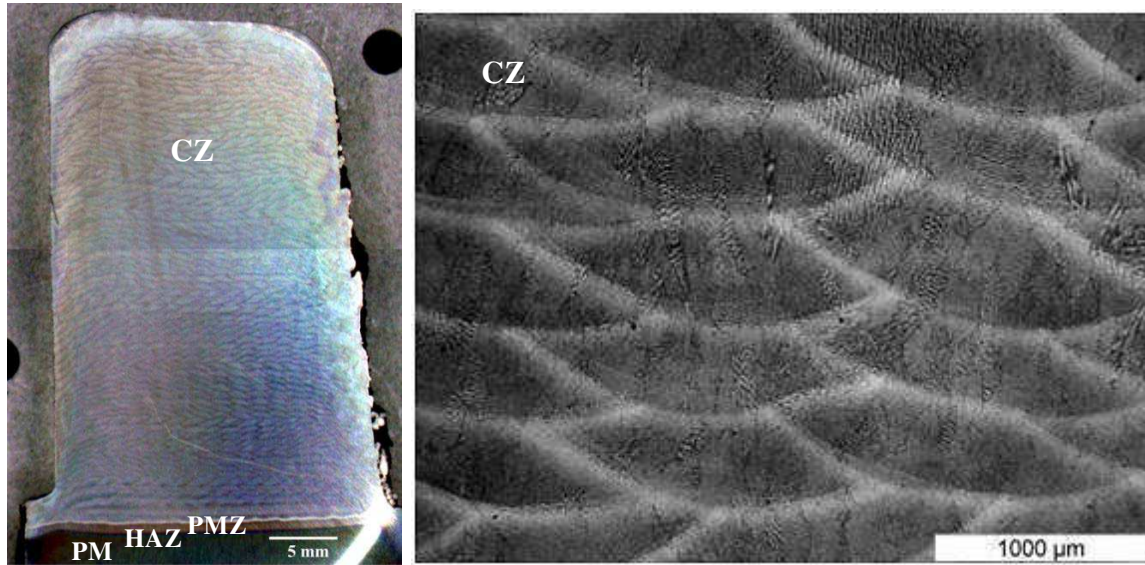
Figure 2. A multi-bead and multi-layer deposit on as-serviced IN718 substrate in ADed condition.

Based on the optimum process conditions identified for depositing single beads, a multi-bead and multi-layer deposit with approximate dimensions of 100 mm × 300 mm × 30 mm was manufactured, as shown in Figure 2. Macroscopic examination of the deposit shows the absence of visible cracks and the presence of some minor micro-porosity, which demonstrates that high integrity free-forms can be successfully built when using optimized laser processing parameters. As observed in the single bead deposit, three distinct regions can be identified, i.e. PM, HAZ (including PMZ) and CZ. The HAZ between the PM and the multi-bead and multi-layer deposit remains relatively narrow (< 1 mm in size) despite the heat accumulation during laser deposition.

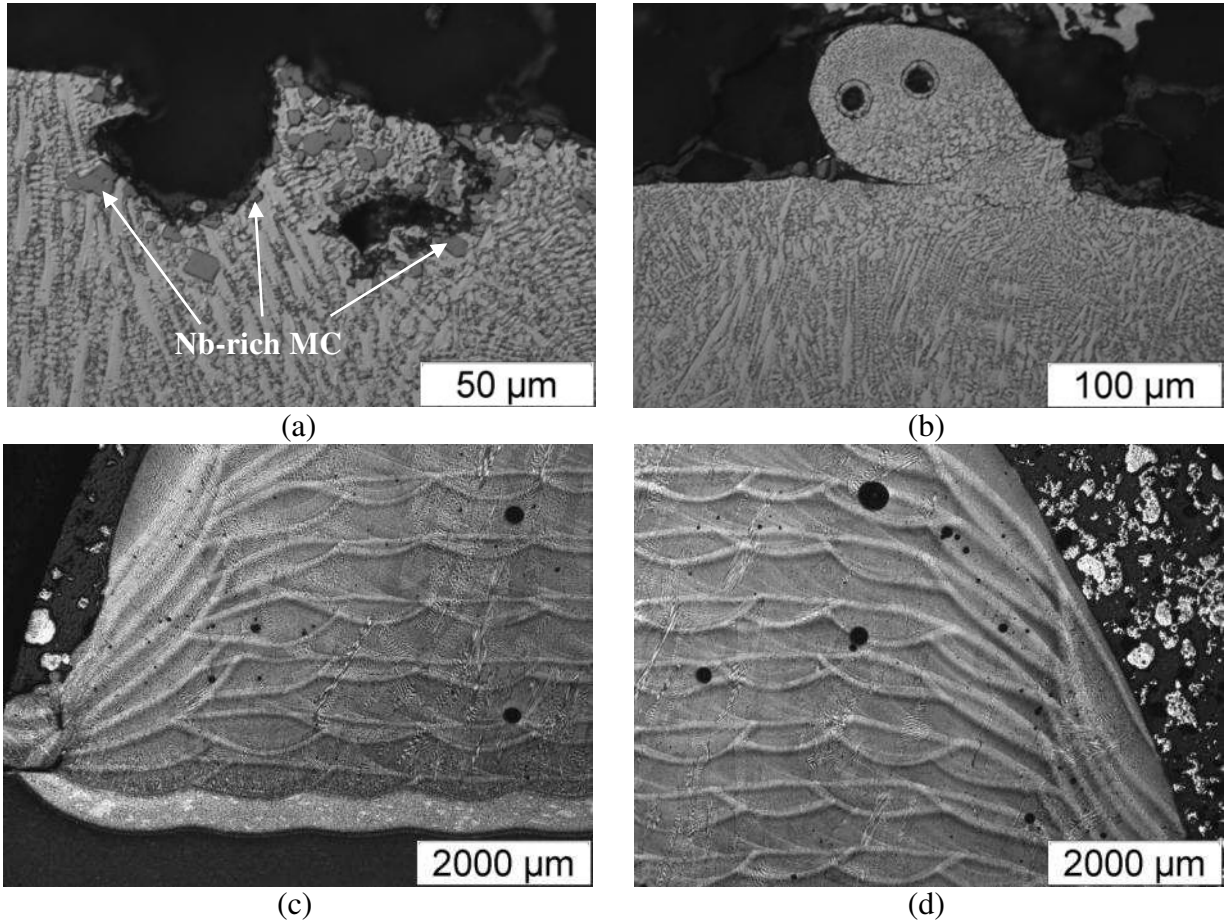
Figure 3. Porosity defects observed in (a-b) single beads and (c-d) multi-bead and multi-layer deposits in ADed conditions.

Porosity: As shown in Figure 3, spherical pores can be present in the single bead and multi-bead/multi-layer deposits. The spherical shape of the pores is indicative of their origin. The pores are most likely entrapped gas bubbles in the molten metal bead that could not escape before solidification. In particular, the small gas bubbles in the molten metal can coalesce (forming larger bubbles) as they rise to the top surface (during cladding the escape of the gas porosity before solidification is accessible only by means of the top surface). Hence, if the liquid metal surface solidifies before the gas bubbles have risen and escaped to the top surface, then the gas porosity will be entrapped within the bead. Figure 3a shows two surface pores that had nearly floated to the solidified top surface. As shown in Figure 3b, the presence of hollow spherical pores within a powder particle on the clad surface indicates that the porosity is probably entrapped from the gas atomization process during manufacturing of the powders. Other sources for the formation of gas porosity include the gases for shielding protection and/or any minor contamination from grease, oil and dirt existing on the surfaces of the work-pieces and powder feed materials. Of particular interest also is the significant amount of primary Nb-rich MC carbides and carbonitrides appearing around the surface pores (Figure 3a). The porosity can precipitate on the dry side of the oxide film but the wetted side can favor the nucleation of intermetallics such as Nb-rich MC carbides and carbonitrides, as observed recently in [9]. As a result, both the porosity and intermetallics can float towards the top surface with their shared oxide films and explains the agglomeration and concentration of the intermetallic particles.

Un-melted powders: As seen in Figures 3b and 4, some particles (similar in size to the powders applied) may appear on the top surface of the deposited beads. Up to the melting conditions, these particles may have good metallurgical bonding or lack of bonding (LOB) with the deposited metal. On occasion, these particles may also result from spattering. In laser welding, spattering occurs due to the significant vaporization of the material at the high laser power density that causes expulsion or ejection of the liquid metal on account of the large recoil force on the molten pool surface. During conduction-mode laser deposition, a large laser beam size is

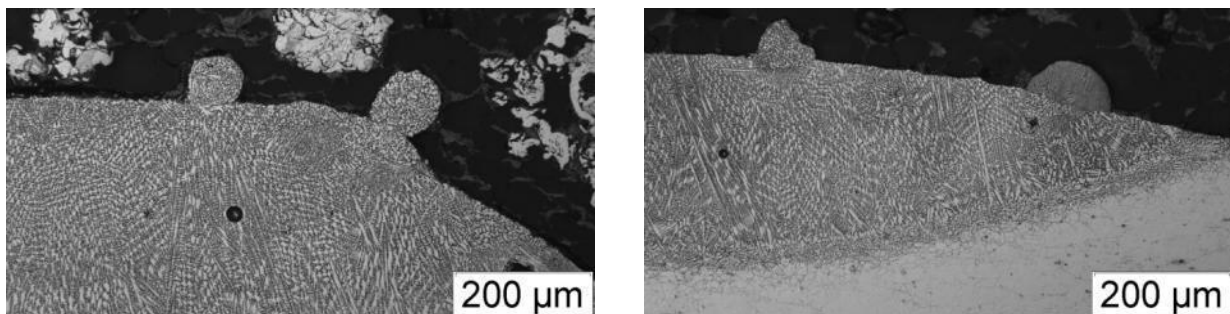
Figure 4. Un-melted powders from single beads.

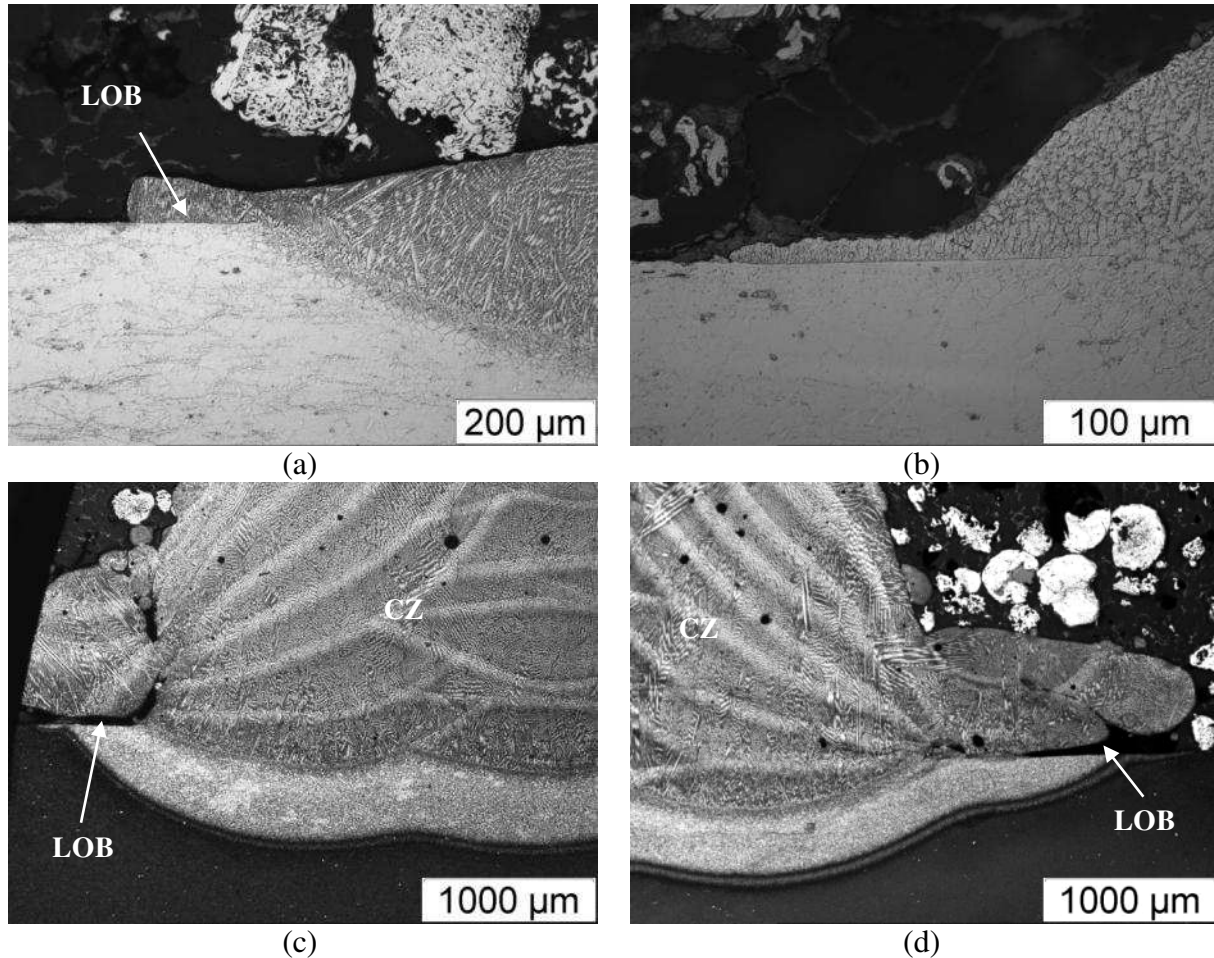
Figure 5. Overlap and lack of bonding defects in (a-b) single beads and (c-d) multi-bead and multi-layer deposits.

Overlap: Figure 5 shows typical overlap defects, which in turn may exhibit LOB between the deposit and the IN718 substrate or the previously deposited bead. On occasion, the LOB defect was observed to extend into the CZ (e.g. periphery of CZ in Figure 5d). In addition, the occurrence of overlaps significantly increased the crown area and width of the top bead. The surface overlaps also influence the bead shape and, as a result, the morphology of the multi-bead

and multi-layer deposits, such that the overall geometry of the freeform may be indefinite, as shown in Figures 5c-d.

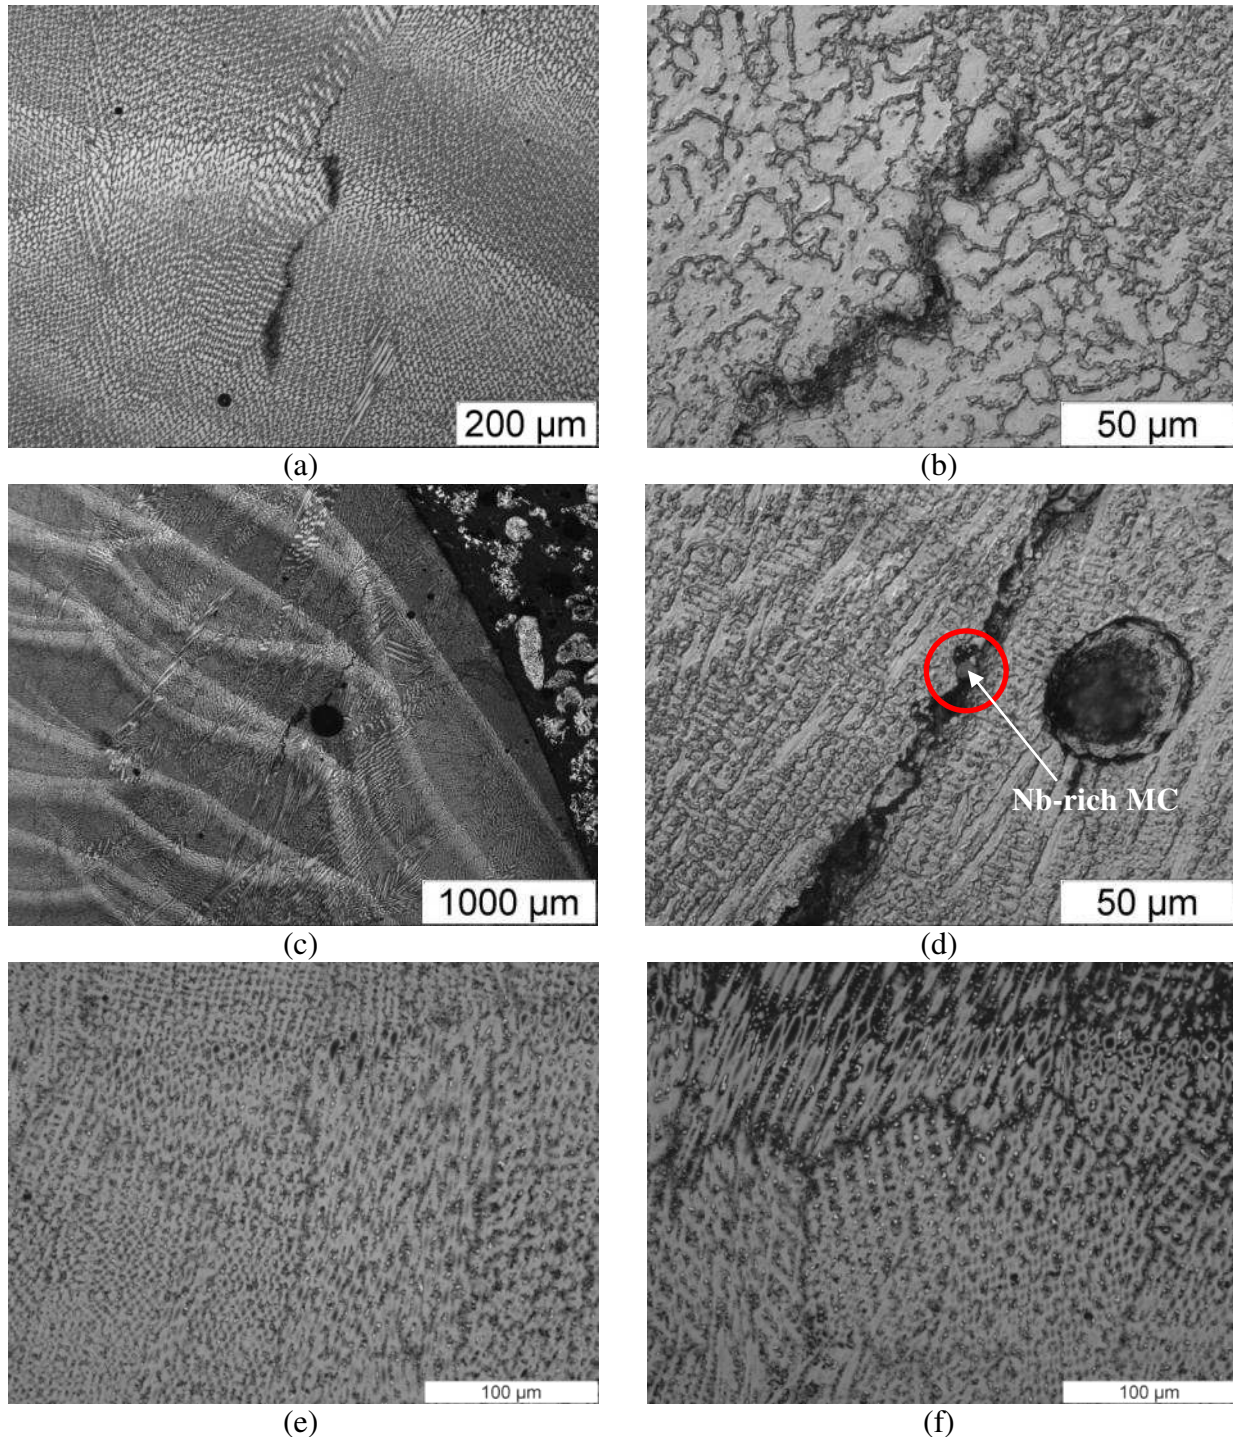
Figure 6. Weld metal liquation cracking in a multi-bead and multi-layer deposit on an as-serviced IN718 substrate in (a-d) ADed and (e-f) PCHTed conditions.

Weld metal liquation cracking: As shown in Figure 6, some interlayer microcracks are frequently present in the lower beads near the layer interface in the ADed condition. These regions in the lower beads act as the HAZ of the adjacent upper layer (beads) deposited later. Therefore, these microcracks are quite similar to the HAZ microfissures or liquation cracks as widely encountered in IN718 welds and are usually termed as weld metal liquation cracking in multi-pass welding [1, 10]. As shown in Figure 6, weld metal liquation cracking occurs in the lower beads near the interfacial area, but the cracks can propagate along the bead interface and even extend into the upper newly deposited beads. Of interest also is the association of the weld metal liquation microcracks with the porosity (Figure 7c) or Nb-rich MC type primary carbides (Figure 7d). The presence of the liquation cracks can be reasoned on the basis of the cast structure in the CZ and the formation of both the Nb-rich carbides and Laves phase during the final stages of solidification. For cast IN718, it is known that liquation cracking is dominated by the melting of the Laves phase rather than constitutional liquation of the Nb-rich carbides, since the former precipitates at a lower temperature [1] and the latter is much lower in amount. Hence, when an

earlier deposited bead is reheated during cladding of a subsequent pass, the solidification grain boundaries in the lower beads adjacent to the layer interface may re-melt and thus form liquated boundaries. The reheating may also promote grain growth, resulting in the formation of migrated grain boundaries along which liquation and even cracking can occur [1].

After PCHTed, the weld metal liquation cracks can be healed (Figures 6e-f) probably due to (i) the lower amount of Laves phase present in the CZ microstructure due to its partial dissolution during the heating stage of the solution heat treatment, (ii) the improved strength of the CZ microstructure due to the release of Nb into the matrix caused by the partial dissolution of the Laves phase during the heating stage and the precipitation of the γ'' strengthening phase during cooling after solution heat treatment, and (iii) release of the thermal strains and shrinkage stresses (associated with rapid solidification after laser deposition) during solution heat treatment [1, 10].

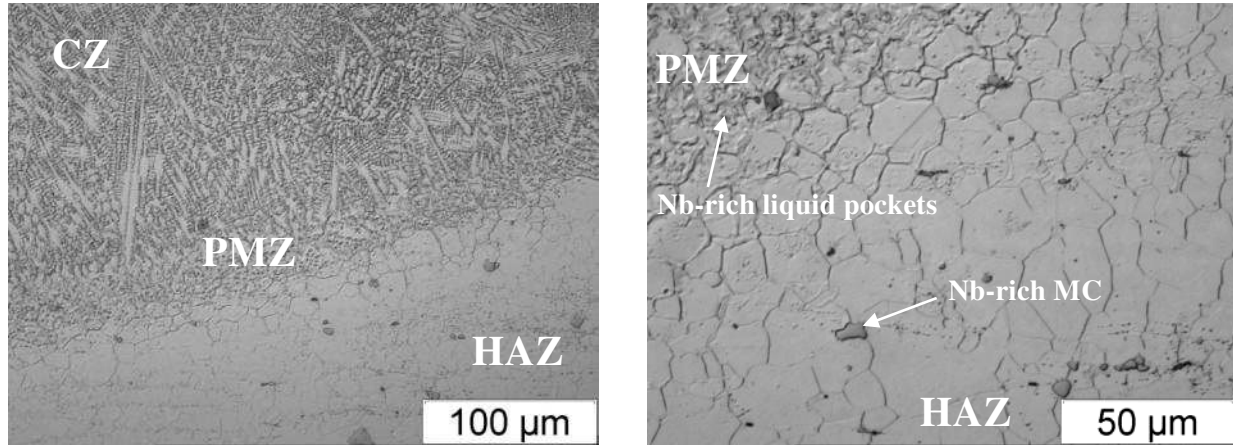
Figure 8. HAZ Microstructure taken from a single bead clad on STed IN718 in ADed condition.

In contrast the microstructures observed in the HAZ between the PM and CZ are more complicated (Figures 8-9) than those in the IN718 substrate materials. In particular, the HAZ was narrow and exhibited no significant grain growth relative to the IN718 PM in the STed condition. Compared to the single beads deposited on STed IN718, the multi-bead and multi-layer deposits, which were clad on the as-serviced IN718, showed HAZ microstructures that evolved (Figure 9) with increasing temperature towards the CZ, as experienced during laser deposition. Specifically, the HAZ near the PM was similar in microstructure to the as-serviced IN718, consisting of the γ

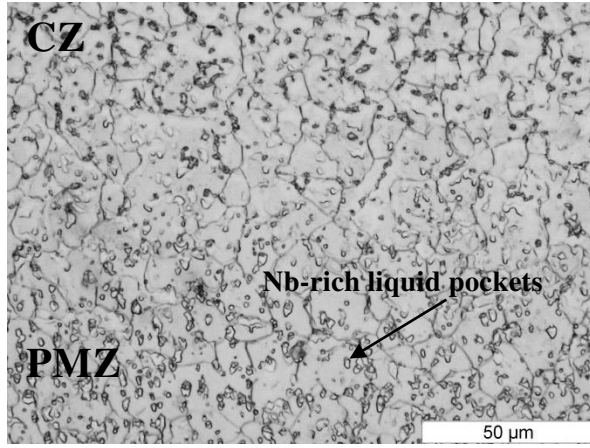
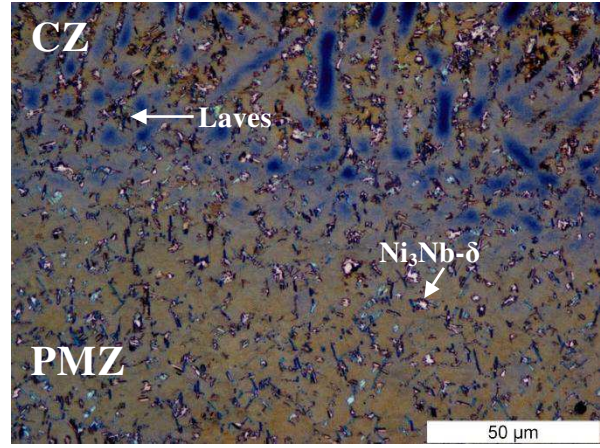
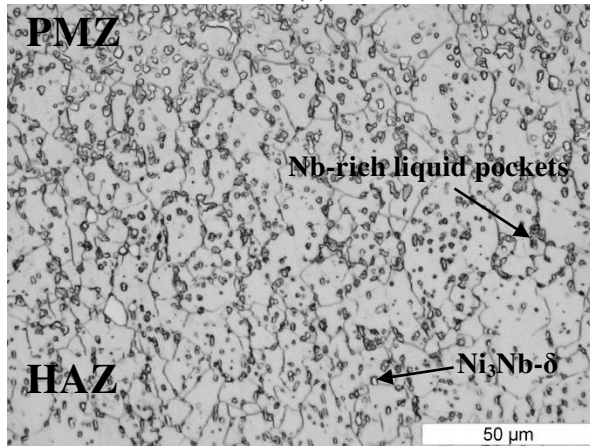
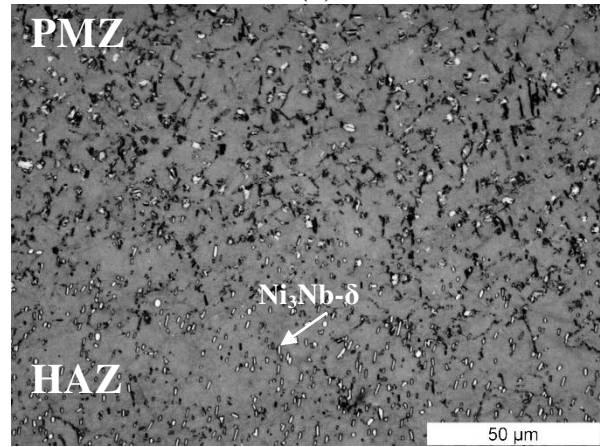
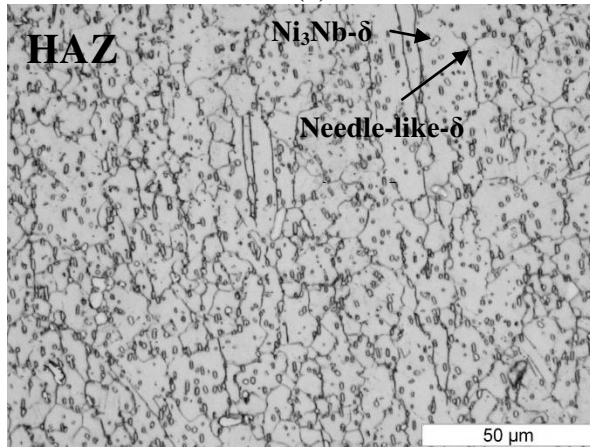
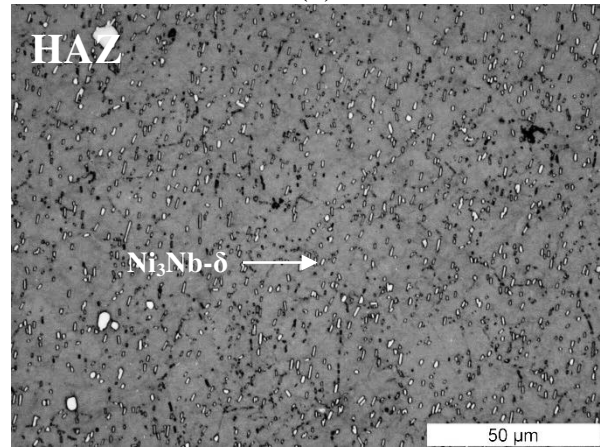
Figure 9. Microstructures of the HAZ between the PM (as-serviced) and the CZ of a multi-bead and multi-layer deposit in (a, c, e) ADed and (b, d, f) PCHTed conditions.

matrix, δ -phase (globular and needle), Nb-rich MC type primary carbides and carbonitrides, as well as γ' and γ'' . The PMZ in the HAZ close to the CZ (Figures 9a and c) contained some liquid “pockets”, as a result of $\text{Ni}_3\text{Nb}-\delta$ phase dissolution during the heating stage of the laser deposition process that renders relatively high temperatures [10, 11].

In the PCHTed condition, the fraction of needle-like $\text{Ni}_3\text{Nb}-\delta$ precipitates observed in the PMZ close to the CZ is high (Figure 9b) and their precipitation most likely occurred from the liquid “particle” formed during solution heat treatment (Figures 9b and d). As the solution heat treatment was performed at 954°C , which is lower than the solidus temperature of the $\text{Ni}_3\text{Nb}-\delta$ precipitates, the thermal conditions were insufficient for complete dissolution of the globular $\text{Ni}_3\text{Nb}-\delta$ particles in the HAZ. Thus after PCHT, the HAZ near the PM (Figure 5f) has a similar microstructure to the IN718 (as-serviced or PCHTed), consisting of the γ matrix, globular $\text{Ni}_3\text{Nb}-\delta$, Nb-rich MC type primary carbides, as well as γ' and γ'' .

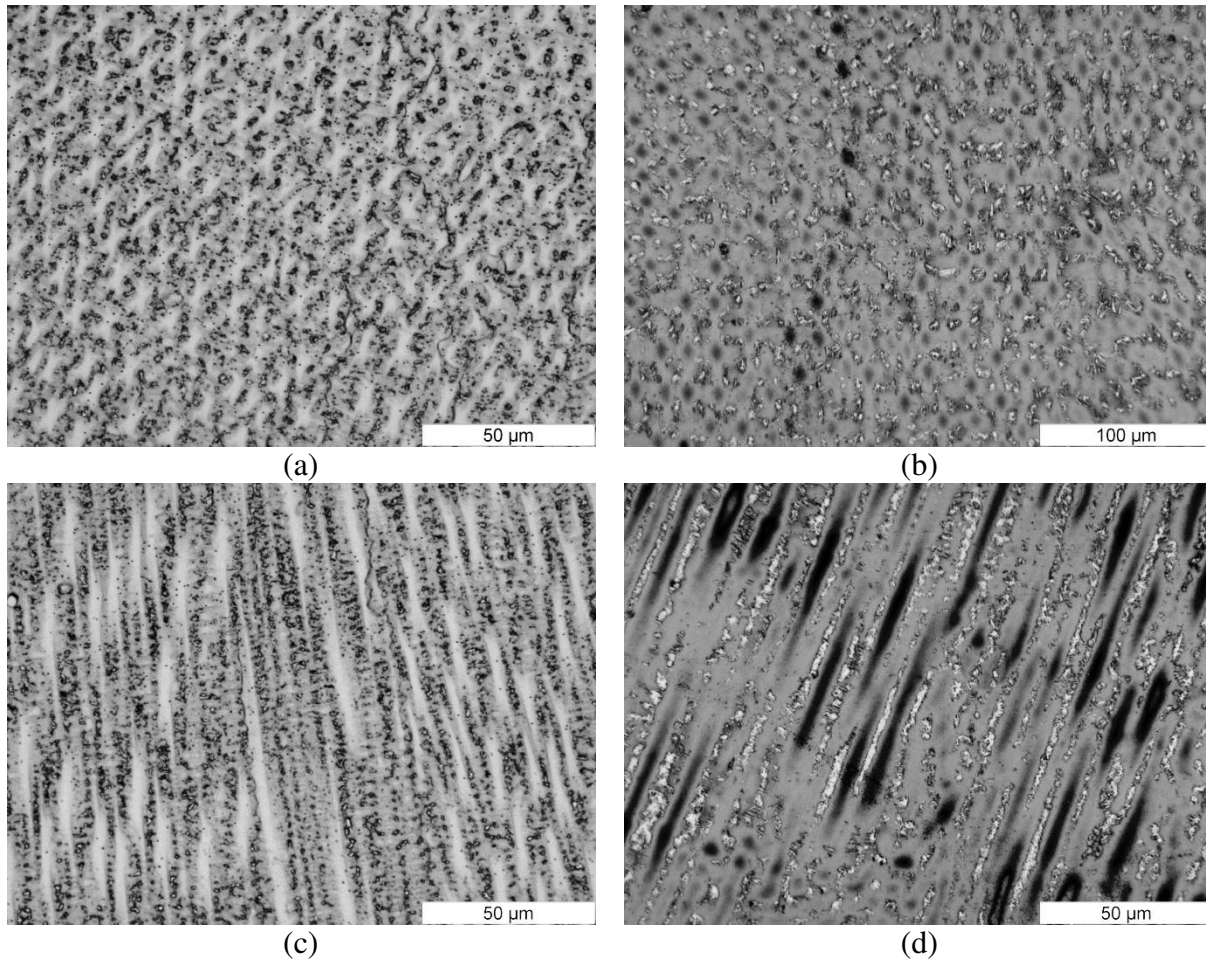
Figure 10. Microstructure of the CZ in (a, c) ADed and (b, d) PCHTded conditions; fine discrete Laves particles are observed at the CZ center (a, c) while slightly coarser and interconnected Laves particles are apparent near the layer boundary (c, d).

In the CZ, fine dendritic structures are apparent (Figure 10) and are expected on the basis of the heavily alloyed composition of IN718 as well as the relatively rapid cooling rate after laser deposition. Also, these dendrites in the CZ were finer and more equiaxed in the bead center relative to those near the layer interface. That is, the columnar dendritic growth adjacent to the weld bead or the layer interfaces results in fewer, coarser and interconnected Laves particles. In contrast, within the interior of the bead, the fine equiaxed dendritic growth renders small well-separated interdendritic regions that lead to the formation of relatively fine discrete Laves particles [12]. In laser deposition, the relatively rapid cooling rate can also extend solute solubility, which reduces the extent of segregation. During solidification, the elements Nb, Ti and Mo accumulate at the front of the liquid/solid interface and segregate to interdendritic areas, leading to the formation of carbide and Laves particles; however, the γ and NbC eutectic is suppressed during rapid cooling [3, 12].

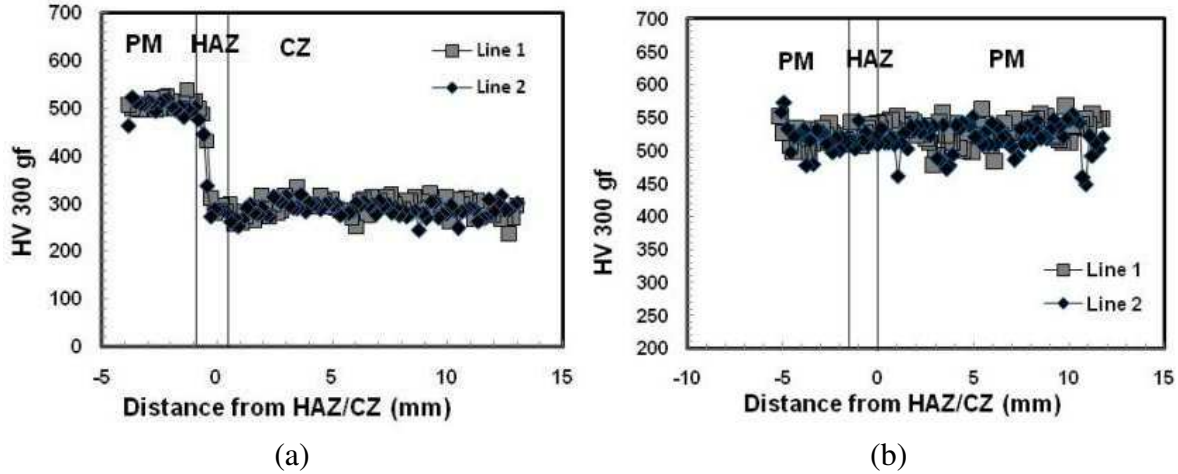
Figure 11. Vickers microindentation hardness profiles in (a) ADED and (b) PCHT conditions using as-serviced IN718 substrates.

The Vickers hardness profiles from the PM to the CZ were measured for a multi-bead and multi-layer deposit on the as-serviced IN718 in both the ADed and PCHTded conditions (Figure 11 and Table I). The hardness of the CZ was about 291 HV in the ADed and 490 HV in the PCHTded conditions. The lower hardness of the CZ in the ADed condition can be related to the thermal cycling that occurs during laser deposition that may dissolve the principal strengthening phase γ'' , which has a dissolution temperature around 900°C. Full heat treatment of the deposit can cause precipitation of the γ' and γ'' strengthening phases and thus allow nearly complete recovery of the hardness, as demonstrated in the PCHTded condition. The as-serviced IN718 substrate was fully heat treated before service and hence the PM region has a high average hardness of ~507 HV in the ADed condition, and no significant variation was measured after PCHT (502 HV).

As mentioned above, the hardness difference observed in the CZ in the ADed and PCHTded conditions mainly reflects the γ'' phase fraction precipitated in the microstructure. As the Laves phase present in the CZ microstructure of the deposits in the ADed condition consumes much of the Nb, a relatively low amount of Nb is available for γ'' precipitation. In

addition, the precipitation of the strengthening phases is hindered during laser deposition due to the relatively rapid thermal cycle. Hence, the application of a PCHT [12] is needed to release Nb into the γ matrix by dissolving the Laves phase particles during solution heat treatment; this released Nb is then available for γ'' precipitation during aging. Nonetheless, the amount of Nb available in the CZ for γ'' precipitation in the PCHT condition is lower than that in the PM, due to the partial dissolution of the Nb-rich Laves phase and the associated formation of δ precipitates. Moreover, the newly formed δ phase is also incoherent with the matrix and thus contributes little to the strengthening effect. As a consequence, the relative hardness in the CZ after PCHT remains slightly (3%) below that of the PM (Table I).
