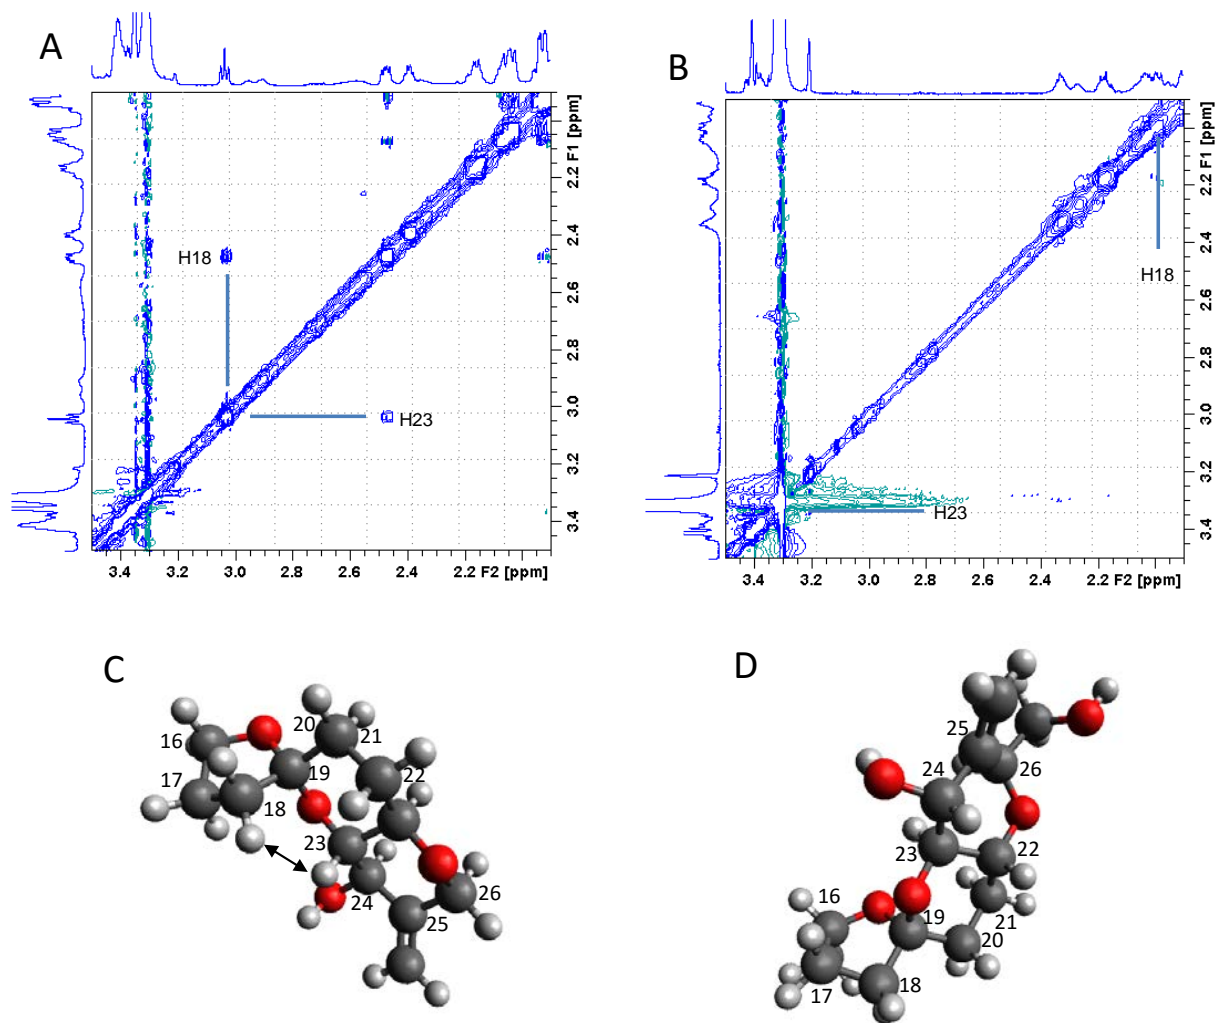
Figure 5. Section of the NOESY spectrum of 19-*epi*-DTX2 showing the correlation between H18 and H23 (A) and of DTX2 showing the absence of a correlation (B). Geometrical optimizations of 3D chemical structures for 19-*epi*-DTX2 (C) and DTX2 (D).
