The Tibbitt to Contwoyto Winter Road in the NWT: Identification of Available Data and Research Needs

LABORATORY MEMORANDUM
CHC-LM-006

FEBRUARY 2011

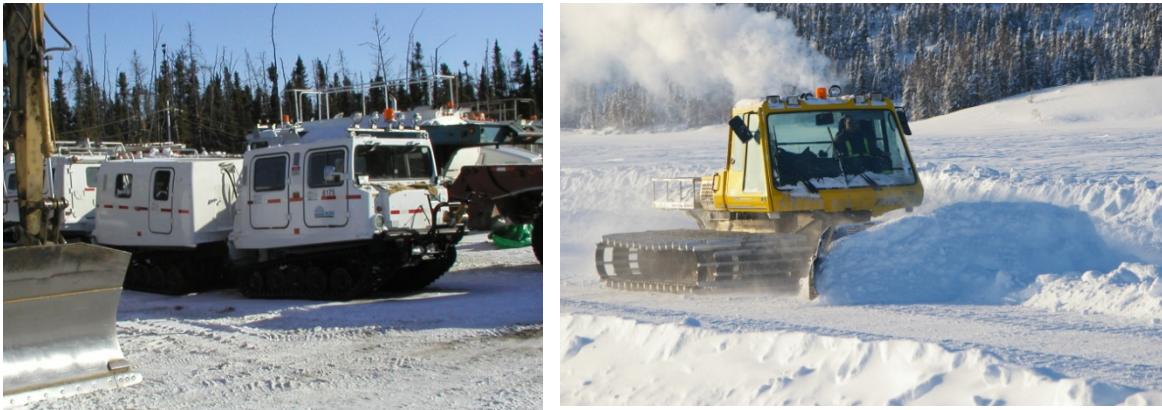
Figure 2: A Hagglund (left) and a Snow Cat (right), two light vehicles used in the initial stages of road construction to clear the ice.

Build-up initiation occurs in mid to late December, when helicopters are sent out to drill a few holes. If the ice thickness is deemed adequate, crews get on the ice with light winter vehicles, such as the Hagglunds (Figure 2), a Swedish-built amphibious vehicle, with the purpose of flattening the snow cover. Snow is an insulating material that slows down ice growth considerably. It is the main reason behind strongly fluctuating ice thickness profiles. The Hagglunds can be supported by about 30 cm of ice, and can be fitted with ploughs, though they are

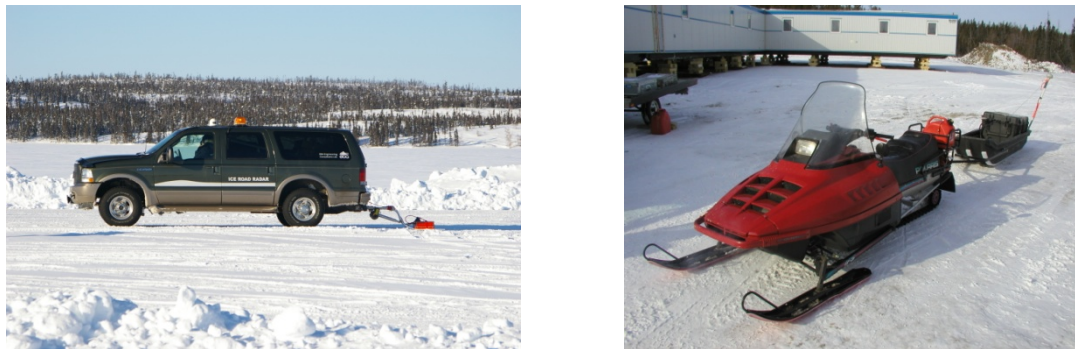
Figure 3: A ground penetrating radar (GPR) system, pulled by a light vehicle (left) or a snowmobile (right), is used to conduct high density ice, thereby closely monitoring ice thickness.

During construction, ice thickness is measured on an on-going basis either by drilling holes through the ice or, more systematically, with a ground penetrating radar (GPR)(Figure 3). More information on this is provided later.

Thickness profiles are critical. A GPR model SR3000 is used, which records a difference in the dielectric response of two different materials. The ice-water interface can be easily detected, but not the snow-ice interface. This is done by calibrating the device against a representative snow thickness. Drill holes are also done occasionally to confirm readings. The device may be pulled behind a pickup truck and the survey can be carried out at up to 40 km/h. Data is produced in real time and displayed on a screen. This procedure is done along one or more parallel lines running along the road, starting at the centre, then on both sides. The procedure when opening up a road at the beginning of the season is a little more rigorous because the ice is thinner at that time.

EBA uses another type of GPR, which is capable of measuring water depth (in addition to ice thickness), though the snow still has to be carefully accounted for. This instrumentation is in a sleigh and is pulled by a snowmobile.

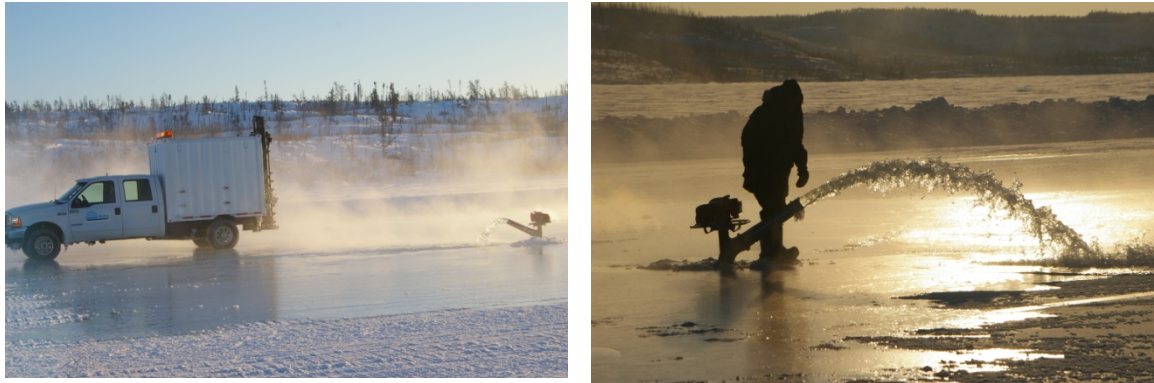
Figure 4: Left) A vehicle fitted with an auger at the back. Right) A pump in action.

Flooding is useful to improve ice surface quality and also increases the thickness of the ice cover (though the strength of that ice is known to be lower than that of natural ice). It is either done directly on the ice or with 'flood trucks' designed for that purpose (Figure 4). Some light trucks are fitted with a drill which puts holes into the ice at short intervals, and is followed by the pump-hauling crew. The flood trucks are required for the maintenance of the portages. The trucks can be filled by drilling a hole in the ice and inserting the pump nozzle into it. Flooding is often required to smooth the ice near the portages, and is used more often in the southern part of the road than in the north. It is also done more often in areas where the lakes are shallow. When too much flooding is required to fix a long segment of damaged ice, the crew may choose to build a new road alongside it instead. This is more often done in the north. Flooding may take place around the clock with two shifts. It is generally not required for express lanes, because these lanes are used by empty vehicles.

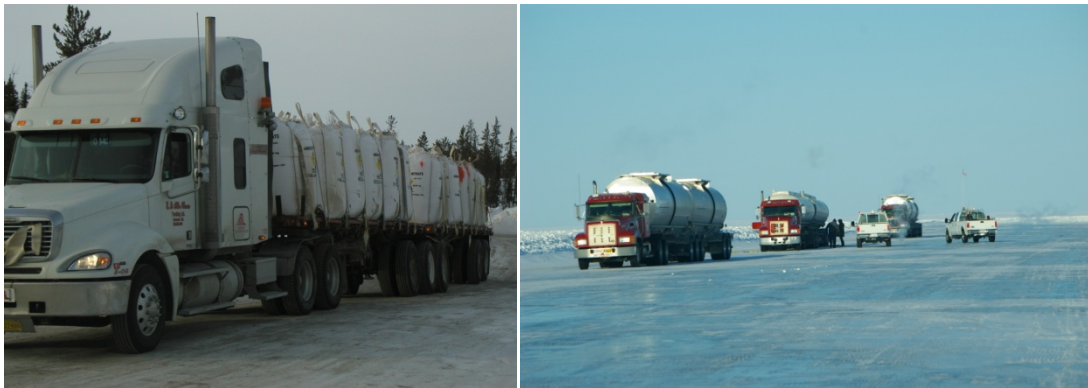
Figure 5: Examples of end-users: Left) A transport carrying ammonium nitrate. Right) A convoy of fuel tankers.

A few (4-5) major trucking companies, plus a few other minor ones, are the main end-users (Figure 5). A 'load' is a truck, typically with several axles. What limits the size of the loads that can be hauled on the road is pressure on the wheels (and therefore on the ice). The largest ones are currently about 40 tonnes (while the heaviest ever was about 88 tonnes). But it is also its length, since in order to haul more while respecting the design pressures, the load would have to be too long to handle some of the portages. The road normally sees about 170 loads per day, for a total of about 8000 loads in 2008.

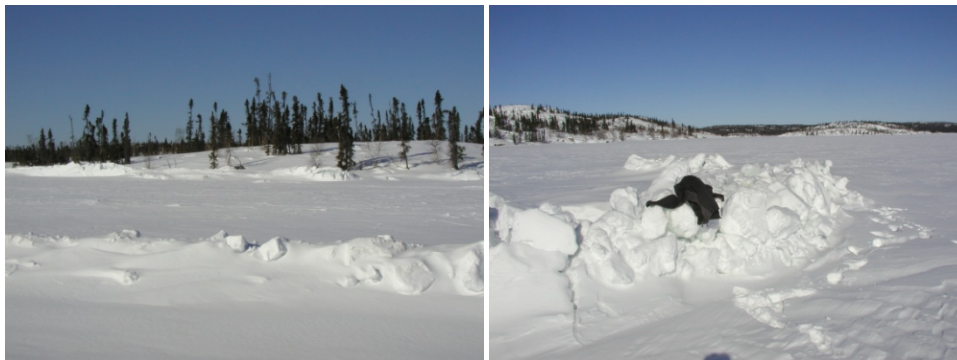
Figure 6: Two examples of a 'blowout'. Coat for scale at right.

Surface quality is a main concern, particularly when affected by sudden events such as '**blowouts**'. These are the sudden breakage of the ice, caused by water waves produced by the moving loads (Figure 6). For instance, an experiment was conducted once whereby a few holes were drilled into the ice and a truck drove by at speeds of 25, 20, 15 and 10 km/h. They noted that the water spurted out of the hole much more at the higher speeds, while it remained stable at the lowest speed. This argument is used by JVMC to explain to drivers why they have to keep their speed down (bearing in mind that these people are paid – handsomely – by the trip and a cruising speed of 25 km/h is already *very* slow).

One way to mitigate the risks of blowouts is to lay out the ice road, whenever possible, so that it does not make a 90 deg. angle with the shoreline. This is based on past experience and observations. For instance, an accident occurred some time ago when the first truck of a two-truck convoy headed toward a portage on an ice road at right angle with the shoreline. Its speed was considerable, thereby creating a wave (so it is believed) that blew out the cover, and caused the second truck to run into the ice fragments.
