## ICE/STRUCTURE INTERACTION TESTS WITH ICE CONTAINING FLAWS

By G.W. TIMCO

(Hydraulics Laboratory, National Research Council of Canada, Ottawa, Ontario K1A 0R6, Canada)

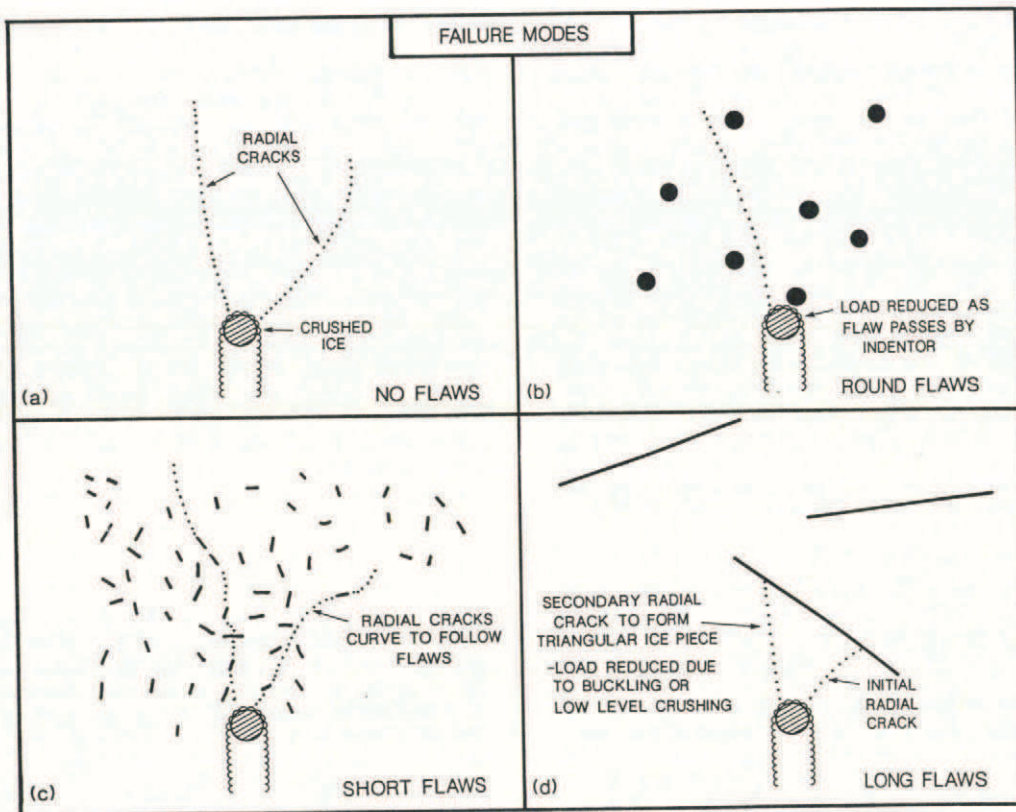
Fig. 1. Schematic representation of the failure modes observed in the tests.

This is much lower than the loading on the structure and therefore propagation of the radial cracks will occur. In general, the length of these radial cracks was somewhat variable but they were typically of the order of 0.5–1 m during the tests. A schematic diagram of this failure mode is shown in Figure 1a.

Figure 2 shows the load-time records for the test in three different ice sheets with different round flaw densities. For virgin ice ( $n = 0$ ), the load-time series is cyclic and relatively uniform throughout the whole test. With a small flaw density ( $n = 7 \text{ m}^{-2}$ ), "dips" occur in the load-time series, resulting in less uniform behaviour. These "dips" in the load occur when the indenter interacts directly with one of the round flaws (see Fig. 1b). For high flaw densities

$L = 60 \text{ cm}$ . For this flaw length, eight tests were performed for flaw densities up to  $7 \text{ m}^{-2}$  (see Table III). Even at the lowest flaw density ( $1 \text{ m}^{-2}$ ), there was a marked change in the failure mode of the ice compared to unflawed ice. With the radial cracks connecting to the flaws, an ice-splitting event would occur such that triangular pieces of ice would form and fail by buckling or crushing (see Fig. 1d). Similar

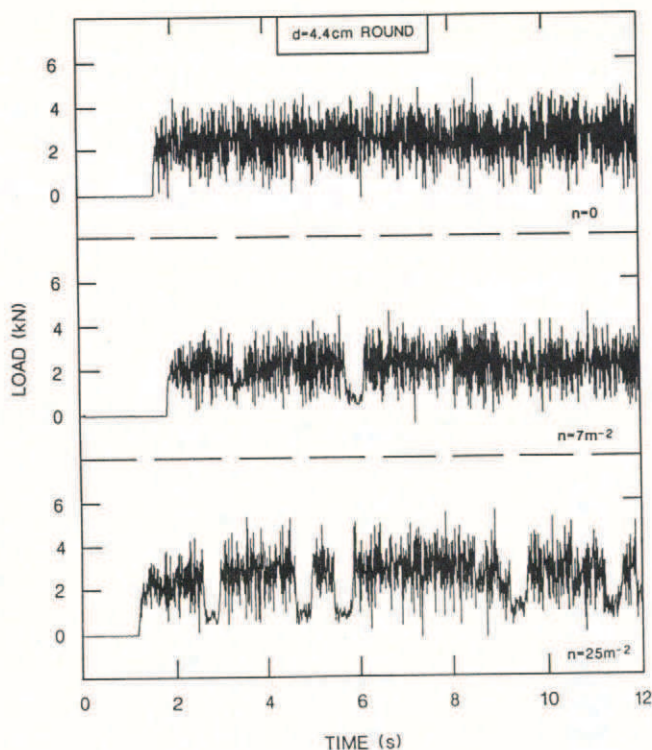
Fig. 2. Time series of the load on the structure for ice containing round flaws of density  $n = 0, 7$ , and  $25 \text{ m}^{-2}$ .

( $n = 25 \text{ m}^{-2}$ ), these dips are, as expected, much more numerous. From the load-time series, the average and peak loads were determined for each case and the results are listed in Table II. (Note: in determining these loads, the time series from 2 to 12 s was used; i.e. the initial zero load before contact with the ice was omitted.) The results are presented in Figure 3 in terms of average and peak pressures on the structure as a function of flaw density. These are compared to the values measured in the unflawed ice. With regard to the *peak* pressure on the indenter in the flawed ice, it appears that the flaws have no effect, regardless of their density. For the *average* pressure, on the other hand, it is evident that it decreases with increasing flaw density. This results from the drop in the load as the indenter interacts with a flaw.

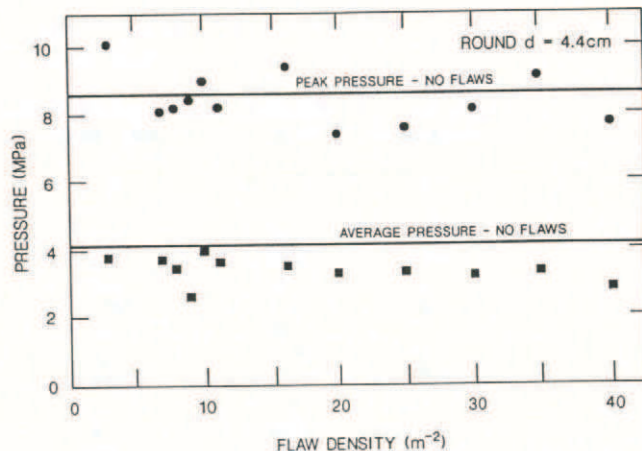
Fig. 3. Peak (●) and average (■) pressure on the structure as a function of flaw density for round flaws of diameter 4.4 cm.

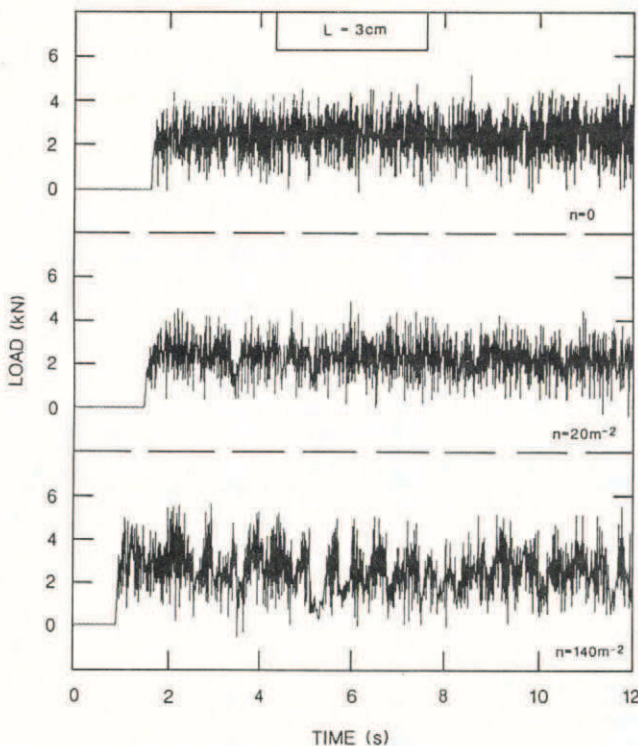
Fig. 4. Time series of the load on the structure for ice containing flat flaws of length 3 cm and densities 0, 20, and  $140 \text{ m}^{-2}$ .

$L = 3 \text{ cm}$ . For relatively short flaws of 3 cm length, 19 tests were performed for flaw densities up to  $140 \text{ m}^{-2}$  (see Table III). In these tests, the ice failed by crushing with radial cracking similar to that of the unflawed ice. For high flaw densities, however, it was noted that the radial cracks would sometimes deviate slightly from their apparent path to follow one of the flaws (see Fig. 1c). This occurred only if the flaws were more or less parallel to the direction of the crack propagation. In terms of the load-time series, their behaviour with increasing flaw density (shown in Figure 4) was very similar to that observed for the round flaws. Similarly, as shown in Figure 5, the peak pressures remain independent of flaw density, whereas average pressures decreased with increasing flaw density.

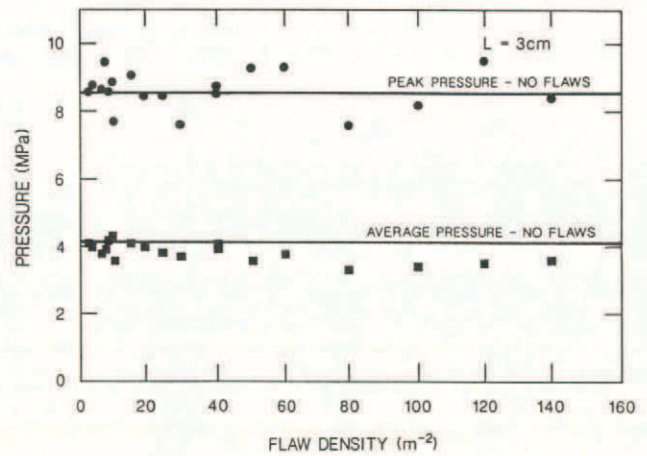
Fig. 5. Peak (●) and average (■) pressure on the structure as a function of flaw density for flat flaws of 3 cm length.

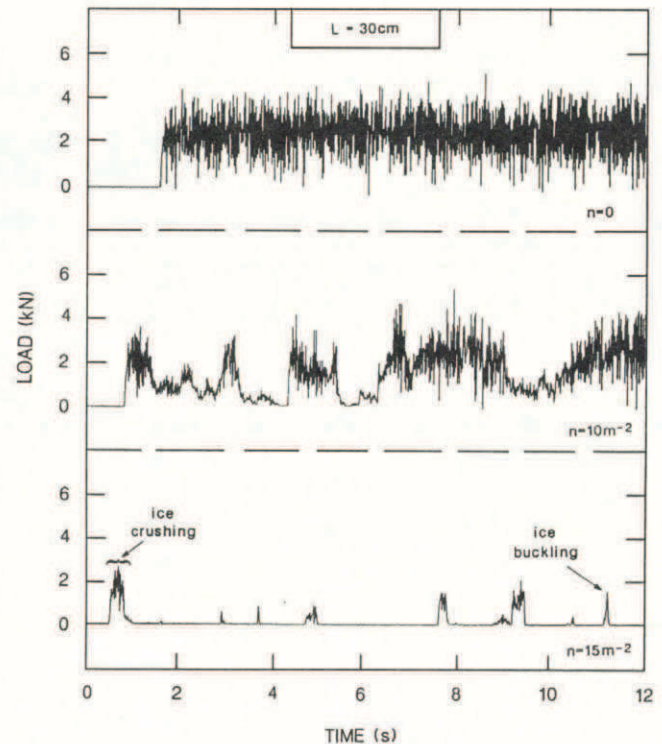
Fig. 6. Time series of the load on the structure for ice containing flat flaws of length 30 cm and densities 0, 10, and  $15 \text{ m}^{-2}$ .

the tests as shown in Figure 6. For intermediate flaw densities ( $n = 10 \text{ m}^{-2}$ ), the overall level of the crushing force is significantly reduced, and there are times when very low loading occurs. For the higher flaw densities of  $15 \text{ m}^{-2}$ , the overall loading is very significantly reduced, having long stretches with no load at all on the indenter. Figure 7 shows the peak and average pressure as a function of flaw density for  $L = 30 \text{ cm}$ . For flaw densities up to  $\approx 10 \text{ m}^{-2}$ , the peak pressure is similar to but slightly less than that for unflawed ice but, for densities higher than that, the peak pressures decrease significantly. With regard to the average pressure, it is lower than that for unflawed ice for all flaw densities.

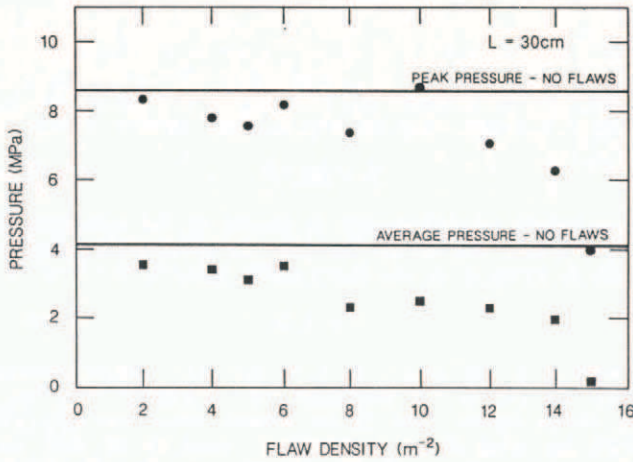
Fig. 7. Peak (●) and average (■) pressure on the structure as a function of flaw density for flat flaws of 30 cm length.

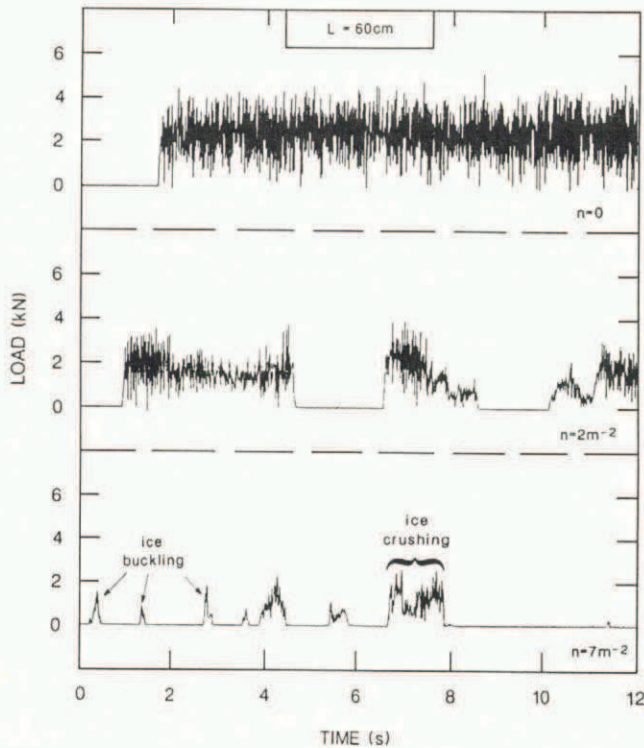
Fig. 8. Time series of the load on the structure for ice containing flat flaws of length 60 cm and densities 0, 2, and  $7 \text{ m}^{-2}$ .

Figure 8 shows the changes in the time series with increasing flaw density. For  $n = 7 \text{ m}^{-2}$ , the crushing occurs at very low loads, with significant times when there is no load at all on the structure. During this time of zero load,

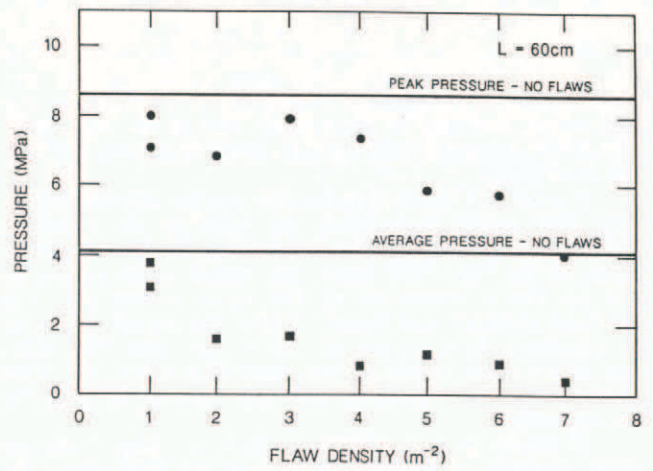
Fig. 9. Peak (●) and average (■) pressure on the structure as a function of flaw density for flat flaws of 60 cm length.

the large broken pieces of ice would slide past the indenter, producing a relatively low loading event. In Figure 9, a comparison of both the peak and time-average loads with that for unflawed ice shows that the long flaws significantly reduce these loads on the structure. As shown in the load-time series, there can be extensive time periods when the load on the structure is small or zero (if the flaw density in the ice is high and the flaw lengths are long). This can significantly change the nature of the loading on the structure.

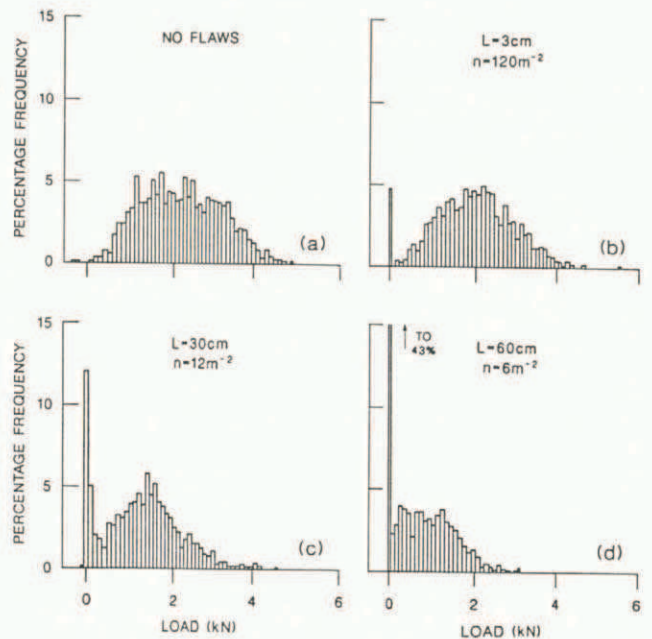
Fig. 10. Frequency histograms of the load on the structure (a) no flaws, (b)  $L = 3 \text{ cm}$ ,  $n = 120 \text{ m}^{-2}$ , (c)  $L = 30 \text{ cm}$ ,  $n = 12 \text{ m}^{-2}$ , (d)  $L = 60 \text{ cm}$ ,  $n = 6 \text{ m}^{-2}$ . Note the shift towards lower loads and long times with zero load on the structure for the longer flaws.

A comparison can be made of the relative frequency of the load on the structure for any flaw length. This is done in Figure 10 for comparable total flaw lengths ( $360 \text{ cm m}^{-2}$ ) for all flat flaws. Also included on this figure is the load-frequency histogram for the case of no flaws. Comparing the loading behaviour on the structure is very informative when viewed in this manner. If there are no flaws in the ice, the loading events follow a more or less

normal distribution. For high-flaw densities of the smaller flaws, the distribution retains its normal shape, but there is an added "spike" in the spectrum representing zero load on the structure. For increasing flaw length, this "spike" at zero load increases dramatically, such that for  $L = 60$  cm the load on the structure is non-existent 43% of the time. Also, the whole spectrum shifts towards lower loads with increasing flaw length.

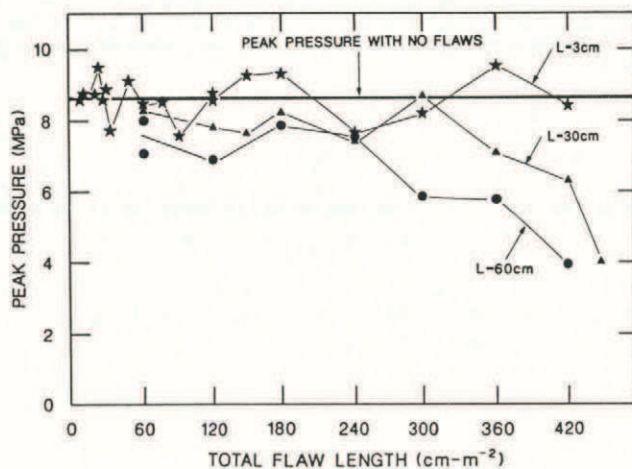
Fig. 11. Peak pressure on the structure versus total flaw length ( $\text{cm m}^{-2}$ ) in the ice for flaws of length 3 cm, 30 cm, and 60 cm.

It is of interest to compare the relative effectiveness of each flaw length in reducing the loads on the structure. This can be accomplished by normalizing the flaw length in terms of the total flaw length per square meter (given by  $n \times L$ ). This is shown for all flat flaws in Figure 11 (for the peak pressure) and Figure 12 (for the average pressure). In examining these figures, it can be seen that long flaws can have a great impact on the loads on the structure, even for very low flaw densities. The reduction in the load can be substantial.

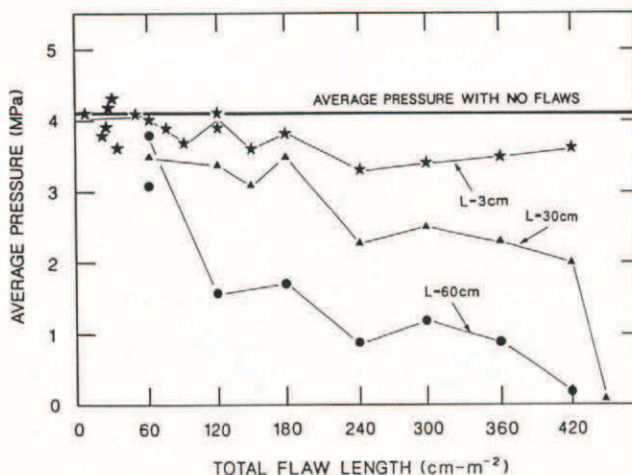
Fig. 12. Average pressure on the structure versus total flaw length ( $\text{cm m}^{-2}$ ) in the ice for flaws of length 3 cm, 30 cm, and 60 cm.

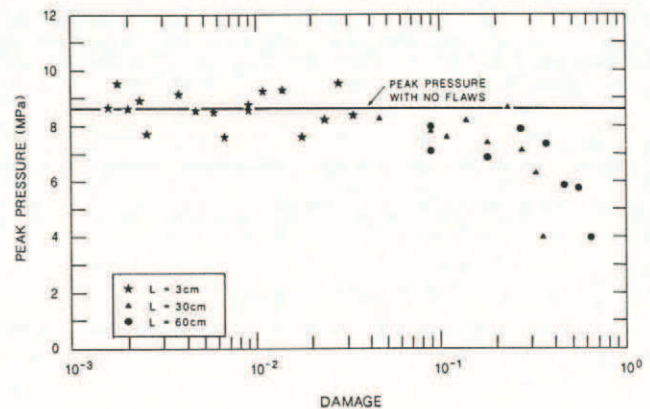
Fig. 13. Peak pressure on the structure versus the damage ( $D$ ) in the ice for flaws of length 3 cm, 30 cm, and 60 cm.

The test data can be examined in terms of the damage coefficient  $D$ ; this gives more meaningful comparison of the different tests than simply looking at the total flaw length (i.e. Figs 11 and 12). Figure 13 shows the peak pressure versus the damage in the ice (defined using Equation (4))

for all three flaw lengths. In general, there is a good correlation amongst the three. The figure indicates that the peak pressure which the ice sheet can exert on the structure is relatively insensitive to damage up to a level of 0.2. Above this value, the peak pressure decreases rapidly. In a similar manner, Figure 14 shows the average pressure versus damage for all three flaw lengths. Again there is good correlation. In this case, however, it appears that the average pressure is insensitive to damage for  $D$  up to  $10^{-2}$ .

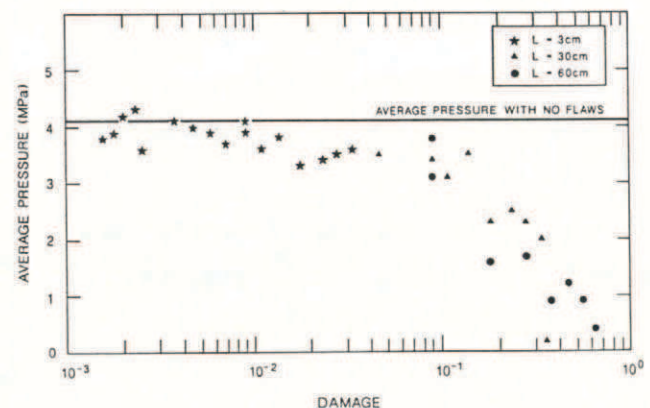
Fig. 14. Average pressure on the structure versus the damage ( $D$ ) in the ice for flaws of length 3 cm, 30 cm, and 60 cm.

Above this value, the average pressure decreases slightly up to  $D = 0.1$ , whereupon it drops rapidly with increasing damage. This simple analysis yields consistent results and may be a very useful way of looking at ice behaviour.

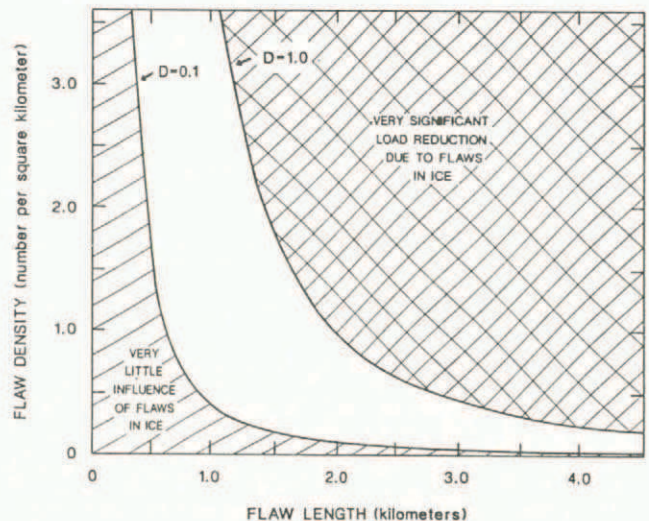
Fig. 15. The calculated ranges of flaw length ( $L$ ) and density ( $n$ ) which affect the ice loads on Arctic structures based on the damage index  $D = n(L/2)^2$ .

A second and more general approach to applying the results to predict full-scale behaviour is based on the simple model of ice damage caused by flaws. Certainly, from Figures 13 and 14, there appears to be good correlation of all test results suggesting that  $D$ , which is a dimensionless parameter, may be a useful index for damage in a much broader sense. By using the same definition for damage (i.e. Equation (4)) and assuming that the amount of damage in the ice for load reduction is the same as that found in these experiments, it is possible to predict the size and density of flaws required for load reduction in Nature. In terms of the peak load on the structure, it would seem that the damage has little effect for  $D$  less than 0.1 (from Fig. 13). For  $D > 1.0$ , it is quite evident that there is a very substantial reduction in the peak loads on the structure. Using these limits and Equation (4), it is possible to "map" the areas of flaw size and density which correspond to these values in Nature. The calculated ranges, which are shown in Figure 15, indicate that relatively few long cracks are required for a substantial reduction in load.
